TIR GOFAL MANAGEMENT PLAN: HERITAGE MANAGEMENT INFORMATION (HE2)

**Prepared for:
Cefn Meurig**

Tir Gofal Reference No
W/11/4983

ACA Report No. **2005/59**
Project Record No. **53668**

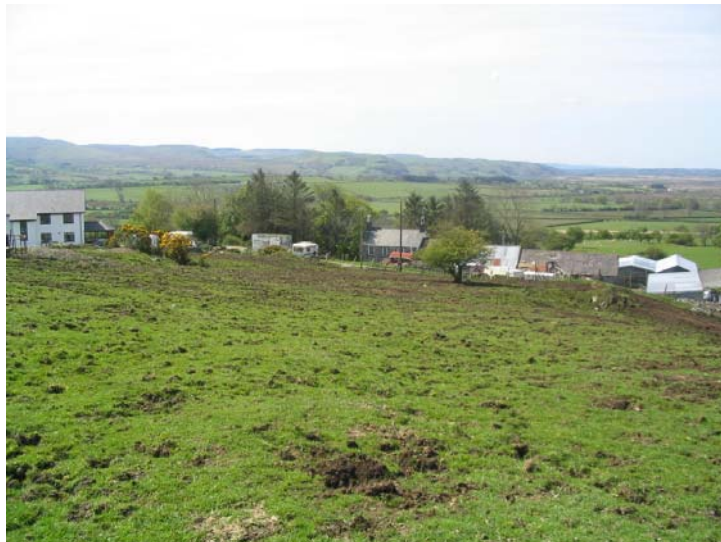
1	CEFN MEURIG (53919)	Unknown enclosure	SN7250168012	U		Specific
---	---------------------------------------	-------------------	--------------	---	--	----------

Enclosure complex alongside the eastern side of Cefn Meurig farmstead. Four rectangular enclosures abut a field boundary. Other linear features are present on this site which may be remnants of earlier field systems. The extent of the complex is undefined but earthwork banks are clearly visible in the south and west of the field behind the farmstead. At the time of the visit, this field was heavily poached by cattle with erosion to some the earthwork banks. Poaching is concentrated around a round feeder in the east of the area.

Looking south-west towards the enclosure complex and Cefn Meurig beyond.

The earthwork banks should be protected from damage. The management aim is to encourage a stable grass cover over the site without poaching or causing erosion.

- Stop supplementary feeding within the area of the earthworks. Consider re-siting the feeder away from the enclosures. eg. in the north-east part of the same field.

- Reduce stocking levels in this field.

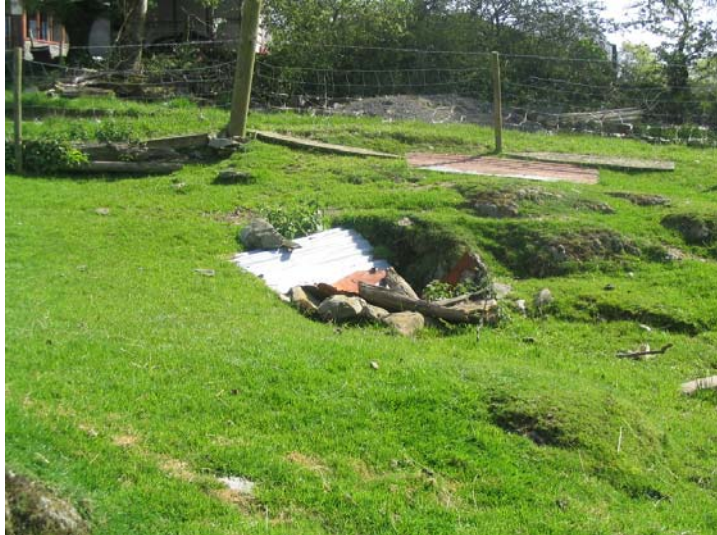
CEFN MEURIG [\(53920\)](#) Post Medieval well SN7254067951 B

A well is identified at this location on the 1st edition Ordnance Survey map (1888). The well is an enhanced natural spring, apparent as a shallow circular depression enhanced by boulders on the downslope side. Corrugated iron sheets now cover the well.

The well at Cefn Meurig.

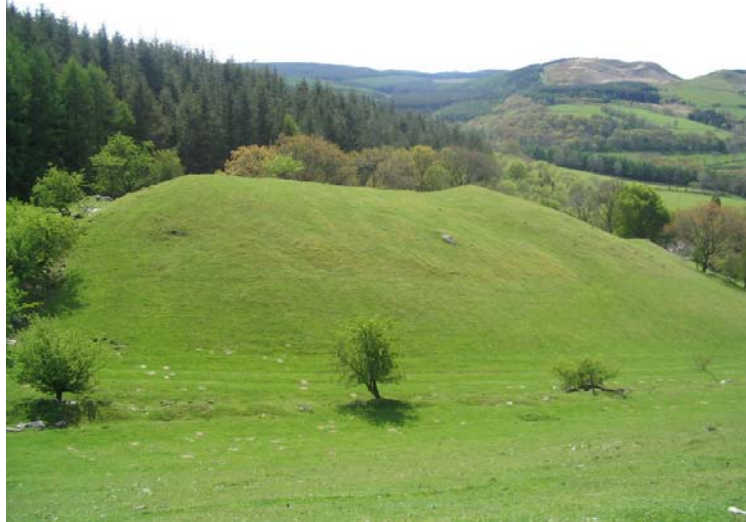
[\(53923\)](#)

A ditched enclosure with an area of ridge and furrow some 100m to the north recorded by the RCAHMW. The site occupies the west facing slope of a low hill. The enclosure is ploughed down but still visible. No obvious traces of the ridge and furrow were observed within the Tir Gofal application area.

The enclosure is ploughed down but still visible.

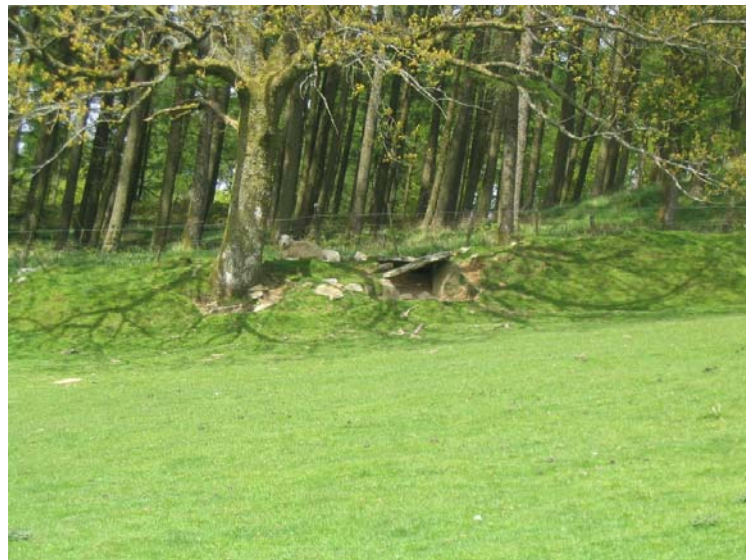
[\(54280\)](#)

There is a narrow stone culvert, approximately 0.8m wide with large cap stones in a field bank some 200m northwest of Pantyfedwen farmstead. A drainage function is considered unlikely and the feature may have served as a sheep crawl.

The stone culvert could have served as a sheep crawl.

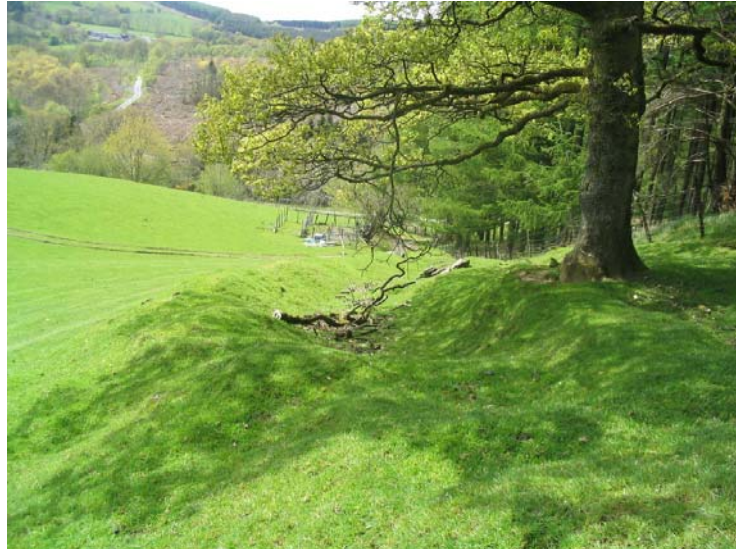
[\(54281\)](#)

An unusual earthwork feature on sloping ground along a field boundary to the west of Pantyfedwen farmstead. It consists of an elongated flat bottomed depression some 18m by 0.5 by 3m defined by large earth and stone banks. Possible interpretations might include a sunken shelter for the storage of perishable foodstuffs or the point where a hedge bank bisects an earlier boundary line.

The earthwork is built into a shallow slope.

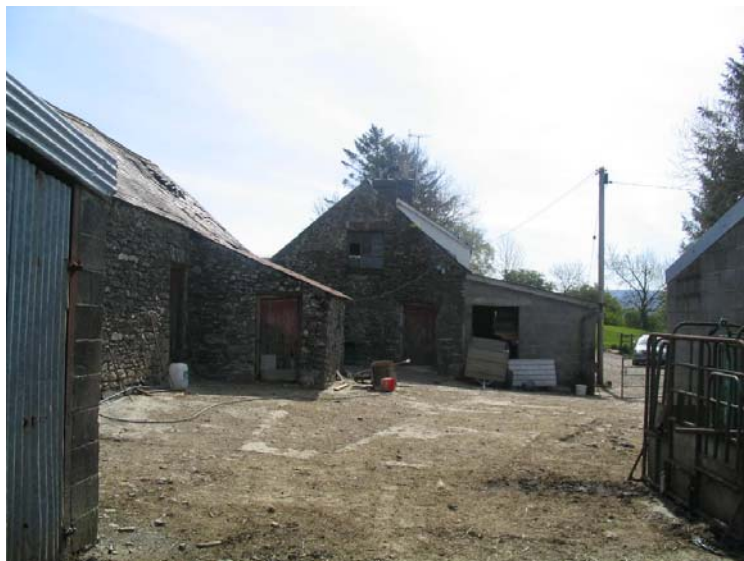
Name (& PRN)	Period/Site type	NGR	Status	SAM/listing	Management required
CEFN MEURIG (53918)	Post Medieval farmstead	SN7253667952	B		Generic

A working farmstead complex on sloping ground above the Afon Meurig. The farmhouse, outbuildings and a barn are positioned in a line opposite a small outbuilding. Modern agricultural buildings are situated to the north. Map evidence (OS 1888, 1905) suggests a 19th or early 20th century date for traditional buildings at Cefn Meurig. Traditional buildings have experienced some modifications but the farmstead retains many original elements.

The barn and outbuildings at Cefn Meurig.
