TIR GOFAL MANAGEMENT PLAN: HERITAGE MANAGEMENT INFORMATION (HE2)

**Prepared for:
Mynydd Melin
Tir Gofal Reference No
W/13/5483**

**ACA Report No. 2005/102
Project Record No. 53694
Prepared by
Philip Poucher**

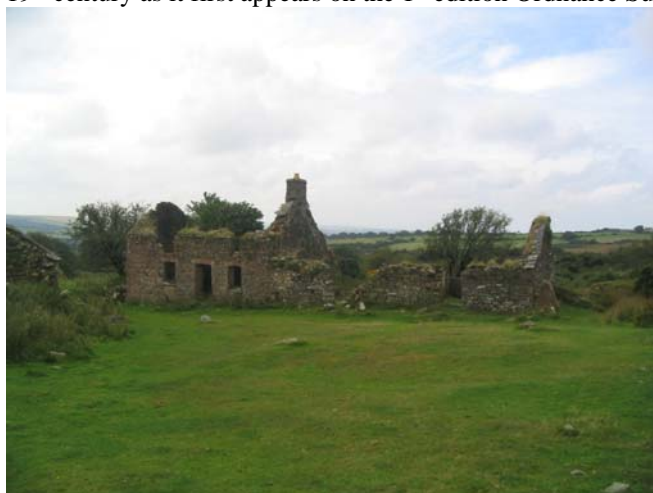
A deserted small farmstead complex, the buildings are still standing but ruinous. The site consists of a mortared rubble built farmhouse, originally 2-storey high with a slate roof. A small barn range is attached to the northern end of the farmhouse, including 3 concrete cattle stalls. Opposite this range stands a detached mortared rubble built barn range. The internal floor and roof of the farmhouse have gone, the interior is rubble filled with a tree growing in the southern end and vegetation covering the rear wall. The attached barn range is greatly ruined. The detached barn range is also greatly ruined and vegetation filled, only the gable and rear walls stand close to their original height. The farmstead complex is not marked on either the old series Ordnance Survey map of 1819 or the tithe map of c1841, suggesting it was built in the mid to late 19th century as it first appears on the 1st edition Ordnance Survey map of 1889. *Visited 09/09/2005 (PP)*

SW facing shot of the main farmhouse and attached barn range of the deserted farmstead complex PRN 54327.

The aim of the management for this site should be to preserve and stabilise surviving building remains. Many walls stand to nearly their full height and the plan of this small farmstead complex is still clearly visible. However, many of the remains are vegetation covered, with thick vegetation growing on the rear of the main farmhouse building, two trees growing close to its southern gable wall and a tree growing internally, which could be destabilising the remains and causing damage.

- The tree growing within the farmhouse should be carefully cut back and treated and dead material removed. Tree branches growing against the southern gable wall may also need to be cut back in future.
- Thick vegetation covering some of the building walls should be carefully cut back to reveal the wall structure beneath, to assess any potential damage the vegetation growth may be causing to the structure. The vegetation should only be completely removed if this can be done without causing further damage to the structure.

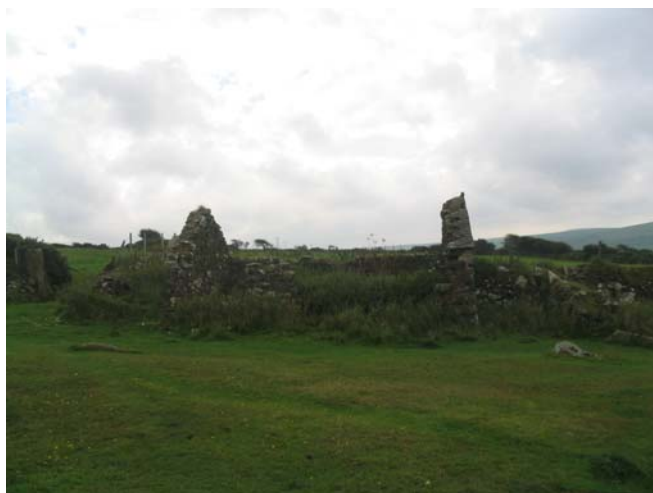
SE facing shot of the detached barn range at deserted farmstead complex PRN 54327.

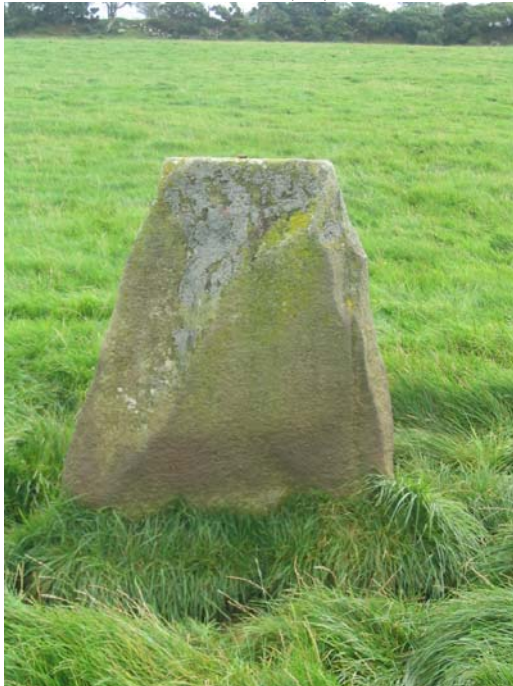
A 'stone' marked on the 1st edition Ordnance Survey map of 1889. Visible as a deliberately placed upright stone near the centre of the field, measuring c0.9m x c0.3m and 1.4m high. Identified as an animal rubbing stone. *Visited* 09/09/2005 (PP)

E facing shot of rubbing stone PRN 21454.

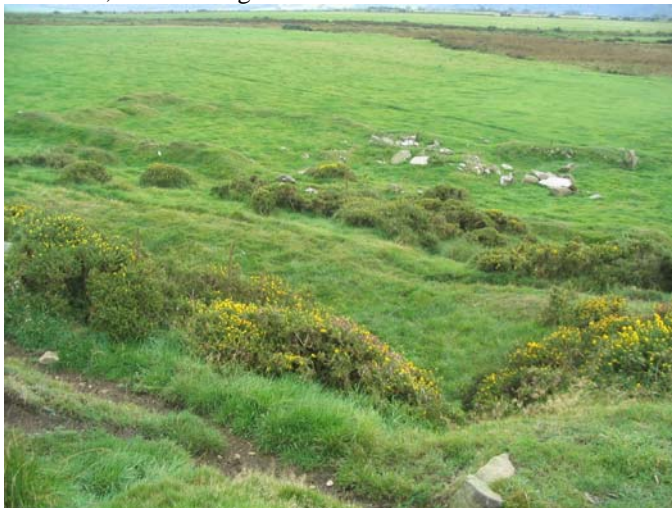
A small cottage site marked on the 1st edition Ordnance Survey map of 1889, although possibly already abandoned by that time. Low banks of tumbled stone define the main dwelling, a 2 cell structure aligned NE-SW, measuring c10m by 4m with opposing entrances in the largest (northernmost) cell. Stone and earth banks define enclosures on both east and west sides of the main dwelling. A platform measuring c11m by 4m is cut into the hillside immediately north of the main dwelling. The site appears in a fairly stable condition, covered in grass with areas of heather around the northern platform. *Visited* 09/09/2005 (PP)

Looking S over the earthwork remains of cottage site PRN 54326. The upper platform lies in the foreground, with the earth and stone banks of the cottage and surrounding enclosures beyond.

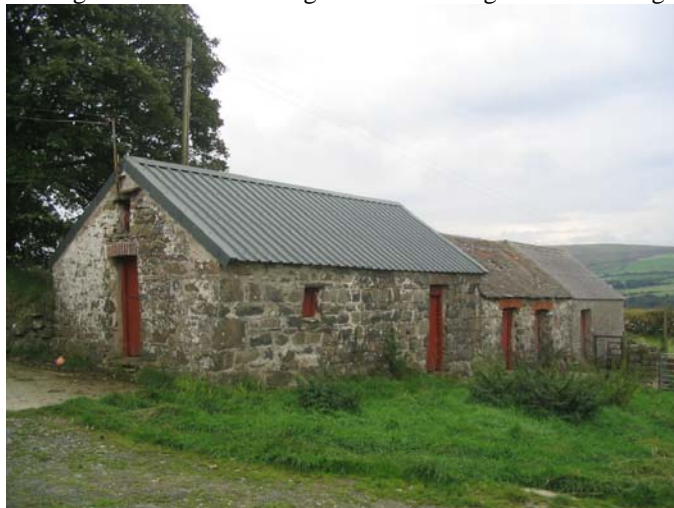
Name (& PRN)	Period/Site type	NGR	Status	SAM/listing	Management required
1	MYNYDD-MELYN <u>(54332)</u>	Post Med/ Farmstead	SN0151435123	B		Specific
<p>A working farmstead complex lying in the Cwm Gwaun valley below Mynydd Melyn. The first record of a dwelling here comes from 1591 when Thomas Bateman is recorded as the owner although the current farmstead appears to be made up of a mixture of 19th and 20th century buildings. The traditional farm buildings consist of a range of farm buildings to the south of the farmhouse with a longer range of farm buildings on the opposite side of the farmyard to the west, modern farm buildings lie beyond. Another traditional farm building lies to the east of the farmhouse, flanked by more modern lean-to's. These buildings are built of mortared rubble, in places roughly coursed and limewashed internally with brick quoins and lintels, although some lintels are of slightly different brick and styles. Roof coverings are mixed, originally slate and patched in places with corrugated iron, many roofs have been replaced with a mixture of more modern materials. The individual barn building to the east is built in the same style with a slate roof, but also with several tiers of nesting boxes in the gable wall. These traditional buildings are all marked on the 1st edition Ordnance Survey map of 1889 and also appear to be marked on the tithe map of c1841. A stream flows through the farmyard, emerging from at stone built structure at the northern end and running under a culvert for much of its length. The buildings remain in use and in relatively stable conditions although the slate and corrugated iron roofing is deteriorating in places. <i>Visited 09/09/2005 (PP)</i></p>

SE facing shot of the southern barn range, also showing the varying roofing materials. Slate with corrugated iron patching remains on the central barn, although in a deteriorating state.

The aim of the management for this site should be to ensure the survival of the traditional buildings and maintain the historic character of the complex of farm buildings as a whole. The farmstead buildings are still in use and generally in a good state of repair, although some of the slate roofs, patched with corrugated iron in places, are noticeably deteriorating and weather damaged. Many of these traditional roofs have been replaced over the years with a variety of more modern materials.

- Deteriorating roof coverings, both damaged traditional roof coverings and more modern replacements, should be replaced with traditional materials appropriate to the farmstead and its locality (slate and corrugated iron).

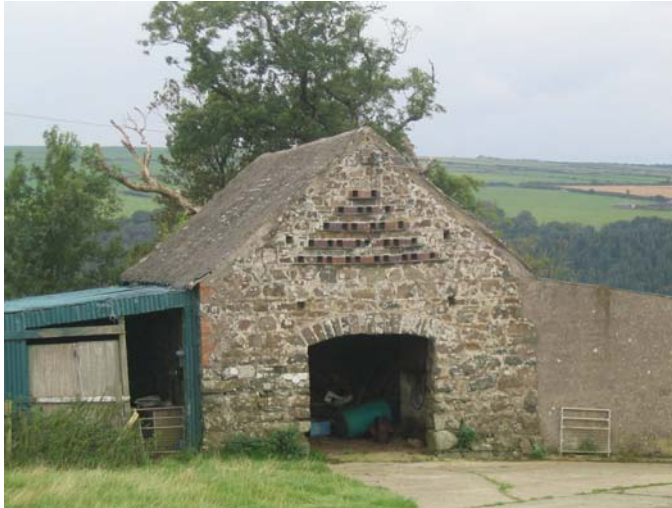
SSW facing shot of individual traditional farm building to the east of the farmhouse.
