TIR GOFAL MANAGEMENT PLAN: HERITAGE MANAGEMENT INFORMATION (HE2)

**Prepared for:
Brixton Farm**

**Tir Gofal Reference No
W/12/5097**

**ACA Report No. 2005/94
Project Record No. 53705
Prepared by
Philip Poucher**

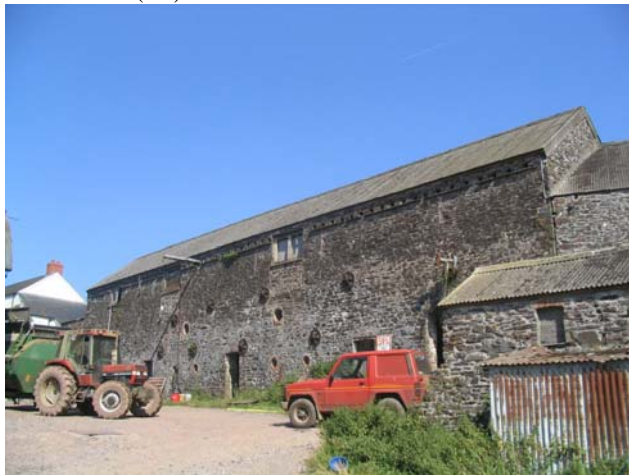
A large grade II listed mid 19th century farm building range, built of mortared rubble, 2 storeys high with an asbestos roof. The main range consists of a stable at the western end, cowhouse in the centre and cartshed at the eastern end. The stable and cowhouse have both been segmentally vaulted in brick running lengthways with the cartshed transversely vaulted, a rare feature in this area. The entrances all have brick voussoirs except the larger cart entrance, both stable and cart entrances are arched, cowhouse entrances square headed with 'porthole' ventilation. A drainage passage runs along the length of the range to the rear. The 1st floor contains a hay loft with a long boarded threshing floor. There is single storey access to the rear, loft openings in the front wall are partly blocked, although the winch has been retained. Pigeon boxes run the length of the building, with several tiers of boxes in the western gable wall. Attached to the east is a slightly lower 2-storey range at a slightly splayed angle. This houses a former chaff room at the western end, with corn store above and a lofted stable at the eastern end. The gable wall has slit ventilators and twin segmental cart entrances. This end originally had a wheel pit with water fed from ponds to the east. This whole range is still in use and appears in relatively good condition, although the ceiling of the former chaff room is showing signs of deterioration with splits in the beams and holes in the floor boards visible. *Visited 17/08/2005 (PP)*

NW facing shot of combination farm building.

The aim of the management for this site should be to ensure the survival of the traditional buildings and maintain the historic character of the complex of traditional farm buildings as a whole. Specific recommendations for the cartshed/stable PRN 16147 are described above. Generally the buildings appear in good condition and stable. However, thick vegetation is growing around the remains of a barn building and a corrugated iron building at the NE edge of the farmstead complex. Vegetation is also growing in and around brick corner pillars of the corrugated iron building, dislodging some of the bricks.

- Vegetation may have to be cut back in this area to ensure the visibility and long term survival of traditional buildings on the edge of the farmstead complex.
- Vegetation should be carefully removed from the brick pillars which may require consolidation and repair using materials appropriate the farmstead complex as a whole. Advice should be sought from the local buildings conservation officer prior to any work on the fabric of the building as this building may fall within the curtilage of listed buildings at this farmstead.

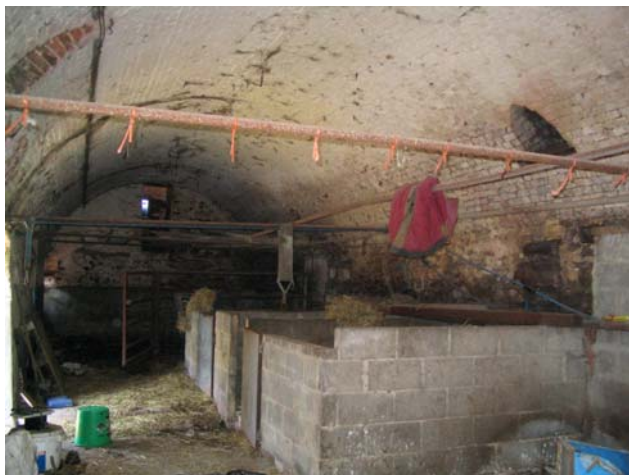
Internal shot of cowhouse in the centre of the main range of the combination farm building, showing the unusual brick vaulted ceiling.

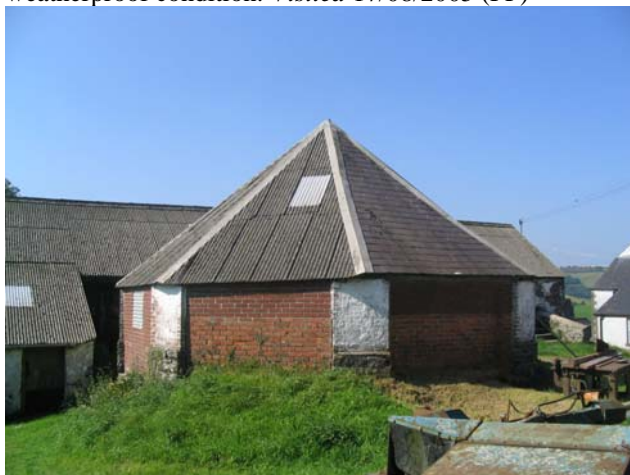
A grade II listed octagonal horse engine house dating to the mid 19th century, part of farmstead complex PRN 21365. The partly asbestos/slate roof sits on whitewashed stone and brick piers, with modern brick infilling in between. The horses would have turned a driveshaft passing into the adjacent hayloft via a low opening. Apparently some of the machinery remains on the site. This building is long disused but in a stable weatherproof condition. *Visited 17/08/2005 (PP)*

SW facing shot of horse engine house.
