## **TIR GOFAL MANAGEMENT PLAN: HERITAGE MANAGEMENT INFORMATION (HE2)**

Prepared for:  
**Pwllffein**

Tir Gofal Reference No  
**W/11/5252**

Report No. **2006/8**  
Project No. **53717**

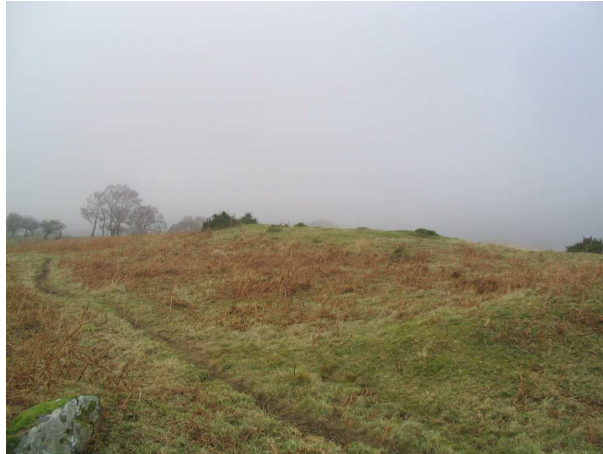
1 TWYN SWND ( <a href="#">4059</a> )	Bronze Age round barrow	SN76592257	A	SAM Cm181	Specific
<p>A scheduled round barrow, following a site visit in 2002 the site was described as:</p> <p>One of a pair of round barrows, its twin being PRN 4058. It is also part of a larger barrow cemetery and prehistoric monument complex (PRN 45572).</p> <p>This barrow measures some 15m in diameter, it stands 1.5m high and is located on a natural knoll at the western end of a low ridge on moorland pasture. There is evidence of kerbing on the southwest side and within a hollow dug into the top of the barrow are the remains of a cist, evidenced by the two short end stones and one long side stone.</p>

The group as a whole is in an area of rough pasture with patches of bracken present. Sheep from a neighbouring farm have been grazing here following a recent change in ownership. The barrow would seem to remain much as previously described. Grass cover is generally good but there is a small patch of gorse on the south side.

- To remove bracken growing on and around the round barrows by cutting or crushing. Cutting is the preferred method on the monuments themselves as it avoids significant disturbance. Crushing should only be carried out in dry conditions when the risk of damage to buried archaeology is minimal.

- Monitor the condition of the monuments. Consider changing stocking levels at the Tir Gofal 5 year review or earlier if their condition worsens.
- Reinstating the boundary fence that crosses barrows PRNs 8890, 8891 will require scheduled monument consent. Contact Cadw for further advice. Contact details are included.

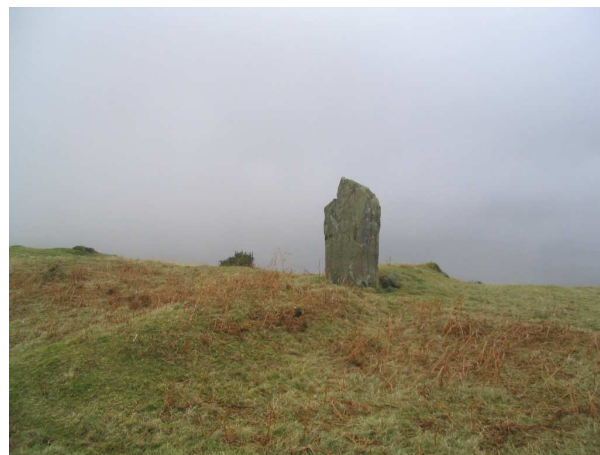
- 1**     **SYTHFAEN** ([4060](#))     **Bronze Age standing stone**     **SN76602257**     **A**     **SAM Cm181**     **Generic**

A standing stone associated and in alignment with two barrows, PRNs 4058 and 4059. It is of fine, hard sandstone and is embedded within an old field boundary. The stone measures some 2m in height, 1.2m in width and 0.4m thick. The stone occupies a prominent position with views in all directions, except to the immediate west where the view is obscured by the barrows, although there are more distant views achievable. Another large stone is in the same boundary, 9m to the N, and there are other reasonably sized stones (c.0.4m) scattered along the bank and beside it which may be evidence of barrow robbing, or evidence of another barrow.

No management threats were identified. The site would seem to be in a stable condition.

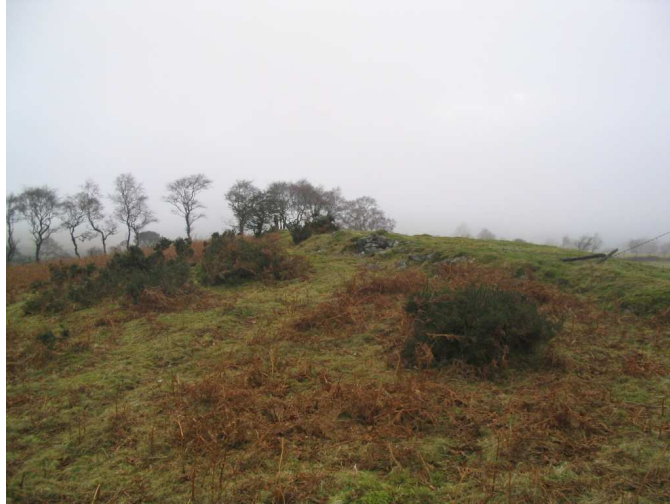
- 1**     **NANT FFYNNON-WEN** ([8890](#))     **Bronze Age round barrow**     **SN76512250**     **A**     **SAM Cm181**     **Generic**

This barrow is located on a local rise on a gentle south-west facing pasture slope, c.100m southwest of barrows 4058 and 4059, and shares this natural knoll with its twin barrow PRN 8891 which lies 30m away to the SW. It measures 11m in diameter and stands to a height of 0.4m. An old central excavation crater is 2.5m across and 0.2m deep. The barrow is composed of turf-covered stones and a fence runs across the mound, with a ditch south of the fence which may be evidence of a former hedgebank. The barrow lies part in improved pasture (the northwest portion) and part in unimproved pasture (the southeast portion).

This site is crossed by a boundary bank and only the southeast part of the mound is within the boundary of Tyle Pengam. The fence is tumble down and sheep from the neighbouring farm have been grazing the area following a recent change in ownership. Bracken is present over much of this area with gorse on the surface of the barrow, though it is for the most part under grass cover.

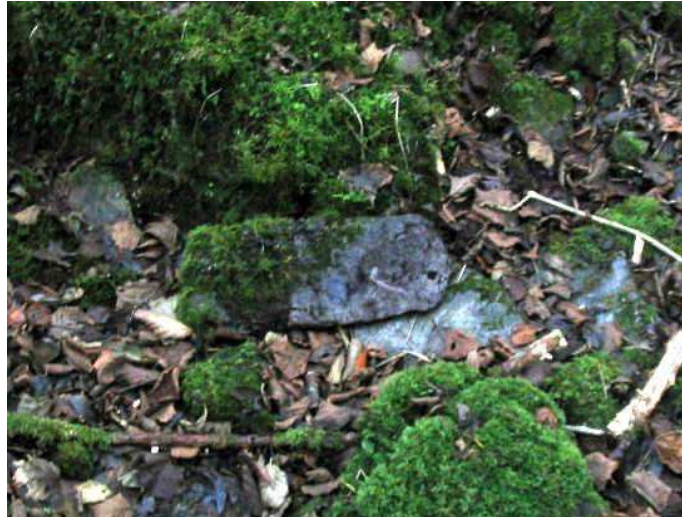
- 2 TYLE-PENGAM ([21955](#)) **Post Med farmstead** SN76422300 B Specific

A ruinous late eighteenth or early nineteenth century farmstead complex comprising of two opposite stone ranges, roofed with local tile stone originally. Tyle Pengam is marked on the 1" OS map of 1831 and the current layout is present on the more detailed tithe map of 1841?

House, on the west side of the farmyard, in rubble stone with stone end stacks and outshut to rear. Standing walls to eaves height. 2-storey, double fronted elevation with central door, the whole offset slightly to allow for main chimney to right (now collapsed). Internal structural detail (walls, floors etc.) now gone, the whole having been roofless for a number of years. Broken down walls of outbuilding adjoin this house to north. Outbuilding opposite with walls to eaves height except on collapsed west wall. Opposing lateral doorways and positioning of joist slots suggestive of former combination threshing barn, ?cow shed. Ruinous remains of pigsty against south wall. A collection of earth and stone walled enclosures survive nearby.

The owner hopes to restore the building, reconsolidating masonry, reinstating the roof and other lost elements as appropriate. These works will need to be agreed with the Brecon Beacons National Park Planning Authority before work can start. Contact details are included. The following is recommended:

2.
  - As a general rule, replacement features should be modelled on similar surviving examples. Where these do not exist the emphasis should be on matching details appropriate for the locality and buildings age. Some examples of intact tile stone roof structures are included for comparison.

- Sourcing similar tile stone is problematic; tile stone quarries in the locality have closed but working pennant sandstone quarries further east may have suitable available stone. Replacements should match the colour, texture and thickness of existing stone as closely as possible.

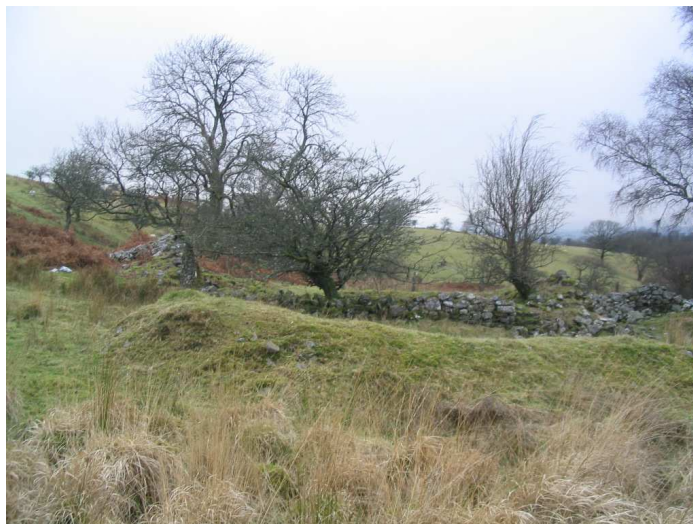
[\(55357\)](#)

A ruined drystone long hut in the lee of a hillslope at 290m OD. Standing walls to over 1m and earth and stone wall bases of a single cell c12m x 6m. Probable appended structure on the north side c4m x 6m. The site is surrounded by an earth and stone banked enclosure and may be associated with an area of ridge and furrow (PRN 55456) further up slope to the south. The site is grass covered with one or two scrubby trees present and is basically in a stable condition. WWS December 2005.

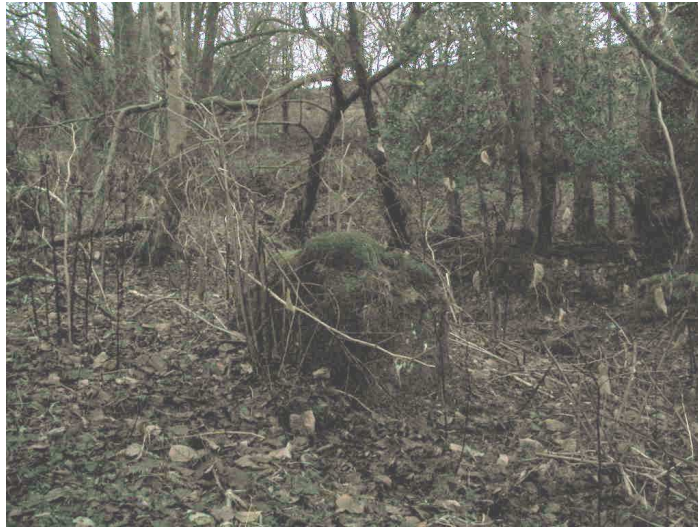
[\(55358\)](#)

A stone is recorded within the farmstead of Tyle Pengarm (Tyle Pengam) on the 2nd edition Ordnance Survey map (PRN 21955). A large irregular boulder of c.1.4m square lies at this location. The function of the stone is uncertain. Possibly a mounting block.

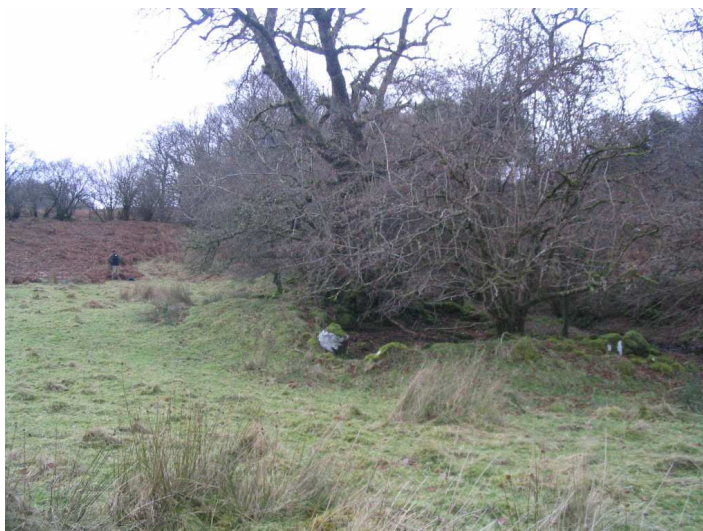
[\(55457\)](#)

Ruined rectilinear stone structure, much of the detail obscured by stone spread and grass cover. Situated on cross contour platform alongside a stream at 210m OD in an area of long established enclosure. Overall measurement c.30m x 6m incorporating 4 cells. Entrances difficult to identify but probably facing trackway then stream to east. The building is not identified on the tithe survey (1841?) or later cartographic sources. There are a number of trees rooted in the walls including one mature oak. Grass cover or moss covers the greater part of the site with some leaf litter present. It is basically in a stable condition. WWS December 2005.

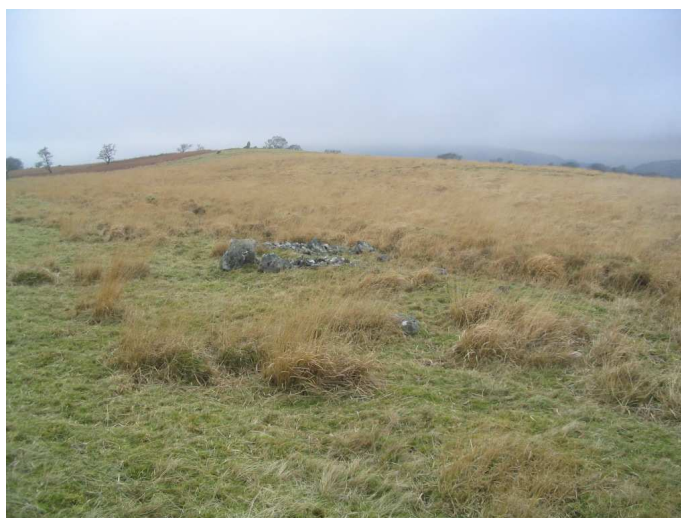
[\(55458\)](#)

An ill defined rectilinear stone platform c.9m by 4m incorporating some large boulders in its make up. On an east west alignment in the lee of a hillslope. The date and function are uncertain. It is situated near to an area of ridge and furrow (PRN 55456) and may relate to settlement during the medieval or later periods. Under rough pasture at time of visit. WWS December 2005.

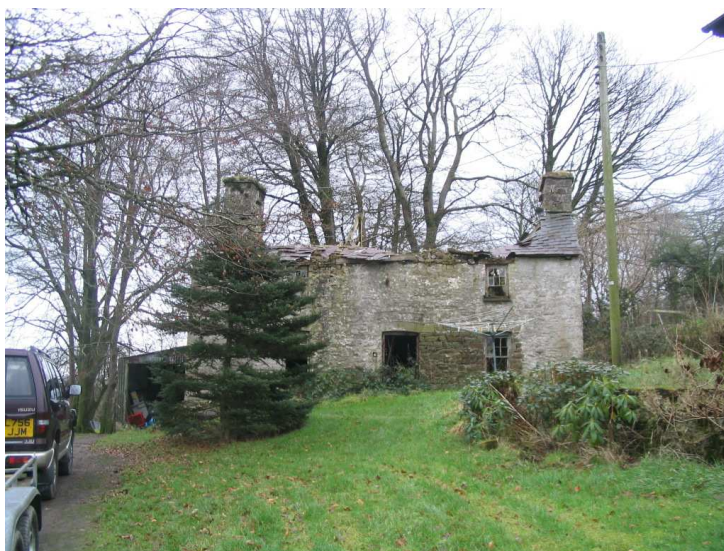
<b>PWLLFFEIN (NEW HOUSE)</b> ( <a href="#">54796</a> )	<b>Modern house</b>	<b>SN4248346716</b>	<b>C</b>		<b>Generic</b>
	<p>Early 20th century two storey farmhouse with a slate roof and one brick end stack. 2-storey, three bay symmetrical front with central door and sash windows with margin lights. Red brick door and window dressings and corner quoins. The house has a datestone of 1916 and replaces an older residence adjacent (PRN 54798). It is currently occupied and in good condition. WWS December 2005.</p>					
	<b>PWLLFFEIN (OLD HOUSE);GWAR-CWM</b> ( <a href="#">54797</a> )	<b>Post Medieval house</b>	<b>SN4252446716</b>	<b>B LB2</b>		<b>Generic</b>
	<p>The old farmhouse at Pwllffein. Grade II listed as one of the earlier surviving farmhouses in the area, unaltered. Late 18th or early 19th century farmhouse in rubble stone, whitewashed to front with slate roof and stone end stacks. Outshut rear. 2-storey, double-fronted elevation with 12-pane sashes each side and centre door, all offset slightly to allow for deeper chimney wall to left. Heavy quoins at front corners. Upper windows are smaller and set under eaves, lower windows have cut-stone voussoirs to cambered heads. Door has single stone lintel. Split slate sills. Single-storey rear outshut under corrugated iron roof with cambered headed doorway to east and door and window to rear (Cadw 1993). The farmhouse is derelict and in a poor condition with a collapsed roof and rotting internal woodwork. WWS December 2005.</p>
