## **TIR GOFAL MANAGEMENT PLAN: HERITAGE MANAGEMENT INFORMATION (HE2)**

Prepared for:  
**Middle Hill Farm**

**Tir Gofal Reference No  
W/13/5652**

**ACA Report No. 2005/131  
Project Record No. 53722**

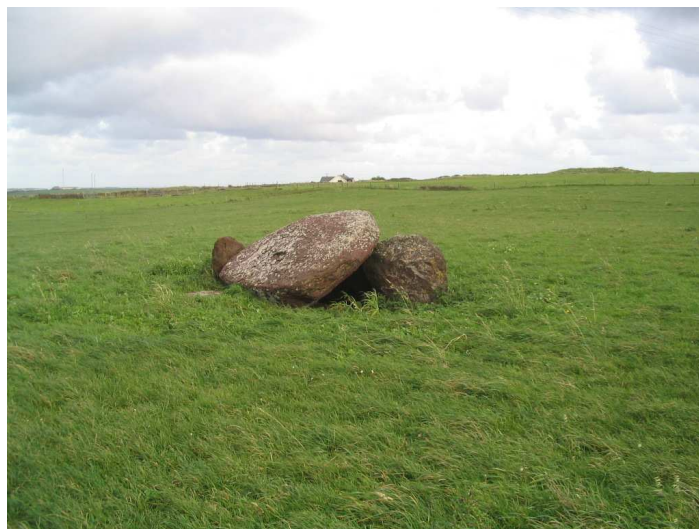
A fine burial chamber in the centre of a field of wind blown burrows, now scheduled as a site of national importance. A large wedge shaped cap stone is supported on the east by two large side stones which form the side of the chamber. On the west, a third sidestone has fallen so that the capstone rests slumped on the prostrate stone (Rees 1992, 29). Fenton (1811) recorded a "low circular agger of earth raised around it (the burial chamber) of no inconsiderable area" but no trace of this remains today.

The field in which the chambered tomb lies is within a ley arable rotation. At the time of the archaeological farm visit the site was under pasture with no active erosion of the ground surface. In previous years cattle trampling causing erosion to the ground surface has been highlighted as a seasonal occurrence.

View of the chambered tomb from the southeast.

Please note: any works, which would have the effect of demolishing, destroying, damaging, removing, repairing, altering, adding to, flooding, or covering up a monument must have scheduled monument consent, e.g. infilling of erosion, fencing. Cutting of vegetation does not require scheduled monument consent.

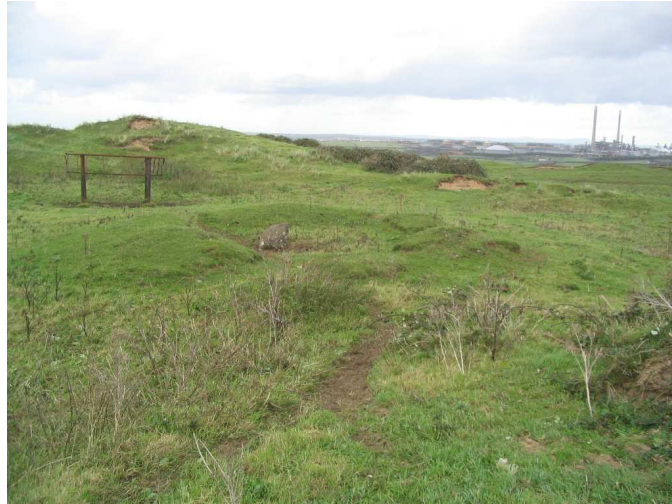
A hollowed out round barrow, 13m in diameter, with a standing stone 0.6m high near its centre.

Today the barrow survives in a much degraded condition, its centre having been excavated out, leaving an earthfast stone in the centre. It lies within a bowl shaped depression in the dunes where cattle are fed and consequently there is much trampling and continuing erosion to the site and surrounding area.

The round barrow has experienced erosion due to cattle trampling.

The management aim within Tir Gofal should be to improve the condition of the roundbarrow and protect it from further damage. The following recommendations apply.

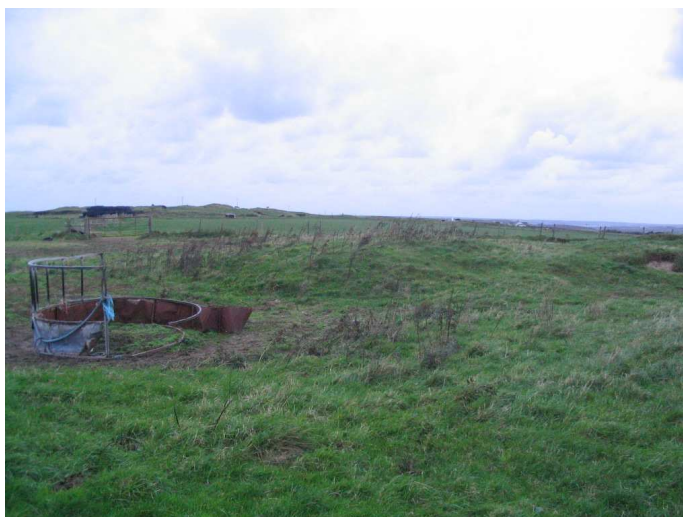
A round barrow, 15m in diameter and 1.3m high. Part of a group of three (PRN 47441) on low lying Kilpaison Burrows. In previous years cattle trampling causing erosion to the ground surface has exposed Old Red Sandstone and Carboniferous Limestone boulders which make up the mound. At the time of the archaeological farm visit the site was under pasture with no active erosion present.

View of the round barrow from the southeast.

The management aim within Tir Gofal should be to improve the condition of the round barrows and protect them from further damage. The following recommendations apply.

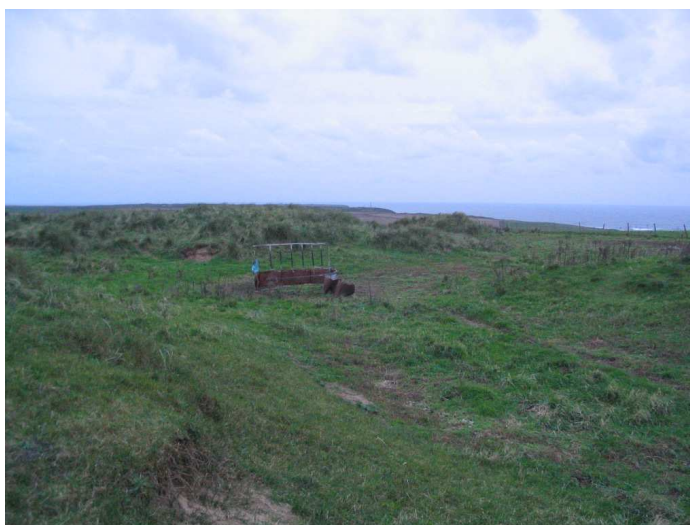
A possible round barrow, represented by a semi-oval circular mound 12m by 7m, manifesting as a stonier area within a spread of small Old Red Sandstone chips. Part of a group of three (PRN 47441) on low lying Kilpaison Burrows. The round barrow is located in sand dunes and now difficult to make out due to the encroachment of the sand. When visited the area was grassed over with little active erosion present.

The round barrow, situated behind the feeder, is now difficult to make out due to the encroachment of the sand.

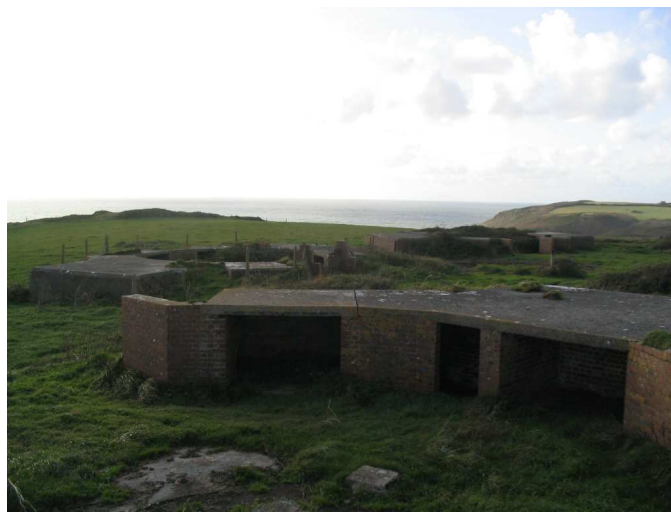
Complex consisting of one command post, four gun pits, two holdfasts, and thirty five hut bases. c1941 - 44 (Thomas 1993). It was re-used as a hydrophone station c1950- 1967.

The field in which the site lies is in a ley arable rotation. Current practice is to place stock feeders within the gun pits over winter and to regularly plough between the core of the site and the outlying gun holdfasts. At the time of visiting the site was under pasture with some intermittent bramble and nettle patches. These do not impact significantly on the visibility of the monument at present.

General view of the anti-aircraft battery overlooking the sea

Whetstone Hill Heavy Anti Aircraft Battery is a Scheduled Ancient Monument. The following management recommendations are made in consultation with Cadw.

- Continue current management practices as long as they do not damage the site.
- Monitor vegetation around site. Consider scrub control at the Tir Gofal five year review if the condition worsens significantly.

Please note: any works, which would have the effect of demolishing, destroying, damaging, removing, repairing, altering, adding to, flooding, or covering up a monument must have scheduled monument consent, e.g. infilling of erosion, fencing. Cutting of vegetation does not require scheduled monument consent.

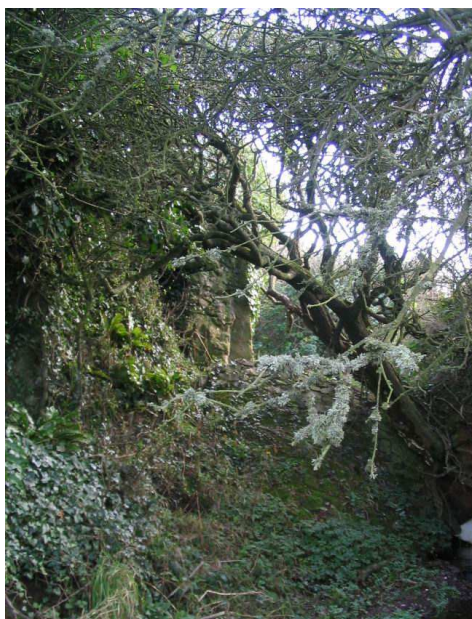
A disused limekiln marked on the 1<sup>st</sup> edition Ordnance Survey map of 1875 as “old limekiln.” It is situated on a slight rise above the shoreline of Angle Bay. The kiln is D-shaped c8m diam. of mortared rubble construction and has two opposing draw holes, c0.6m diam and 4m high. The whole front of the kiln has collapsed *en masse* and the draw hole to the coast side has partly collapsed. The pot is open.

The site is fenced out and very overgrown with bushes some of which have rooted in the structure.

The outer kiln wall has partly collapsed.

The lime kiln is obscured by vegetation and at risk of damage by tree root action or windthrow.

The management aim is to protect the kiln from further damage. Tir Gofal recommendations:

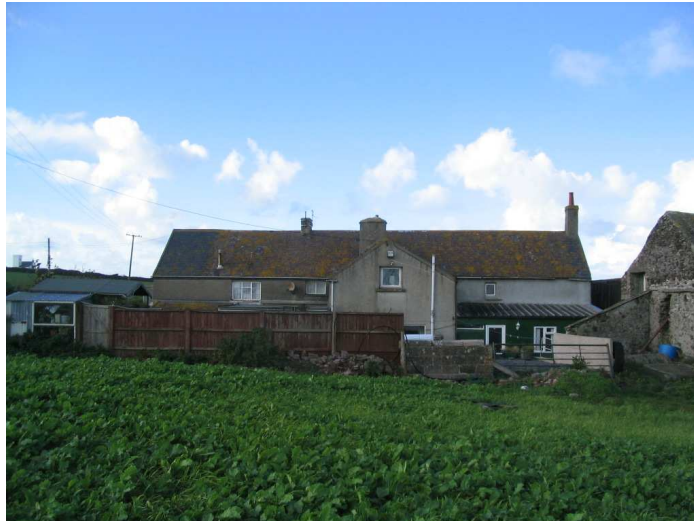
A working farmstead complex with a lateral chimney type farmhouse that was once part of the Cawdor Estate. The complex is now much modified but some interesting original features remain.

The house is on a different alignment and likely to pre-date the outbuildings. It has a lateral chimney and the remains of a spacious fireplace reminiscent of a regional Pembrokeshire farmhouse type. Interesting internal details recorded by the owner include the use of ships timbers in the roof and a type of wattle and daub partition incorporating brambles. The house has been extensively modernised over the course of the last century.

The house has a lateral chimney and is reminiscent of a regional Pembrokeshire farmhouse type.

The owner hopes to make repairs to the building, re-grouting the roof and re-consolidating masonry as necessary. Further to this it is intended that lost lintels and doors will be reinstated.

- Repairs should be based on an ethos of repair over replacement as far as is practically possible in order to preserve the historic character of the building.
- Replacement features such as doors should be modelled on similar surviving examples.
- Roof grouting should be matched in terms of materials and finish. Roof grouting is a regional characteristic when roof slates were rendered over for protection against the strong westerly winds. Cement, as opposed to lime based products, were traditionally used. Contact Cambria for further advice if necessary.

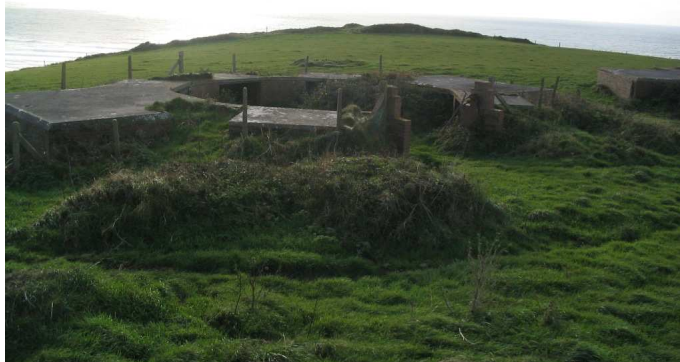
Single storey, irregular octagonal plan, fair-faced brick, flat concrete roof over shelters & lockers, earth reveted. Gate in N wall. 2 detachment shelters & 7 ammunition lockers set into the walls. Holdfast for 3.7 gun with cable duct to command post. c1941 – 44 (Thomas 1993).

Looking from behind the gun pit towards the sea.
