## **TIR GOFAL MANAGEMENT PLAN: HERITAGE MANAGEMENT INFORMATION (HE2)**

**Prepared for:  
Lower Mounton Farm**

**Tir Gofal Reference No  
W/13/5709**

**ACA Report No. 2005/111  
Project Record No. 53727**

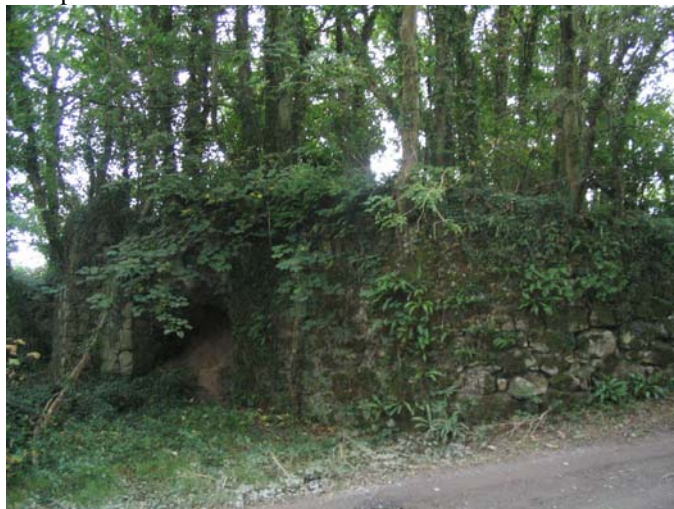
A disused grade II listed limekiln at Mounton Quarry. Probably early 19<sup>th</sup> century in date. It may have been disused by the mid 19<sup>th</sup> century as there appears to be no trace of any firebrick lining, although it is still marked, and the quarry still appears operational, on the 1<sup>st</sup> edition Ordnance Survey map of 1889. The kiln itself is large free-standing structure, 3-4m high, built of coarse local stone. The crucible is c2.5m in diameter, narrowing towards the base with working apertures to the NW and NE. The remains of a stone built hut stands on top of the kiln to the SW. There is a working platform in front of the kiln to the north and east, with piles of broken limestone along the east side. The site is scrub and ivy covered, with trees growing on top of the structure and to the north and east. *Visited 21/09/2005 (PP)*

**SE facing shot of the limekiln PRN 54739, showing the NW aperture.**

The aim of the management on this site should be the preservation and maintenance of the grade II listed limekiln structure. At present the site is relatively intact but with a great deal of scrub cover, including tree cover and ivy. Small trees have established themselves on top of the structure and root action may be causing structural damage, falling trees in this area also pose a threat to the integrity of the structure. The ivy cover may also be penetrating into the stonework causing structural damage.

- Trees on top of the limekiln structure should be carefully cut down and treated to prevent the roots causing structural damage. Some trees that grow close to the structure may also have to be removed if their roots or branches appear to affecting the structural integrity of the limekiln. Fallen trees leaning against the structure should also be removed to relieve the pressure on upstanding masonry.
- Ivy cover on the walls on the limekiln should be cut back and carefully removed.

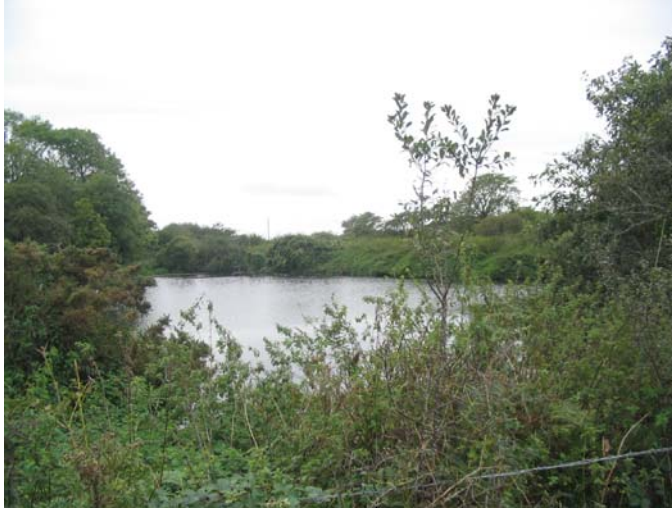
A large 19<sup>th</sup> century limestone quarry. The quarry, now filled with water and surrounded by scrub, lies on the eastern side of the trackway to Mounton farmstead. On the south side of the quarry lies a large early 19<sup>th</sup> century limekiln (PRN 54739). On the western side of the trackway lies the large tree and scrub covered spoil heaps from the quarry. The 1<sup>st</sup> edition Ordnance Survey map of 1889 marks several small cottages in the area, possibly housing quarry workers. The main period of quarrying activity would appear to be during the 19<sup>th</sup> century although limestone from this area is likely to have been used during iron smelting work in nearby Canaston Woods operating in the early to mid 17<sup>th</sup> century. *Visited 21/09/2005 (PP)*

NW facing shot of the water filled quarry.

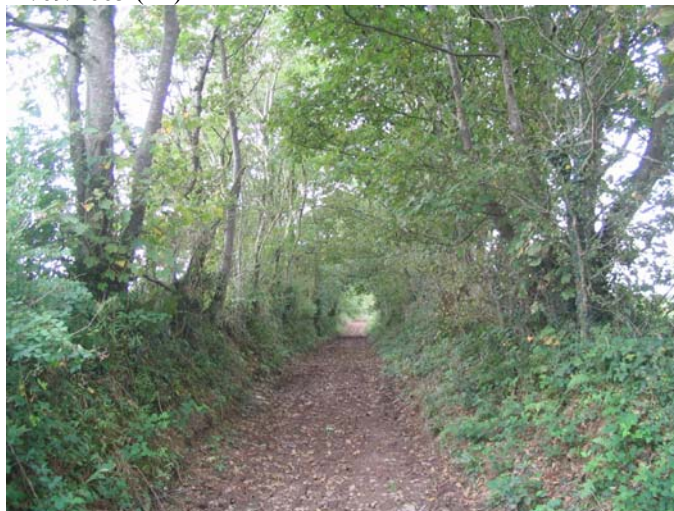
A trackway leading from the A415 past Mounton Quarry (PRN 17071), Mounton farmsteads (PRNs 54741 & 54742) and up to Mounton Chapel (PRN 3625). The trackway is single carriage, cobbled in places and often with high banks on either side. Settlement is suggested at Mounton in the Medieval period and Mounton Chapel also has Medieval origins suggesting the trackway also has Medieval origins. *Visited 21/09/2005 (PP)*

**Looking N along the trackway.**

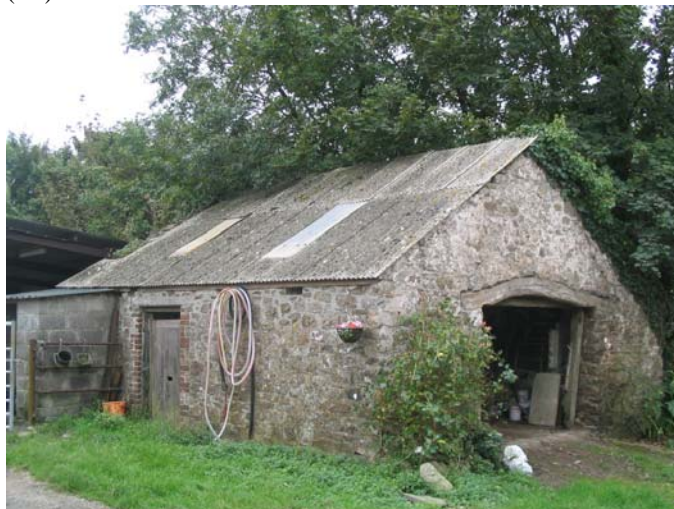
**SW facing shot of traditional farm building to the south of the farmhouse.**

The aim of the management for this site should be to ensure the survival of the traditional buildings and maintain the historic character of the complex of traditional farm buildings as a whole. The traditional farm building to the south of the farmhouse remains in use and in relatively good condition although ivy appears to be encroaching on the western and southern wall that may cause structural damage in future or hide defects. The western wall of the small farm building to the east of the farmhouse has been dislodged and may require consolidation work before further deterioration occurs. To the east of this lie the scrub covered remains of a former pigsty. Enough appears to remain of the structure to benefit from the clearance of surrounding scrub to make it a more visible and working part of the traditional farmstead complex. A former orchard lies behind the pigsty, trees have established themselves on the former boundary wall and the interior is now scrub covered.

- Ivy should be cut back and removed from the farm building south of the farmhouse.

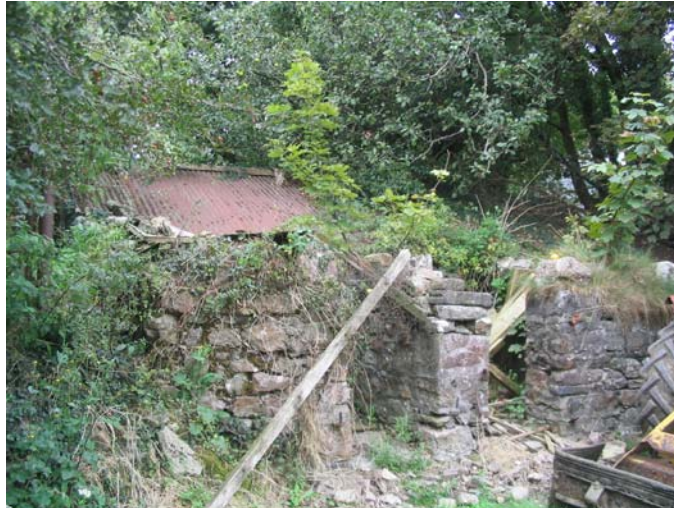
**NE facing shot of the former pigsty building.**

- Scrub, trees and ivy should be carefully cut back from both within and around the pigsty building to reveal the main structure. If it is possible to remove any of this vegetation without damaging the pigsty then this should be done to prevent further damage and make the structure more visible. Once vegetation has been removed it should be possible to better assess the structure of the pigsty which may require consolidation using materials and techniques appropriate to the locality.

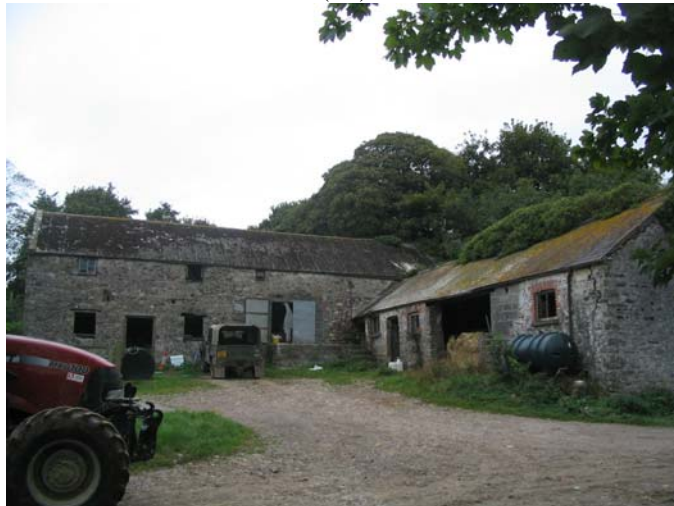
To the east of the farmhouse stands an L-shaped range of farm buildings. The E-W range is 2 storeys high, built of mortared rubble with square headed openings and a corrugated asbestos roof. At the western end is a lofted barn, with a threshing barn to the east. The N-S range is built in a similar style but single storey and with brick window surrounds and a slate roof. Scrub, trees and ivy grows along the eastern walls of this range fronting a now disused section of trackway. To the south lies the ruined wall of a detached farm building, aligned E-W, built in the same style and roughly coursed. To the west of the farmhouse lie the scrub covered remains of a former pigsty, built of mortared stone with brick quoins and a slate roof. The tumbled remains of a stone built barn lie to the north of this, in an area used to store hay bails at the time of this visit. *Visited 21/09/2005 (PP)*

**NNE facing shot of the main barn range at Upper Mounton Farmstead.**

The aim of the management for this site should be to ensure the survival of the traditional buildings and maintain the historic character of the complex of traditional farm buildings as a whole. The farm buildings are mainly still in use and currently appear in a relatively stable condition. However, ivy, scrub and trees grow along the eastern face of the L-shaped range of farm buildings. This vegetation could be causing structural damage, hindering maintenance and hiding defects. Some facing stones have also fallen away from the northern face of the E-W range of these farm buildings. To the west lies another pigsty building, heavily covered in scrub although it is possible enough remains of the structure for it to be returned as part of the upstanding complex of traditional farm buildings in this farmstead.

- Ivy should be cut back and removed from the eastern face of the L-shaped range of farm buildings. Tree branches may also have to be trimmed back if they are in danger of causing structural damage to the eastern face of this range.
- The northern face of the E-W range should be consolidated where facing stones have begun to fall out.
- Scrub should be carefully cut back and removed from the former pigsty structure to prevent further damage and make the structure a more visible element of the farmstead complex. Once scrub has been cleared from the structure it should be possible to assess the extent of any damage and whether further consolidation work is required.
