TIR GOFAL MANAGEMENT PLAN: HERITAGE MANAGEMENT INFORMATION (HE2)

**Prepared for:
Tymawr
Tir Gofal Reference No
W/11/5291**

**ACA Report No. 2005/115
Project Record No. 53743
Prepared by
Philip Poucher**

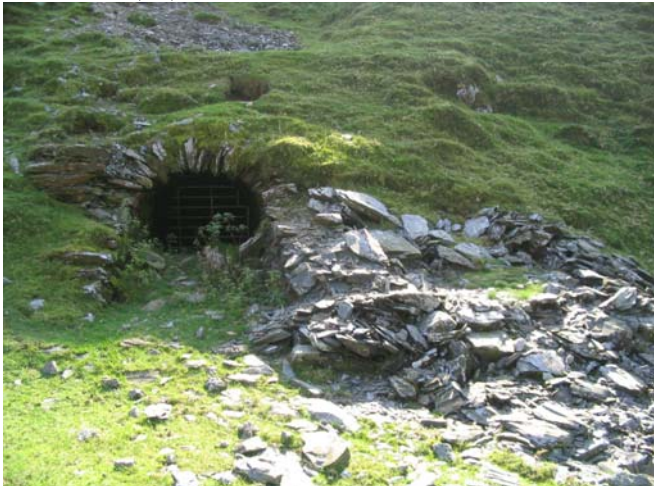
<p>SSE facing shot of a mine level opening at Ystwyth mine PRN 19983, with the tumbled remains of a stone built hut to the right of the entrance.</p>

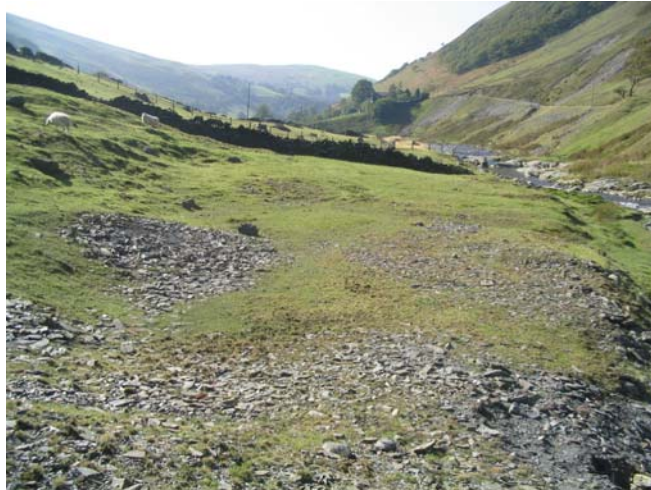
SW facing shot of building platforms where much of the ore at Ystwyth mine (PRN 19983) would have been processed.

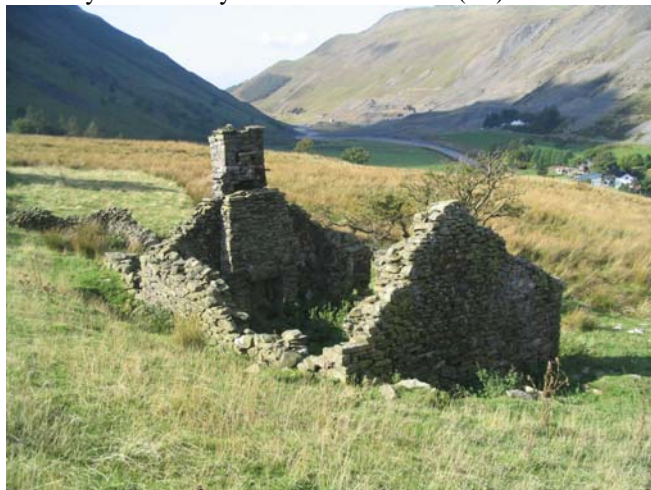
A small ruined cottage marked on the 1st edition Ordnance Survey map of 1888. The cottage is built of random slate rubble, mortared in places. The gable walls stand to almost their full height, the long walls are partly tumbled and the roof has gone. The cottage measures approximately 7m x 5m, two windows and a central doorway in the northern wall with the chimney-stack surviving against the western gable wall. Tumbled drystone walls mark enclosures to the west. The cottage is probably part of the settlement attracted to this area by Post Medieval mining activity, and may have been abandoned when mining activity ceased in the early 20th century. *Visited 05/10/2005 (PP)*

SW facing shot of the remains of Pant-glas cottage PRN 54651.

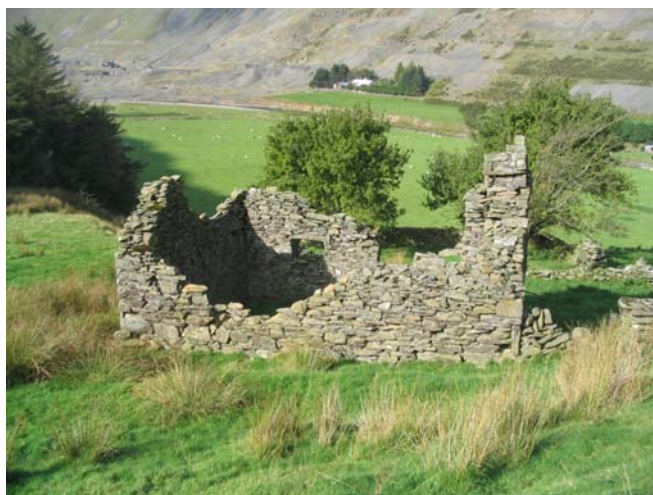
A ruined cottage marked on the 1st edition Ordnance Survey map of 1888. Built of mortared random rubble, the eastern gable wall stands to roughly its full height, the remaining walls are partly tumbled. The cottage measures approximately 8m by 6m with a doorway and partly blocked windows in the northern wall and the fairly complete remains of the chimney-stack against the eastern gable wall. A drystone walled enclosure lies in front of the cottage, with farm building remains (PRN 54653) lying at the foot of a short but steep slope in front. It is unclear if the two are associated. The cottage is probably part of the settlement attracted to this area by Post Medieval mining activity, and may have been abandoned when mining activity ceased in the early 20th century. *Visited 05/10/2005 (PP)*

W facing shot of Dol-y-twlch ruined cottage PRN 54652.

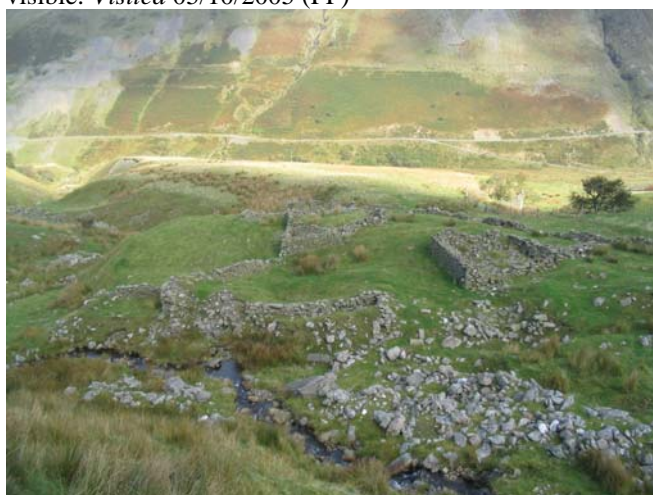
A small ruined farmstead complex, marked on the 1st (1888) and 2nd (1902) edition Ordnance Survey maps and Wmffre (2004) records the name from the late 16th century onwards, although it is not clear if this actually refers to a dwelling at this location. The main dwelling lies at the northern end of the complex, measuring c7 x 5m with tumbled drystone walls, central doorway and flanking windows in the northern wall. A small stone built lean-to lies against the western gable wall. A large drystone walled enclosure measuring c7m x 7m lies to the south, with a small ruined barn building (c5m x 3m) at the southern end and a larger ruined barn building/enclosure (c5m x 6m) to the southwest. The 1st edition Ordnance Survey map also marks a further two small square buildings at the southern end of the complex, and a small building, possibly a pigsty, to the east of the main dwelling. No above ground remains of these buildings are currently visible. *Visited 05/10/2005 (PP)*

N facing shot of the ruined Cwm-du farmstead complex PRN 54654.

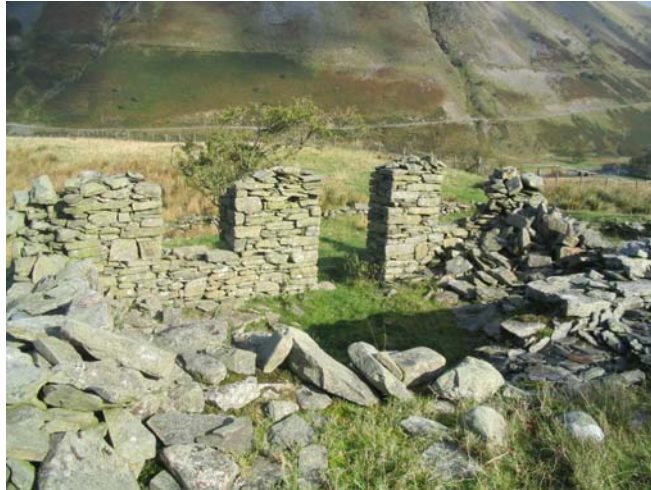
NE facing shot of the main dwelling at Cwm-du farmstead complex PRN 54654.

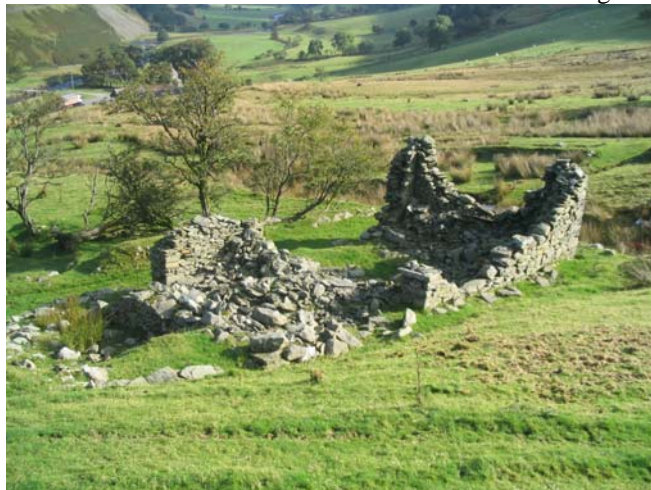
A ruined cottage marked on the 1st (1888) and 2nd (1902) edition Ordnance Survey maps. The cottage is a drystone built 2-cell structure measuring c10m x 5m, with a c3m wide lean-to on the western gable wall. The walls are greatly tumbled although the eastern corners still stand close to their original full height. The remains of stone walled enclosures lie in front (to the north) and a stone built raised ford gives trackway access across the stream on the eastern side of the cottage. *Visited 05/10/2005 (PP)*

ENE facing shot of Pen-y-gwndwn ruined cottage PRN 54655.

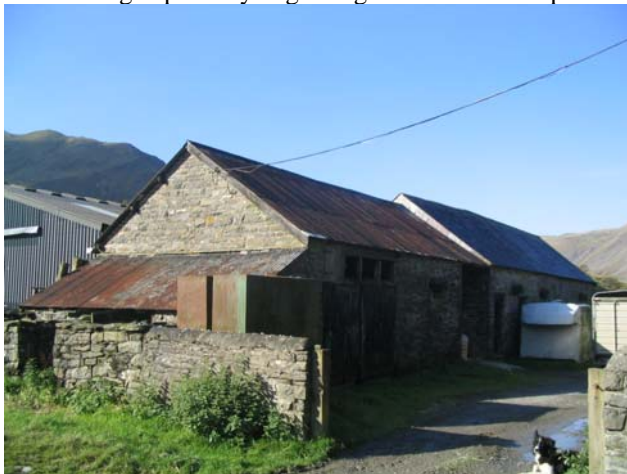
A small working upland farmstead first marked on an estate map of 1781. The detached farmhouse stands at the north-eastern corner of the farmstead. Traditional farm buildings consist of a single range aligned roughly E-W, built of mortared random rubble, slate roofed at the western end, with a corrugated iron roof on the slightly lower eastern end. The western half of the building contains wooden cattle stalls and a hay loft, the eastern end contains the former threshing barn. A former 2-bay pigsty lies against the eastern gable wall. Modern farm buildings have been built against the southern wall of this building. The traditional farm buildings are still in use and in a well maintained condition, although the corrugated iron roofing is possibly beginning to deteriorate in places. *Visited 05/10/2005 (PP)*

SW facing shot of the traditional barn range at Tymawr farmstead PRN 54650.

The aim of the management for this site should be to ensure the survival of the traditional buildings and maintain the historic character of the complex of farm buildings as a whole. The farmstead buildings are still in use and generally in a good state of repair, although the corrugated iron roof may be beginning to deteriorate.

- Deteriorating corrugated iron roofing could be replaced with traditional materials appropriate to the farmstead and its locality (slate and corrugated iron).

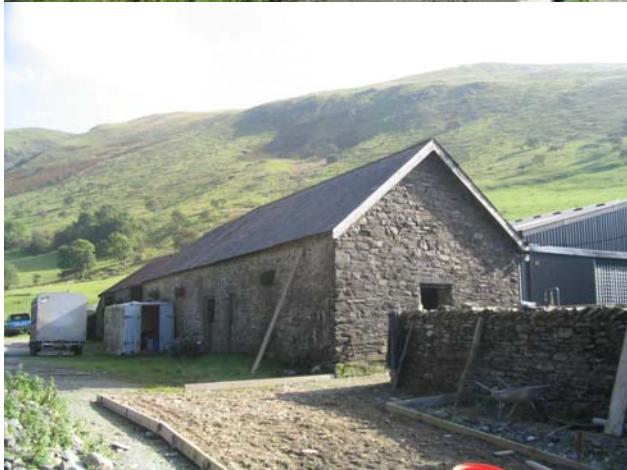
SE facing shot of the traditional barn range at Tymawr farmstead PRN 54650.
