TIR GOFAL MANAGEMENT PLAN: HERITAGE MANAGEMENT INFORMATION (HE2)

Prepared for:
Glanrafon Isaf

Tir Gofal Reference No
W/11/5445

Report No. **2005/132**
Project No. **53755**

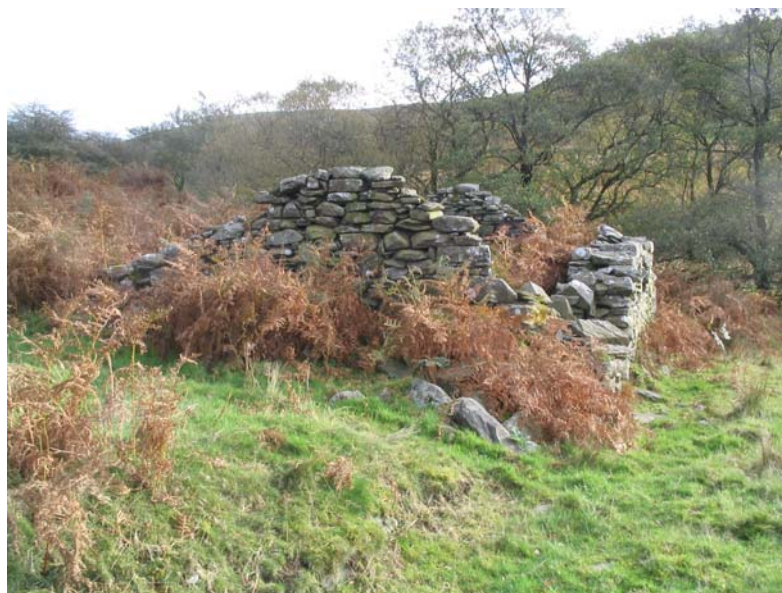
Name (& PRN)	Period/Site type	NGR	Status SAM/listing	Management required
CWM YR OLCHFA <u>(7158)</u>	Post Medieval cottage	SN71986038	B	Generic
A single room cottage, sited up and down slope, with the entry in the lower pine end and described with a wickerwork chimney hood by the RCAM in 1976. The building is now ruined but the stone walls stand to roof height. There are no traces of the wickerwork hood remaining. The whole area is bracken covered. WWS November 2005.

The ruinous cottage of Cwm Yr Olchfa

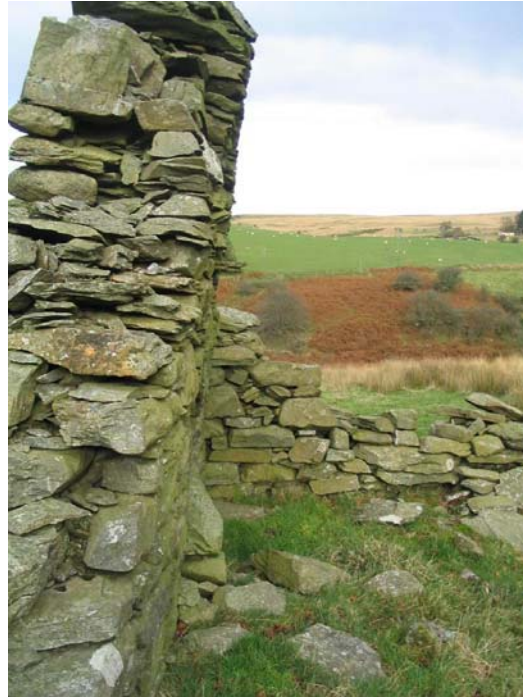
A cottage with secondary downhouse (?diary) and other buildings added at the opposite end. It was described with a wickerwork chimney hood by the RCAHM in 1976. The building is now ruined with its stone walls in the process of collapse and little trace of the wickerwork hood remaining. The area surrounding the site was tightly grazed at the time of the archaeological farm visit. Some mature trees grow around the site. WWS November 2005.

There are few traces of the wickerwork hood remaining.

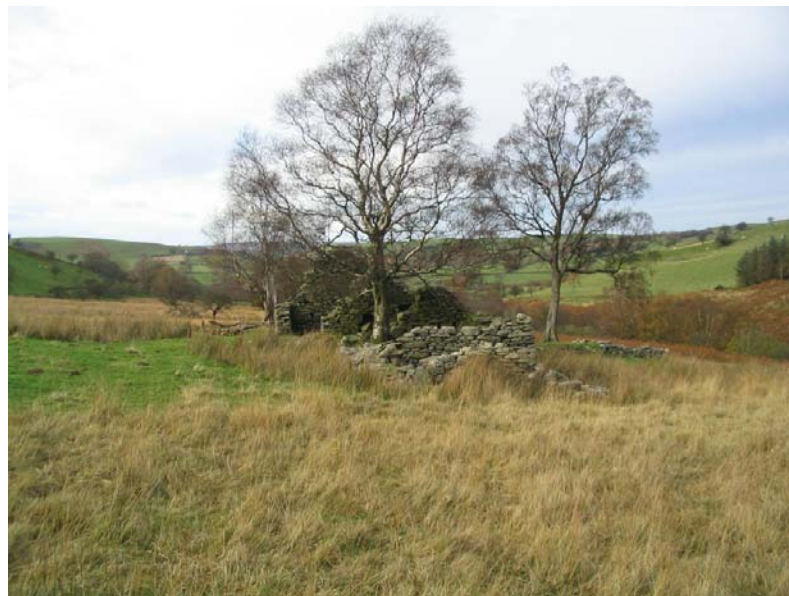
Waun-groes cottage as it stands today.

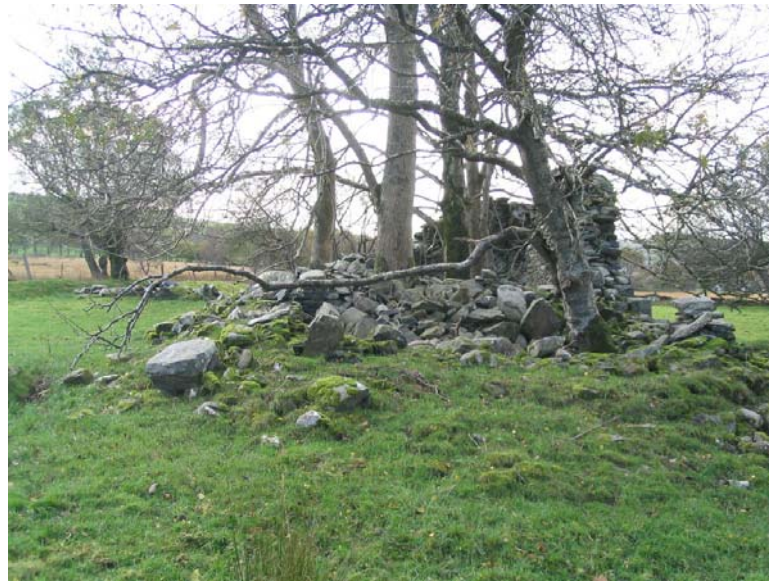
Waun Gota is a stone built, two storeyed house and outbuilding that is presently in the later stages of collapse. The stub walls of a nigstv are situated behind the house to the west. It was established at some

point between the tithe survey of 1845 and 1889 when the 1st edition Ordnance Survey map was published. There are some mature trees rooted in the walls but otherwise the site is pasture covered.

A view of Waun-gota from the north.

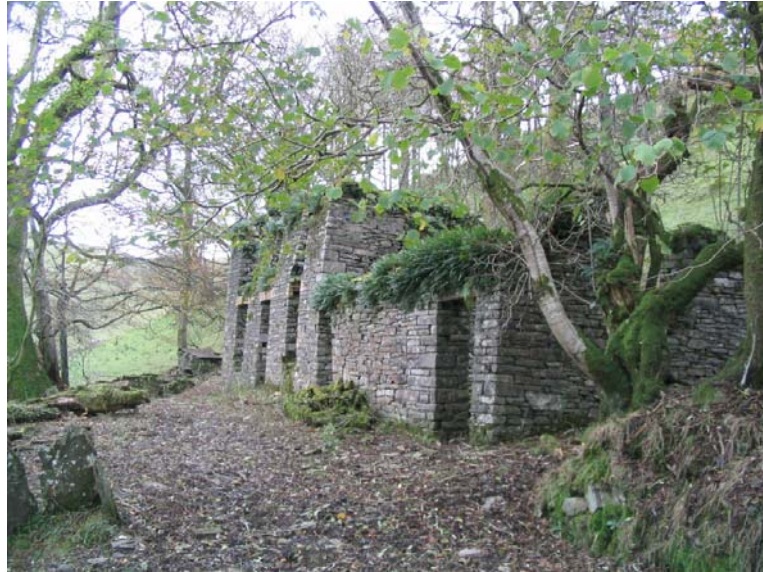
A small farmstead complex that appears on the 1st edition Ordnance Survey map of 1888 and was abandoned after 1964. A late nineteenth century, two storey house, with rectangular plan and central front door adjoins a cow shed attached to the south gable and several smaller structures survive nearby. The buildings are ruinous but walls stand to eaves height.

There are many mature trees around the site.

Tan y gopa farmstead is now ruinous having been abandoned after 1964.

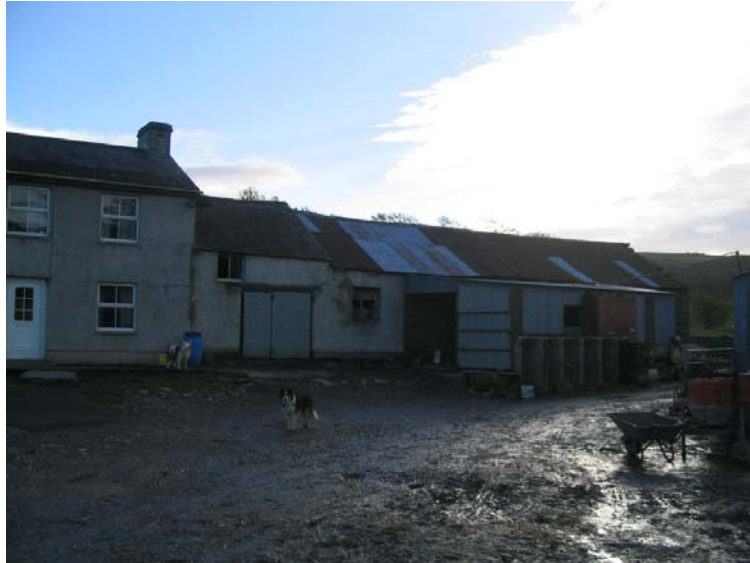
Name (& PRN)	Period/Site type	NGR	Status SAM/listing	Management required
1	GLANRAFON ISAF;GLAN-R-AFON-ISAF (54954)	Post Medieval farmstead	SN7059960931	B	Specific
	<p>Glanrafon Isaf is a working farmstead complex built around a stone and slate farmhouse and downhouse range sited up and down slope. It is identified on the Ordnance Survey Old Series map of 1834 and shown in its present layout when the 1st edition map was published in 1889. In the division between upper farmhouse and lower downhouse it is similar to the longhouse type although true status cannot be confirmed as the owner does not recall there having been internal access between the house and downhouse.</p> <p>The house is now much modernised with little original detail remaining. It is cement rendered and has modern windows inserted. The front wall has a two storey symmetrical arrangement of three windows with central doorway offset to the right presumably to accommodate a large gable fireplace. The downhouse incorporates a workshop and byre and has one wide opening (enlarged) and three doorways of standard width opening onto the yard. The rear wall has been substantially re-built in non traditional materials and the roof incorporates corrugated iron over much of its length. A small stone lean-to adjoins the rear wall. There are few original internal features remaining. Modern outbuildings are situated on the opposite side of the yard to the east.</p>

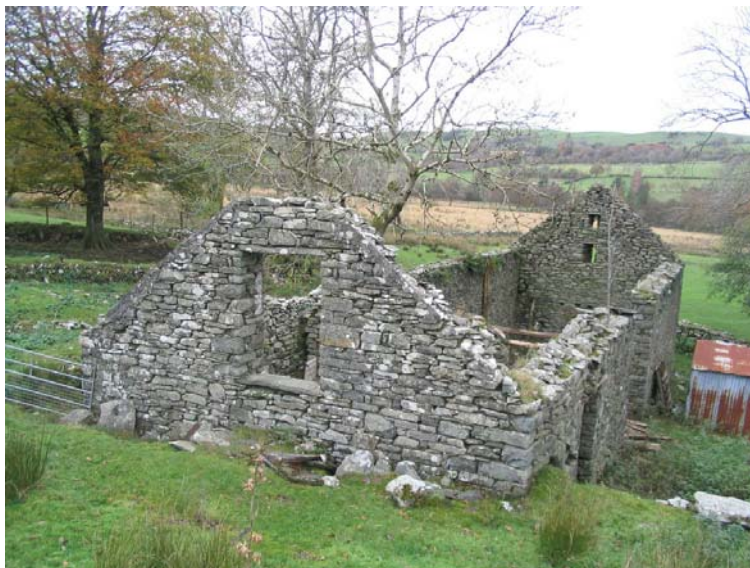
Now derelict nineteenth century farmstead with a common L- plan arrangement comprising a stone and slate farmhouse and combination threshing barn, stable and cow house range. The house, in a not uncommon style for the region, has end gable chimneys and a three bay façade with a door, offset to the right, flanked by windows on either side and three windows at first floor level. The outbuilding to the west is now a roofless ruin although the walls still stand to roof height. A collection of stone walled enclosures survive nearby and there are the remains of a ?pigsty in front of the house to the north.

The ruinous threshing barn, stable and cow house range at Cae Tudor.
