# **WATCHING BRIEF AT PORTHMYNAWYD**

Prepared by Cambria Archaeology as part of a Service Level Agreement with Pembrokeshire Coast National Park Authority

RHIF YR ADRODDIAD / REPORT NO. 2005/17 RHIF Y PROSIECT / PROJECT RECORD NO. 53869

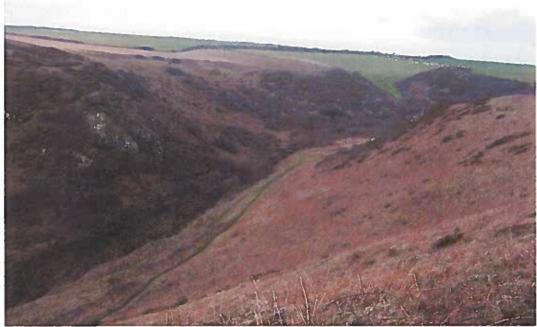
Figure 1: Photograph showing the steep-sided valley at Porthmynawyd. It was unlikely that any *insitu* flint scatters would survive on these hills.

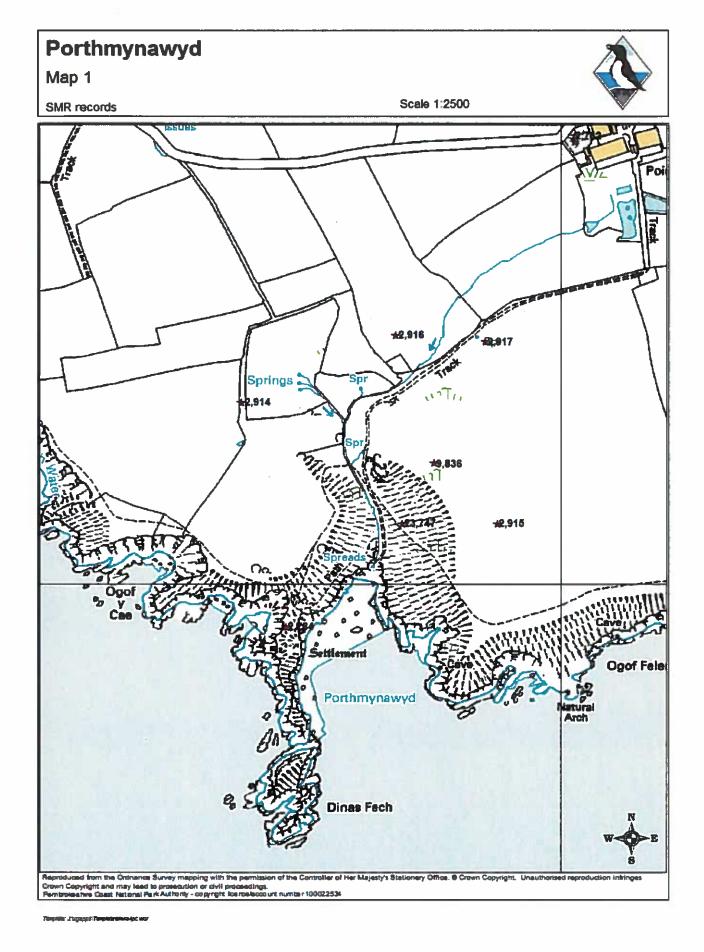
Map 1: Showing recorded archaeological sites at Porthmynawyd.

Recorded archaeology consisted of a limekiln (PRN 23747) and several prehistoric sites. On its west side, the beach is overlooked by a promontory fort (PRN 2784) which also yielded evidence for Roman occupation (PRN 4324). A number of flint scatters are also recorded (PRNs 2914 – 2917, 9836). These sites are depicted on Map 1, and listed in the Appendix.

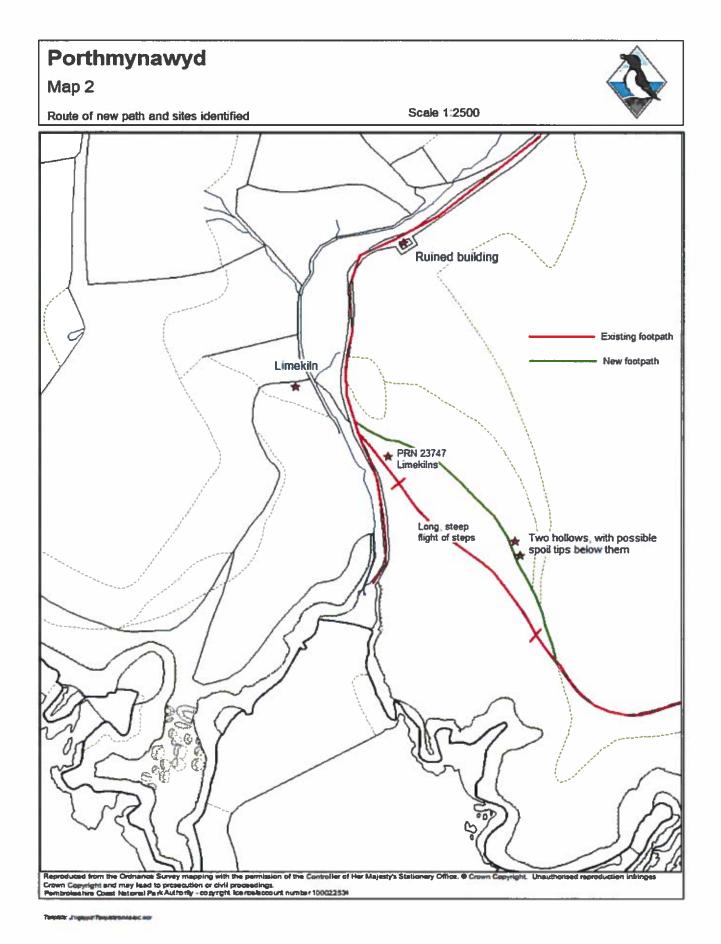
Map 2: Showing the line of the existing and new footpaths.

The Pembrokeshire Coast National Trail runs down a long, steep flight of steps on the east side of Porthmynawyd. Pembrokeshire Coast National Park Authority (PCNPA) wished to divert the path further to the east, in order to by-pass the steps. This also allows the path to run down a shallower gradient, avoiding altogether the need for steps.

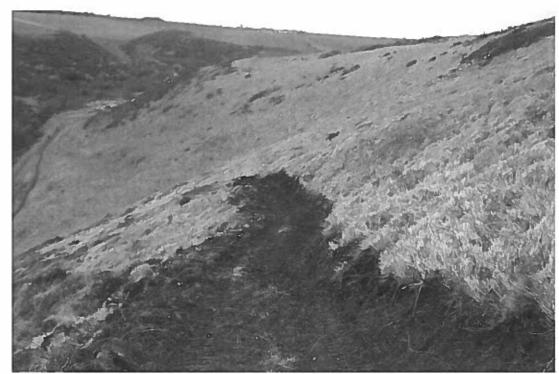
For the most part, the stratigraphy was very simple, consisting of only two contexts. A dense, dark brown/black layer, rich in organics, overlies an orangey-brown sandy clay, with a large number of angular stone inclusions. This appears to be the natural.

The depth of the overburden varies along the length of the path, from approx. 200mm to 500mm. The depth which the path has been dug into the sandy clay consequently also varies, but the maximum depth of excavation was around 600mm. The new path is approx. 1.5m wide.

Figure 2: Showing the new footpath cut into the hillside.
