Removal of a Visitor Cairn at Carn Ingli Camp, Pembrokeshire.

RHIF YR ADRODDIAD / REPORT NO. 2005/32 RHIF Y PROSIECT / PROJECT RECORD NO. 54034

March 2005

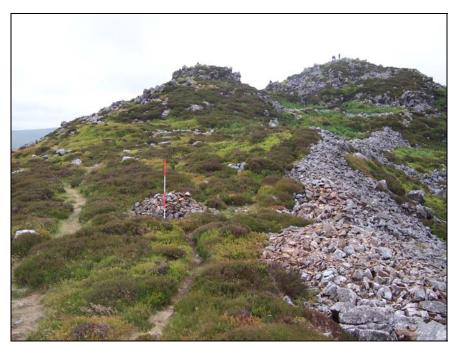
Figure 1. Photograph of the visitor cairn as it appeared in June 2004. In the stone bank (right of picture) the area of disturbance can be seen as a discoloured area of stone.

Since the cairn still appeared to be 'active' – i.e. people were still adding to it, and causing further disturbance (see figures 1 and 2), it was decided that PCNPA would apply for Scheduled Monument Consent to record and dismantle the cairn.

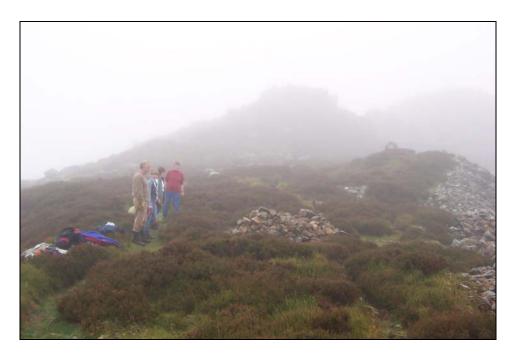
Figure 2. Photograph of the visitor cairn as it appeared in late November 2004. The cairn had not increased in height, but had clearly been added to and 'spread', covering more ground. This may well have occurred during the peak summer visitor months of July and August, when this site sees comparatively heavy recreational use.

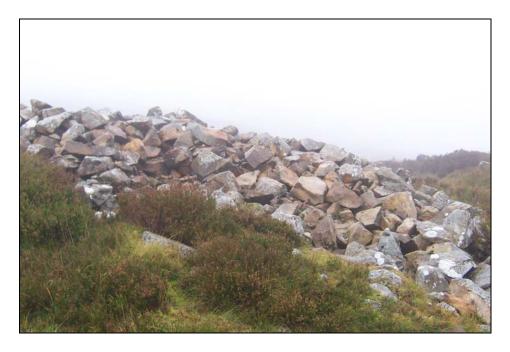
Figure 3. Showing an area of disturbance within the bank of the hillfort. Note the different colours of the stones – the disturbed area is red/pink, whereas weathering and lichen growth has made the undisturbed areas more white/grey.

All work was done by hand. Stones were removed from the visitor cairn, and replaced into the disturbed areas of bank. These areas were quite clearly defined, both by hollows where stone had been removed, and by discolouration. The outer stones on the banks are covered with a white lichen, whereas the inner 'core' of the bank, which is not normally exposed, is more red in colour, and lacks the lichen (see figure 3). Care was taken that the stones, wherever possible, were replaced into the banks with the white surface outwards. This helped to ensure that the 'repairs' were unobtrusive.

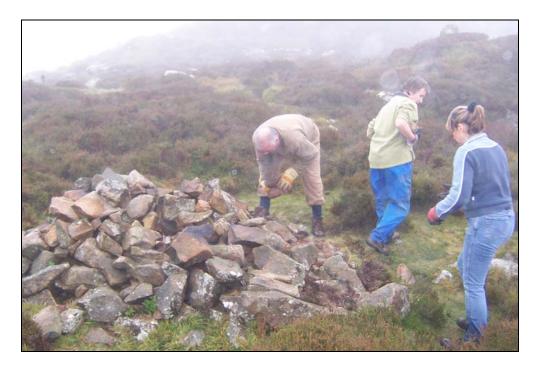
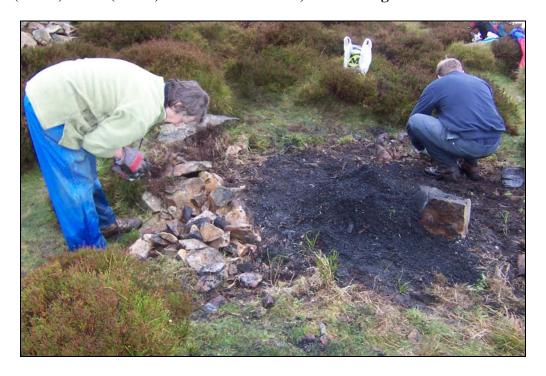
Figure 4 (above) and 5 (below). Volunteers at work, dismantling the visitor cairn.

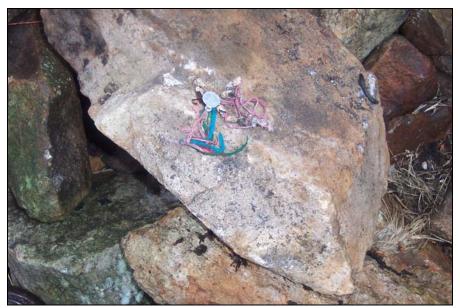
For the most part, the visitor cairn appeared to be a simple pile of stones. Modern litter was found throughout it, including crisp packets, beer cans and paper. About half way down, three necklaces were encountered. One consisted of shells strung on coloured thread, one was a copper cross on coloured thread and one appeared to be a metal St. Christopher, also on coloured thread. The three were encountered together, and had clearly been deliberately placed. Carn Ingli has strong associations with the Christian church, taking its name (Mount of Angels) from the story that St. Brynach would climb the mountain to pray, and that he spoke with angels at its summit. Since the three items appeared to have a religious significance, and to have been deliberately deposited, it was felt appropriate to leave them on site.

Figure 6. The only finds (aside from modern rubbish!), these necklaces or charms appeared to have been deliberately deposited within the visitor cairn.

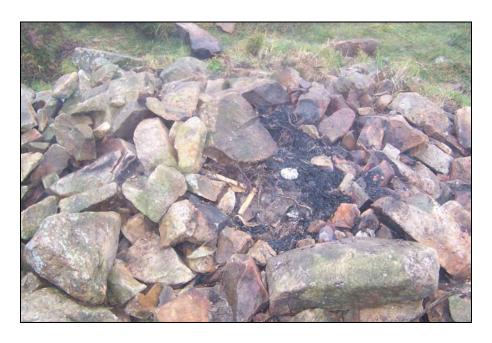
At its base, the cairn contained a thick layer of ash and burnt heather. This appeared to be contained within a roughly built hearth - a ring of large stones surrounding the burnt patch. The remains of a packet of firelighters attested to its modern date and function! The burnt layer must have represented either a significant bonfire, or a series of fires in this hearth. Stones had then been piled over the top of the hearth.

Figure 7 (above). The layer of ash and burnt heather at the base of the visitor cairn. Note the modern foil and kindling mixed in with the ash!

The rubbish and ash was removed from the site and disposed of.

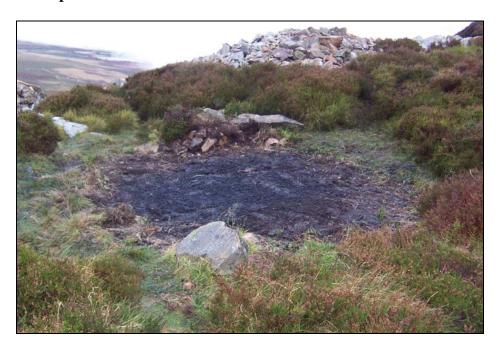
Figure 8 (below). The site of the visitor cairn. It is hoped that, in time, the heather will recolonise this burnt patch.
