TIR GOFAL MANAGEMENT PLAN: HERITAGE MANAGEMENT INFORMATION (HE2)

Prepared for:
Pwll Caerog

Tir Gofal Reference No
W/13/5748

Report No. **2006/11**
Project No. **54178**

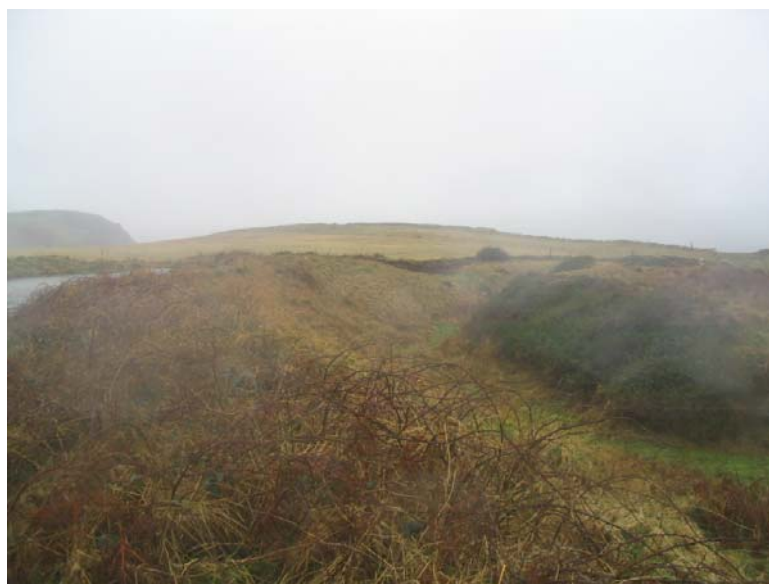
Name (& PRN)	Period/Site type	NGR	Status	SAM/listing	Management required
1	CAER ABER PWLL;CAERAU (2735)	Iron Age hillfort	SM788307	A	SAM	Specific
	A multivalate promontory fort, part of a double fort with smaller fort (PRN 2907) to the east.					
	Hillforts are commonly assigned to the Iron Age (600BC to 43AD). Such sites are commonly viewed as defensive structures, although recent interpretations suggest that they were also built with an element of ostentation and display in mind. Excavated examples have revealed traces of settlement such as round houses, other, post built structures and storage pits.					
	This particular site has a complex multi phased history, and at least seven hut platforms have been recorded within the inner ramparts.

The outer ramparts of Caerau hillfort.

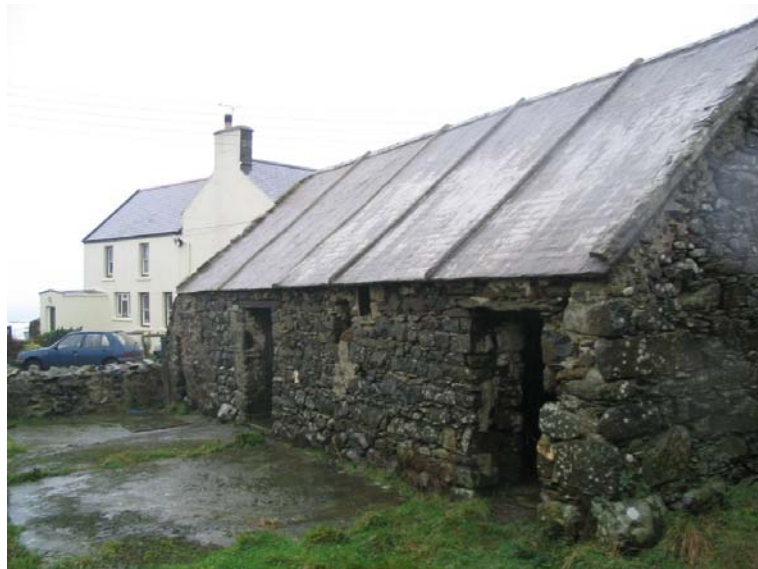
Of the old house little now remains; the round lateral chimney, porch and doorway, and side outshuts have completely gone as has the downhouse. The Victorian cross wing on the right survives though modernised. Where surviving, the traditional outbuildings are relatively well intact though some have been converted into holiday accommodation and none retain internal features of note. The best preserved are a dairy and lean to the south of the house, a row of pigsties to the west and a cartshed range with pigeon loft against the west wall of the house, all of which retain grouted slate roofs in part. Additional buildings shown on the Tithe Map (1840-41), including a second house, have been replaced by modern buildings or destroyed.

Some of the buildings in the group are in need of maintenance, re-pointing the walls or upkeep of the grouted roofs. (WWS January 2006).

Grouted slate roofs survive in part at Pwll Caerog.

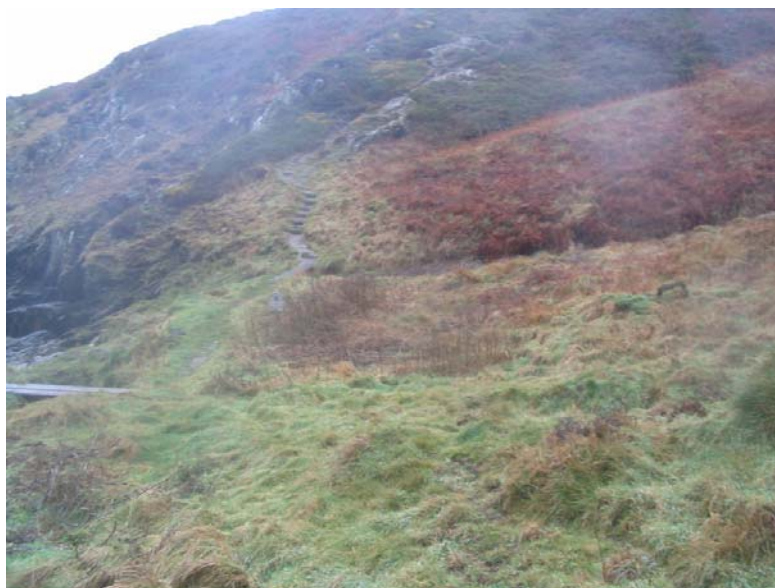
Ruinous structure, only just visible. Possibly two cells surviving with the cell to the east being a possible wheel pit with a ramp above linking the pit to a possible water leat. The building sits within a sub-rectangular terrace which cuts into the tail of the natural slope. A track/ ramp probably for access to sluices and the water leat defines the upper edge of this terrace (Laws & Brooks 2003).

The condition of the site would seem to be much as described previously, though it is ill defined and the plan difficult to clarify. It is within an area of rough pasture grazed by cattle and with no obvious management threats; grass cover is good with no breaks in the ground surface and little scrub present. (WWS January 2006).

The plan of the mill is now difficult to clarify.

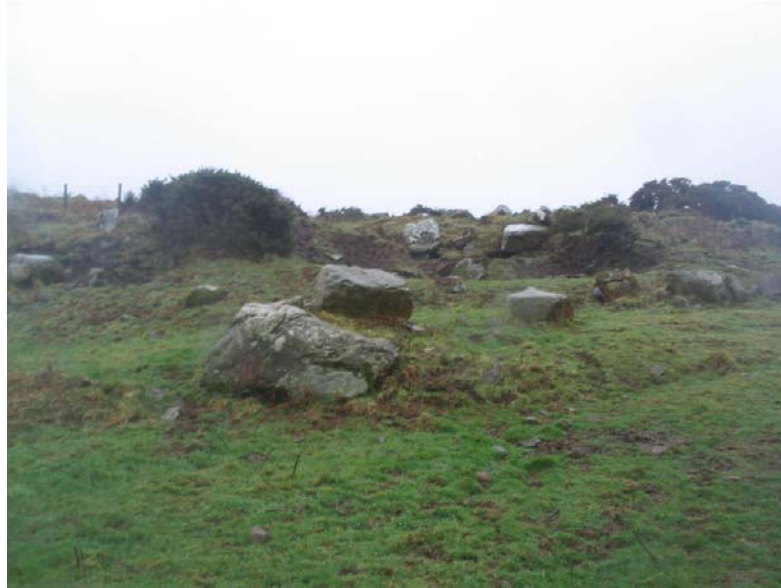
A stone marked on the OS 1st edition map of 1889. At the given location is a large earth fast boulder, approximately 1.4m diameter. A number of smaller boulders nearby probably result from field clearance or nearby quarrying activity (PRN 54968) (WWS January 2006).

The stone, in the foreground, with quarry (PRN 54968) behind.

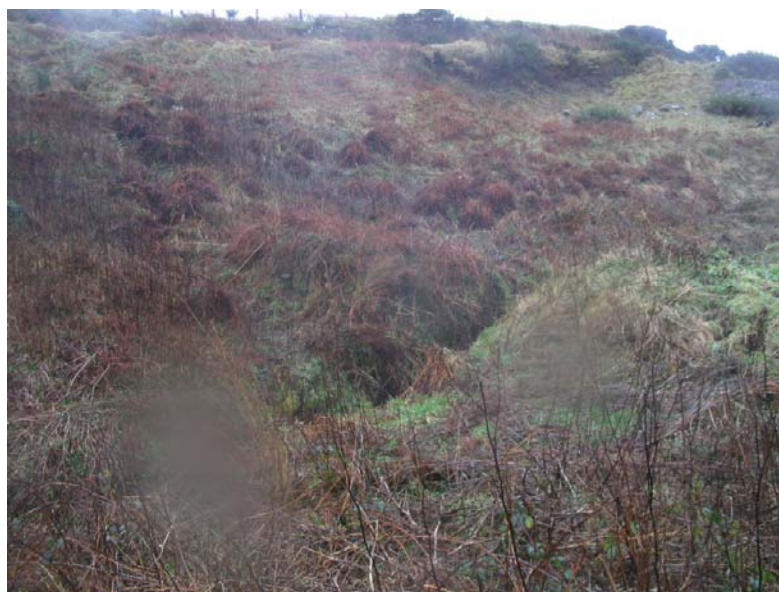
Boulder built stone dam, 22m long, 2m wide, 2m high in front (north). Pool behind (south) is silted up. (Laws & Brooks 2003). The dam wall is breached in the centre where it has been eroded by the feeder stream, otherwise the site is much as described. It is within an area of rough pasture grazed by cattle and with no obvious management threats.

The dam wall is breached in the centre.

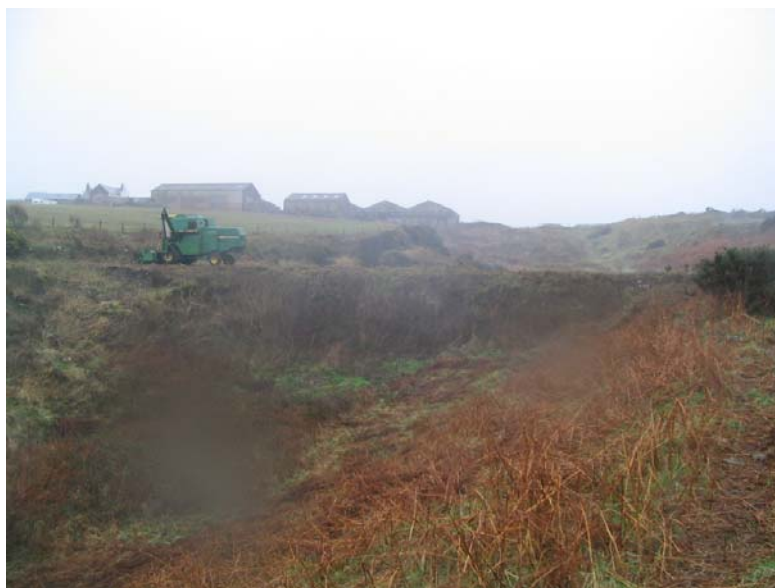
A large flat topped earth bank which runs down a natural gully towards the sea. The dam is approximately 40m long and 6m wide and has a farm trackway running across it. Behind the dam wall is a semi-circular pond, about 50m long. The pond is first marked on the OS map of 1908. The dam is within an area of rough pasture, grazed by cattle (WWS January 2005).

View of the dam looking south up the gully.

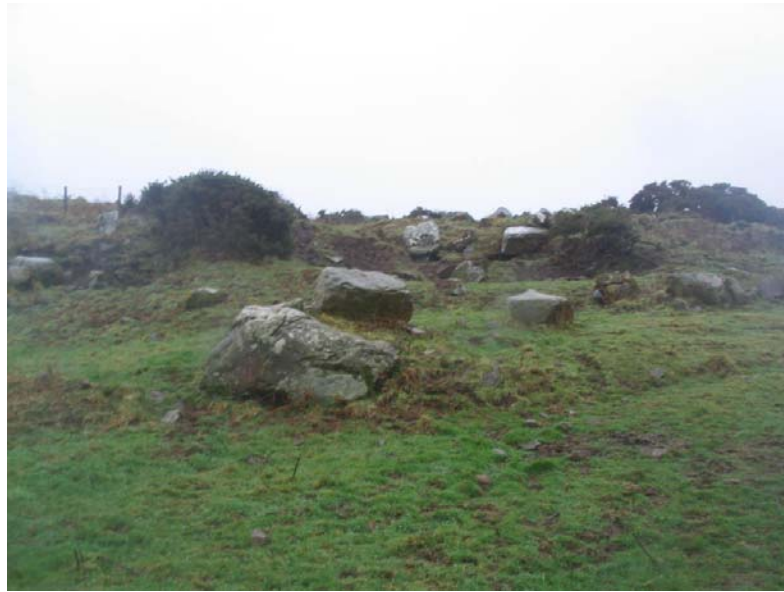
A stone marked on the 1st edition OS map of 1889. The site is in improved farmland. The feature was not

The stone, in the foreground, with quarry (PRN 54968) behind.

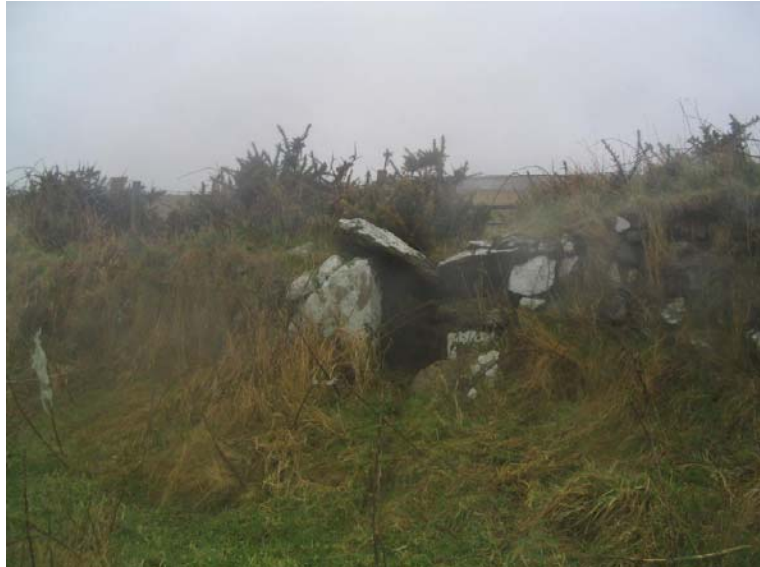
A rectangular opening in the lower part of an earth and stone hedge bank. A broken capstone rests on upright slabs to form a narrow opening 0.6m high by 0.4m wide.

View of the sheep crawl from the north.

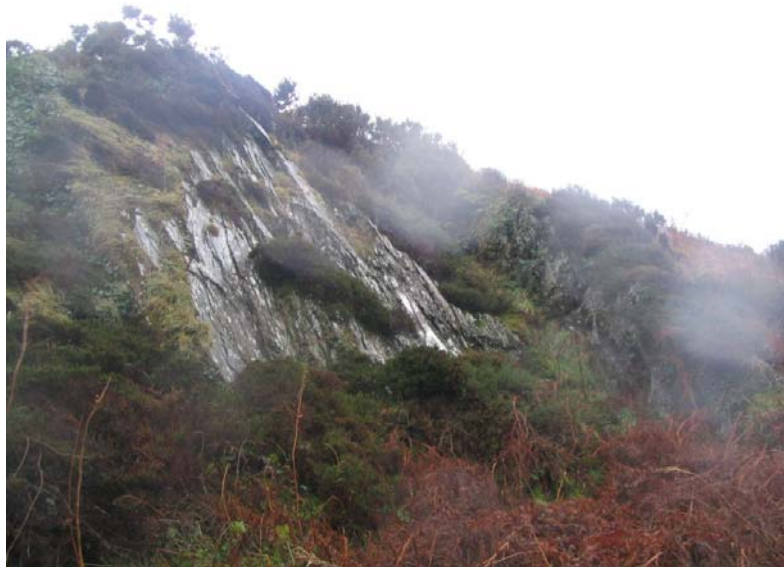
A V-shaped cut into the outcropping rock, representing quarrying activity on a small scale. The exposed faces measure perhaps 4m across, cutting 3m back into the slope. The quarry is within an area of rough pasture, grazed by cattle periodically (WWS January 2006.)

View west towards the quarry face.
