TIR GOFAL MANAGEMENT PLAN: HERITAGE MANAGEMENT INFORMATION (HE2)

**Prepared for:
Bach Sylw**

**Tir Gofal Reference No
W/12/5285**

**Report No. 2006/52
Project No. 54197**

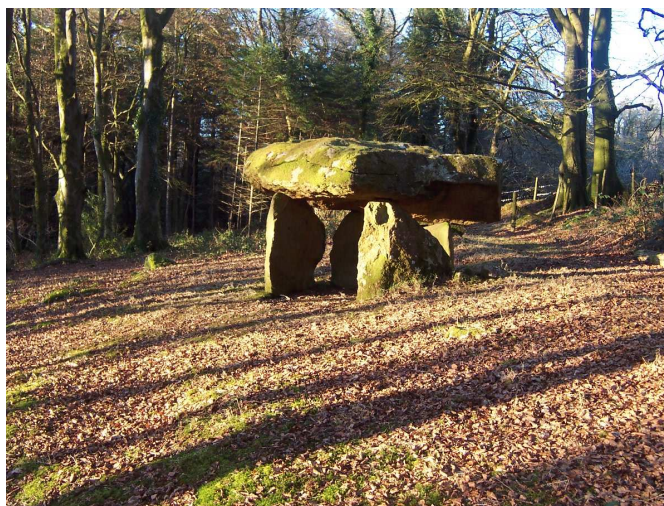
A fine Neolithic burial chamber on sloping ground above the River Taf, now a Scheduled Ancient Monument (SAM Cm031).

Four sidestones support a large wedge-shaped capstone, the southern down slope side left open. A description of 1872 mentions the tomb being surrounded by a circle of isolated stones, but no such feature is now evident. Two small stones lie upslope of the tomb and have been interpreted as a sill for a passage. These combined with the shape of the chamber have led to the suggestion that this tomb may have been a passage grave. (WWS March 2006 based on Rees 1992).

The burial chamber lies within mature beech woodland.

The tomb is known variously as Gwal y Filiast (Lair of the Greyhound) and Bwrdd Arthur (Arthurs Table). It is situated within mature beech woodland close to a forestry plantation. No obvious management concerns were noted. *Visited* 08/02/2006 (WWS)

The condition of the monument is stable with no obvious management concerns identified.

The management aim within Tir Gofal is the continued sensitive management of the monument. The following recommendations are made in consultation with Cadw, in line with recommendations made in the previous Cadw management agreement.

- To encourage and maintain a permanent grass cover on the monument and to ensure that any pasture renewal is carried out by non destructive means which do not disturb the ground surface.
- To control weeds on the monument by annually cutting by hand
- To cut all scrub and sapling growth to ground level annually, leaving roots in situ to avoid disturbing the archaeological layers. Regenerating saplings shall be controlled annually and may be pulled by hand.
- To annually remove all fallen timber from the monument.
- To remove any dead or unstable trees only when ground conditions are dry, leaving roots in situ to avoid disturbing the archaeological layers.

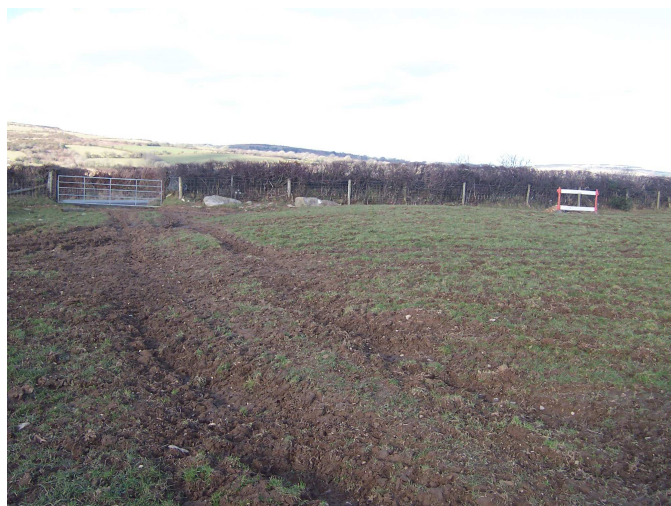
A much reduced round barrow located just inside the gate of a field measuring some 11m in diameter and standing to a height of approximately 0.25m.

On the west side the barrow is being eroded by tractors and farm machinery coming through the gateway. It lies within the corner of a pasture field. *Visited* 08/02/2006 (WWS)

View of the barrow from the south. Erosion by farm machinery visible on west side.

The management aim within Tir Gofal is to improve the condition of the barrow and prevent further damage. The following recommendations apply.

- to ensure that ploughing operations in the area adjacent to the barrow are kept at least 10m from the edge of the mound.
- to control stock at a level that will prevent breakdown of grass cover and erosion.
- to avoid machinery access past the west side of the barrow during wet conditions to prevent further rutting or erosion.
- monitor the condition of the barrow. Contact Tir Gofal Project Officer at the 5 year review or earlier if the condition worsens.

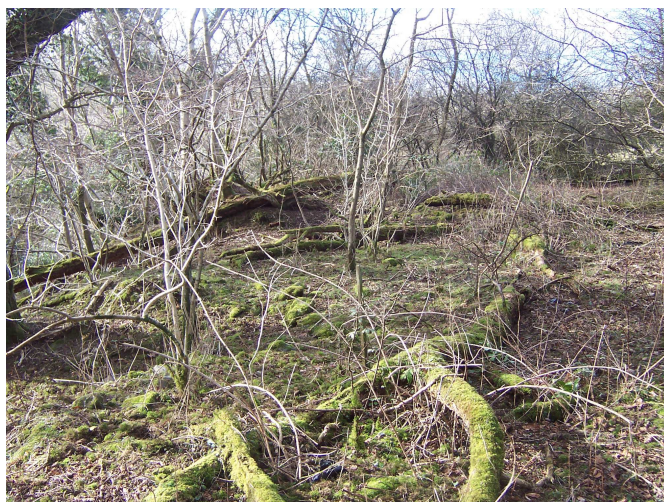
The outline of a building and enclosures are recorded on the Ordnance Survey 1st edition map (1889) representing the site of a former cottage.

The remains now consist of a raised platform (9m east-west by 6m north-south) in the hillslope and the wall traces of an associated outbuilding visible in the hedge bank to the north. The site is overgrown by regeneration woodland. *Visited* 08/02/2006 (WWS).

The former cottage site, viewed from the south-east.

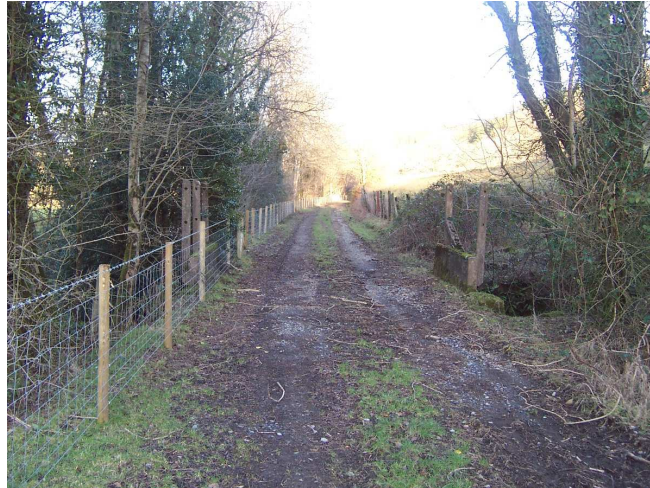
The Whitland to Crymych railway, constructed in 1876 and part of the Whitland & Cardigan Branch of the G.W.R. Now dismantled, although the trackbed remains. *Visited* 08/02/2006 (WWS)

The former Whitland to Crymych railway close to the point where it passes Dolwilym mansion.

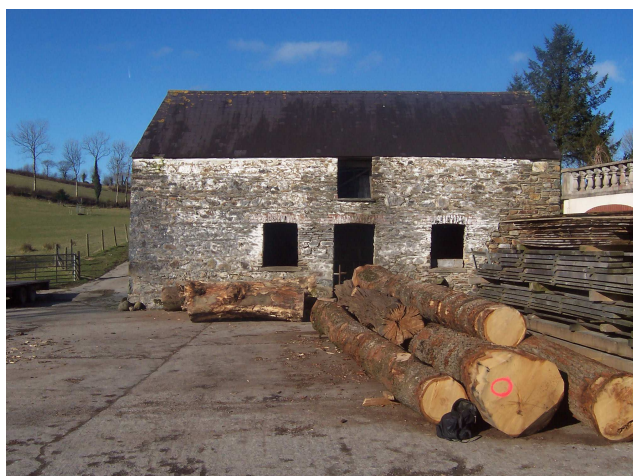
A c19th century outbuilding on the northwest side of the farmyard at Bach Sylw farmstead (PRN 56434). It is of rubble stone and slate construction with red brick heads to door and window openings and comprises a granary loft and ground floor stable built into a slope in such a way that the loft is accessed from ground level in the upslope end. No original internal fixtures or fittings remain.

The building is reasonably intact but requires attention if it is to be maintained in the long term. The loft floor is dangerous: joists above the stable are weakened. *Visited* 08/02/2006 (WWS)

The front (south-east facing) elevation of the stable/ granary at Bach Sylw.

It is intended that the loft floor will be repaired by replacing damaged or rotten joists.

As a general rule, original features should be repaired rather than replaced otherwise replacement features should be in the original style of the building. eg. it is intended that the unsafe granary floor joists will be replaced. New materials should match existing ones.
