## **TIR GOFAL MANAGEMENT PLAN: HERITAGE MANAGEMENT INFORMATION (HE2)**

**Prepared for:  
Abermeurig Mansion**

**Tir Gofal Reference No  
W/11/5496**

**ACA Report No. 2005/119  
Project Record No. 54210**

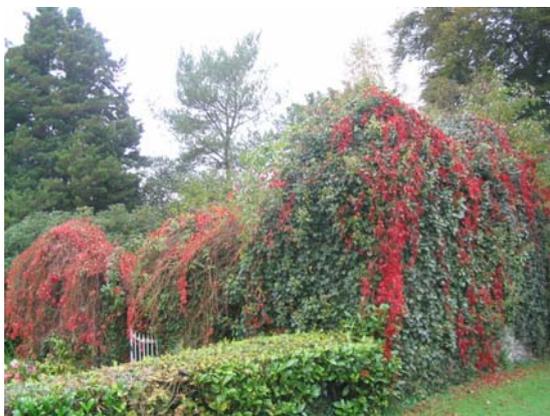
**'The Lodge'**

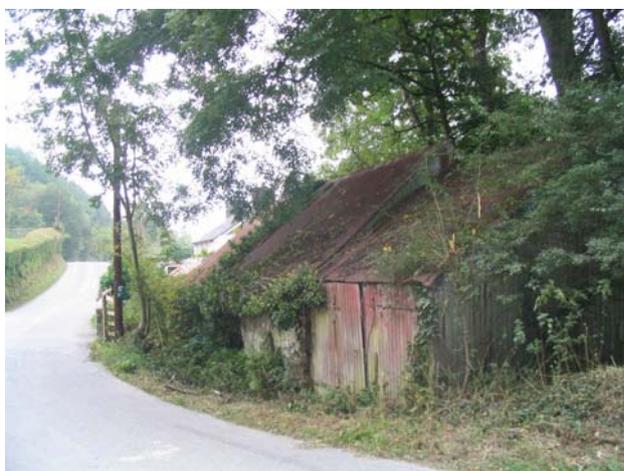
**Cae Melyn roadside cottage**

Clay, or 'clom' (as it is called in Wales) was a cheap and versatile building material, and is likely to have been sourced locally. The vernacular nature of the building makes it probable that it was originally roofed with thatch (a material which was also readily sourced from nearby). The RCAHMW record from 1981 states that it was roofed with slate, which may have replaced an earlier roof of thatch. At the time of the Tir Gofal archaeological farm visit the building was entirely roofed with corrugated tin.

Unfortunately it was not possible to get into the building to view the roof construction, or assess the internal structure and condition. These may hold important information about the development of the building, and allow a more accurate assessment of its origins. The present owner of Abermeurig recalls that it was used by chapel-goers to stable horses during services. It seems unlikely that the building was originally intended for this use (it certainly does not resemble nurse-built stables), but was re-used for this after Canel

Every effort should be made to maintain the building appropriately, to help ensure its future survival.

The walls should be protected from further deterioration, in particular the north-west wall, which has lost all of its protective coating of lime, and is currently undergoing weathering of the core earth fabric. Ideally this should be achieved by re-applying a protective render, but in the short term, preventing further deterioration is the main aim, and this could be achieved by creating a canopy over the wall with corrugated tin. It should be ensured that this does not involve damaging the existing earth wall further by using large numbers of fixings - the aim is to create a protective canopy, rather than a permanently fixed cover.

Leaf litter and other dead vegetation should be cleared away from the base of the wall, as debris may be preventing adequate run-off, and causing damp to penetrate the wall base. Scrub control may be necessary to ensure that the fabric is not damaged by roots, and creeping plants.

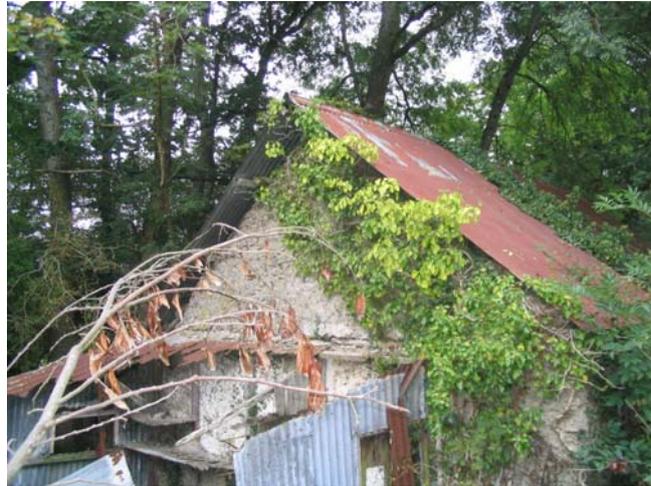
**The southern gable-end of the cottage**

More recent attachments of corrugated tin outshuts have been added over the years, and these have served to protect parts of the original building against which they stand. These additions should not be disregarded as modern, and therefore unimportant, but rather as part of the evolving building. The present owner of Abermeurig remembers the tin extension at the north-east end, being built as a garage to house a neighbour's car. The hinges on the doors of this element are very large and quite ornate, and have clearly been re-used from a much grander building, probably from within the estate.

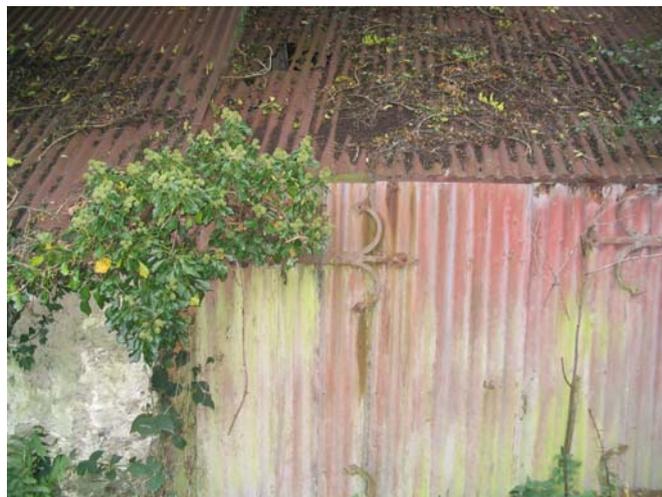
**Detail of hinges, probably re-used from an estate building**

The cottage is now unused, but has survived in reasonable condition, and every effort should be made to prevent further deterioration of the fabric of the structure. This is especially important as it is constructed of clom. The overall importance of buildings such as this is high, as the survival rate for clom buildings is generally low. Other examples are known from the surrounding area, and this part of Ceredigion may be special, both in terms of the incidence of survival of clom buildings, and also the extent to which clom was used regularly as a building material. Every effort should be made to maintain the building appropriately, to help ensure its future survival. *Visited 06/10/2005 (HGM)*

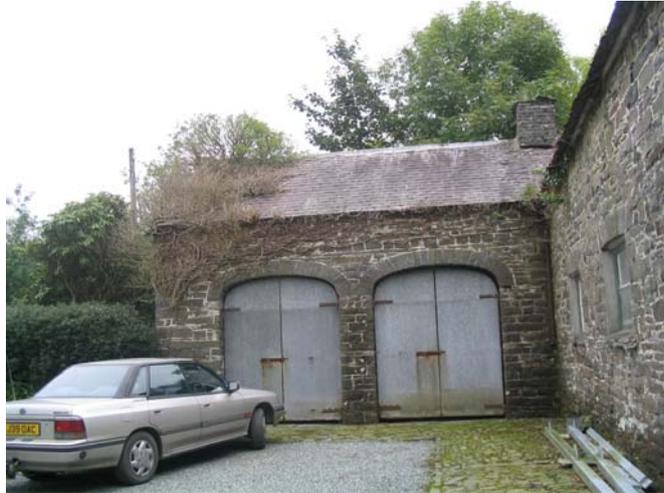
**The north wing, showing coach entrances with modern doors, and cobbled pavement**

The original doors on this carriage-house have been removed, and replaced with galvanised steel doors. The fate of the pre-existing doors is unknown, but the large, ornate strap hinges, which can now be seen supporting the doors of the corrugated iron annex on the clom cottage (PRN 10,050) may originally have supported the coach house doors. Where original door and window openings survive, these are gently arched, with stone voussoirs. However, some have been substantially modified, and the replacement openings have straight lintels. An evenly spaced row of small arch-heads with stone voussoirs, in the southern elevation of the western wing, appears to represent blocked up windows or ventilation openings. Visited 06/10/2005 (HGM)

This building has been granted planning permission to be converted for use as holiday cottages. However, until the conversion is undertaken, the building should be maintained in a stable condition, and fabric, fixtures and fittings should not be allowed to deteriorate.

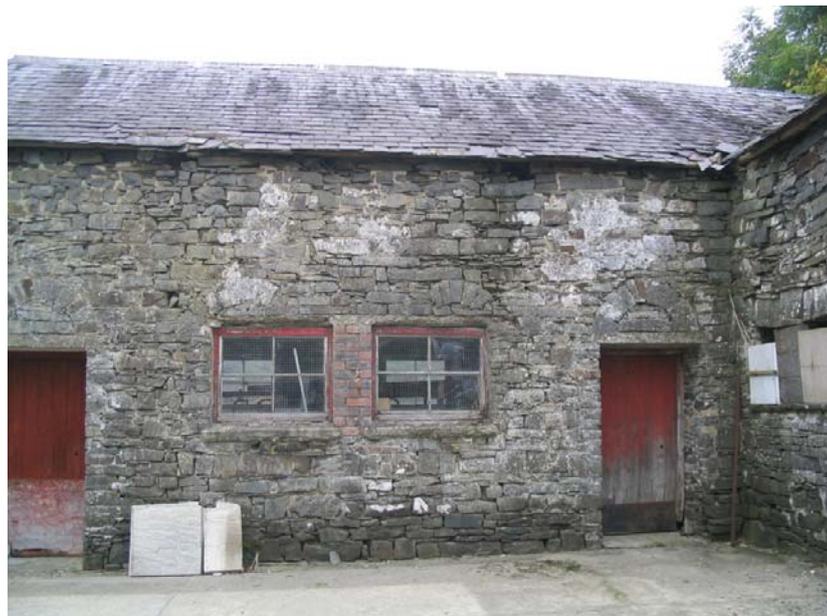
**Row of small arch-heads, with more recent openings below**

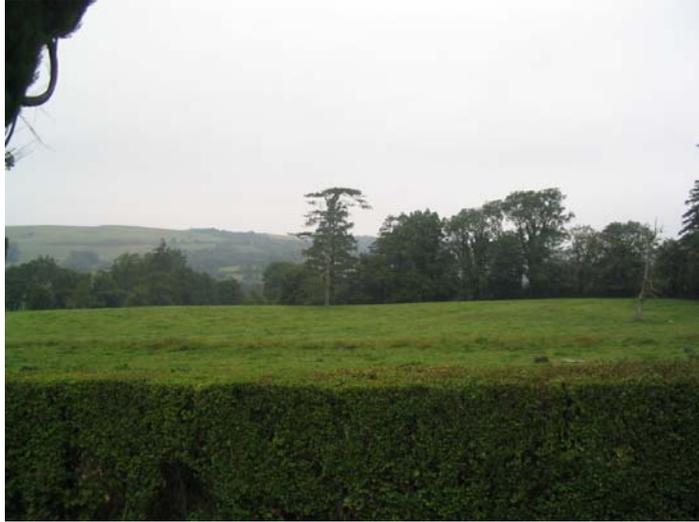
**View of the park, to the north of Abermeurig Mansion**

This oral history, in conjunction with positional information available on the first edition Ordnance Survey map, can be used to establish an appropriate planting regime for the parkland. The first edition Ordnance Survey map is sufficiently detailed to show the location of individual trees, and whether they were coniferous or broadleaf. The species still represented include Canadian Redwood, Oak, and Spruce. The owner remembers that several of the specimens were Elm, but these will have to be replaced with another appropriate species, such as Beech, because of the problem of Dutch Elm Disease. *Visited 06/10/2005 (HGM)*

The planting regime for former parkland to the north of Abermeurig house should be prioritised within the Tir Gofal management plan.

The following is a list of specimen positions, based on information marked on the first edition Ordnance Survey map, and the recollections of the owner (see locational map):

1. SN56,414 56,598 Canadian Redwood, surviving upright, but dead, leave as habitat, and replace when necessary\*.
2. SN56,396 56,619 Elm, now gone. Replace with different appropriate species (oak/ beech)
3. SN56,435 56,618 Oak, still alive.
4. SN56,343 56,640 Elm, now gone. Replace with different appropriate species (oak/ beech)
5. SN56,349 56,679 Oak, now gone. Replant.
6. SN56,293 56,627 Ash, still alive.
7. SN56,296 56,636 Unknown, conifer. No longer extant. Replace with other coniferous species (at owner's discretion).
8. SN56,376 56,654 Spruce coppice - still extant but with several trees missing from the original group. Replant missing trees by using old photograph (in owner's possession) as reference.

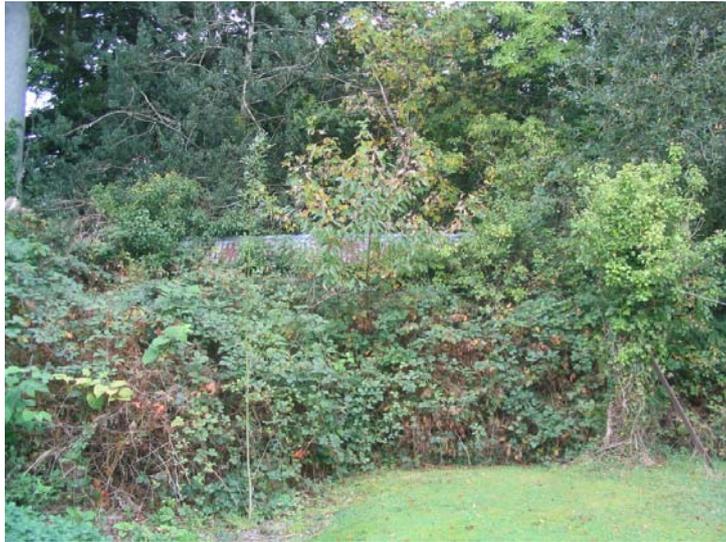
A walled garden to the east of Abermeurig Mansion. Rectangular in plan, and depicted on the Ordnance Survey first edition map with formal divisions between beds, created by a grid pattern of paths. The walled garden would have been used to grow produce for the house. The surviving eastern wall is constructed of stone, and has been rebuilt in a number of places. The north wall is one of the most interesting features of the garden. It is constructed of earth (or 'clom' as it is known in Wales). This wall is currently overgrown with vegetation, and it is difficult to ascertain its overall condition, although there was evidence of collapse in some areas. The top of the wall has a corrugated iron cap shaped as a roof with a central ridge. This would have protected the wall from water penetration, which causes clom to deteriorate rapidly.

**Through thick vegetation, the corrugated tin 'roof' on the clom wall of the garden can be seen**

The importance of the walled garden is high. Ideally, the northern clom wall should be renovated, and failing this every effort should be made to protect it from further deterioration. (See management prescription for Cae-Melyn Cottage PRN 10050)
