## **TIR GOFAL MANAGEMENT PLAN: HERITAGE MANAGEMENT INFORMATION (HE2)**

**Prepared for:  
Pencwm**

**Tir Gofal Reference No  
W/11/5498**

**ACA Report No. 2005/124  
Project Record No. 54212**

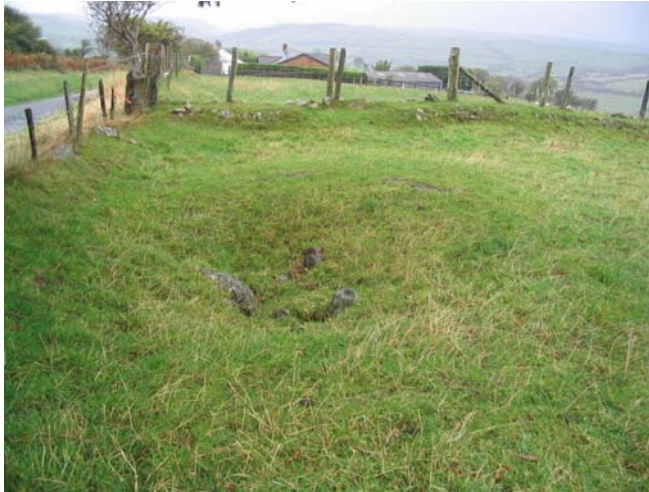
A small mine shaft. Presumably dates to the late 19<sup>th</sup> century as it is not marked on the 1<sup>st</sup> edition Ordnance Survey map of 1888 but marked as 'Old Shaft' on the 2nd edition map of 1905. The site is now visible as a grass covered and rock filled depression measuring c2m x 1m surrounded by a low bank, situated against the field boundary. *Visited* 21/10/2005 (PP)

**W facing shot of the mine shaft.**

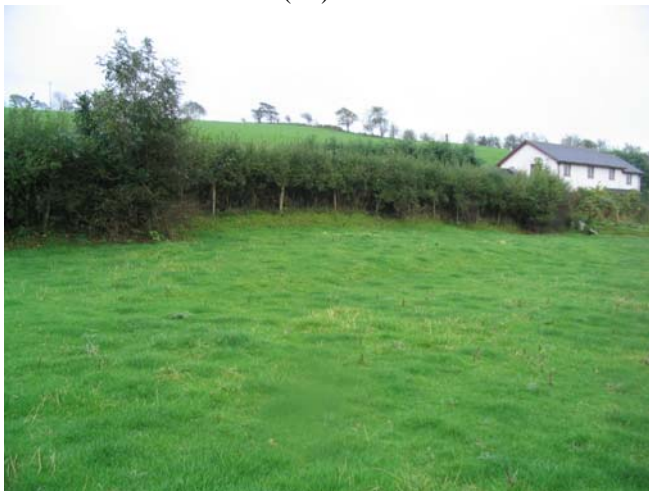
A raised rectangular platform aligned roughly east-west along the field boundary. The platform measures c19m E-W by 6m N-S, and c 0.5m high. The platform would appear to correspond to a range of buildings marked on the tithe map of 1846, part of the small farmstead of Tyn r helig. The farmhouse would appear to survive, now called Tai Bach and lying outside this farm holding but these farm buildings appear to have been removed along with associated field enclosures by the time of the 1<sup>st</sup> edition Ordnance Survey map of 1888. *Visited 21/10/2005 (PP)*

**SSW facing shot of building platform against the hedgeline. Tai Bach lies on the opposite side of the road at the right hand side of the picture.**

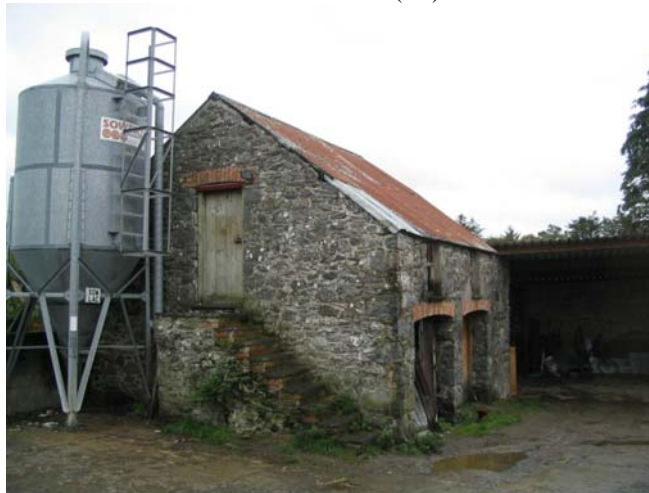
A small working farmstead complex marked on the old series Ordnance Survey map of 1837. To the north of the farmhouse is a U-shaped layout of traditional farm buildings. The western range is built of mortared random rubble with a slate roof, replaced in sections by corrugated metal roofing. This range is divided between a long low section with wide square headed openings and windows facing the central yard, with a taller lofted barn at the southern end. This range is marked on the tithe map of 1847 which also marks an opposing range forming the eastern side of the layout. Only the eastern wall remains of this range, which now has a modern roof, open to the yard. At the northern end of the yard is a late 19<sup>th</sup> century cartshed, built in random mortared rubble with low brick arches over wide double openings facing south, with windows above and a corrugated iron roof. There is an external staircase and doorway in the western gable wall. Modern farm buildings have been built against the western side of this complex and on opposite side of the road to the east. *Visited 21/10/2005 (PP)*

**E facing shot of late 19<sup>th</sup> century farm building at the northern end of the farmstead complex.**

The aim of the management for this site should be to ensure the survival of traditional buildings and maintain the historic character of the complex of traditional farm buildings as a whole. The farm buildings are still in use and generally in a good condition. The corrugated iron roof of the farm building at the northern end of the U-shaped complex is rusting and may be deteriorating in places.

- The deteriorating roofing could be replaced, using materials appropriate to the farmstead and locality (corrugated iron/slate).

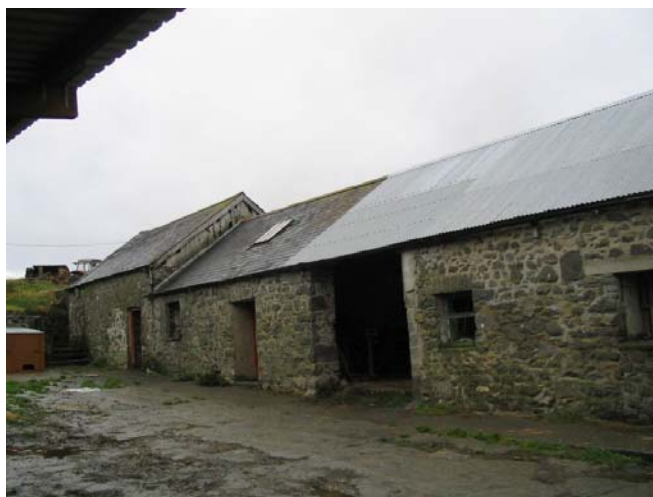
SW facing shot of the western range of farm buildings at Pencwm farmstead.
