TIR GOFAL MANAGEMENT PLAN: HERITAGE MANAGEMENT INFORMATION (HE2)

**Prepared for:
Gilfachgoch**

**Tir Gofal Reference No
W/12/5539**

**ACA Report No. 2006-98
Project Record No. 54227**

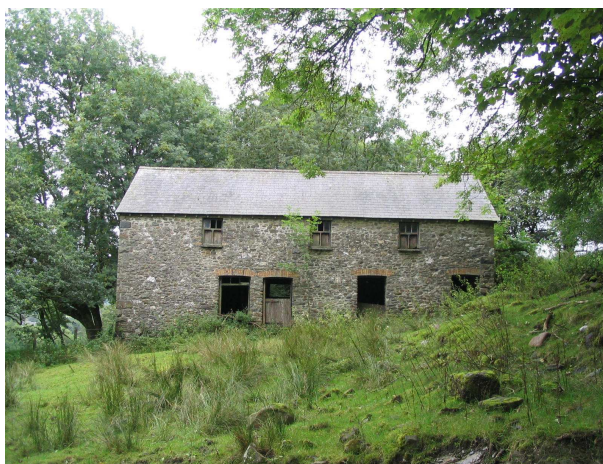
A loose cluster of mature trees now surrounds the complex with other young vegetation coming through. Young trees are rooted in the ruinous farmhouse and cow house. The outbuilding has a few displaced roof slates but is otherwise in good order. Some young trees have become rooted in the wall bases.

The lofted stable range at Bryn-teg survives largely intact.

The management aim within Tir Gofal is to prevent damage by vegetation to the standing remains and buried archaeology. The following recommendations apply.

- Monitor mature trees close to the buildings. Consider felling mature trees which are at risk of windthrow.
- Cut or spray back young trees and vegetation on the ruinous farmhouse, and close to the outbuilding leaving the roots in situ. Spot treat to prevent re-growth.

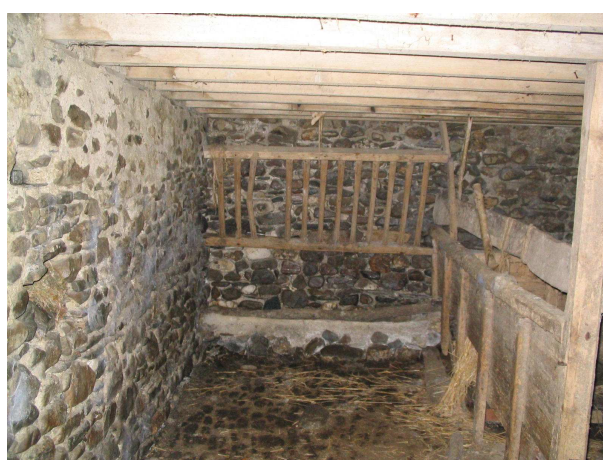
Historic internal fittings at Bryn-teg.

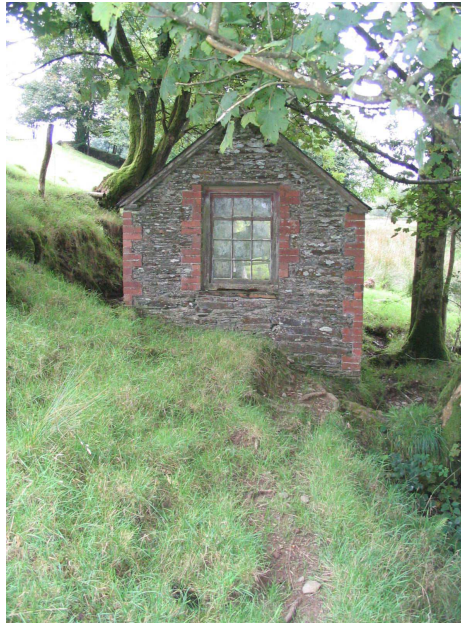
Early 20th century stone-built pump house 6.84m x 2.91m built to house a water pump for Gelynen Farm. The pump house is well maintained. No specific management threats identified.

Facing east towards the pump house.

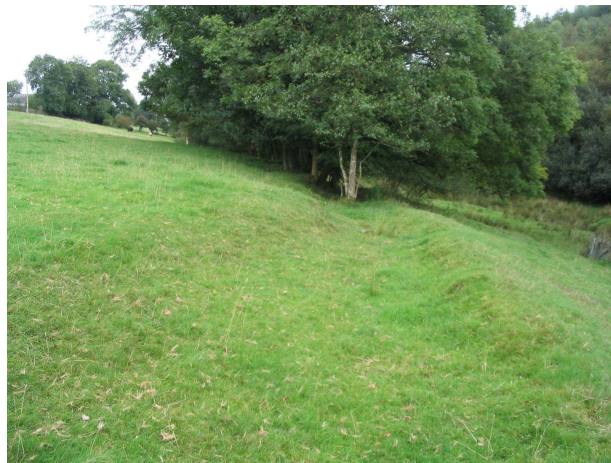
Mill race connected with mill PRN 12627. The mill race still survives although heavily silted. At least parts of it were stone lined.

The mill leat lies within unimproved pasture land. No management threats identified.

Facing east along the silted up mill race.

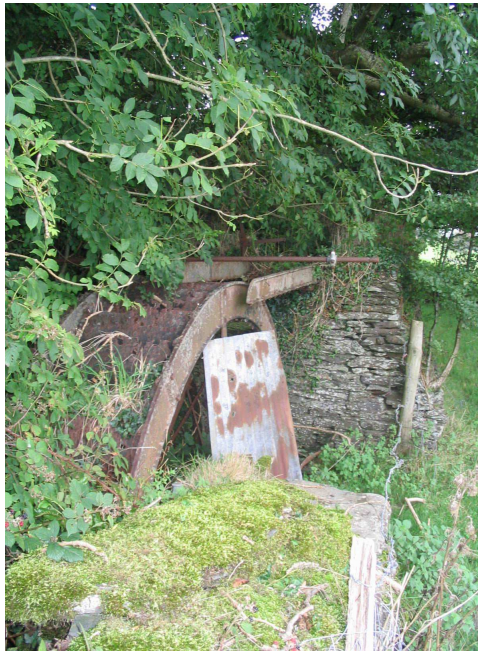
Late 19th century cast iron water wheel, once serving water driven barn machinery at Gelynen farmstead. Part of an unusually intact water power complex incorporating leat (PRN 56940), stone lined wheel pit and the cast iron remains of an overshot launder.

The wheel pit and launder are now fenced out. No specific management threats were identified: a canopy of mature trees prevents excessive scrub growth around the site.

The cast iron water wheel and launder behind Gelynen, once used to power belt driven machinery in the barn nearby.

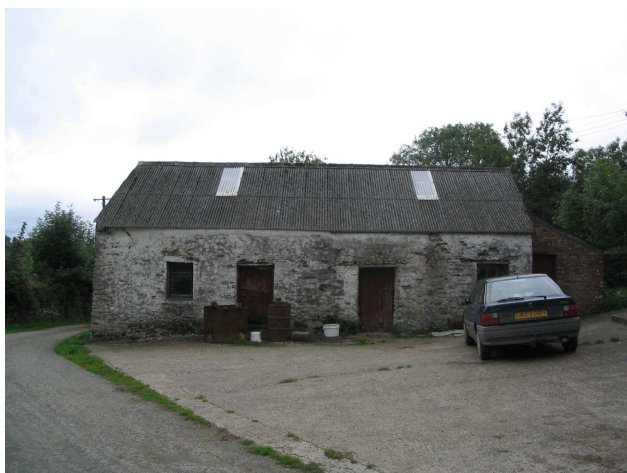
5	GELYNEN (56942)	Post Med cow house	SN30083642	B		Specific
	<p>An early nineteenth century or earlier whitewashed stone and clay bonded cow house, probably the earliest building at Gelynen. Built down the slope with three doorways for transverse tethering then a window in the front wall and a single doorway at the lower end of the rear wall. A former loft is indicated by sawn off loft joists in the transverse walls.</p> <p>The cow house belongs to an increasingly rare class of earlier, pre-nineteenth century lofted cow sheds where animals were tethered. It is not, perhaps amongst the best examples of its kind, but apart from re-roofing it does retain traditional character. The pattern of openings which is one of the diagnostic features for traditional cow houses is undisturbed. The tethering floor has been concreted over in c.1950s cattle stalling. A modern lean-to of brick and asbestos roofed construction adjoins the rear wall.</p> <p>The cow house is currently in a poor condition: the lower pine end has a significant bulge where the wall faces have become detached from the wall core and is now close to collapse. Significant works are required if the building is to kept in a good state of repair.</p>

The late 19th century or earlier cow house at Gelynen.

The cow house is currently in a poor condition: the lower pine end has a significant bulge where the wall faces have become detached from the wall core, and is now close to collapse. Significant works are required if the building is to be kept in a good state of repair.

- Consider removing hedge banks to the west and south of the cow shed to provide a solution that does not involve altering the building. Repair/ re-build the lower end of the building on the original foundations using traditional materials and methods of construction (Capital Works Option).
- Contact Cambria for further discussion if this is not considered viable.
