TIR GOFAL MANAGEMENT PLAN: HERITAGE MANAGEMENT INFORMATION (HE2)

Prepared for:
Glyn Annedd

Tir Gofal Reference No
W/11/5510

Report No. **2006/31**
Project No. **54237**

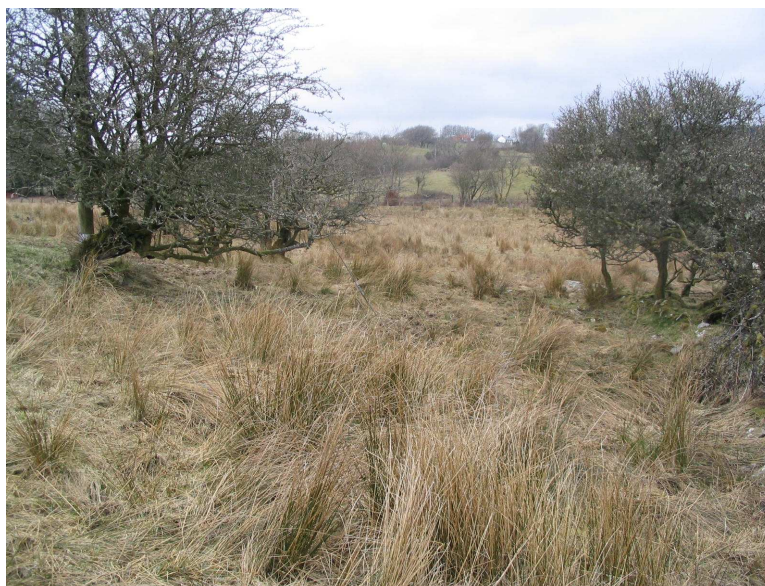
The site has been all but levelled. No traces of a cottage remain other than a random scatter of stones. Earth banks of enclosures surrounding it remain with grown out hedges. In rough pasture. <i>Visited</i> 21/03/2006 (WWS)

The site of the cottage from the south. Few traces remain.

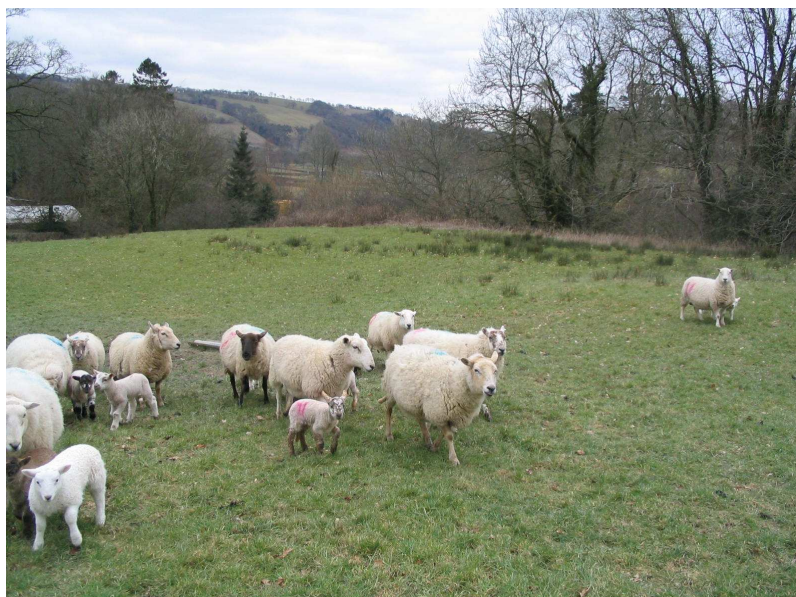
TAFARN MWT [\(55890\)](#)

A fairly level area in sloping ground indicates the site where the inn once stood but no other surface traces of the inn or its associated enclosures remain. In a pasture field.

The *-mwt* place-name element is as a variant spelling of *mwd* (mud) perhaps indicative of clom construction. *Visited 21/03/2006 (WWS)*

The site of Tafarn-mwt viewed from the north. The inn is now evidenced only by a level area in otherwise sloping ground.

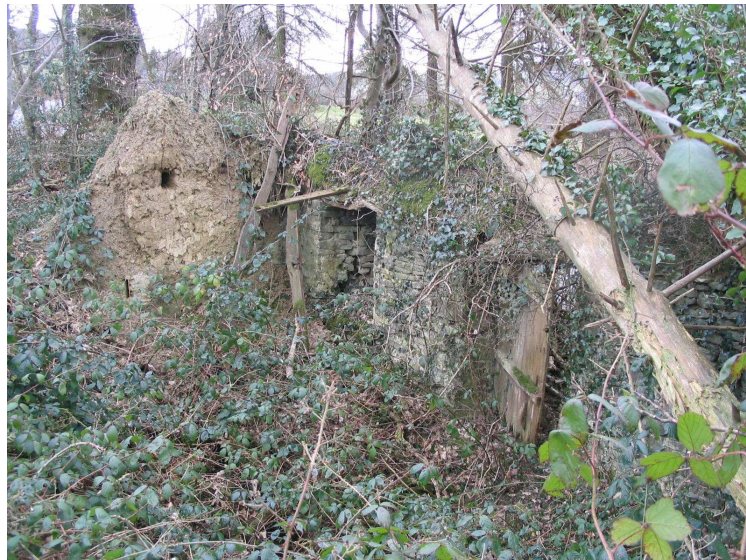
COTTAGE-PARC
[\(55891\)](#)

The cottage has a rubble stone frontage with central doorway and windows on each side, with all other walls of clom (clay bonded) construction. Single storey but roofless with front wall still standing to eaves height but other, clay bonded, walls now much reduced. In regeneration woodland and now much overgrown.

The cottage incorporates both stone and clay-walls in its design.

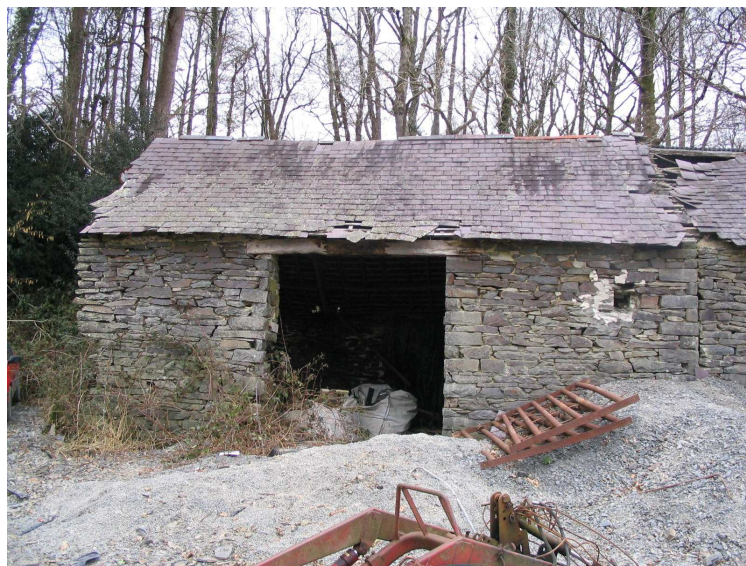
BRON-AERON (54124)	Post Medieval threshing barn; stable	SN60375923	B		Generic
---	---	-------------------	----------	--	----------------

A nineteenth century range of good historic character incorporating a threshing barn and lofted stable, some 60m to the east of the house at Bronaeron (PRN 55892). It is of rubble stone with a slate roof still largely intact. The threshing barn is on the west with characteristic large main door and smaller winnowing door opposite. The stable to the east has a window, then doorway. A former hay loft, indicated by sawn off joists, would have been accessed by a loading door in the east gable wall.

The building is reasonably intact, although a large opening has been made in the west gable wall. It is in poor condition and falling into disrepair with loose or displaced masonry and a leaking roof with a number of displaced slates. Corrugated tin now covers the rear pitch of the stable. *Visited 21/03/2006 (WWS)*

The front elevation of the threshing barn.
