TIR GOFAL MANAGEMENT PLAN: HERITAGE MANAGEMENT INFORMATION (HE2)

Prepared for:
Hen Fynachlog

Tir Gofal Reference No
W/11/5538

Report No. **2006/56**
Project No. **54241**

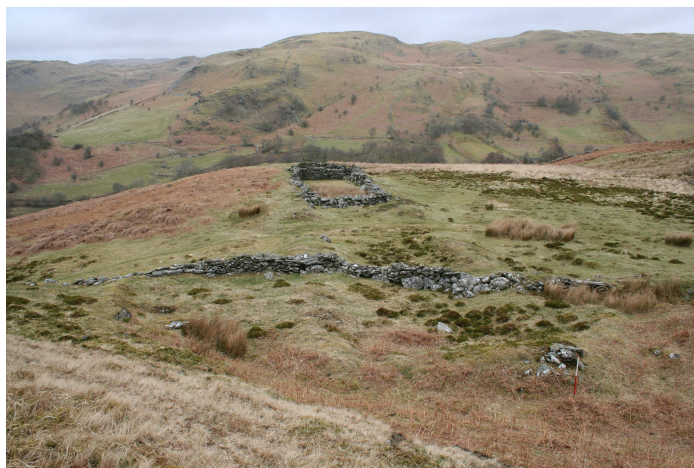
Name (& PRN)	Period/Site type	NGR	Status	SAM/listing	Management required
1	HAFOD EIDOS EARTHWORK (35646)	Post Medieval enclosure	SN77346462	A	SAM	Specific
	Large rectangular earthwork, 56m long x 9m wide overall, unique in its scale and form of construction and now a Scheduled Ancient Monument (S.A.M.). Same as PRN 9328.					
	Earth and stone banks stand up to 1m high and up to 2m wide. Overbuilt by drystone fold at northern end, but southern end is cut into foot of moderate slope, with an apparent drainage channel cut around the end of the enclosure to facilitate free drainage. The south end is also overlain by an old drystone boundary wall, long disused and ruinous. Potentially an enclosure associated with a mediaeval hafod associated with Strata Florida Abbey.					
	The enclosure is situated in unenclosed rough grazing land, largely pasture but with bracken and some rushes present. Stable grass cover predominates. Some reed growth has colonised the interior of the sheep fold. No specific management threats.

The earthwork enclosure, viewed from the south.

The aim within Tir Gofal is the continued sensitive management of the monument. The following management recommendations are made in consultation with Cadw.

- Monitor the condition of the monument. Consider scrub/ bracken control if its condition worsens by cutting vegetation close to ground level then removing debris from the site.

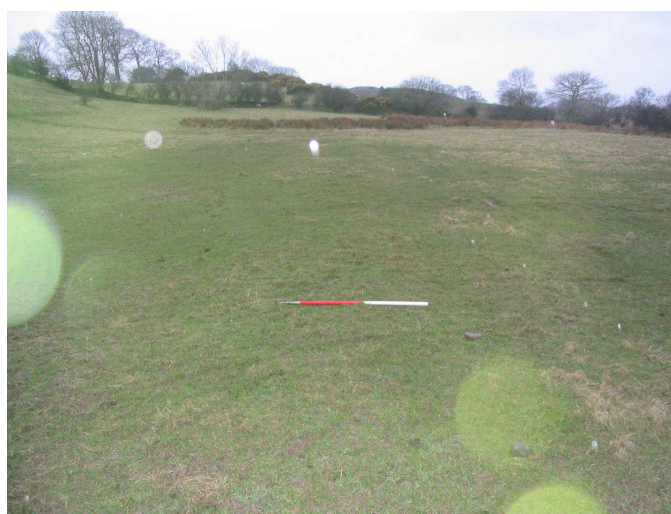
- 3 [\(56445\)](#) **Unknown road?** **SN57577005 A** **Specific**

A low linear earthwork, approximately 6m wide and no more than 0.2m high, can be traced for approximately 90m in pasture to the east of Lletty Crugiar, probably representing the line of an ancient road. The line of the earthwork bears no relation to the current field system which it is likely to pre-date. Further investigation is required if its true nature is to be understood.

Looking northeast along the line of the road earthwork.

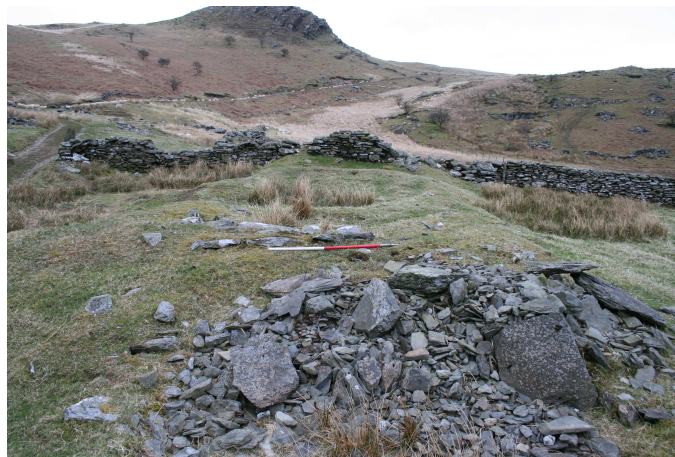
BLAEN MWYRO [\(8556\)](#) **Medieval?;Post** **SN78256479** **B** **Generic**
Medieval? long hut

Low grassy wall bases, about 0.5m high, define the remains of a three celled structure of unknown function. Measures 15m x 5m overall. It appears that the drystone, eastern gable wall survives in part, having been incorporated into a later drystone field boundary. It is possible that the shadow of a small enclosure appended to the structure survives on its southern side. Two ruinous, but upstanding structures to the north are of unknown relationship - the details of both have largely been obscured by demolition and the dumping of rubble. The site lies within a pasture field. No management threats.

The remains of the long hut, seen from the west. The eastern gable wall survives in part, preserved in the current field boundary.

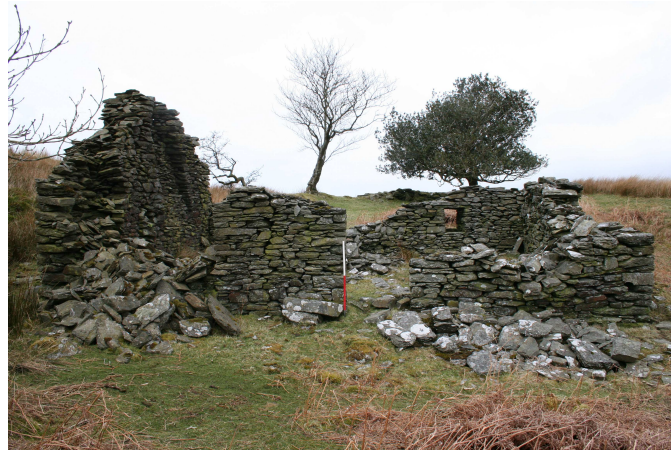
HAFOD EIDOS ([9329](#))

Ruined stone farmhouse in process of collapse. The building has a central door and windows in the SE facing wall, with a fireplace in the SW gable end. On level ground to the south lie the remains of a yard and outbuildings. On the slope above are the remains of an earthwork potato clamp. No specific management threats: the site is in unenclosed rough grazing land.

The front (E) facing elevation of the farmhouse.

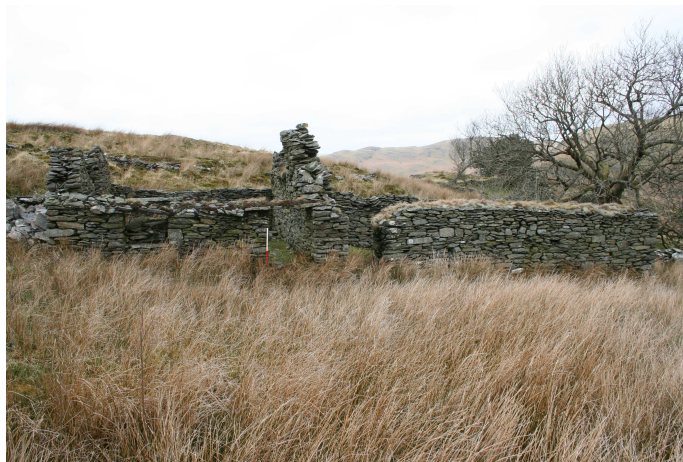
HAFOD EIDOS ([9330](#))

Ruined stone outbuilding at Hafod Eidos. Built cross contour with upper lofted stable and a beudy at the downslope end, only the dilapidated walls now surviving. No specific management threats: the site is in unenclosed rough grazing land.

The front (E) facing elevation of the outbuilding.

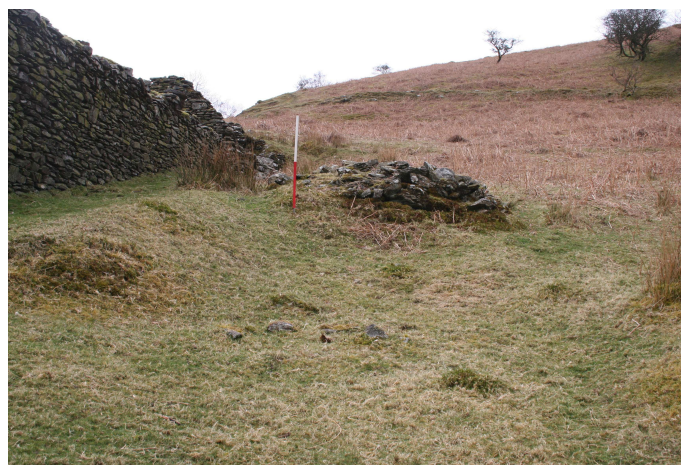
GELLI CLWYDAU [\(35644\)](#) **Post Medieval farmstead** **SN77126472 B** **Generic**

Ruined stone cottage and outbuildings. Known to be occupied into the mid-19th century. Built on large cross-contour levelled platform which may be speculated to indicate an early origin. Same as PRN 9327. A circular stone rubble spread behind to NW may represent the foundations of a circular pigsty. The site lies within an area of rough pasture and bracken. No specific management threats.

The possible remains of a circular pigsty lie behind the farmstead.

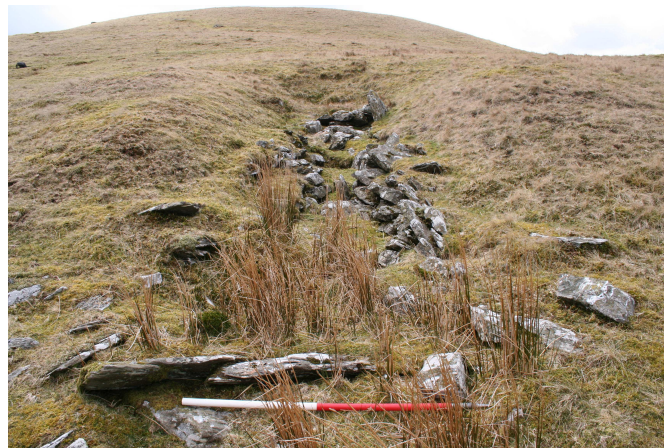
MWYRO UCHAF II [\(35657\)](#) **Medieval?;Post** **SN78776405** **B** **Generic**
Medieval sunken shelter

Unusual cut into slope which includes a drystone revetment/structure and may be ancillary to PRN 35658. The cut measures 10 x 3m and is up to 1.5m deep, opening out at downslope end. There is a perceptible widening of the cut at its South, upslope end. Inside the cut is the ruined base of a drystone structure or revetment wall which displays rough coursing. 5m to SW is a small platform, 5 x 4m with a large boulder at S. end. Situated in unenclosed rough grazing land. No specific management threats.

The sunken shelter, as seen from the north.

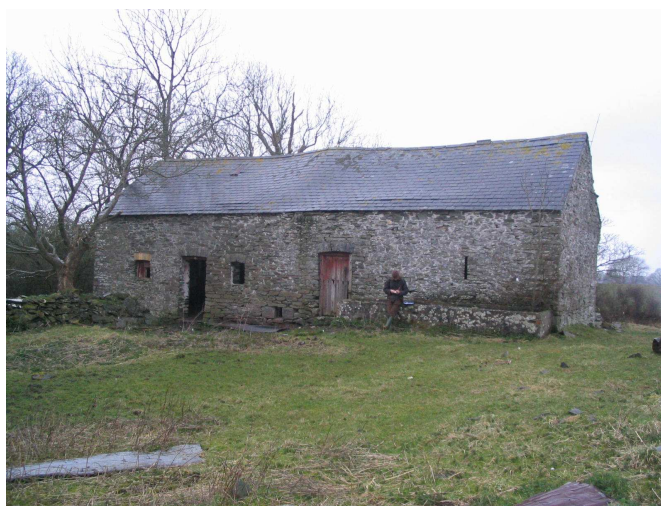
LLETTY-GRUGIAR **Post Medieval** **SN5730369909** **B** **Generic**
[\(55876\)](#) **farmstead**

Deserted farmstead complex around a large square yard. Includes standing buildings in a layout unchanged since at least 1888 (OS 1st edition). Comprises the ruinous remains of stone, 2-storey gabled farmhouse with central doorway and two windows as centrepiece. In front, forming two sides of a yard are two substantial ranges; a roofless lofted carthouse/ granary and cartshed on the E and a substantially intact threshing barn/ stable hayloft on the W retaining evidence of drive shafts, fly wheels and barn machinery (threshing, winnowing etc.). The gearing of a horse gin lies outside to the north. The origins of the farmstead are uncertain. It is listed as a freeholding in 1760 (Wmffre 2004, 758). No specific management threats: the site is in a pasture field and surrounded by some mature trees.

The barn and stables at Lletty-grugiar

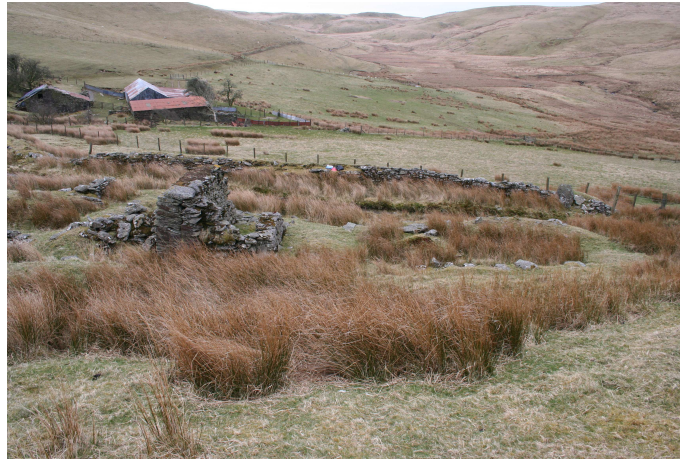
GARREGLWYD ([55885](#)) **Medieval? Post Medieval? deserted rural settlement** **SN7882064647 B** **Generic**

Ruined farmstead on S facing slope above the Afon Mwyro. Comprises of the ruinous gable end of a building overlying spread earthwork foundations of a possibly earlier long hut. The site lies within a pasture field. No management threats identified.

Garreglwyd former farmstead. View from south.

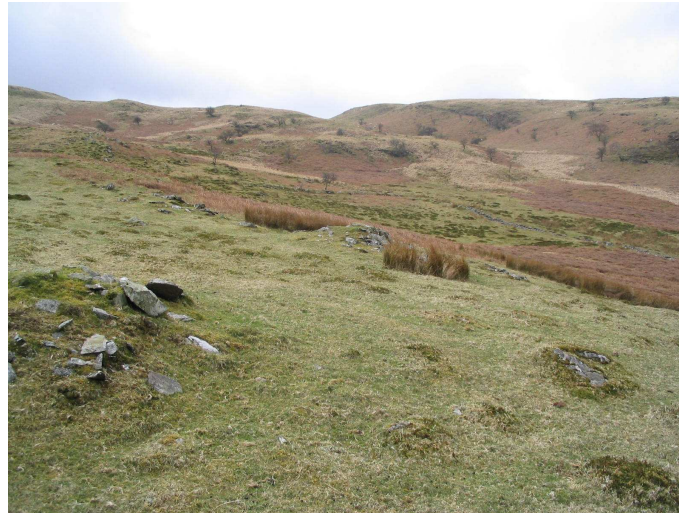
Area of circular or sub-circular clearance cairns between 2-5m in diameter. Full extent uncertain. Not accurately surveyed.

The cairns lie within unenclosed rough grazing land and are partially grassed over.

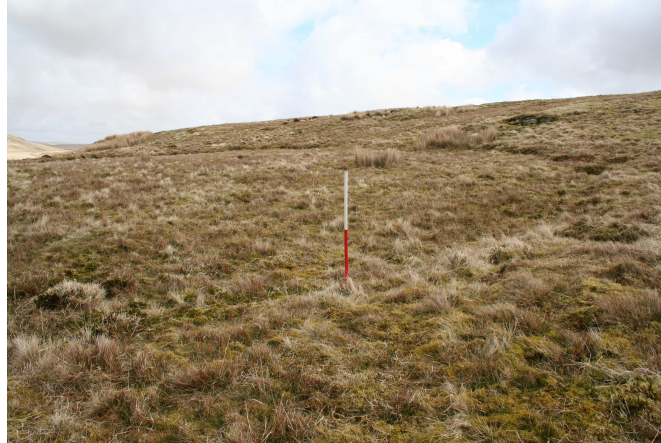
A rectangular peat cutting, approximately 20m EW x 30m NS and 0.3m deep.

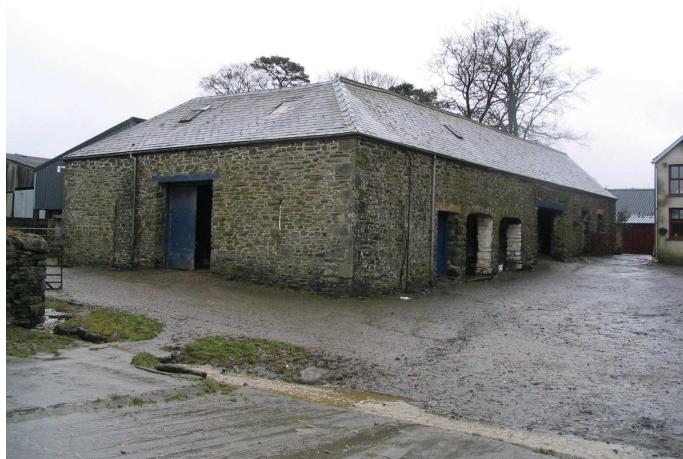
The main range at Hen Fynachlog.

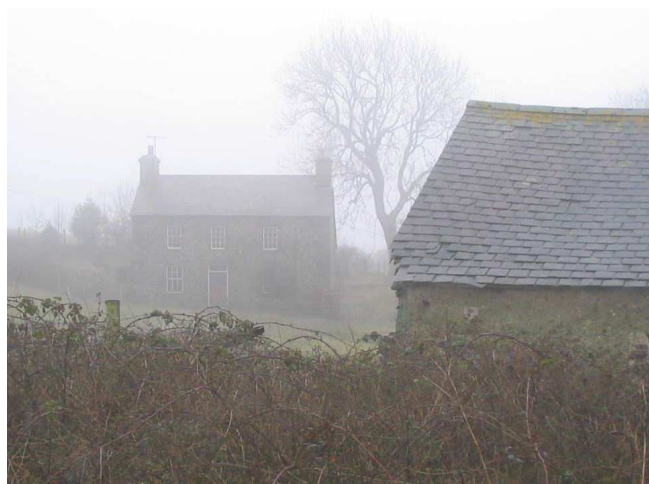
A redundant though substantially intact farmstead of historic character situated on high ground above the Afon Gwenffrwd. It comprises a stone built 2 storey farmhouse with 2 gable chimneys of "typical" 19th century character and several outbuildings laid out in front (to the NE) to define a yard. They include a derelict and much modified threshing barn range, with elements of clom (earth walled) construction, a lofted cart shed opposite and a late 19th/early 20th century cow shed of exceptional preservation, unusually intact when so many similar examples have been modified. Also several smaller buildings of less specific function. The farmstead is depicted in its current layout on the OS 2nd edition of 1905.

Elements of clom construction remain at Brechfa-Isaf
