TIR GOFAL MANAGEMENT PLAN: HERITAGE MANAGEMENT INFORMATION (HE2)

**Prepared for:
Gorsto Farm**

**Tir Gofal Reference No
W/12/5639**

**ACA Report No. 2006/60
Project Record No. 54255
Prepared by Alice Pyper**

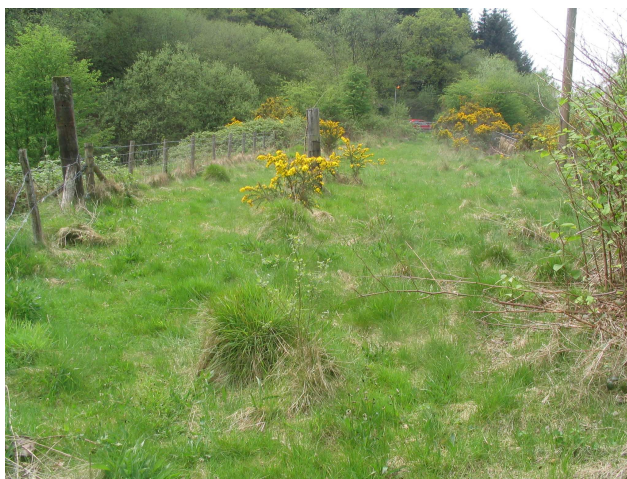
<u>(56314)</u>	Post Medieval;Modern railway	SN7172413969	C	Generic
<p>A branch of the Swansea Vale railway diverts from the main line to the Amman Works. This section survives as a large earthwork embankment which has become rather overgrown on the side, but the line of the track itself is grassed over. <i>Visited 12/05/2006 (Alice Pyper)</i></p>

A branch of the Swansea Vale railway which crosses through Gorsto Farm

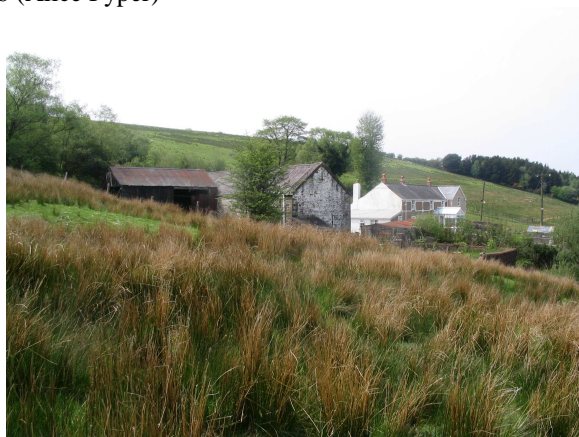
A small farmstead complex marked on the old series Ordnance Survey map of 1831. The Ordnance Survey map of 1906 shows the farmstead layout established in its current form with the farmhouse and combination farm building (PRN 56318) lying on either side of the farmyard. A third range of outbuildings on the north side of the farmyard must post-date the production of the Ordnance Survey map of 1918 (Carmarthenshire sheet 49.03). A further pitched roofed tin/wood/corrugated asbestos shed lies to the south of the farmhouse and farmyard entrance. The owner relates that this shed was once a cobblers workshop and was relocated to its current site.

To the northeast farmstead is the remains of a trackway leading to the fields to the east of the farmstead. A number of large stones have been used to make up the level the trackway on this southfacing slope. Farmsteads are archaeologically sensitive areas and may have seen continued occupation over a long period of time. *Visited* 12/05/2006 (Alice Pyper)

A view of Gorsto Farm from the northeast

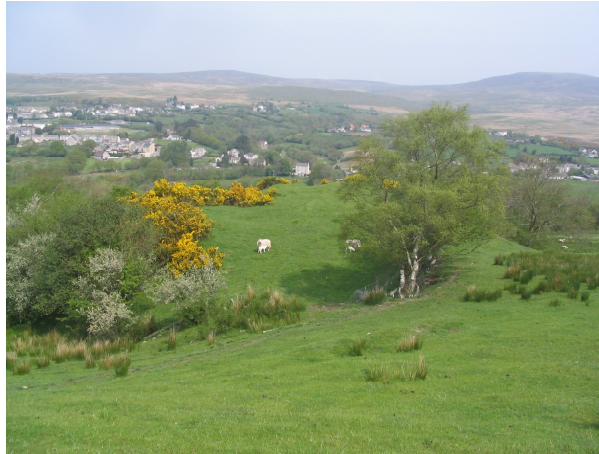
The 2nd edition Ordnance Survey map of 1906 shows a large area on the edge of Gwauncaegurwen consisting of spoil tips, trackways, tramways, shafts and mine buildings. Much of this has since been removed and relandscaped following open casting operations in the area. To the southeast of Gorsto farmstead is an area of spoil tipping resulting from earlier iron ore extraction. The spoil tips are wooded on the tip sides with gorse bushes established on the top of the slopes. Further trial pits have been identified by the current owner (PRN 56613). *Visited* 12/05/2006 (Alice Pyper)

A view of the iron ore spoil tip from the south looking towards the Black Mountain

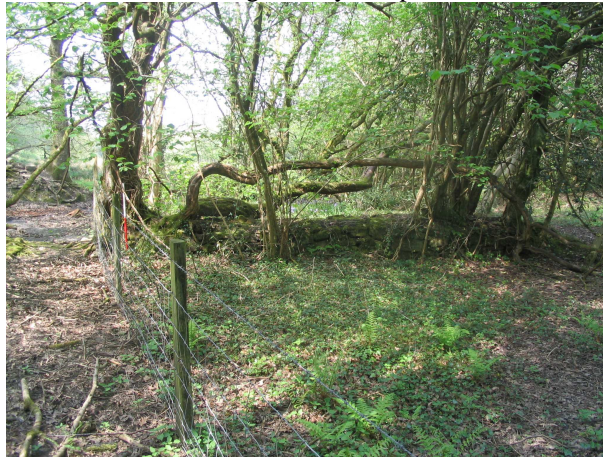
A building is shown in this location on the 2nd & 3rd edition Ordnance Survey maps of 1906 & 1918, lying on the north side of the river Amman.

When visited in 2006 the river appears to have shifted its course further to the north and the remains of this building can now be traced on the south side of the river. The remains of the building consist of rubble masonry up to 0.4m high with trees growing from the wall tops. The dimensions of the building on its longest axis are approximately 8 metres east southeast - west northwest. Bricks also lie scattered about in this area. Only the southern and western walls were identified on the visit, no traces of the other walls were observed. The historic maps show that the building was located between the river Amman and the Swansea Vale railway at the western extent of the Cwm-teg colliery complex. *Visited 12/05/2006 (Alice Pyper)*

The remains of a colliery building associated with the Cwm-teg complex.

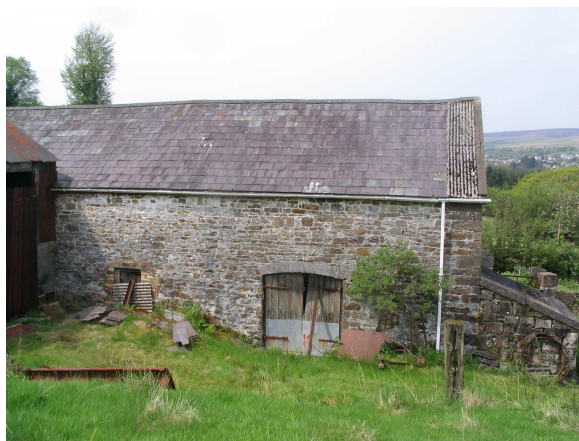
The southern end of the building, a later addition in brick, is also two storey with access to the 1st floor from external steps at the gable end. This section was not inspected internally. On the east side of the barn is tin barn at right angles to the stone barn. This is in a somewhat dilapidated state. It encloses double loading doors which lead directly into the 1st floor of the barn.

Attached to the far northern end of the barn is a ruinous pigsty with yard fronting to the west.

The barn is in a fair condition largely, although the pigsty at the northern end is rather overgrown. *Visited 12/05/2006 (Alice Pyper)*

The east side of the combination farm building at Gorsto – the barn end and pigsty attached

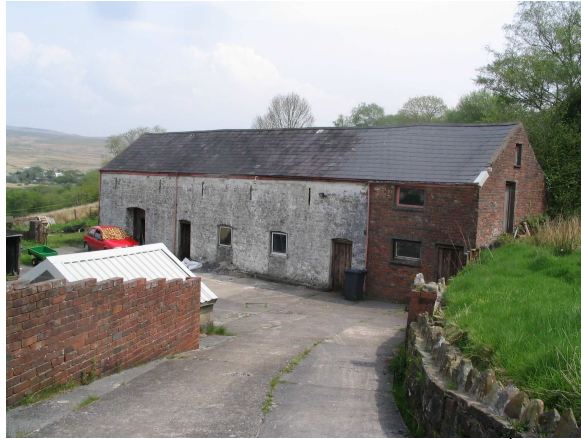
The southern section of the building has a granary loft (the first floor is constructed with reinforced concrete) with ventilation slits on the west side only, beneath is the cow shed formerly accessed by four equally spaced doorways, the central two have been half blocked. Internally are concrete and metal cow stalls positioned in a single row on the long axis of the building, providing accommodation for 5 pairs of beasts.

The west side of the combination farm building, showing the 20th century brick extension
