# TIR GOFAL MANAGEMENT PLAN: HERITAGE MANAGEMENT INFORMATION (HE2)

Prepared for: Bigni

Tir Gofal Reference No W/11/5646

ACA Report No. 2006/96 Project Record No. 54257

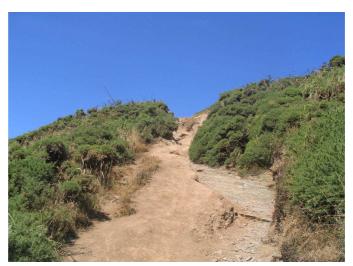
The site lies within an area of lightly grazed pasture. Scrub and grass cover now predominate between the bare rock. Areas between the church and the summit of the hill have been eroded by footpaths. The two parallel terraces are largely free of erosion although a substantial gully has emerged at the western end exposing revetment material below. This erosion was not noted during A National Trust Survey of 1985 and would seem to be a comparatively recent phenomenon.

Visitor erosion on the hillfort earthworks. Facing north-west.

Visitor erosion continues to be the main problem on the mount. It is most acute where, towards the western end of the two parallel terraces (defensive lines of promontory fort PRN 1041) a substantial gully and considerable erosion have occurred. The erosion was not noted during a National Trust Survey of 1985 and would seem to be a comparatively recent phenomenon.

- A scheme of remedial works should be implemented in order to stabilise the erosion and improve the condition of the earthworks.
- Prior to this measures will need to be taken to ensure that an adequate record is made of the
  disturbed earthworks. That is, the cross section through the terraces will need to be recorded
  and photographed.
- Due to the scale of the work to be undertaken. This work is considered to be beyond the scope of the Tir Gofal scheme.
- Any future programme of remedial works and recording should be agreed with Cambria Archaeology (advisor to TG) before commencing.

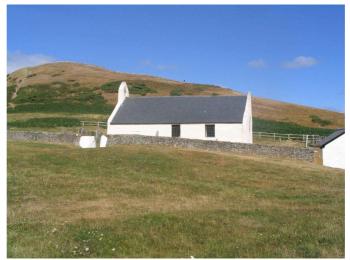
Beyond the south-east of the churchyard is a large mound, some 12m across x 1.5m high the northern part of which underlies the raised interior of the churchyard. Its nature is uncertain. There is a remnant dune system in the area and the mound does appear to have a sandy make-up. However, it is not as sandy as undoubted dunes in the area. It is possible that it represents a round barrow.

The mound with the church of the holy cross beyond. Facing north.

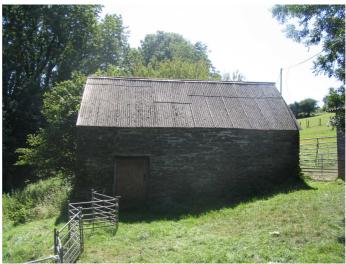
The farmhouse, lying separate at the northern end of the complex, is a typical vernacular house of the region, with symmetrical frontage and opposing end chimneys, now modernised with a concrete render and replacement widows. To the south lie the agricultural buildings, arranged in an extended rectangle at the time of the Ordnance Survey 2nd edition map, although now with few historic elements remaining, the only surviving remnants being a small barn and a stable. These buildings are of local slate stone construction and would originally have had slate roofs. A number of small breeze block and corrugated iron stables and sheds are now situated in-between.

The north elevation of the small barn at Blaen-cneifa. The circular outline of a horse gin is shown behind on the Ordnance Survey 1<sup>st</sup> edition (1889).
