TIR GOFAL MANAGEMENT PLAN: HERITAGE MANAGEMENT INFORMATION (HE2)

**Prepared for:
Gernant**

**Tir Gofal Reference No
W/11/5681**

**ACA Report No. 2006/75
Project Record No. 54262**

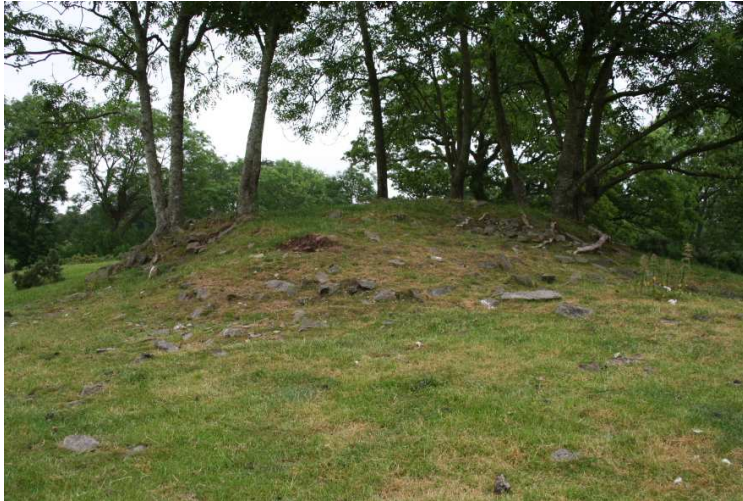
<u>(56290)</u>	Post Med/ Summerhouse	SN5060459483	B		Generic
<p>A summerhouse with an adjacent flagstaff marked on the 1st edition Ordnance Survey map of 1889. The site is located on the summit of a hill with clear all-round views, though mainly to the northwest down the Aeron valley. Mapping evidence suggests it was built in the mid to late 19th century on land belonging at the time to Ty Glyn Aeron mansion (PRN 7010), presumably erected either by the Winwoods, or Price Lewes who bought the property from them in the 1880s. The 1st edition OS map appears to show a very small rectangular summerhouse with the flagstaff on the south-western side. By the time of the 1964 OS map only the flagstaff remained and currently the site consists of a mound of turf covered earth and stone roughly 5m in diameter, covered in small trees. The mound presumably represents the base of the flagstaff, there are no above ground structural remains of the summerhouse. <i>Visited 12/06/2006 (PP)</i></p>

**NE facing shot of the mound
believed to be the flagstaff base.**

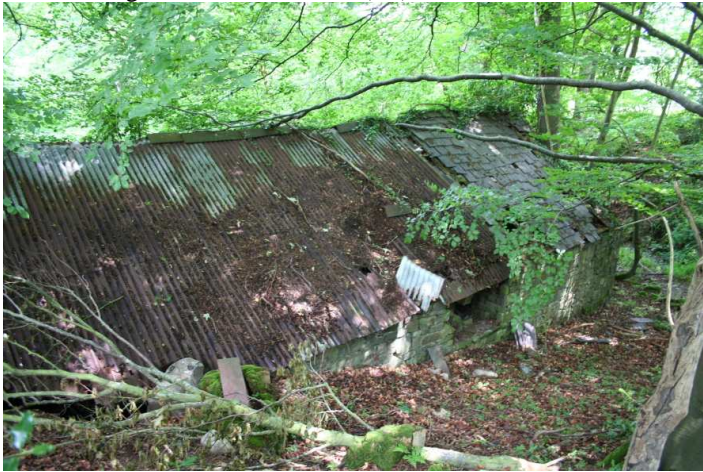
Name (& PRN)	Period/Site type	NGR	Status SAM/listing	Management required
1	<u>(56288)</u>	Post Med/ Building	SN4758259527	B	Specific
<p>An agricultural building first recorded on the 1st edition Ordnance Survey map of 1889 but now disused and partly ruinous. The building lies adjacent to a stream at the base of a small hill, with access from a trackway past Llaethliw farm to the east.</p> <p>The building is one-storey and mortared rubble built, divided into two rooms. The larger NW room is roofed in corrugated tin, with a large open doorway and adjacent smaller doorway in the long NE wall, with a window in the opposing wall. Internally the room is featureless, still containing a wooden trailer and disused farm machinery. A small room occupies the SE end of the building, roofed in slate, with a doorway in the NE wall and small window in the gable. This room is also featureless internally, with no indication that it was used as a dwelling, and appears to have been used as a store.</p> <p>Soil and material has built up at the NW end of the building, part burying and putting pressure on the walls and roof at that end. The site is surrounded by vegetation, some growing on the building and trees growing adjacent to the walls. Facing stones have fallen away from the NE side of the building, doorways and windows have gone, and the wall is bulging in places. The roof structure is still mostly intact although deteriorating. <i>Visited 12/06/2006 (PP)</i></p>

<p>Looking ESE over the remains of the farm building.</p>					
2	<u>LLETTY-SHON (56294)</u>	Post Med/ Farmstead	SN4789761180	B	Specific
<p>A farmstead complex marked on the old series Ordnance Survey map of 1834, although Wmffre (2004) records the farm name from the 1770s onwards. The complex consists of a farmhouse with ranges of farm buildings to the west, including one traditional range marked on the 1st edition Ordnance Survey map of 1889.</p> <p>This combination farm building range is built on three level, constructed of mortared rubble with slate roof and mostly brick voussoirs, stone on the lower (eastern) end.</p>

The aim of the management for this site should be the preservation and maintenance of this farm building which, although disused, is still currently in a fairly good state of preservation. Material has built up at the NW end of the building putting pressure on the wall and roof. Surrounding trees are also threatening the wall and roof through branch movement and root action. Vegetation has established itself on the building that may be causing damage or hiding defects. Some facing stones have fallen away from the building and the wall is bulging in places.

- If the building was to be returned to agricultural use then the condition of the walls should be examined by a suitable qualified builder as they may need repairing and consolidating and fallen facing stones replaced. Loose and missing slates should also be replaced on the SE end.
- To ensure the continued preservation of the site vegetation should be cut back and treated, including trees threatening the integrity of the structure. Vegetation should only be completely removed when this will not cause further damage to the structure.
- Some of the build-up of soil at the NW end of the building should be removed to relieve pressure on the walls and roof at that end.

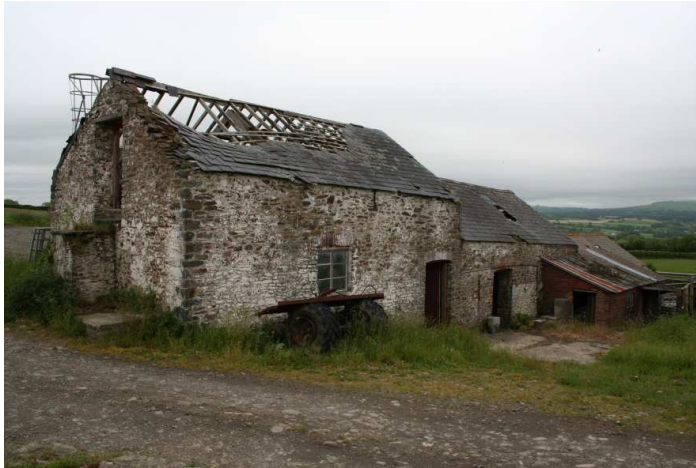
The upper (western) end consists of a former stable block with remains of wooden stalls and hayloft, and a doorway and window in the southern wall. The central section contains breezeblock stalls, opposing doorways with a window in the northern wall, ventilation slit in the southern wall. The lower (eastern) section contains a former milking parlour with concrete stalls, limewashed internally and three doorways (one now partially blocked) in the southern wall.

This range appears partially disused, with a deteriorating roof structure, loose and missing slates. Much of the roof covering on the western barn has now gone leaving the barn open to the elements. *Visited 12/06/2006 (PP)*

E facing shot of the traditional farm building range at Lletty Shon farmstead.

The aim of the management for this site should be to ensure the survival of the traditional buildings and maintain the historic character of the complex of farm buildings as a whole. This is a working farmstead complex although the range of traditional buildings only appear to be in partial use. The roof structure is generally deteriorating, with some broken joists visible and loose and missing slates. Most of the slates at the western end have gone exposing the barn and interior features to the elements which has led to much of the woodwork going and vegetation establishing itself within the building.

- The roof structure should be repaired to maintain a weatherproof covering. This may be relatively simple procedure of replacing slates and repairing some joists for much of the roof structure but would probably require more extensive repair work at the western end. This work should be assessed and undertaken by appropriate qualified contractors.

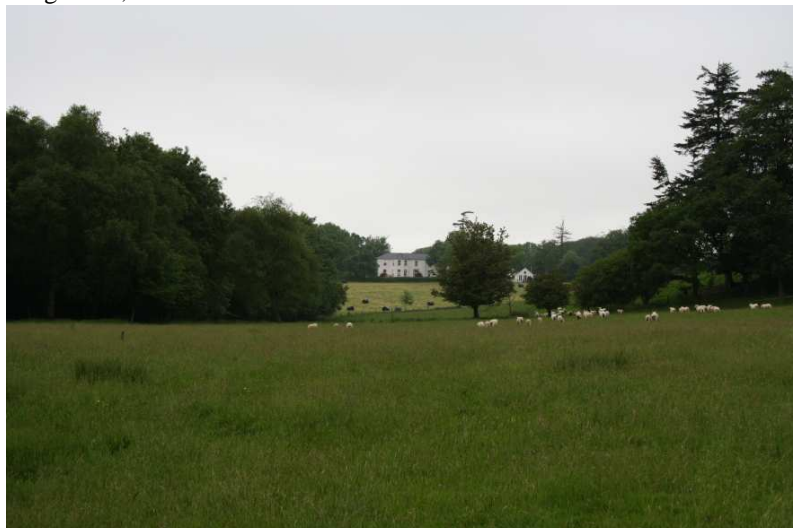
An area of estate managed landscape, with possible parkland characteristics, along the Aeron valley floor to the south of Ty Glyn Aeron mansion house. The house was built on its current site in 1825 by Thomas Winwood, replacing the earlier Ty Glyn Uchaf that originally lay close by. The new house faced south along the river valley and the fields along this view have a relatively open aspect with open boundaries, unobscured by hedgerows, with some dispersed tree planting in the field immediately in front of the house (outside this farm holding), all allowing an uninterrupted view. Woodland belts along the river bank may have formed part of this view and the 1st edition Ordnance Survey map of 1889 also shows coniferous planting along the lower valley, possibly planted with exotic species.

It is very difficult to establish the limits and design of this landscape from available sources. Although a natural belt of riverside woodland may have formed part of the designed landscape there is no obvious sign of management or woodland walks, and the extent marked on current maps is very similar to the extent shown on the 1843 tithe map. There is no indication of dispersed planting within this farm holding and the coniferous plantations, which were established at some point between the tithe map of 1843 and the 1889 OS map, appear to have been removed during the 20th century with no clear indication as to their function and species. The 1889 OS map also suggested parkland may extend onto the hillside, with dispersed trees and a summerhouse located there. Although the summerhouse was probably built by the mansion owners to take in more extensive views the dispersed planting appears on the ground to be relicts of removed hedgerows, most of which would not have been visible from the house. *Visited 12/06/2006 (PP)*

N facing shot showing the more open aspect to fields along the view of Tyglyn Aeron, the white building in the background.
