A SURVEY OF DEFENDED ENCLOSURES IN CEREDIGION, 2006: GAZETTEER OF ORDNANCE SURVEY GRID SQUARE SN24

RHIF YR ADRODDIAD / REPORT NO. 2006/20
RHIF Y PROSIECT / PROJECT RECORD NO. 54269

SITE GAZETTEER OF 10KM GRID SQUARE SN24

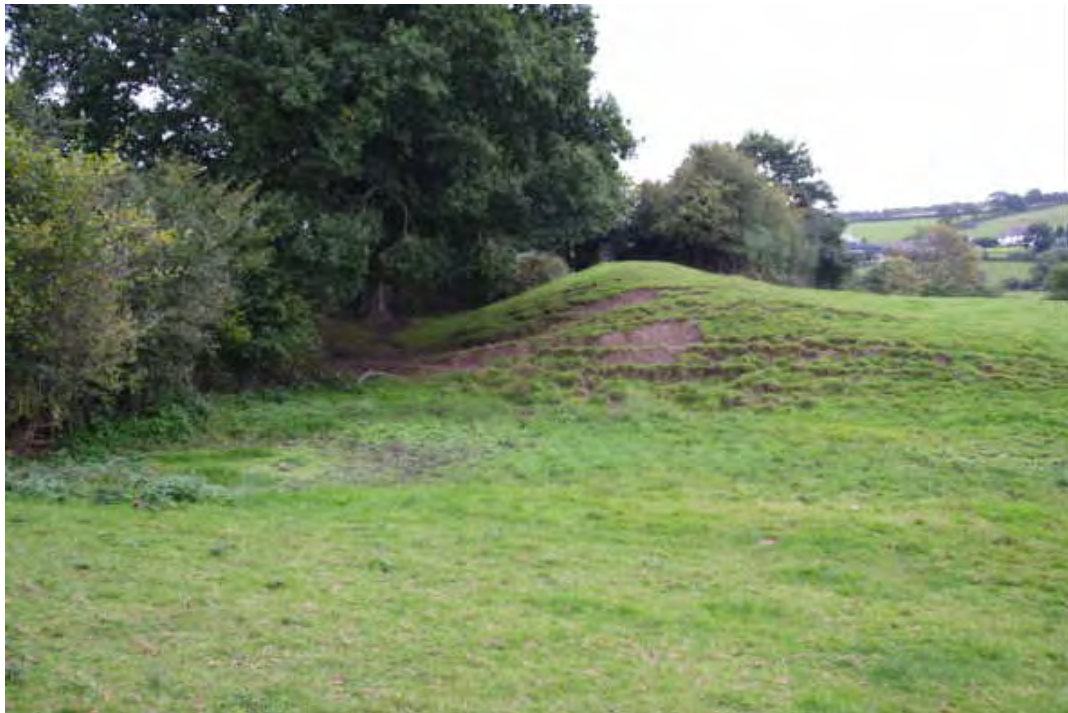
Onen-deg enclosure lies on a river terrace of the River Teifi, a few metres above the floodplain. To the north the valley side rises steeply above the site. The enclosure area is irregularly shaped, measuring approximately 70m east - west and 70m north - south. It is naturally, but poorly, defended by the steep, but low, slope down to the floodplain to the south and west. A bank and ditch defends the eastern, easily approachable side. This bank is c. 60m long, c. 18m wide and up to 2.5m - 3m high. It is flanked by a silted ditch up to 0.5m deep on its outer, eastern side. Part of the bank is overlain by a hedge-bank. A break in the bank is, according to the Ordnance Survey in 1972, modern. The easily approachable northern side of the enclosure is not obviously defended. However, examination of the ground suggests that an in-filled ditch may run on this side of the enclosure - a continuation of the ditch on the east side. Firmer ground midway along this ditch on its north side may indicate the site of an entrance. It is assumed that there must originally have been a bank accompanying this ditch, otherwise the enclosure would have been open on the north side, and that this has now been removed. Either this, or the defence is unfinished. In 2005 the site was under improved pasture.

Ground photograph looking along defensive bank.

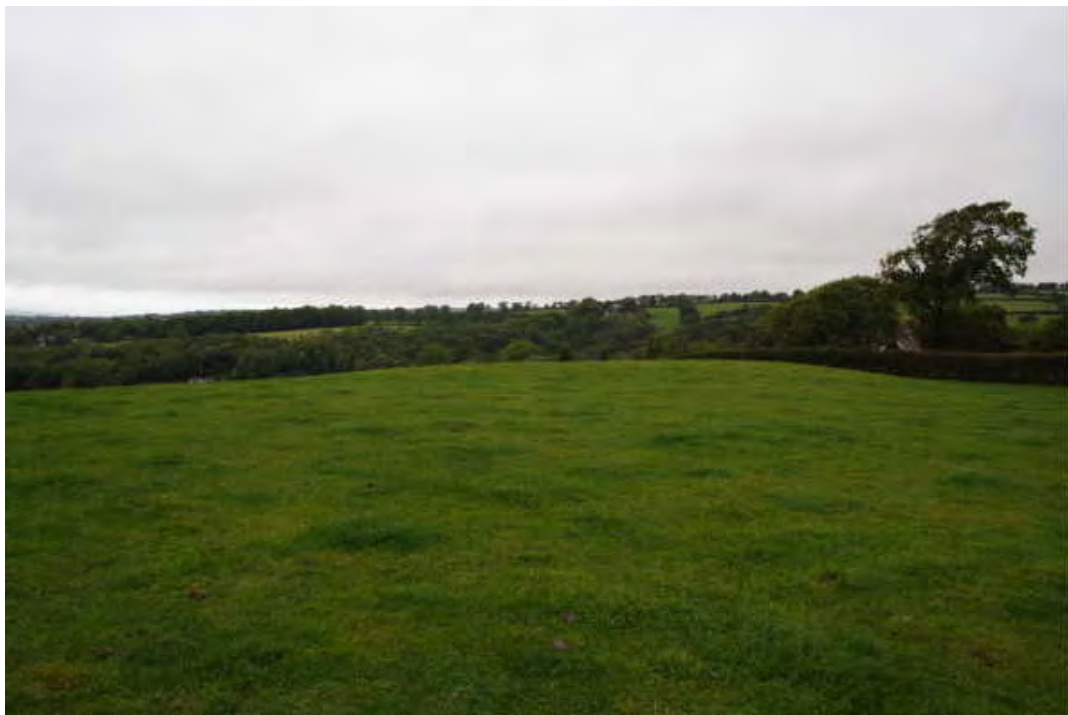
The earthwork consists of a circular platform about 1.5m high and approximately 35m - 40m across its widest extent, about 20m - 25m diameter across the top of the platform. There is no obvious external ditch and no entrance onto (into) the platform. The internal area is very slightly dished, rather than flat. A slight, wide earthwork bank leads down the steep slope from the platform; this may be a natural feature. In 2005 the site was under improved pasture.

The nature of Gaer is uncertain. The platform nature of the earthwork and absence of a ditch do not indicate an Iron Age defended enclosure or a medieval ringwork. It is too large for a prehistoric burial mound. The closest parallels are probably the raised raths of Ireland.

Ground photograph looking at the earthwork of Gaer.

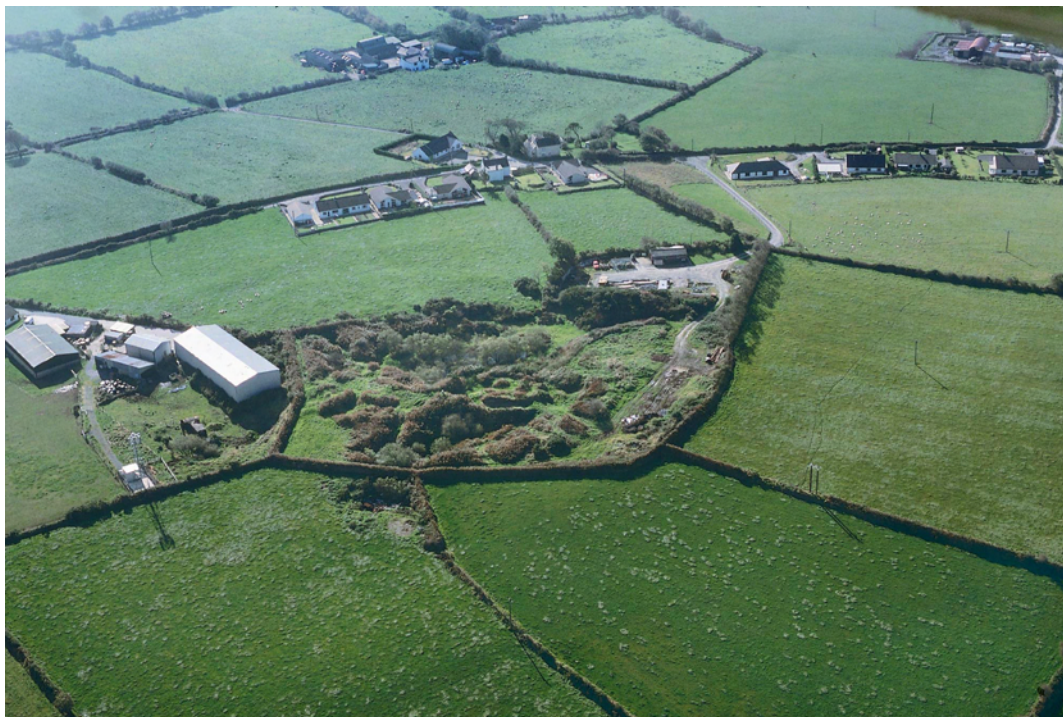
It is a bivallate, oval or circular hillfort, with widely spaced ramparts. These survive best on the south side and north side. On the south side low earthworks up to 140m long and up to 0.8m high in improved pasture mark the lines of banks and ditches. However, some care has to be exercised in this interpretation as vertical aerial photographs taken in the 1940s indicate that small-scale quarrying may have taken place here. On the north side of the fort a similar length of the defensive circuit also survives, also in improved pasture, but here the earthworks are much slighter. The defences on the western side have been destroyed by quarrying, while a watching brief during the construction of a phone mast on the east side showed that the ditch of the outer rampart survives below ground, but it is likely that the remainder of the ramparts has been destroyed in this section. The interior area of the hillfort measures approximately 120m diameter with a diameter of approximately 200m to the limits of the outer defensive circuit. There is a gap of about 20m between the inner and outer ramparts. As noted above almost all of the interior (including that part now occupied by a farm) has been destroyed. It is likely that the entrance has also been destroyed.

Aerial photograph RCAHMW Crown Copyright © reference 99-cs-2290.

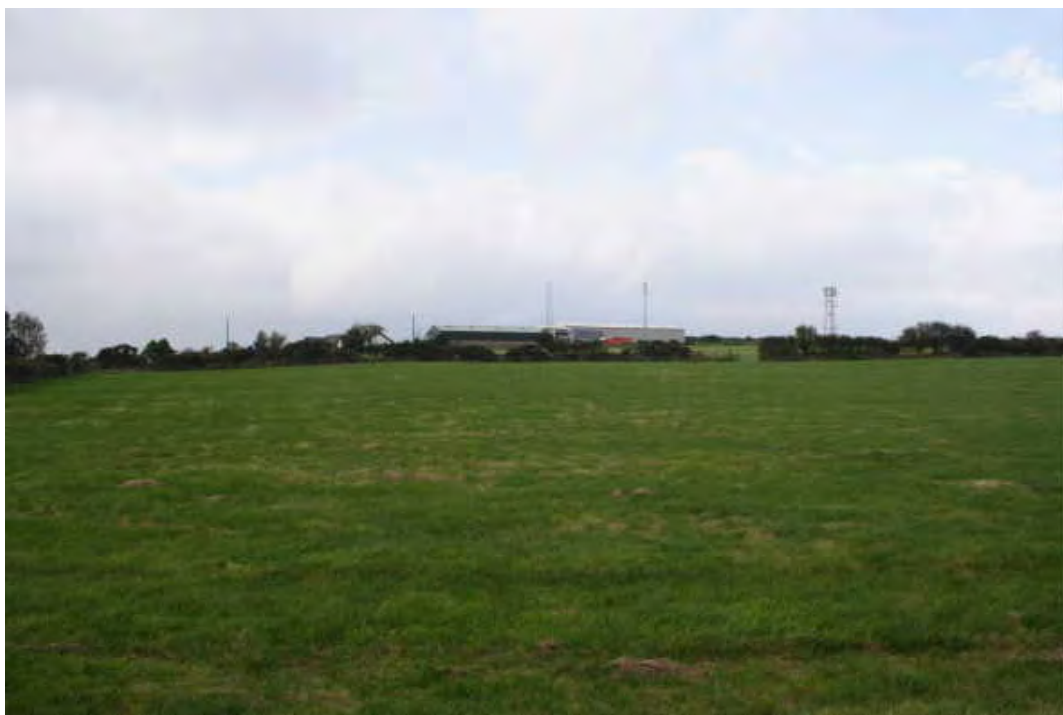
Gaer Pwtan occupies the summit of a rounded hill at approximately 220m above sea level. The hilltop was subjected to extensive quarrying in the 19th century; this has destroyed much of the hillfort's interior. However, significant remains survive.

Ground photograph - general shot of site from a distance.

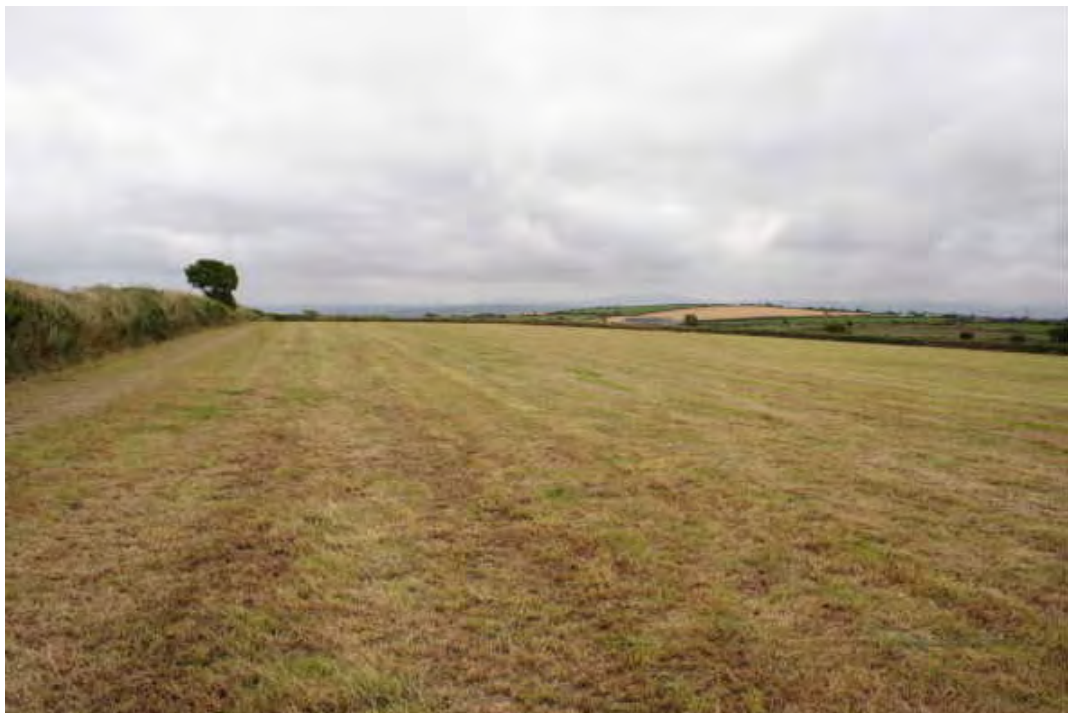
Aerial photographs show a very distinct site with a circular cropmark ditch approximately 44m diameter lying within the southwest quadrant of a larger elliptical enclosure. This larger enclosure measures 160m north - south and 140m east - west. A break on the northwest side of the inner enclosure may mark an entrance. A clear break in the west side of the outer enclosure is an entrance. There is no earthwork or other surface evidence for the outer enclosure, but a platform of just 10cm - 20cm seems to correspond with the location of the inner enclosure.

Part of the site was the subject of a geophysical survey in 2005. The ditches of both enclosures are very clear in the survey with part of an extra enclosure abutting the outer enclosure to the south. It is possible to see this in the aerial photograph; although without the gradiometer results it would be difficult to interpret this as archaeological rather than geological. Despite the clearness of the ditches on the results plot it is still quite difficult to locate the entranceway to the inner enclosure. It could either be to the west-northwest, or the northeast. Within the inner enclosure it is possible to see several circles, perhaps indicative of an extended period of occupation, though no other inner divisions can be seen. The entrance to the outer enclosure can be seen where the aerial photograph indicates in the west side of the oval. Immediately east, inside the enclosure, a series of features have been located. Their form and purpose are not entirely certain, perhaps to control the movement of livestock and people. It is not clear if these features are contemporary with the enclosures, or even if they are archaeological in nature. In 2005, the site was under improved pasture.

Ground photograph looking over site of cropmark enclosure.

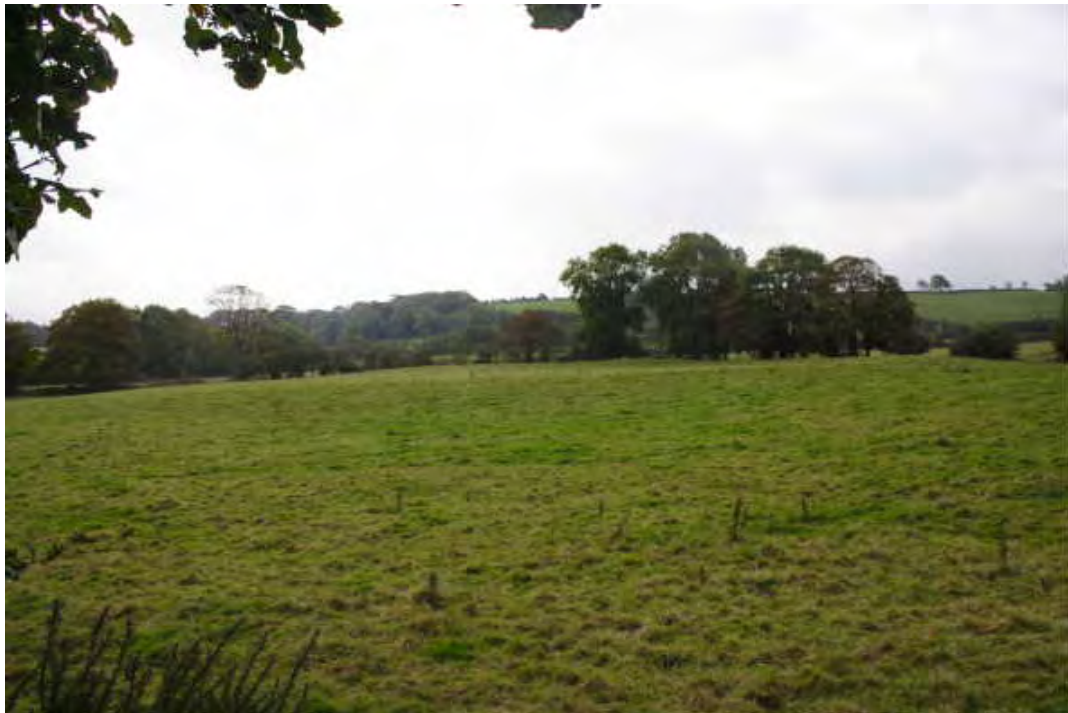
In 2005, this site was seen only from the public road, which runs immediately to the north and east. It is a rectangular earthwork enclosure, measuring approximately 90m east - west and 70m north - south. It comprises a distinctive bank up to 1m high flanked by an external ditch surviving up to 0.5m deep. The entrance was not seen. The site is under improved pasture and is in good condition.

Ground photograph looking at earthwork enclosure.

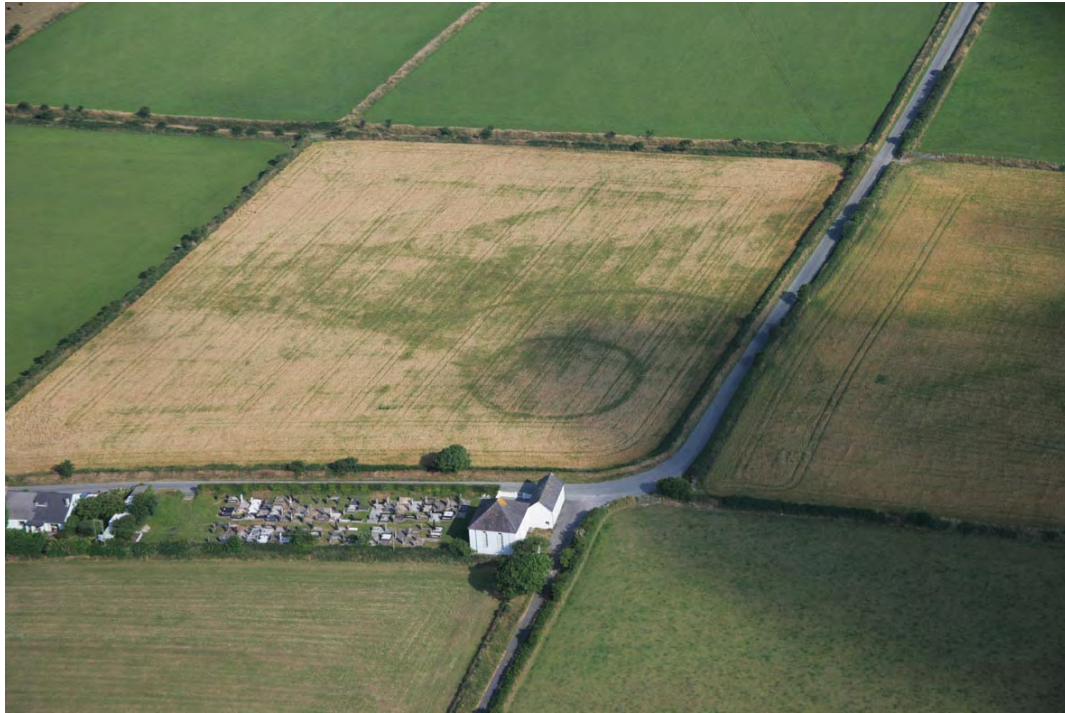
Aerial photographs show an inner circular cropmark ditch, approximately 35m in diameter. Concentric to this, c. 25m distant from it is an outer circular enclosure, approximately 85m - 95m in diameter. The entrance to both enclosures face west-southwest. Ditches flanking a possible entrance track run between the two entrances. These ditches may continue outside the outer enclosure entrance, but this is not certain, and these features may be geological.

Aerial photograph RCAHMW Crown Copyright © reference 2005-cs-1496.

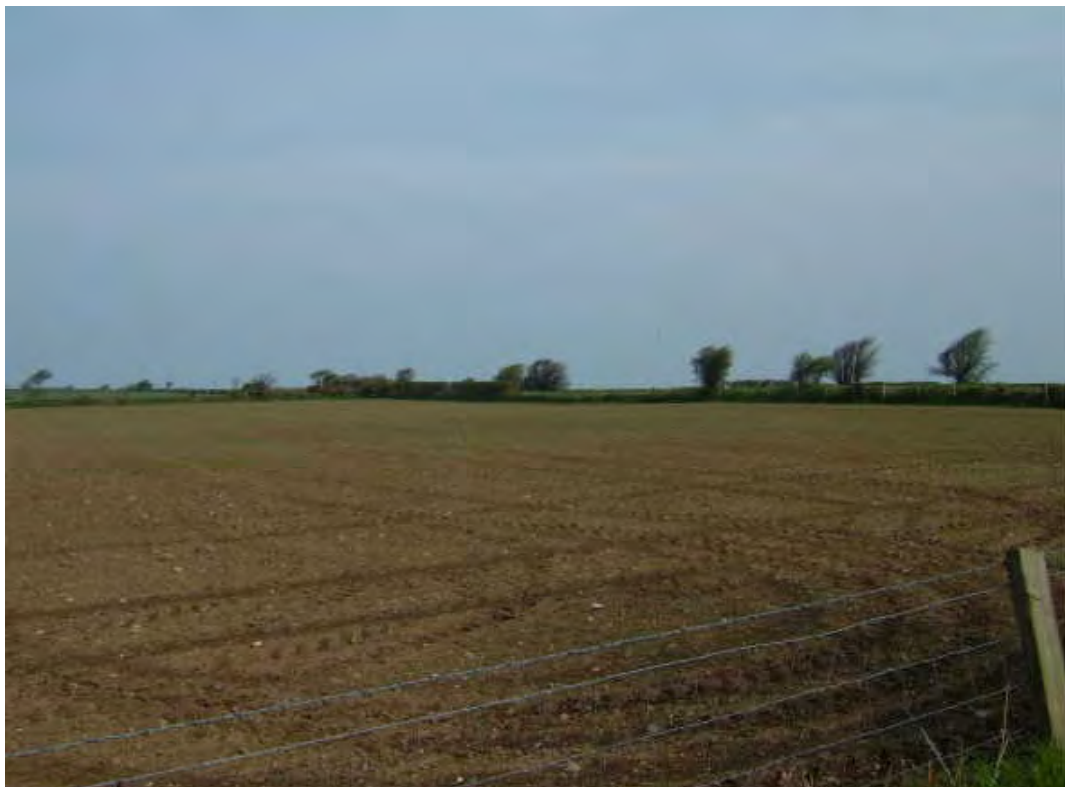
A site visit in April 2005 was undertaken as the field was being ploughed. No trace of the outer enclosure or the ditched track-way was visible, but a curving stony band up to 0.2m high in the ploughsoil probably marks the line of the bank inside the inner enclosure ditch.

Ground photograph looking over the site of the cropmark enclosure.

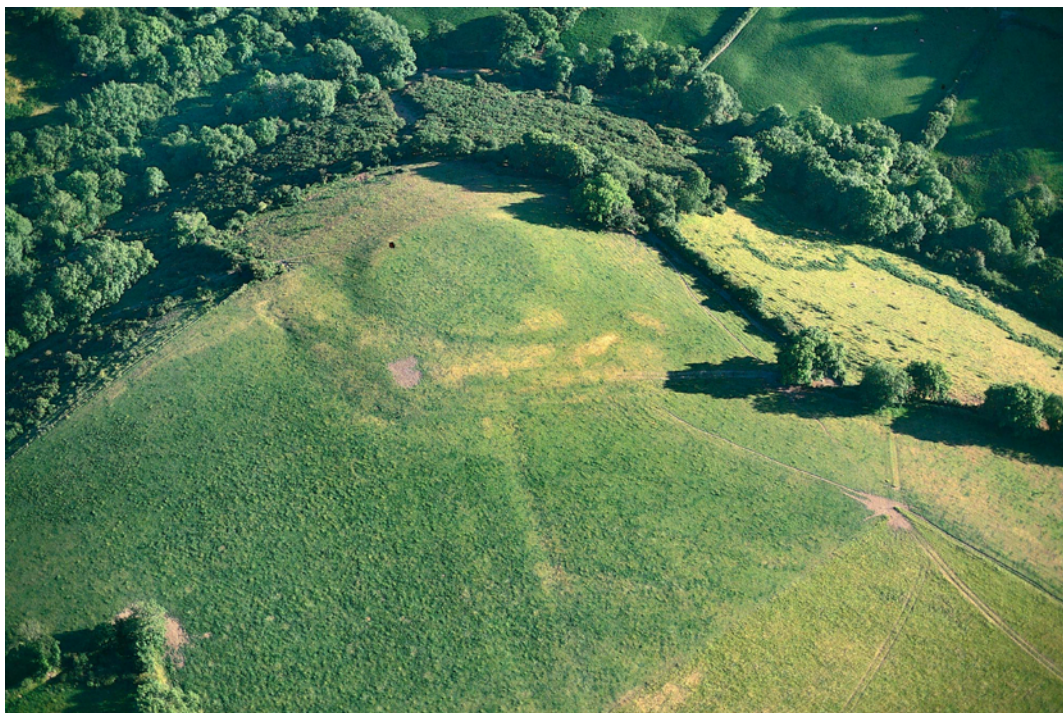
An aerial photograph shows all the elements of this site, plus what may be a third line of defences on the north side. The photo seems to show an entrance on the northeast side, but on the ground this is clearly incorrect. In 2005, the site was under improved pasture and in good condition.

Aerial photograph RCAHMW Crown Copyright © reference 96-cs-0993.

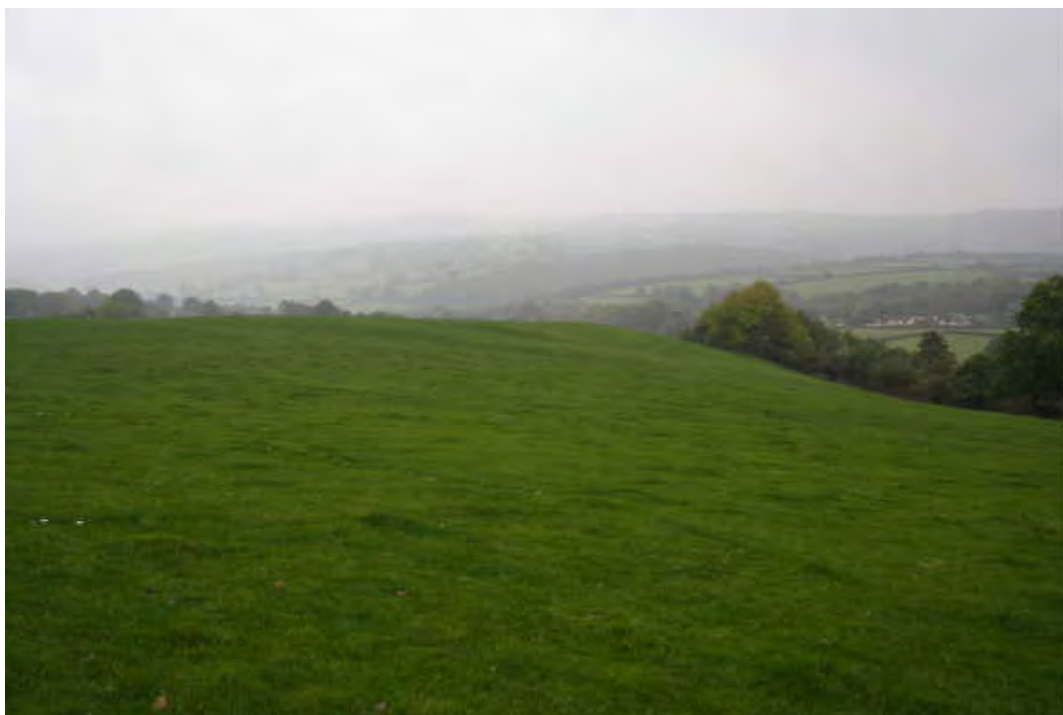
It is an earthwork site, with an inner circular enclosure c. 50m - 60m diameter defined by a bank up to 1.5m high at its highest point close to a simple northwest-facing entrance. Away from the entrance the bank is up to 1m high. A slight hollow marks the line of the ditch outside this bank except on the steep south, southwest and southeast side. The interior of the enclosure is flat. The outer line of defences lies 12m - 15m from the inner enclosure and consist of a length of bank up to 1m high on the north side. This bank terminates at the northwest facing entrance and fades to the northeast. However, to the northeast the line of the outer ditch is clearly visible as a linear hollow up to 0.7m deep. An old track (marked as a boundary on maps) running concentric to the enclosure on the steep slope to the west, south and southeast may perpetuate the line of outer defensive circuit.

Ground photograph looking over earthworks.

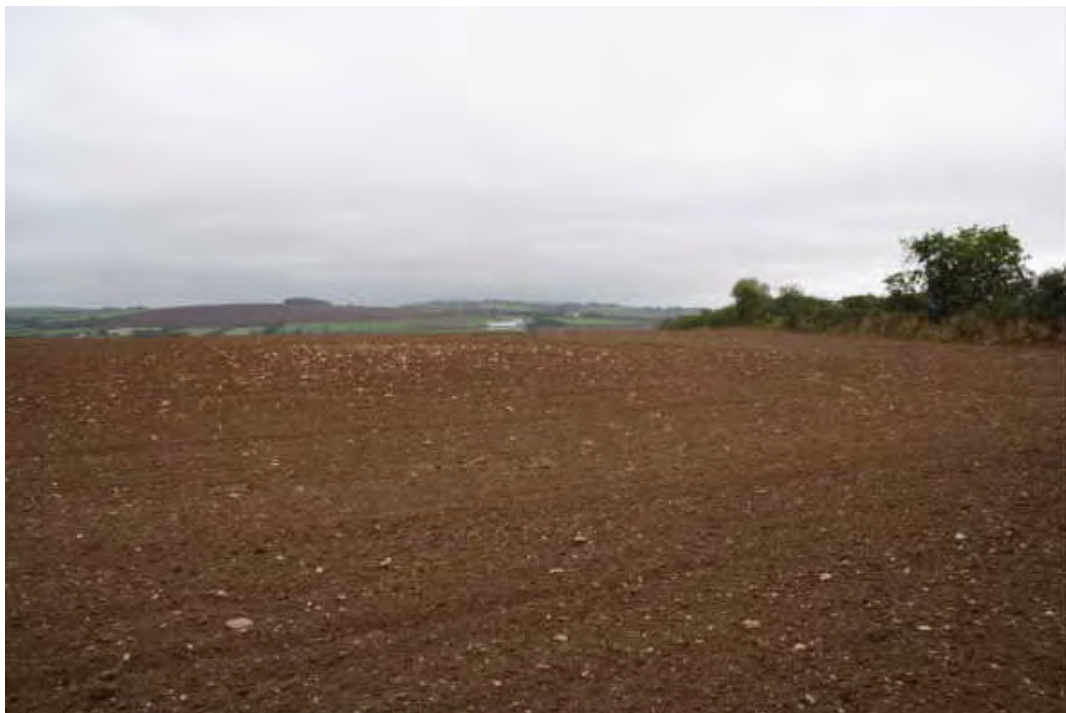
Ground photograph looking over site of cropmark enclosure. Note round barrow in foreground.

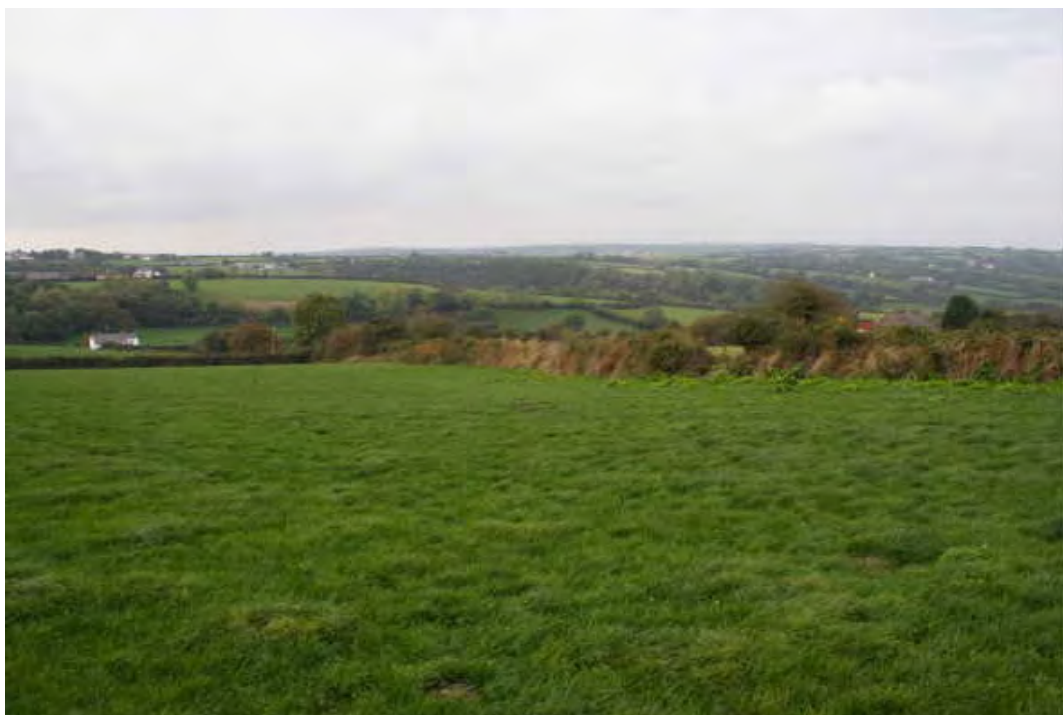
Ground photograph with slight hollow marking position of the cropmark enclosure.

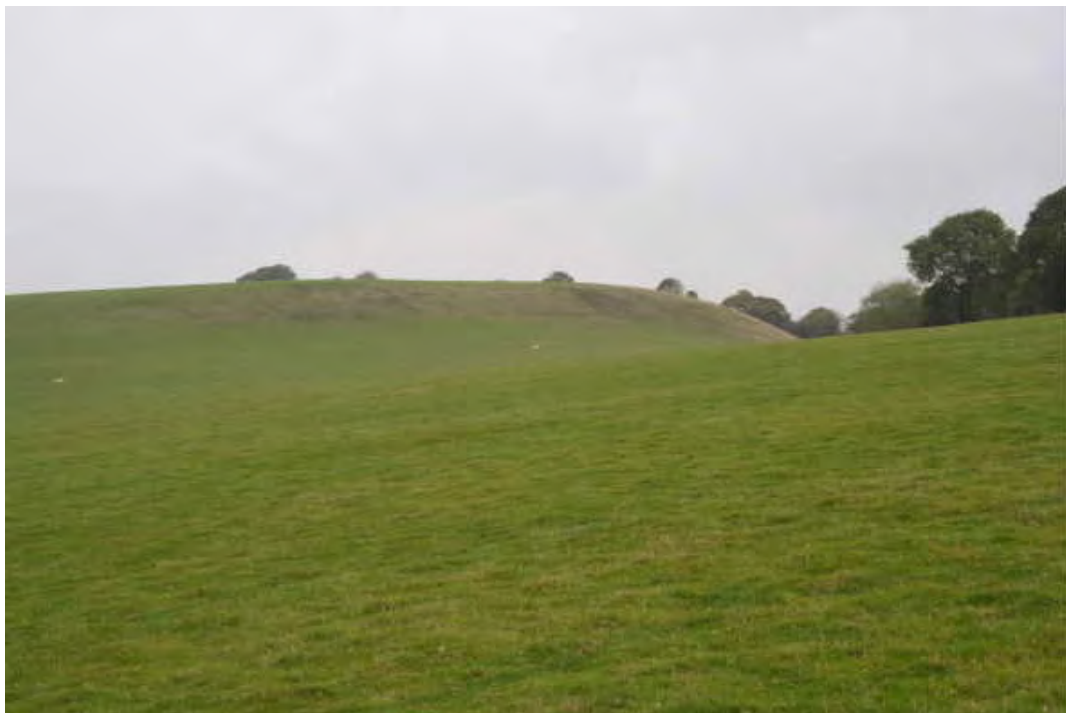
Ground photograph looking towards site on cropmark enclosure on hillock.

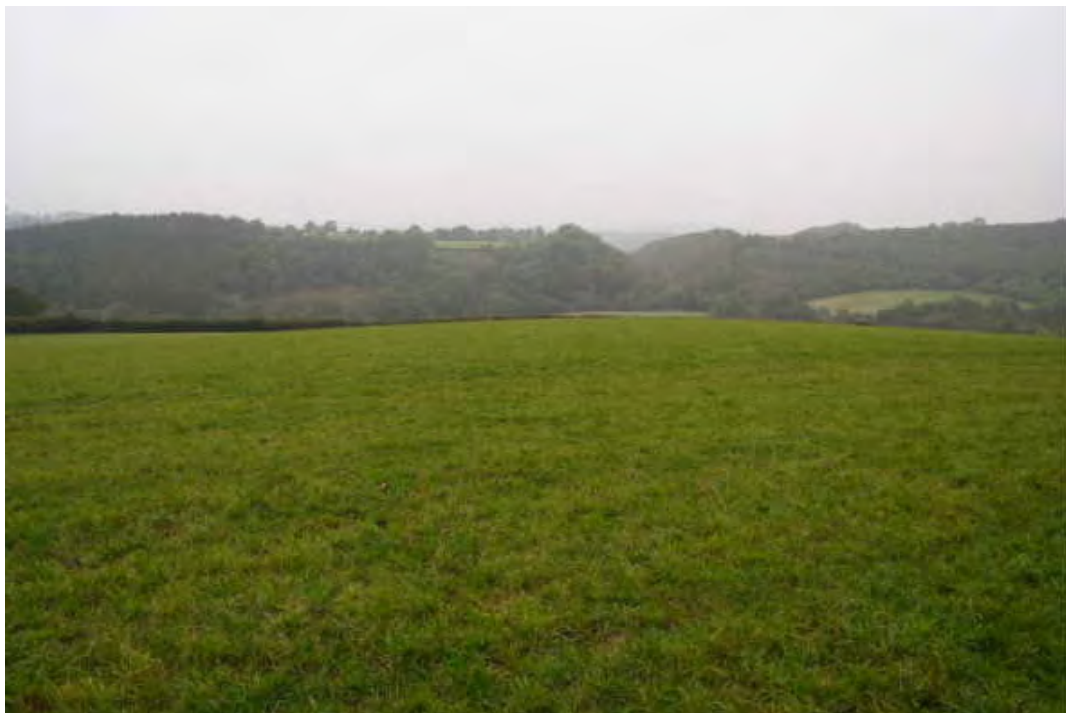
Ground photograph looking towards site of cropmark enclosure located on hummock.
