A SURVEY OF DEFENDED ENCLOSURES IN CEREDIGION, 2006: GAZETTEER OF ORDNANCE SURVEY GRID SQUARES SN56, SN57 AND SN58

RHIF YR ADRODDIAD / REPORT NO. 2006/20
RHIF Y PROSIECT / PROJECT RECORD NO. 54269

SITE GAZETTEER OF 10KM GRID SQUARES SN56, SN57 and SN58

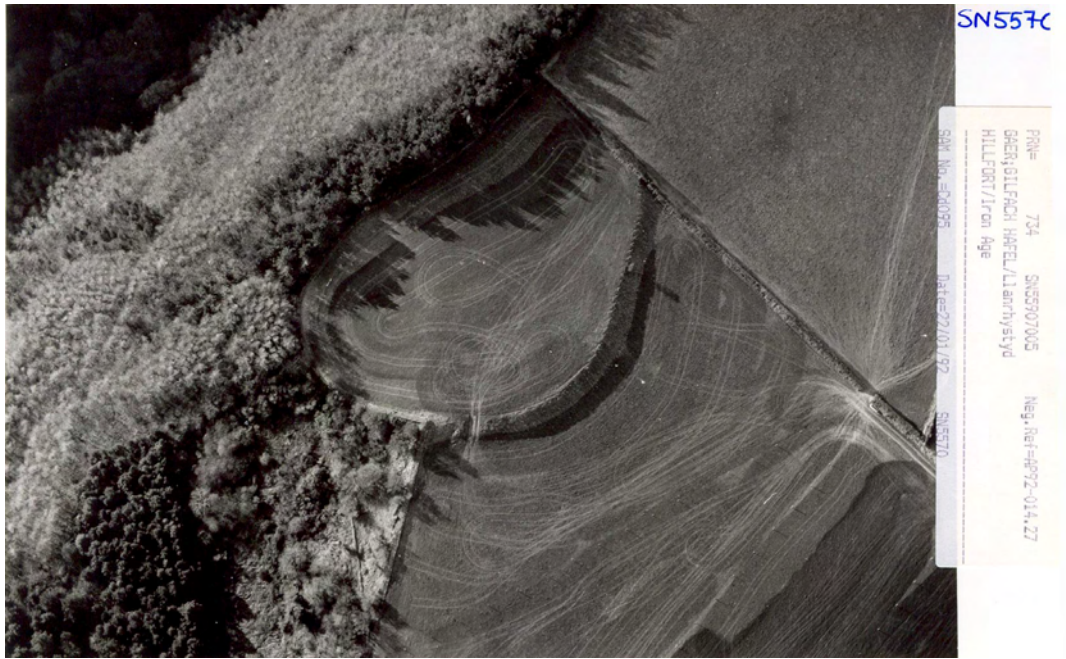
Gaer is a defended enclosure located on a hilltop at 130m above sea level. It is naturally well defended on the south side by a steep valley side that falls away to the Wyre 70m below. The other sides are defended by a bank up to 2m high externally, but level with the internal area. There is little trace of a ditch. The entrance is presumed to lie on the west side. The sloping oval internal area measures 160m east - west and 70m north - south and is under improved pasture. The banks are under scrub.

Aerial photograph Cambria Archaeology.

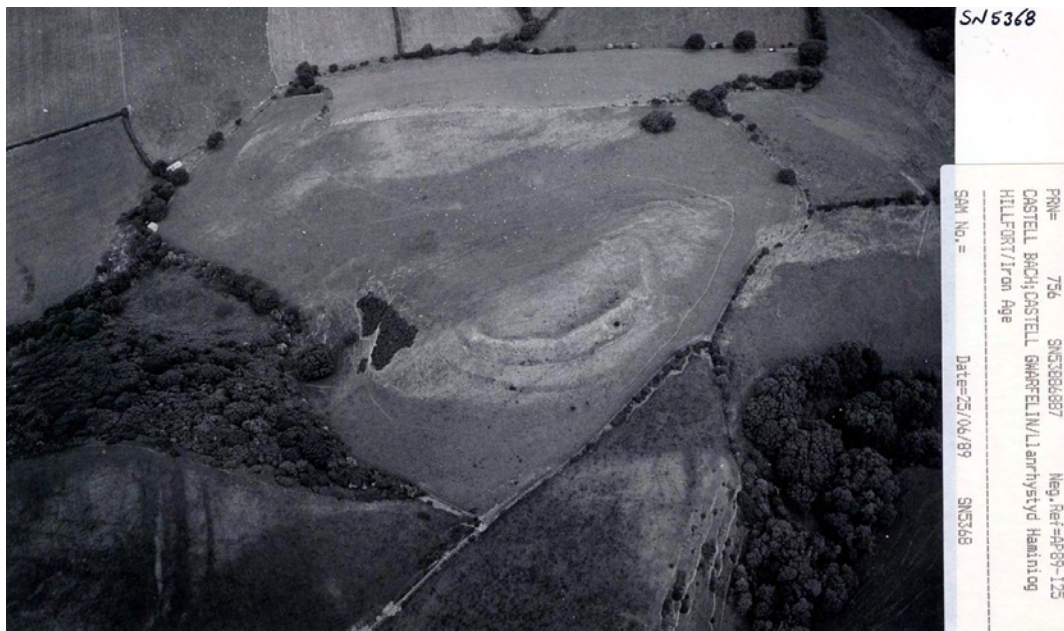
Castell bach is located on the flat summit of a hillock at 100m above sea level. It is a naturally very well defended site. To the north and west the land falls steeply away from the site onto the coastal plain. On other sides the land falls sharply away from the summit by c. 10m before levelling out, and then to the south rising gently. The fort is overlooked from the south. There are no obvious built defences on the naturally well-defended northwest side (but one suspects the steep slope has been artificially steepened), but on the other sides a bivallate rampart protects a roughly oval area 90m by 40m. The bivallate character of the defences can only be detected on aerial photographs, where an outer ditch shows in parching on the south and eastern side of the fort. A substantial earthwork represents the inner, main defence. This bank is partly formed by scarping of the steep natural slope and is partly built up. On the NE, E and S sides the bank rises to over 0.5m above the flat interior, and is up to 3m high. It achieves its greatest height at the south end. The outer face is eroding - soil creep owing to the steepness of the slope, and sheep scraps - revealing the stony character of the bank. In several areas on this external face one or two courses of dry-stone revetment wall have been exposed. The entrance is a simple east-facing gap through the bank. No ditch is visible on the surface, but aerial photographs show a ditch to this bank in parched conditions, with a second ditch as described above. A shallow hollow towards the NE end of the otherwise featureless interior may mark the site of a round-house. In 2005, the site was under improved pasture.

Aerial photograph Cambria Archaeology.

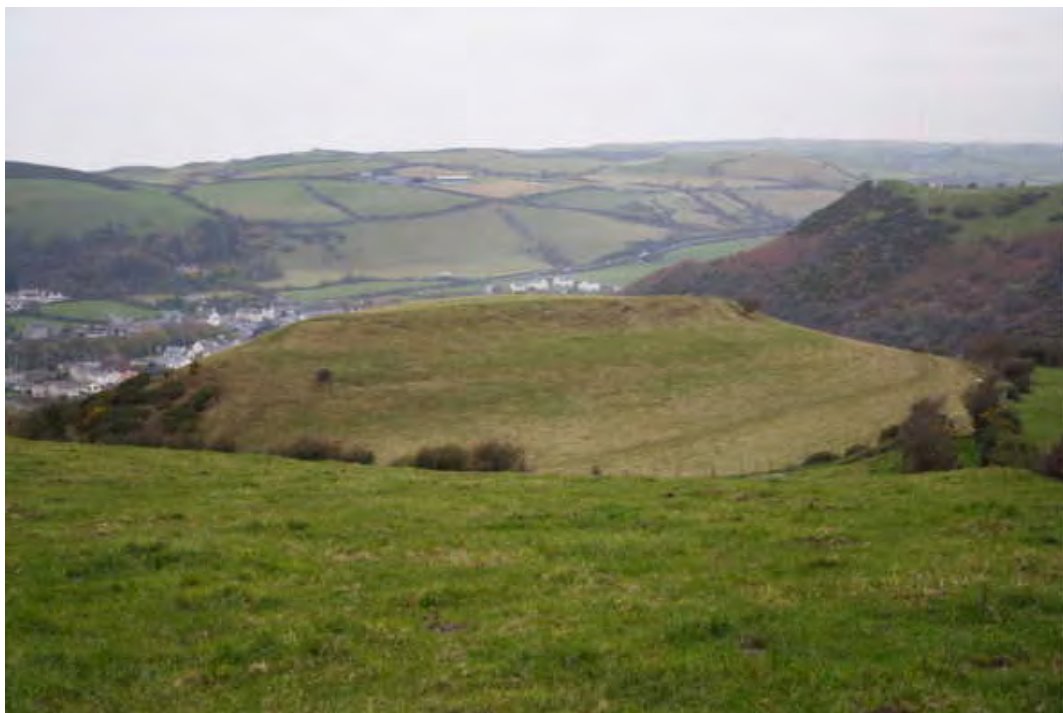
Ground photograph looking at Castell Bach.

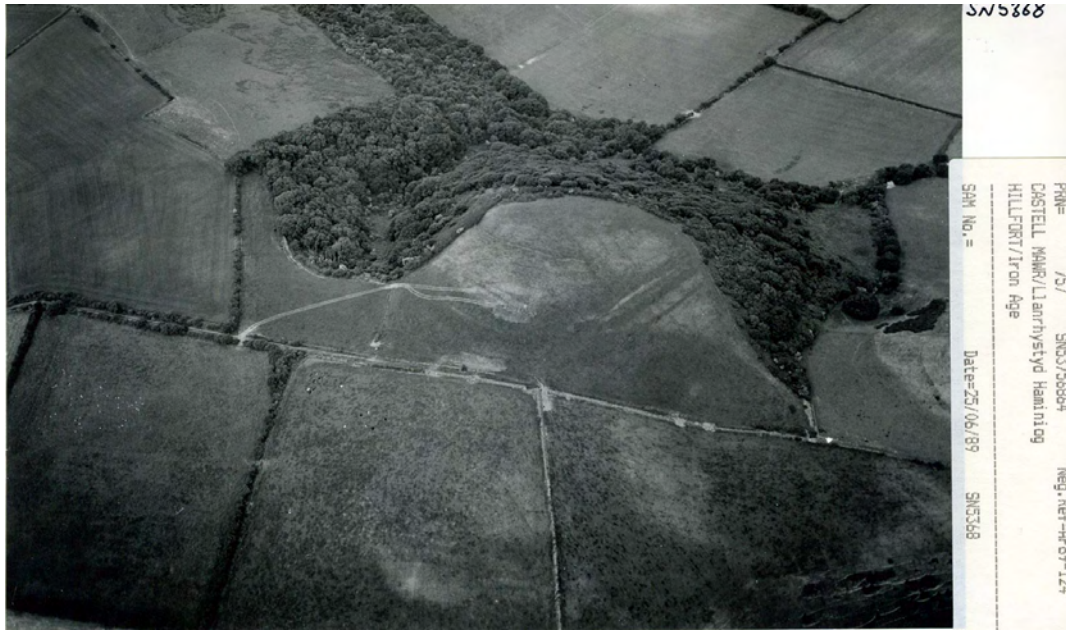
On aerial photographs this fort is clearly much more complex than is visible on the ground. It is a multivallate fort, with three lines of ditch on the northeast and southeast side. Slight in-turning of the inner ditch at the entrance suggests a more complex arrangement than indicated by the earthworks. A line of a thinner ditch running across the centre of the interior may possibly mark the course of an earlier defence. There is no trace on aerial photographs of the defensive circuit on the west side as shown on the OS 1st Edition. In 2005, the site was under improved pasture.

Aerial photograph Cambria Archaeology.

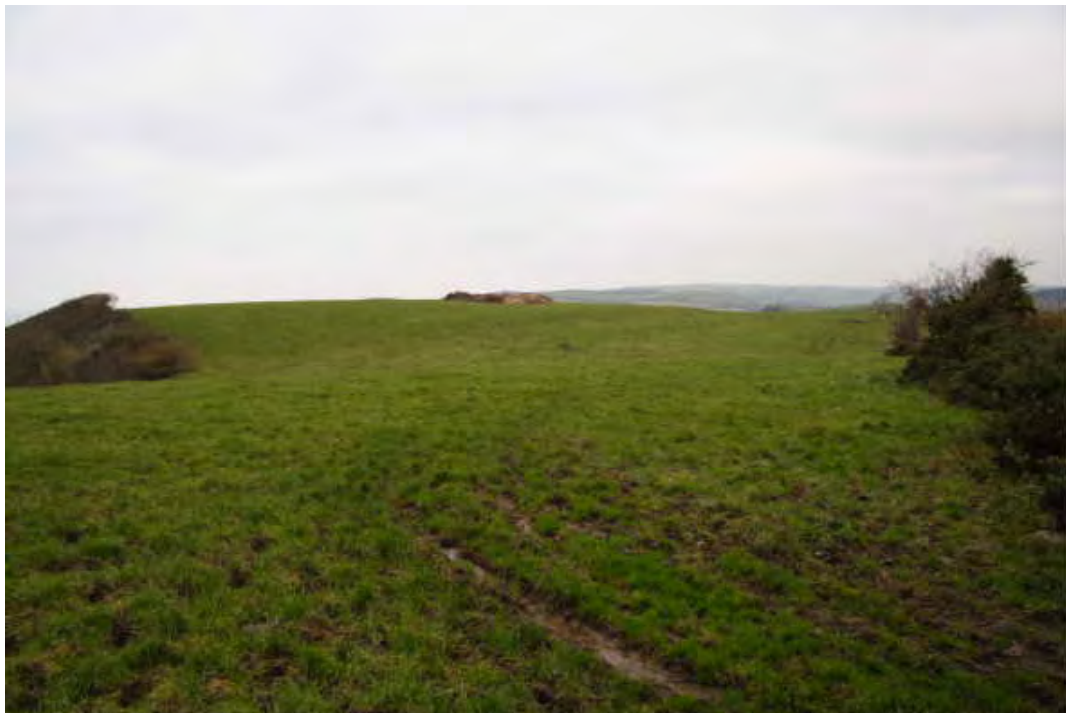
On the ground the site now has the appearance of a promontory fort, using the steep natural slopes as part of the defensive circuit, rather than a hillfort located on a promontory, as the historical documentation suggests. A curving earthwork bank up to 2m high externally (but making use of a natural break of slope) but rising only 0.5m above the fort's interior, runs from the edge on the steep natural on the north side of the fort to the steep slope on the south side. On the southeast side the defence is clearly bivallate, with a ditch outside the bank followed by a second ditch and an outer bank up to 0.5m high. A simple gap mid-way along the main, inner bank marks the site of an entrance. There is no trace of a defence on the west side of the fort above the steep natural slope. Given the configuration of the surviving earthworks it is difficult to envisage how such a circuit would have functioned on this side. The interior of the fort is roughly circular, approximately 120m diameter, and slopes gently down from a high point on the southeast side of the defensive circuit.

Ground photograph looking at earthwork defences.

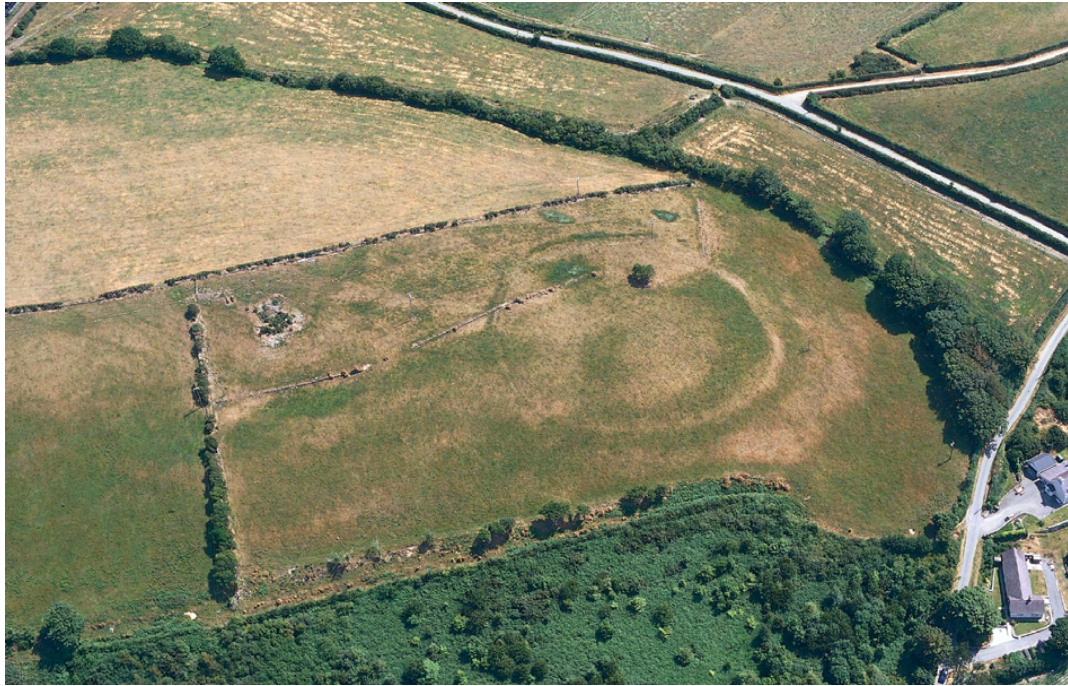
Troed-y-Rhiw enclosure is situated on towards the end of a rounded inland promontory at 90m above sea level. The site itself occupies a hollow or concavity on the otherwise sloping ground. On aerial photographs it shows as an oval cropmark bank and ditch, the internal area approximately 72m by 57m. The Ordnance Survey in 1973 recorded a simple south-facing entrance, but no break here is visible on aerial photographs. Two cropmark ditches approach the enclosure from the northeast, possibly indicating the site of an entrance. On the ground a bank up to 0.25m high is visible on the west side of the enclosure. The east side is marked by a sharp break of slope. In 2005, the site was under improved pasture. It had last been ploughed in the late 1990s.

Aerial photograph RCAHMW Crown Copyright © reference 2003-cs-1436.

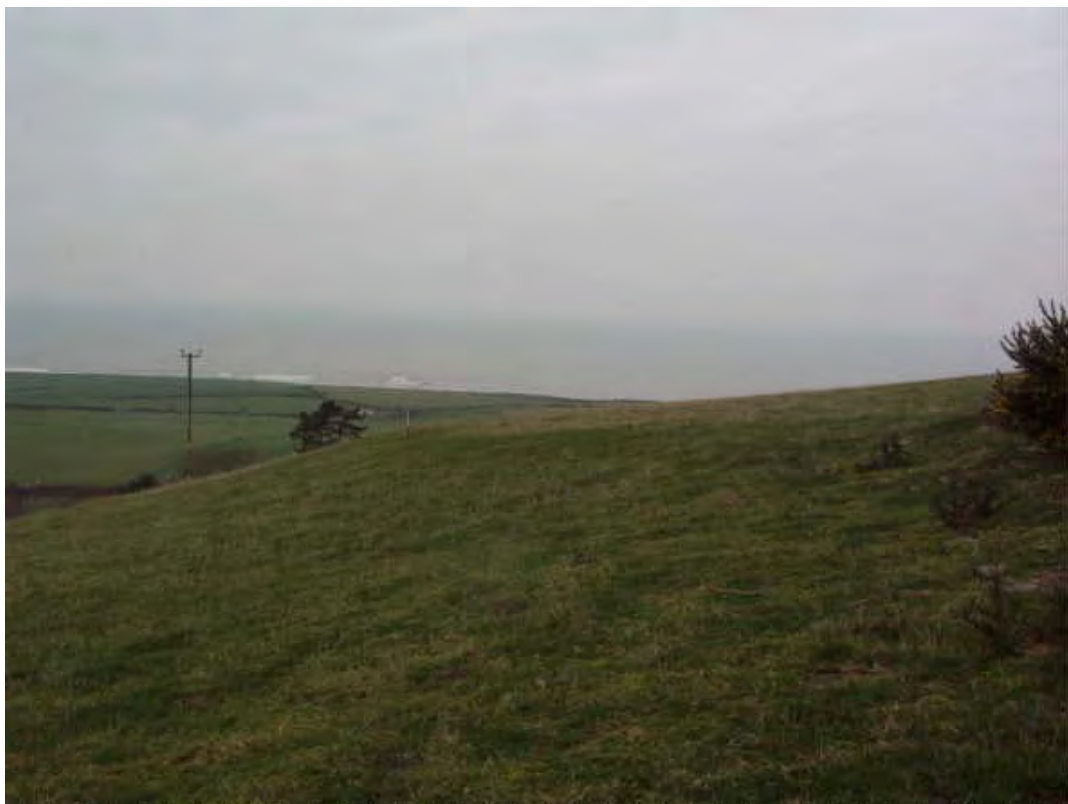
Ground photograph showing slight surviving earthworks.

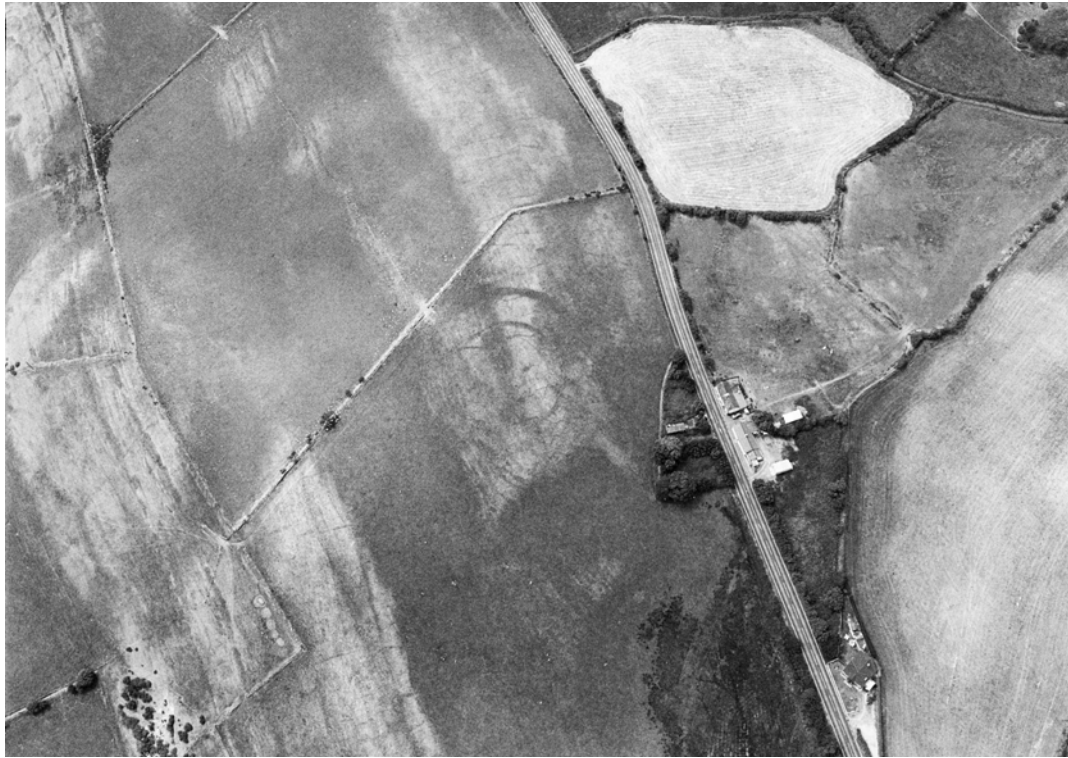
Banc-y-Gaer enclosure lies at the northern end of a low flat-topped ridge at 170m above sea level. Land falls away from the site to the west and north, but is fairly level to the east and south. Aerial photographs show a concentric, roughly circular enclosure defined by cropmark ditches. The diameter of the inner enclosure is about 42m. The cropmarks are not complete, and therefore the position of the entrance is uncertain. On the ground there is no trace of the inner enclosure (but the site visit was conducted in heavy, driving rain), but the line of the outer defence is marked by a c. 30m long and 0.5 high section of curving bank on the south side. In 2005, the site was under improved pasture.

Aerial photograph RCAHMW Crown Copyright © reference 955142-50.

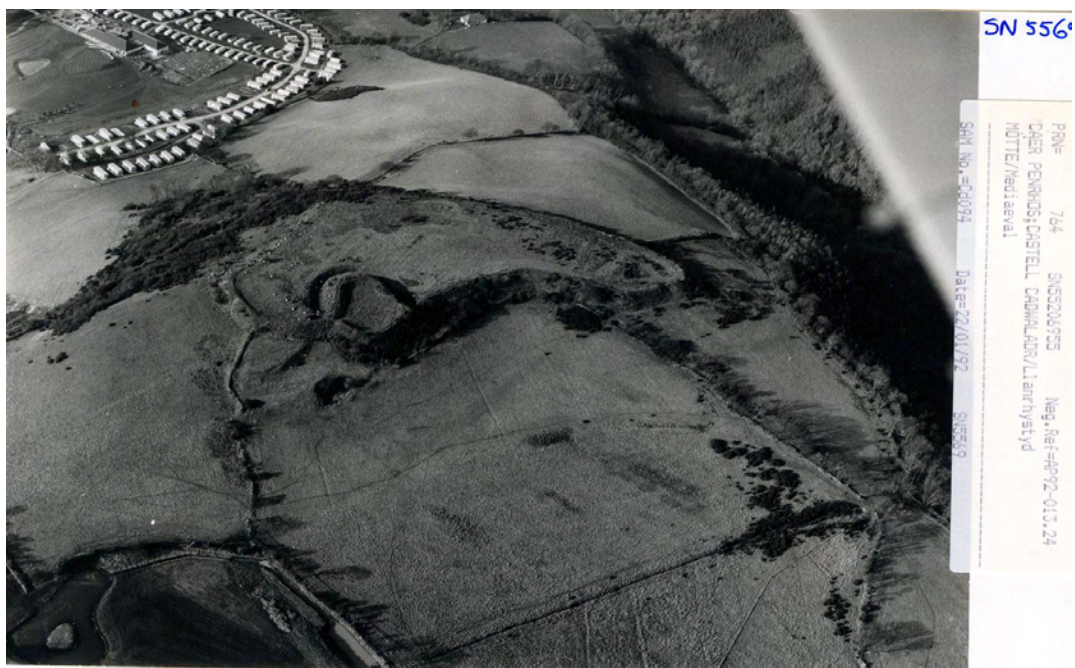
Recorded as a medieval castle built by Cadwaladr ap Gruffydd in 1148, Caer Penrhos is a complex site consisting of a ringwork possibly built over an Iron Age fort. It lies at 140m above sea level on a rounded hill. The presumed Iron Age fort is irregular in shape, 230m north - south and 80m east west, with a simple entrance at the northeast tip. It is defended by a bank and ditch with evidence on aerial photographs of a partial outer ditch on the east side. Aerial photographs also show a possible cropmark annexe at the northern end of the fort. The medieval ringwork is more massive and is built across the defences of the fort. It is bounded by a rock-cut ditch on its south and west sides. It measures approximately 44m by 26m internally. The relationship between the two elements is not entirely clear. If the large enclosure is Iron Age in date, then it is very large for the region. The character of its defences is however consistent with known Iron Age sites. It is likely that the Iron Age defences were modified in the medieval period. For a full description see T Driver. The site is mainly under improved pasture, but with scrub in some areas, particularly on the banks.

Aerial photograph Cambria Archaeology.

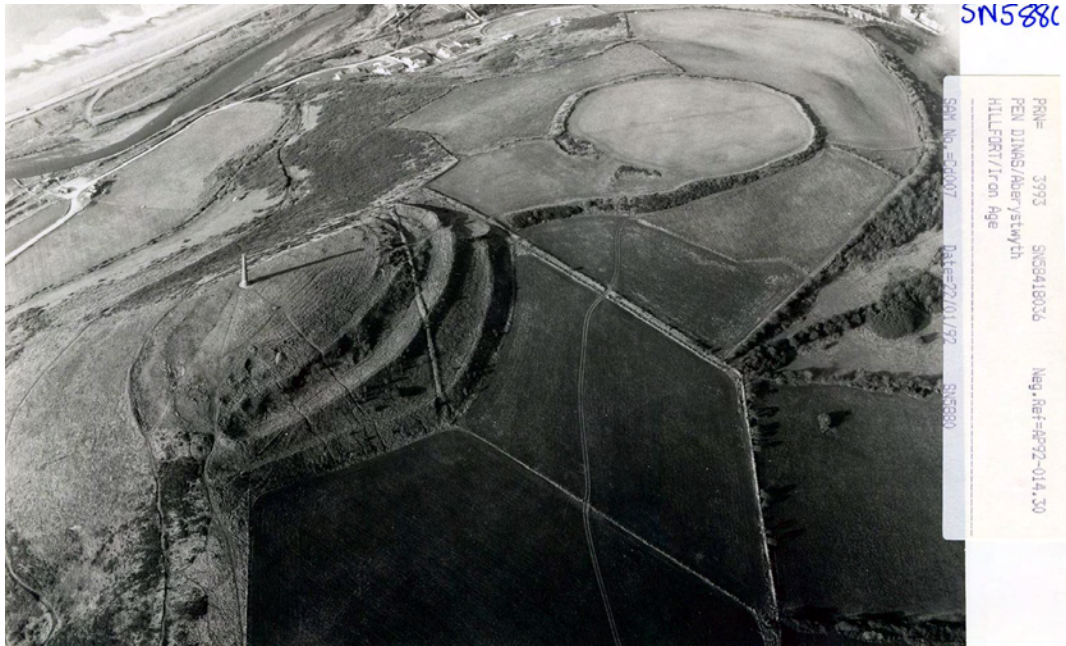
Pen Dinas is a hillfort occupying a strong position overlooking Aberystwyth and Cardigan Bay. It is 6.0ha in total. The main enclosure is multivallate, with a univallate annexe to the north. Excavations in the 1930s by Darryll Forde revealed complex phasing.

Aerial photograph Cambria Archaeology.

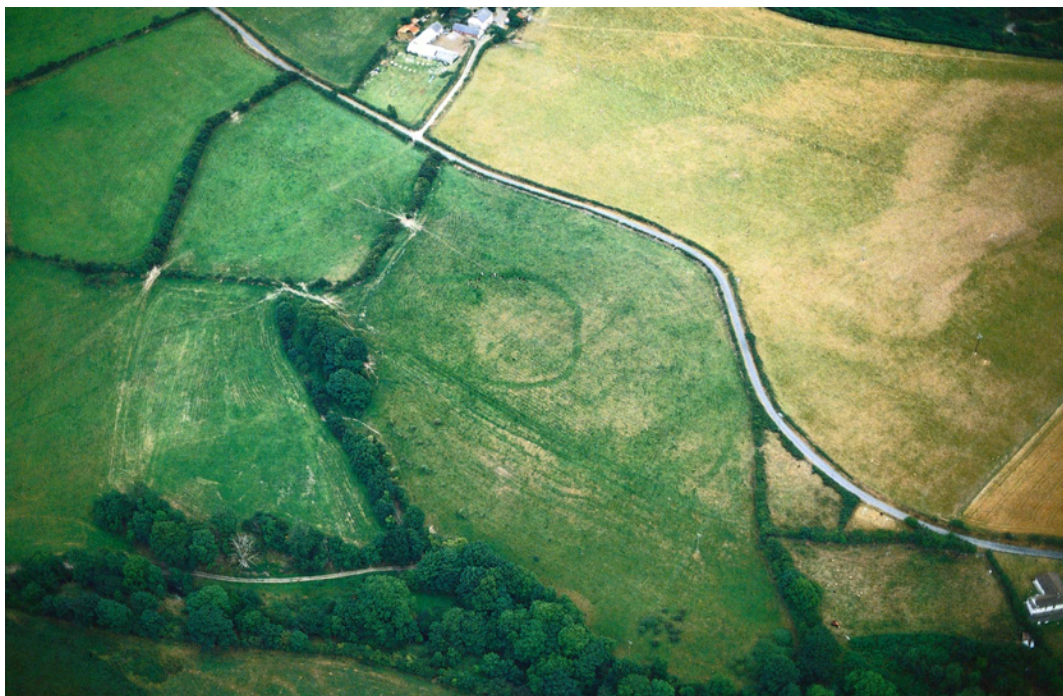
This is a cropmark site, with no earthwork or other surface evidence. It is located on sloping ground on the edge of a steep valley side at 70m above sea level. To the south the land rises gently by 10m from the site to a rounded summit 220m away. It is a concentric enclosure, with the sub-rectangular inner enclosure 60m north - south and 40m east - west represented by an incomplete cropmark ditch. Cropmark splodges within the enclosure may indicate pits. The ditch marking the limits of the concentric outer enclosure is narrower than the inner and lies 55m from it, to the west and south. A public road follows this ditch, indicating the its course must have been visible when the road was laid out. In 2005, the site was under improved pasture.

Aerial photograph RCAHMW Crown Copyright © reference 89-cs-757.

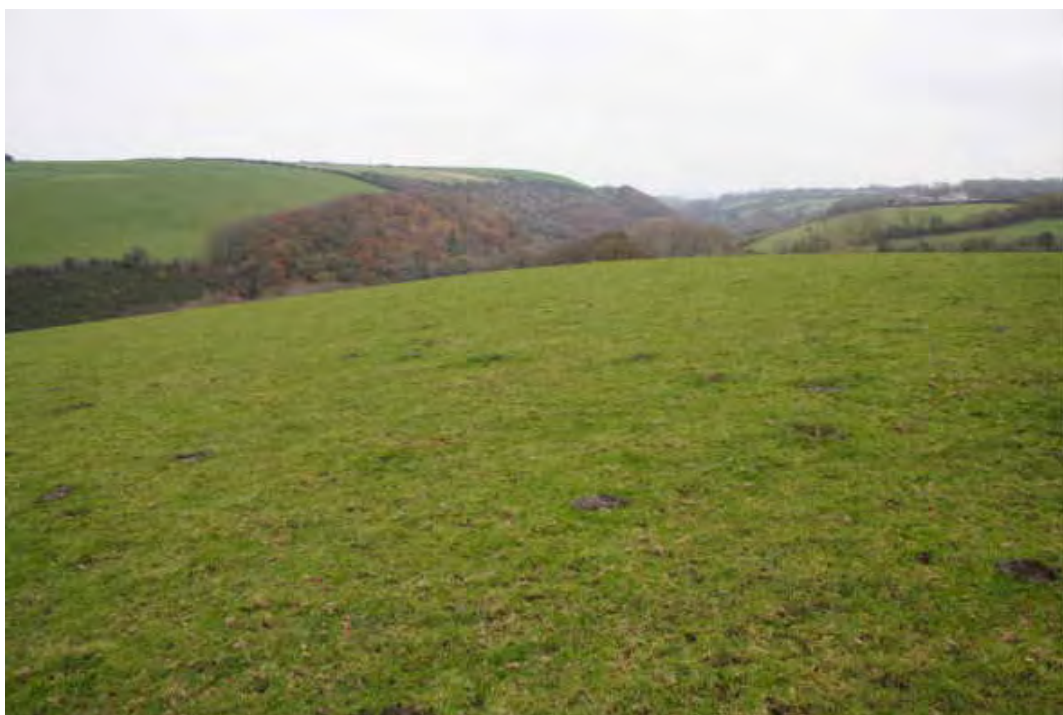
Ground photograph looking over site of cropmark enclosure.

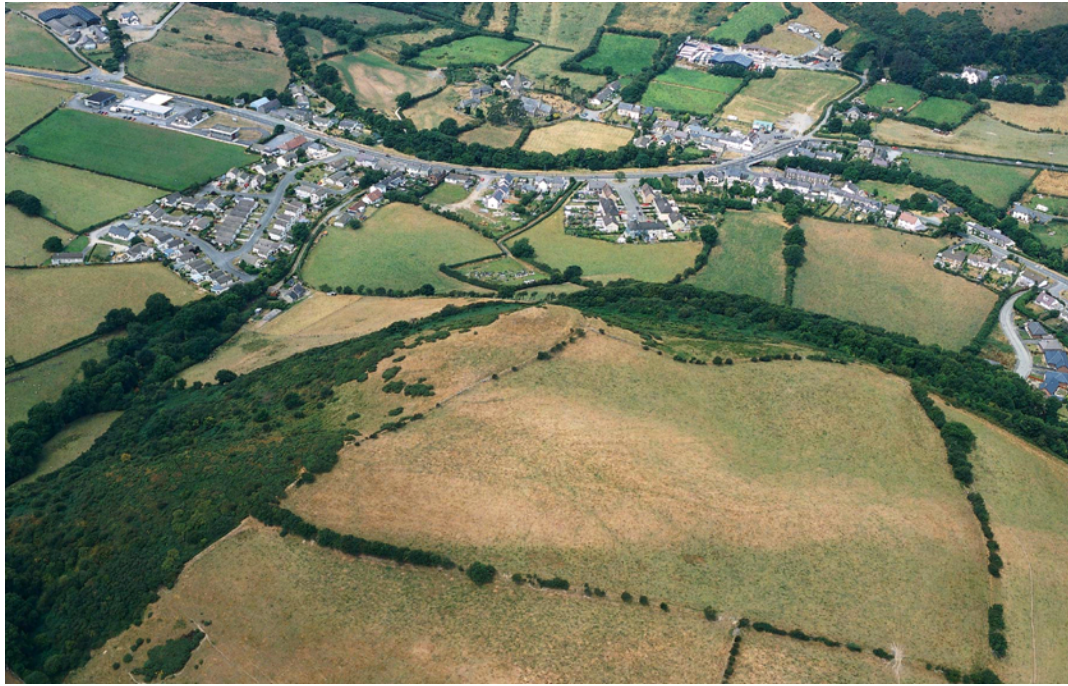
A small cropmark enclosure occupies a saddle between two local summits. Land falls away steeply from the site to the north, south and west. It is a cropmark site, with only slight surface undulations hinting at buried remains. Aerial photographs show two close-set concentric ditches enclosing a roughly circular internal area 26m diameter. A wide break in the cropmarks on the north side probably indicates the location of the entrance. In 2006, the site was under improved pasture.

Aerial photograph RCAHMW Crown Copyright © reference 99-cs-1941.

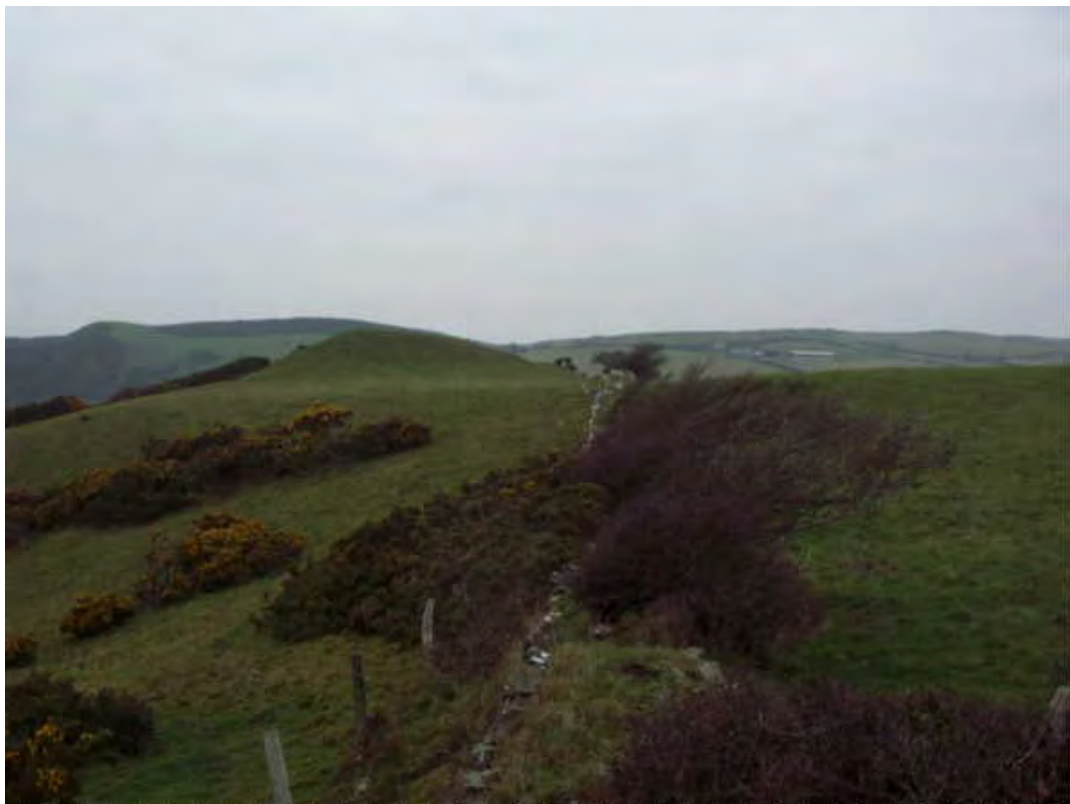
Ground photograph looking towards site of cropmark enclosure.

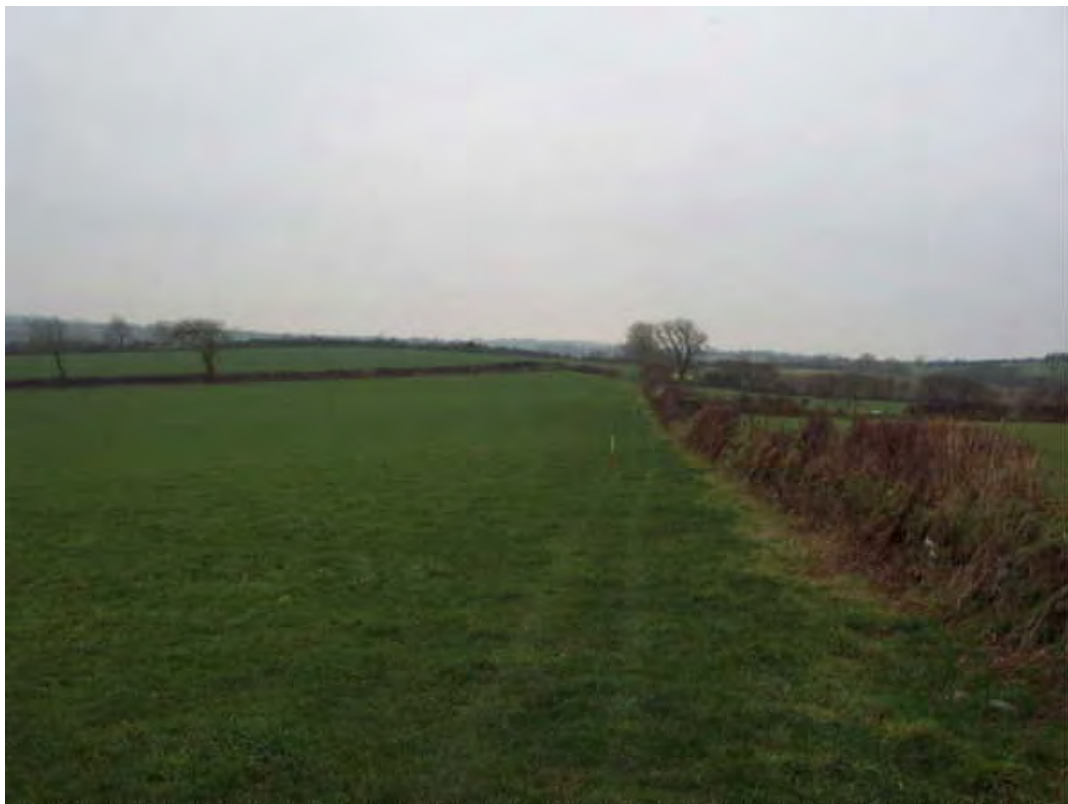
This is a cropmark enclosure lying on a gentle southwest-facing slope at 140m above sea level. Aerial photographs show an almost circular cropmark ditch with an internal diameter of c. 42m bisected by a field boundary. There is no obvious entrance. On the ground the southern half of the site is marked by a very slight rise in the ground - no more than 0.25m. Otherwise there is no trace of the enclosure on the ground. In 2006, the site was under improved pasture.

Ground photograph looking over site of cropmark enclosure.

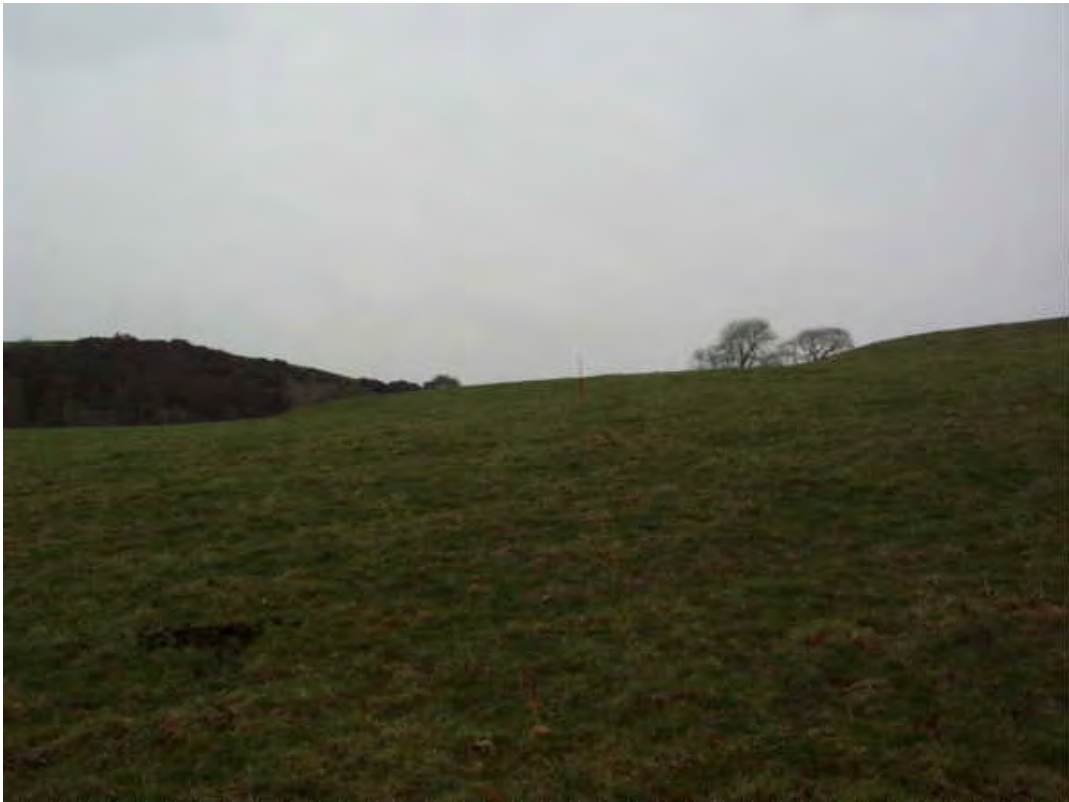
This cropmark enclosure lies on a very gentle southwest-facing slope at 150m above sea level. Immediately to the southwest the land falls steeply away into the Wyre valley. The site is overlooked from higher ground to the northeast. It is a cropmark site only, with no earthwork or other surface evidence. Vertical aerial photographs show cropmark ditch surrounding a round-cornered rectangular area, c. 36m by 25m internally. The location of the entrance is unknown. In 2006, the site was under improved pasture.

Ground photograph looking over site of enclosure.

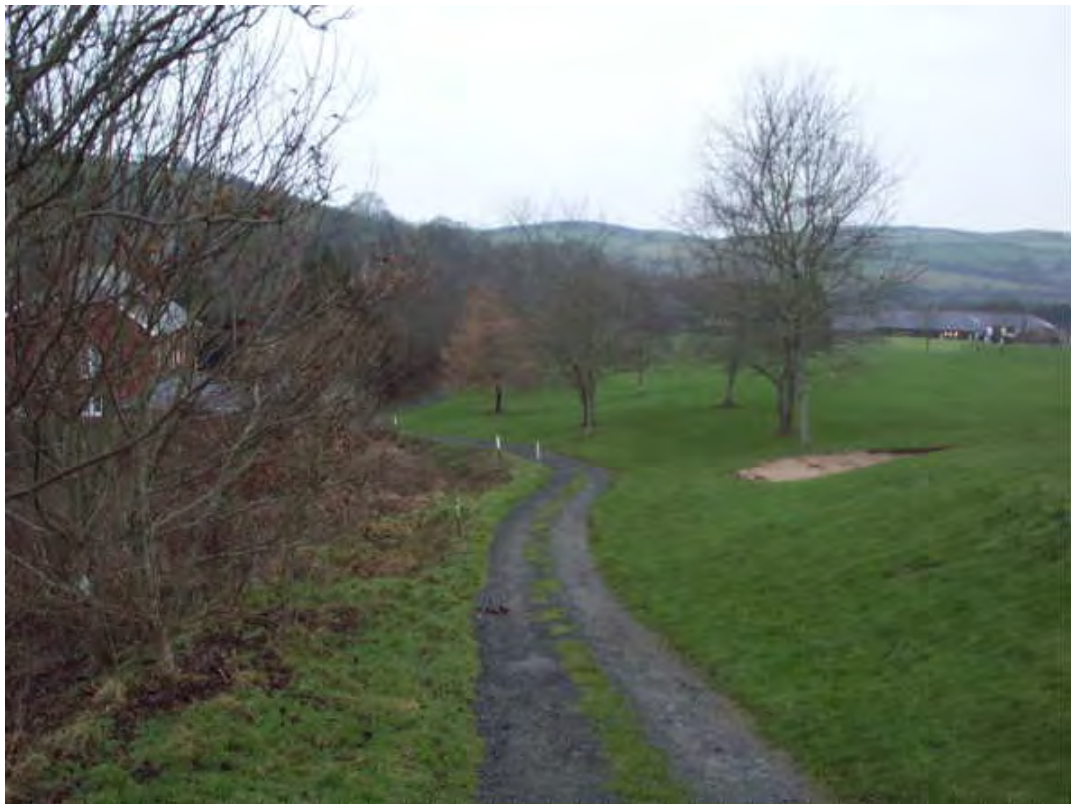
A partial cropmark of a bivallate defended enclosure was noted on vertical aerial photographs (CUCAP RC8kn ca 78) by T Driver. The western and north corner of a possible rectangular enclosure with close set ramparts were noted. The site lies towards the foot of a valley, on a west-facing slope at 50m above sea level. The site is now part of a golf course, and the whole area was landscaped in about 1990, including the creation of ponds. There is no surface trace of this site.

Ground photograph looking at site of cropmark.

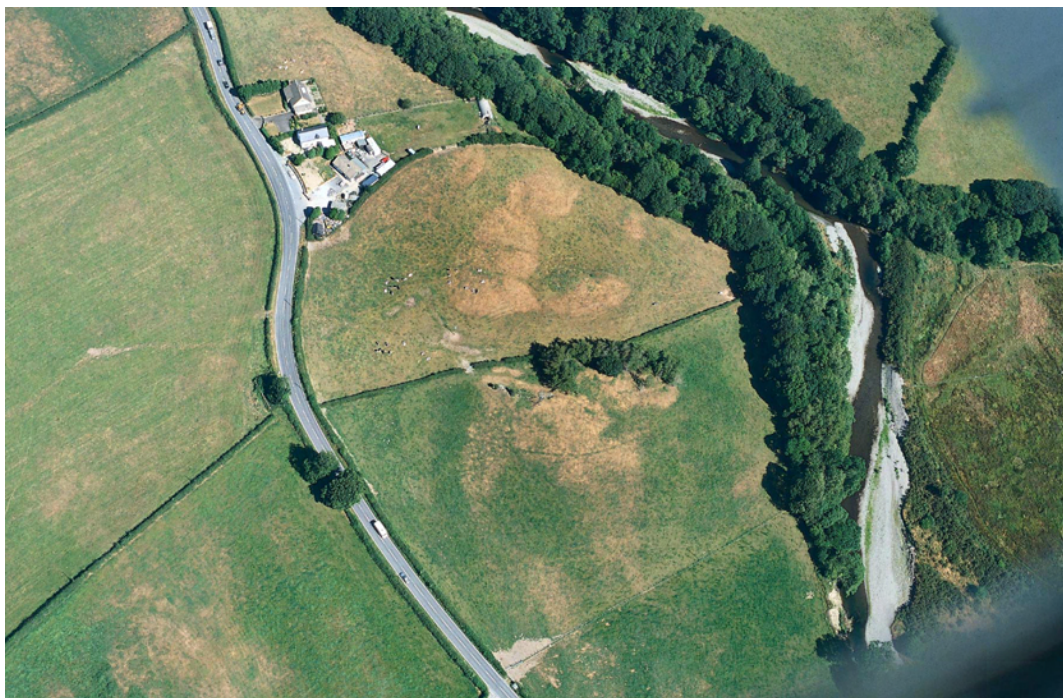
A possible cropmark enclosure. It is located on a slight rise, with a fairly steep north face, on an otherwise fairly flat area, c. 20m above the River Ystwyth. It is a cropmark only, with no earthwork or other surface evidence. Aerial photographs show a faint, thin curving cropmark ditch along the south side, and a separate more substantial ditch on the west side. Projected, these ditches produce an oval enclosure of c. 120m by 65m. A small quarry (abandoned) has been dug into the slope within the enclosure. Apart from trees on the steep north slope, the site is under improved pasture.

Aerial photograph RCAHMW Crown Copyright © reference 9-cs-1899.

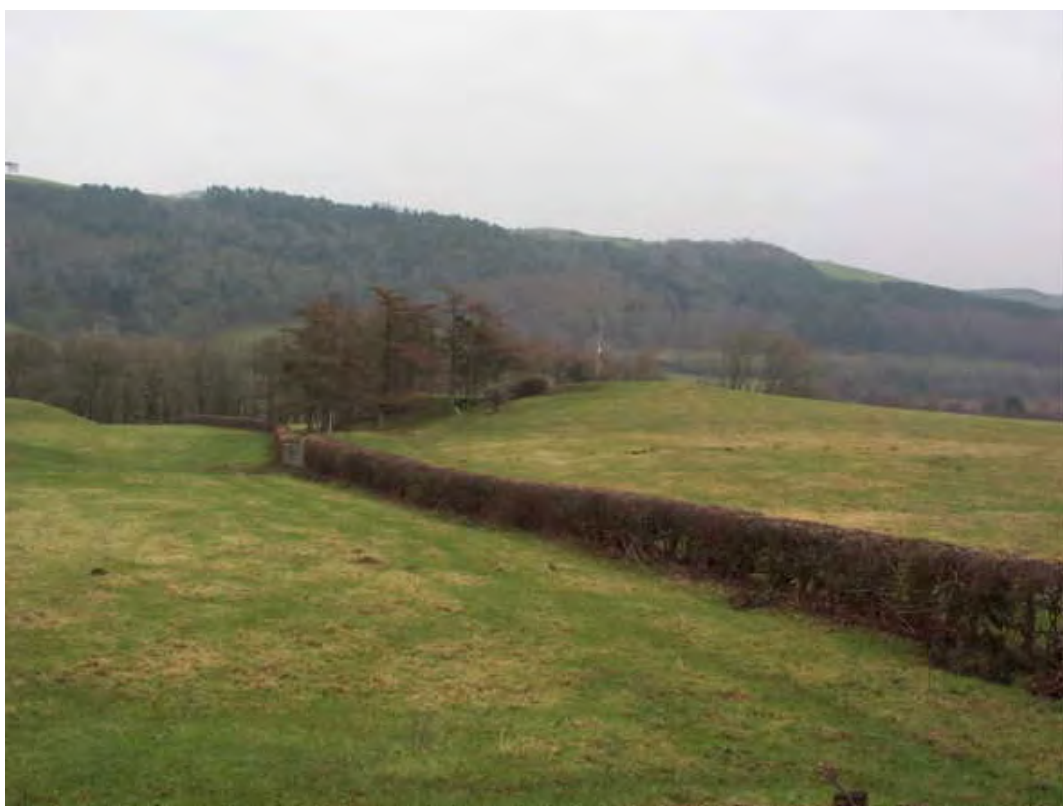
Ground photograph looking towards site of cropmark.
