**ASHFIELD ROW-  
LLANGADOG WATERMAIN  
RENEWAL SCHEME**

**ARCHAEOLOGICAL WATCHING BRIEF**  
**JANUARY 1997**

**Project Record No.33552**

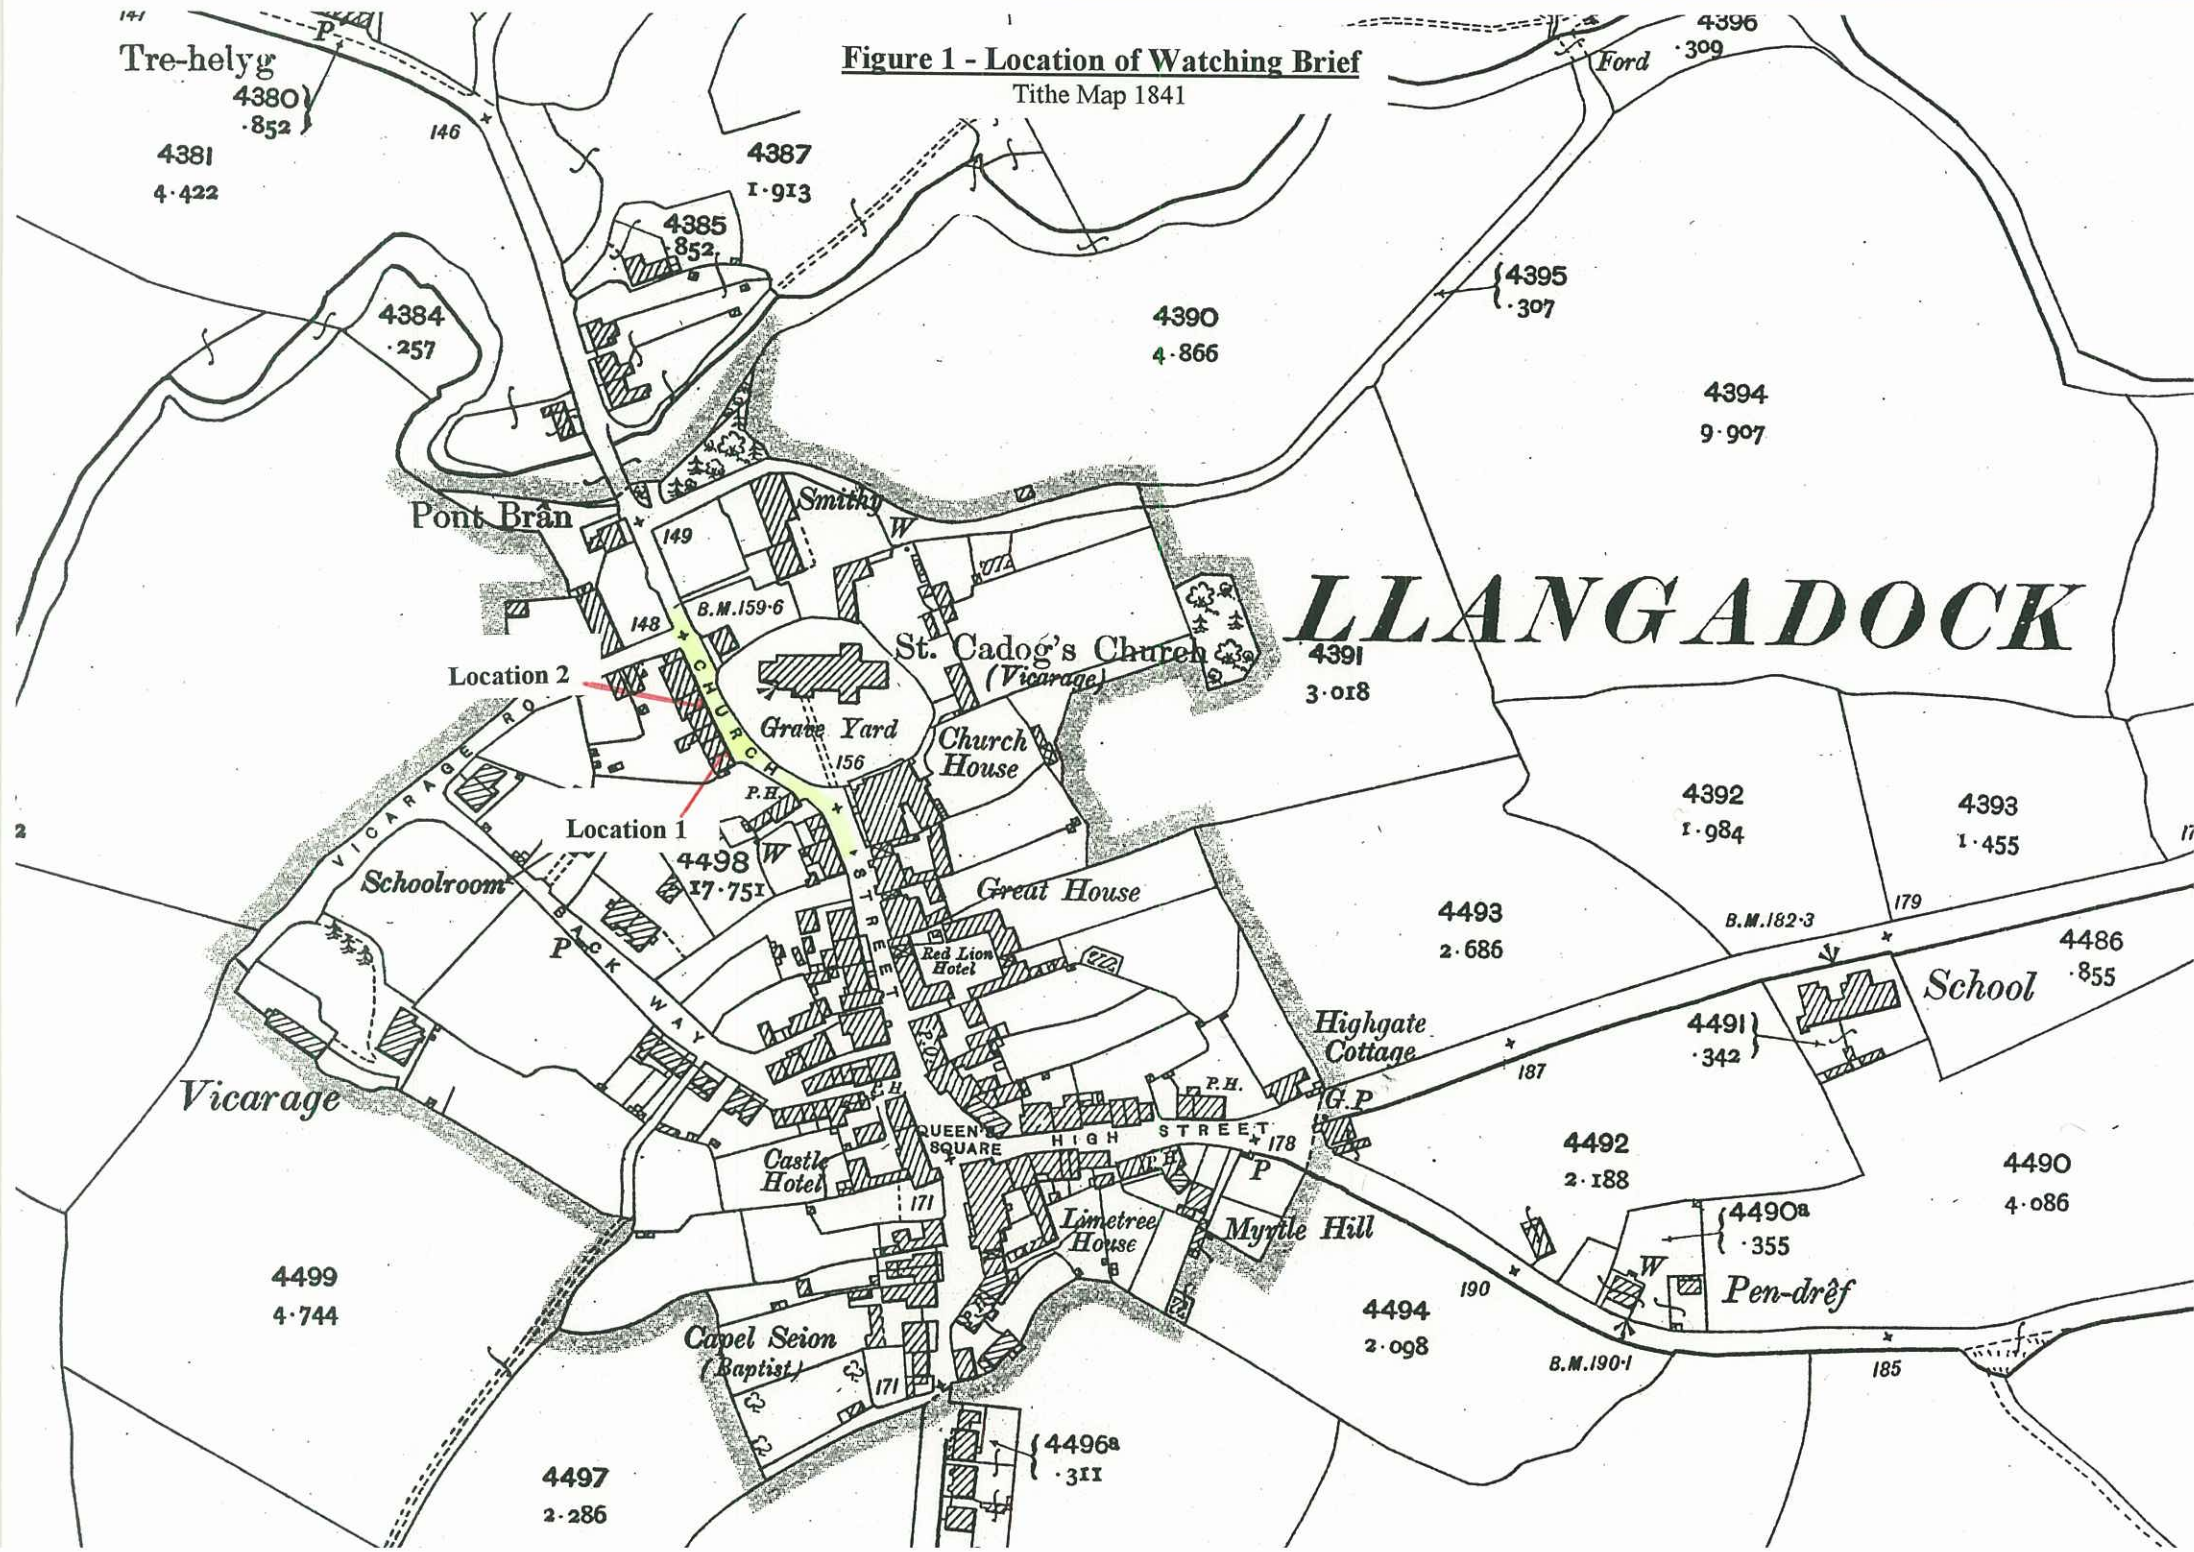
The watching brief was conducted on the section of the pipeline route along Church Street as it passed St. Cadog's Church (PRN 4049; NGR SN 7062 2845) in the centre of the village of Llangadog (PRN 12781) (Figure 1). The watermain was contained within the existing road line, and for part of its length was confined to the existing watermain trench.

A natural increase in the level of the bedrock occurred within the monitored section. A rise in the bedrock level, of approximately 0.3 metres, occurred at Location 1 (see Figure 1 - between house numbers 1 and 2, Church Street). The bedrock level then decreased at Location 2 (between house numbers 4 and 5, Church Street) to a level deeper than the excavated trench, revealing the natural clay (007) described above.
