## **TIR GOFAL MANAGEMENT PLAN: HERITAGE MANAGEMENT INFORMATION (HE2)**

**Prepared for:  
Llygad-enwyn**

**Tir Gofal Reference No  
W/12/5756**

**ACA Report No. 2006-105  
Project Record No. 54503**

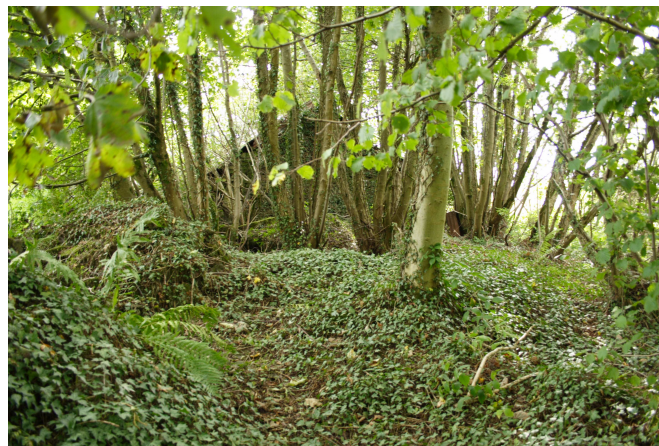
Minor farmstead comprising three buildings in a close U-plan arrangement recorded on the Ordnance Survey 1st edition map (1888) in a fork between two roads.

The complex is now derelict and falling into disrepair. Surviving buildings include a small threshing barn to the west, part of a range that once included the house, now evidenced only by low spread wall bases. The building is of rubble stone and slate and corrugated tin roofed construction. An open fronted cart shed roofed with corrugated tin lies to the south. A collection of earth banked enclosures survive nearby.

Regeneration woodland now surrounds the site.

The earthworks of the former farmhouse at Gwar-y-cwm. The barn lies behind it to the south.

The management aim within Tir Gofal is to prevent damage by vegetation to the standing buildings and ruinous remains. The following recommendations apply.

- Monitor mature trees close to the buildings. Consider felling mature trees which are at risk of windthrow.
- Cut or spray back young trees and vegetation close to the buildings leaving the roots *in situ*. Spot treat to prevent re-growth.

The owner has stated a desire to carry out building restoration (Capital Works options). The aim of management is to ensure the survival of the traditional buildings and maintain the historic character of the complex as a whole. The roofs of the surviving buildings are deteriorating.

- Deteriorating roofing should be replaced with traditional materials appropriate to the original construction of the farmstead and its locality (slate and corrugated iron).
- Wherever possible repair original features rather than replace them. Re-use or repair elements of the old roof structure as far as is practically possible.

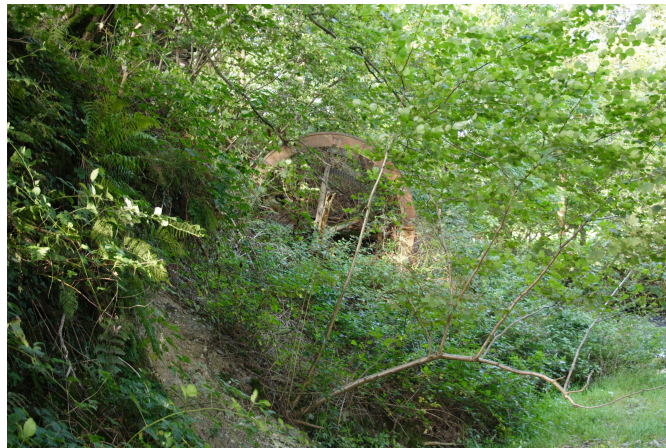
Identified as a working woollen mill on the Ordnance Survey 1st edition Ordnance Survey map (1889). Served by leat (PRN56836). The mill building is ruinous and scrub covered. A cast iron overshot wheel survives below. No management threats identified.

The cast iron water wheel at Felin Ban survives.

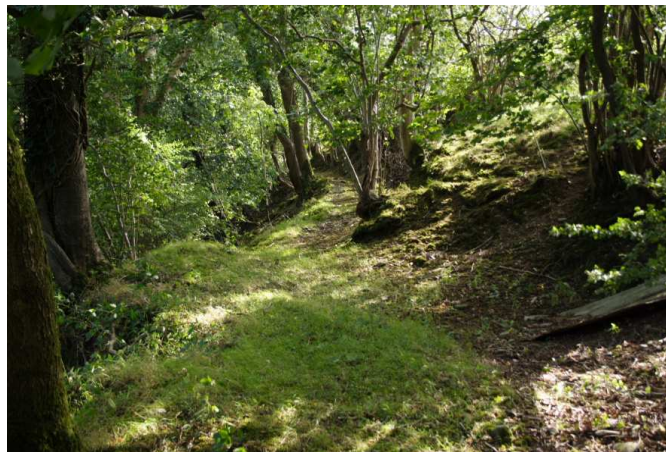
A mill race marked on the 1889 Ordnance Survey map serving Felin Ban woollen mill. The mill race can still be traced for a distance of approximately 75m across land belonging to Llygad-enwyn, visible as a stone lined channel approximately 1.6m wide and 0.3m deep.

No management threats identified.

Facing east along the mill race.

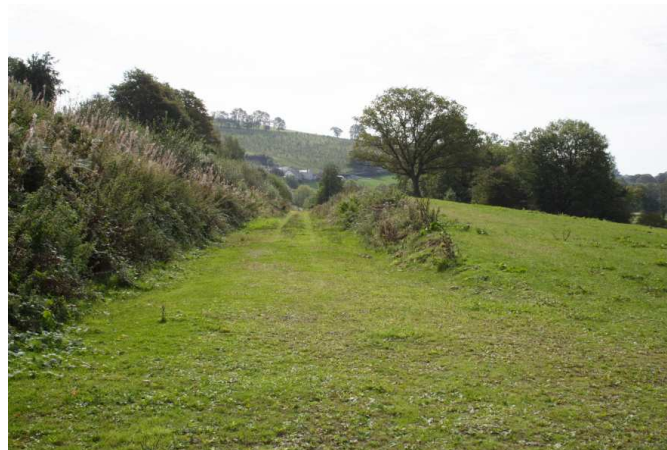
Segment of the disused Manchester & Milford Railway traversing land belonging to Llygad-Enwyn, today visible as a cutting with only the track bed now remaining.

Facing south along the line of the disused railway. Only the track bed now remains.

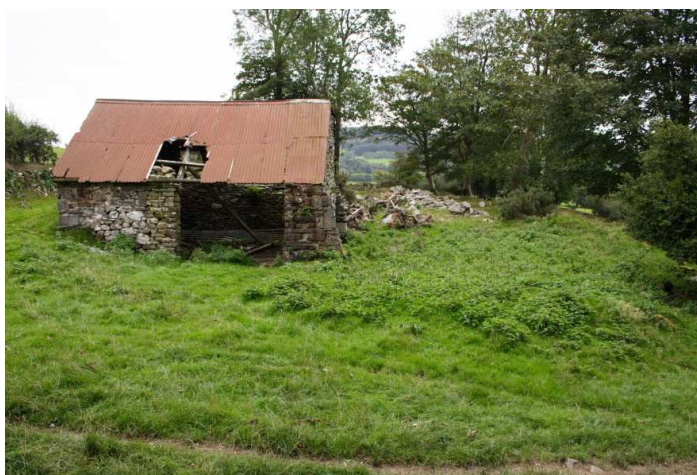
A derelict farmstead consisting of two roughly parallel building ranges. This basic layout is unchanged since at least the time the Ordnance Survey 1<sup>st</sup> edition map was published in 1888.

Includes the ruinous remains of a long rubble stone outbuilding built down-the-slope, now with few diagnostic features remaining, its original function difficult to discern. A long range recorded roughly opposite is now only partly intact, evidenced by a derelict rubble stone cart shed and the low spread wall bases of the former farmhouse. A collection of stone walled enclosures survive nearby.

Pasture is the dominant vegetation although some mature trees have colonised the area. No management threats were identified.

The cart shed at Llwyn-cuan. The farmhouse stood to the right.
