TIR GOFAL MANAGEMENT PLAN: HERITAGE MANAGEMENT INFORMATION (HE2)

**Prepared for:
Llettyngors**

**Tir Gofal Reference No
W/12/5762**

**ACA Report No. 2006/90
Project Record No. 54505**

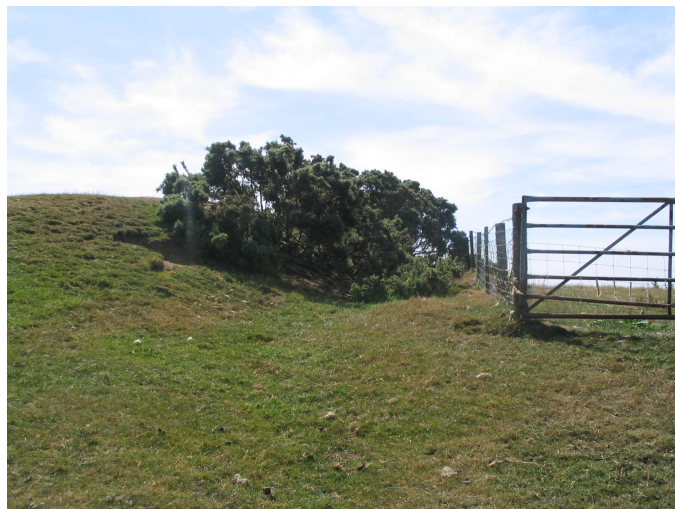
Name (& PRN)	Period/Site type	NGR	Status	SAM/listing	Management required
1	BANC Y RHYFEL;DYFFRYN CAMP (652)	Iron Age hillfort	SN54072656	A	SAM	Specific
<p>A small univallate defended enclosure, situated on a ridge and relying on natural defences in the south. The earthwork commands an excellent view into the valleys to the north and south. The ridge on which it stands is known as "Banc y rhyfel"</p> <p>Oval enclosure on hilltop, defended by a single bank on the E and W sides surviving to an interior height of up to 1m, an exterior height of up to 2m. The ditch is traceable as a slight dip 15cm deep on the E. 60cm deep on the W. On the north there is a scarp giving a bank 2m high externally, while on the S the natural steep slopes do not appear to have been artificially strengthened. The interior and N scarp has been ploughed in the past to regenerate grass for pasture; the banks on E and W are not ploughed.</p> <p>The enclosure lies within improved pasture land. Stable grass cover predominates although gorse bushes now cover the outer face of the western bank. Cadw Scheduled Ancient Monument (SAM) condition reports record erosion through livestock trampling as an ongoing problem: there are active erosion faces on the eastern bank and between the gorse bushes on the western bank.</p>

Gorse bushes on the western bank of Dyffryn Camp

Cadw Scheduled Ancient Monument (SAM) condition reports have recorded livestock erosion as an ongoing issue. There are active erosion faces on the eastern bank and between the gorse bushes on the western bank. Grant aid is available within Tir Gofal to deliver improved management. The following recommendations are made in consultation with Cadw.

- Cut scrub on the western bank. Remove cut vegetation from the area of the earthworks. These areas may require subsequent protection and re-seeding to establish grass cover (Tir Gofal capital works options).
- Consider infilling active erosion scrapes with inert material from elsewhere and reseed to restore the profile of the banks and allow the recovery of erosion scars.
- Graze at a level which will prevent the breakdown of grass cover. Exclude livestock temporarily from damaged areas to allow the recovery of erosion scars. Temporary electric fencing can be used.
- Consider Tir Gofal reversion options. Cease reseedling or ground breaking activities within the scheduled area (see attached map).

Please note: any works, which would have the effect of demolishing, destroying, damaging, removing, repairing, altering, adding to, flooding, or covering up a monument must have scheduled monument consent, e.g. infilling of erosion, fencing, ploughing. Cutting of vegetation does not require scheduled monument consent.

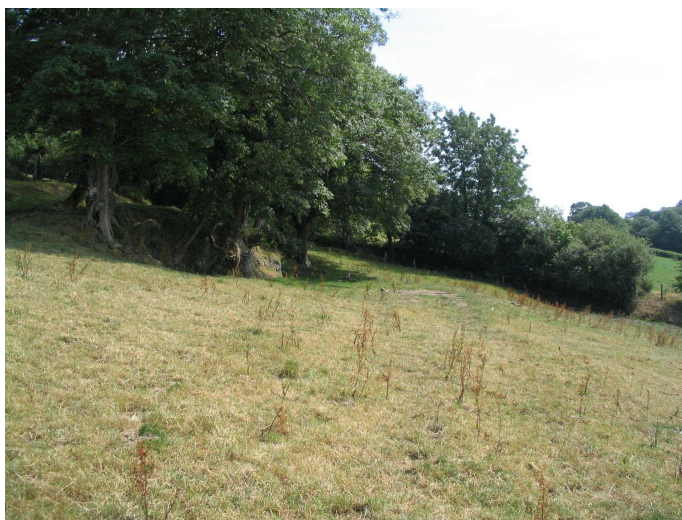
Minor farmstead recorded on Llanfynydd parish tithe map & apportionment of 1840 but not named on later sources. Just one building is marked in outline on the Ordnance Survey 1st edition map (1889) suggesting that the farmstead had been abandoned by that time.

No surface traces of any buildings or enclosures relating to the former farmstead remain today. A roughly level area in otherwise sloping ground is now all that marks the site.

The site of the former farmstead of Cilganwr. No obvious surface remains survive today.

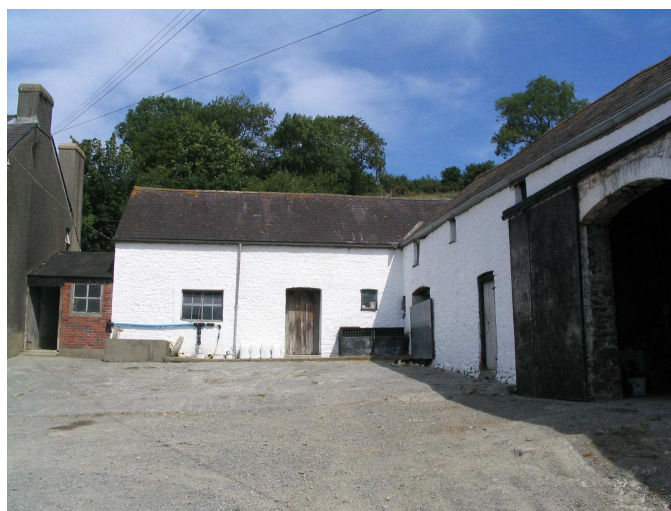
The threshing barn, cart house, granary and lofted stables on the east side of the farmyard at Llettyngors.

Despite having experienced modernisation, Llettyngors is a relatively intact nineteenth century farmstead with a number of original features surviving. Surviving buildings are generally in good order although there are structural concerns with the lower

(S) wall of the threshing barn and the rear (N) roof pitch of the stable is in poor repair.

- Care should be taken to re-use the maximum number of old slates possible. New slates should, ideally match the type, colour, texture, size and thickness of the existing ones. New slates can be mixed with old ones across the roof or reserved for less prominent slopes. Welsh or Spanish slate can be used.

- Wherever possible repair original features rather than replace them. Re-use or repair elements of the old roof structure as far as practically possible.

- It is recommended that structural works are considered in order to stabilise the lower (S) wall of the threshing barn. This work should be carried out maintaining as much of the historic fabric as possible with similar replacement materials used where necessary. Original characteristic features (eg. ventilation slits) should be replicated in any rebuild.
