# ST. LAWRENCE'S CHURCH, YERBESTON

## ARCHAEOLOGICAL WATCHING BRIEF

REPORT NO. 2005/83  
PROJECT RECORD NO. 54883

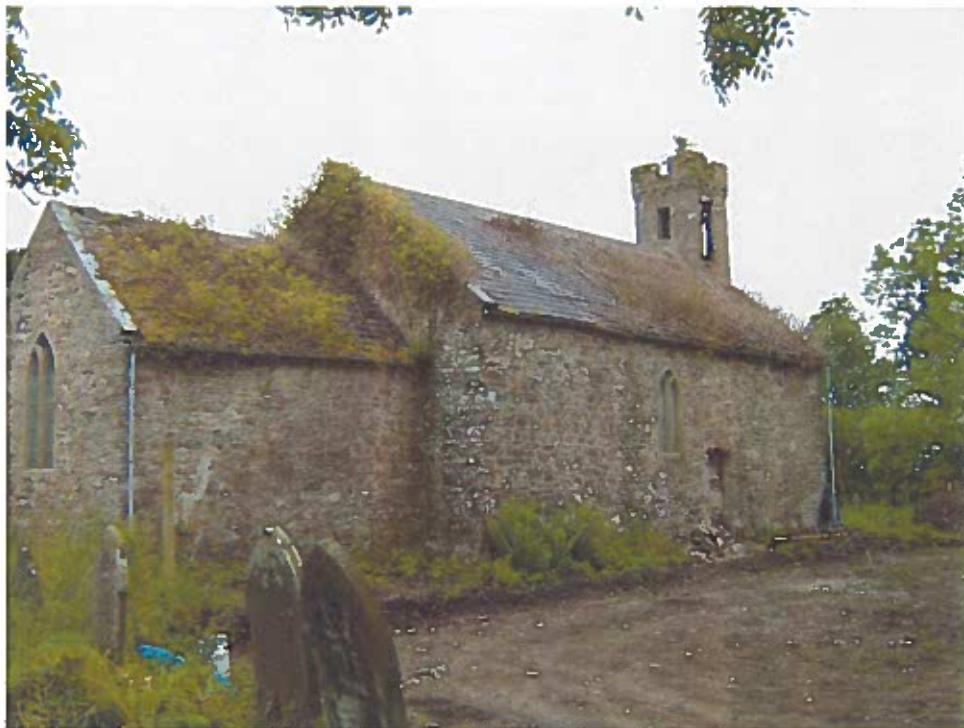
*Plate 1: The church from the northeast showing the area of the external pipes and septic tank stripped. Some of the marked graves are visible in the foreground.*

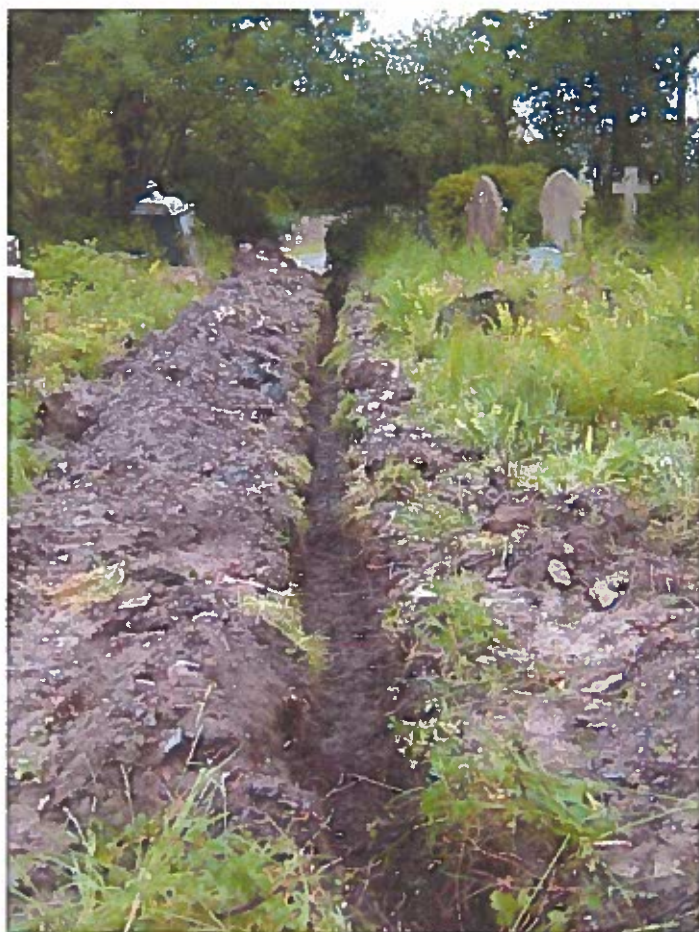
*Plate 2: The cable run trench excavated along the line of the path from the gate to the south door.*

The trench for the external water pipe was largely dug through an area to the north of the church that had been stripped during an early watching brief carried out on a cable run along the line of the path from the gate to the south door (Plate 2). The watching brief on the cable trench revealed a small quantity of disarticulated and clearly disturbed human bone, but no burials or grave cuts. Monitoring of the stripping north of the church revealed no surface features or any indication of buried features.

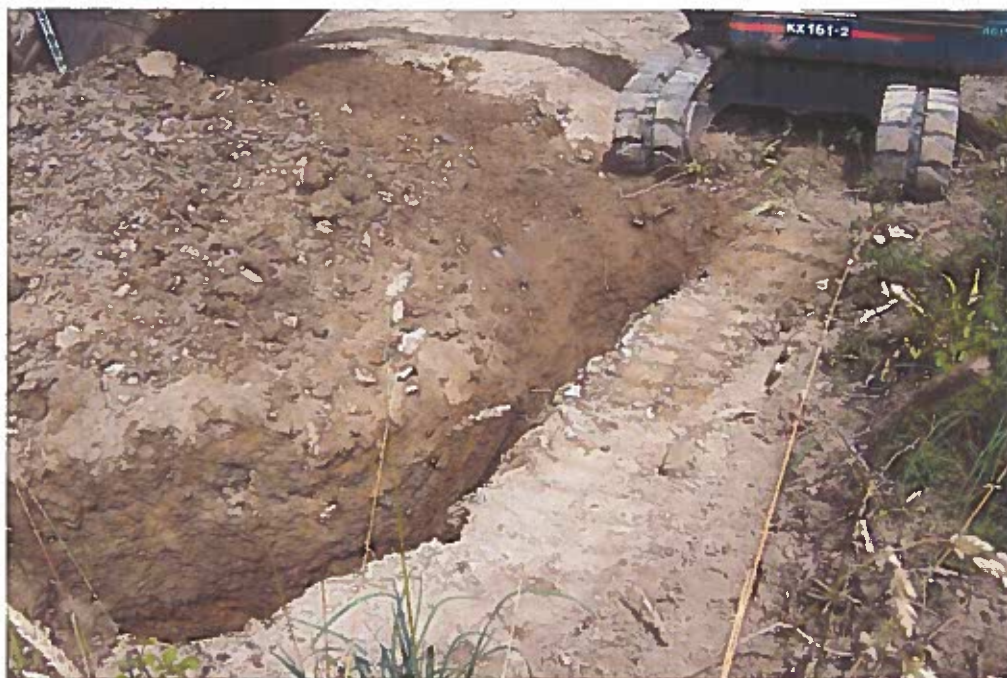
No archaeological features were noted.

*Plate 3: Typical section of the heating system trench dug north of the church. The topsoil had already been removed from this area and the surface examined.*

The trench for the external water pipe measured c.50m in length (Fig. 1). From the west wall it curved around the northwest corner of the church and ran parallel to the north wall for the full length of the building, before curving back and again running the length of the building. Excavation of the pipe trench was carried out by a mini mechanical excavator fitted with a 30cm wide toothed bucket. Therefore, the potential for identifying features in plan was limited. However, the trench sides were clean and any buried features (if they extended into one or both sides) would have been visible (Plate 3).
