# AN ARCHAEOLOGICAL EVALUATION OF LAND TO THE REAR OF PRIORY FARM, MONKTON, PEMBROKESHIRE

RHIF YR ADRODDIAD / REPORT NO. 2005/81  
RHIF Y PROSIECT / PROJECT RECORD NO. 54888

## AN ARCHAEOLOGICAL EVALUATION OF LAND TO THE REAR OF PRIORY FARM MONKTON

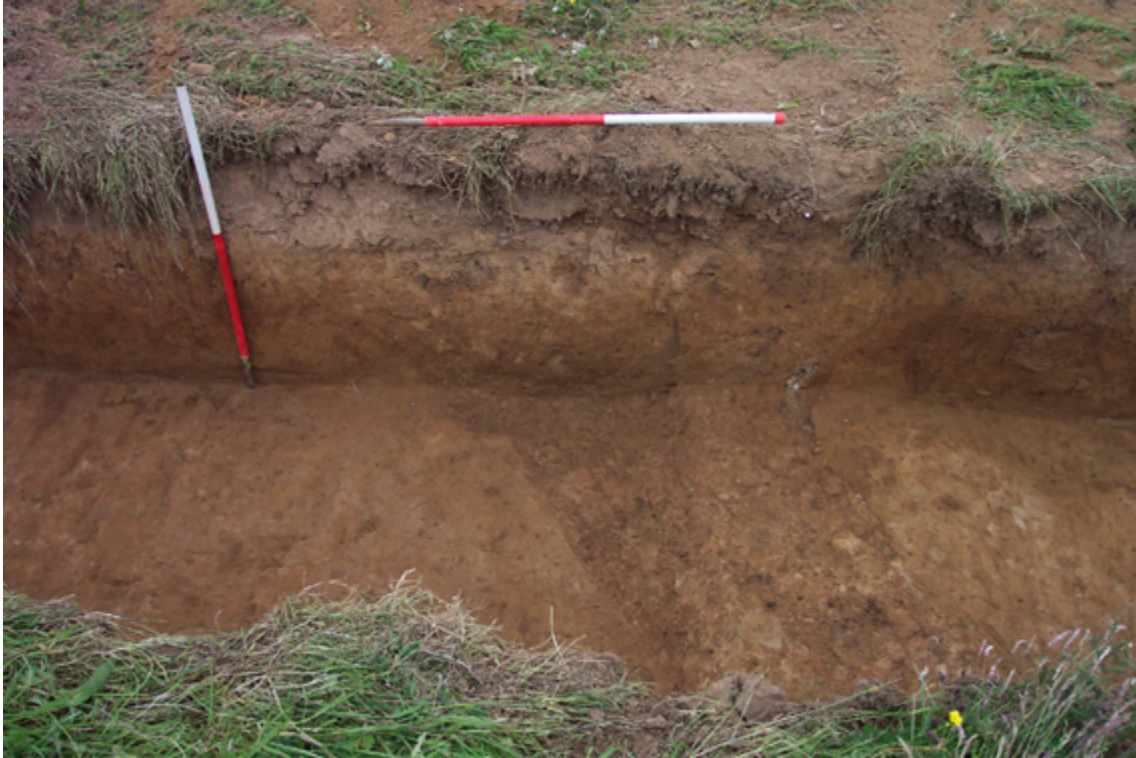
**Photo 1:** Sewer mains cut in Trench 5

This trench was cut to a length of 23m and a maximum depth of 0.80m. It was located partly to evaluate a linear feature identified on the geophysical survey as the possible remains of an earthwork or embankment. It also crossed an area of possible ridge and furrow. Bedrock was not exposed. A single feature, the source of the geophysical anomaly was found to be a mains sewer pipeline running between (and beyond) two manholes visible on the ground surface. No trace of ridge and furrow was apparent. No other features of archaeological significance were identified.

This trench was cut to a length of 17m and a maximum depth of 0.50m. It was located to sample the ditch and interior of the possible enclosure. No features of archaeological significance were identified. Bedrock was not exposed. The continuation of the sewer mains cut identified in trench 5 was picked up in the southern end of the trench.

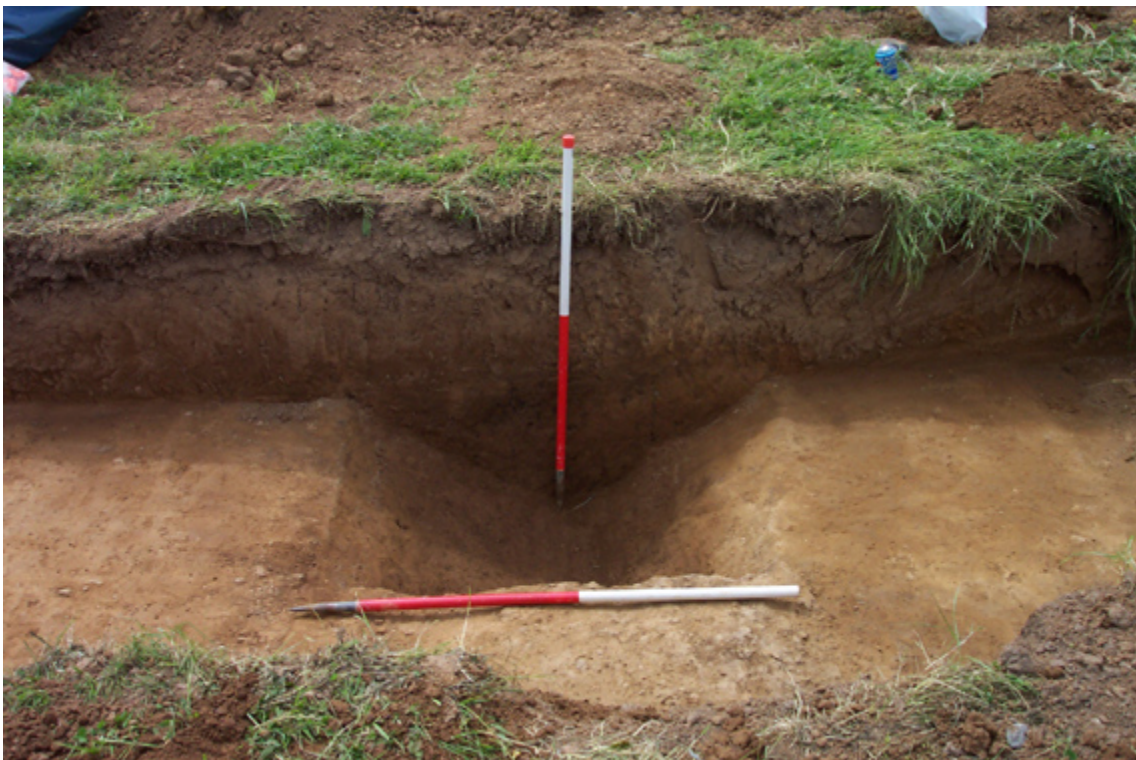
**Photo 2:** Possible linear feature in Trench 6

This trench was cut to a length of 25m and a general depth of 0.60m. It was located to evaluate a linear anomaly thought to be a possible radial field boundary. It also crossed an area of ridge and furrow. A limited area of deeper excavation exposed bedrock at a depth of 1.50m. An apparently linear feature corresponding to the geophysical anomaly was identified at a depth of approximately 0.60m. It was not possible to discern a clear level from which the feature was cut. The supposed fill was slightly darker than the surrounding deposits but with no other inclusions to differentiate it. On excavation, any edges were difficult to ascertain. The feature appeared to be a possible v-shaped cut 0.40m deep and 1.20m wide. On balance, however, it was too ephemeral to be securely identified as an archaeological feature and did not have the characteristics of a field boundary ditch. No other features of archaeological significance were identified.

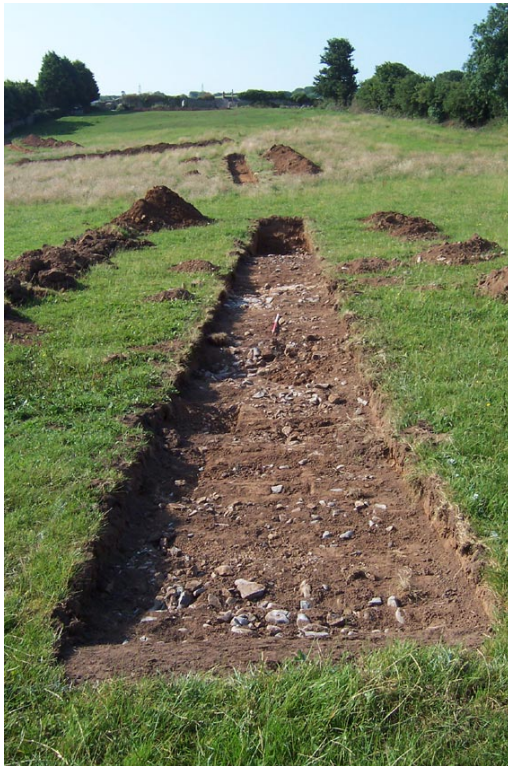
**Photo 3:** Trench 1 looking south

This trench was cut to a length of 24.5m located in order to evaluate some possible archaeological features identified from the geophysical survey. Below the topsoil, solid limestone bedrock was exposed across the entire length of the trench at a depth of 0.20m to the north and 1.0m to the south. Pockets of subsoil corresponding to geophysical anomalies were investigated as possible archaeological features but they were found to be contained within naturally formed fissures in the bedrock rather than cut features.

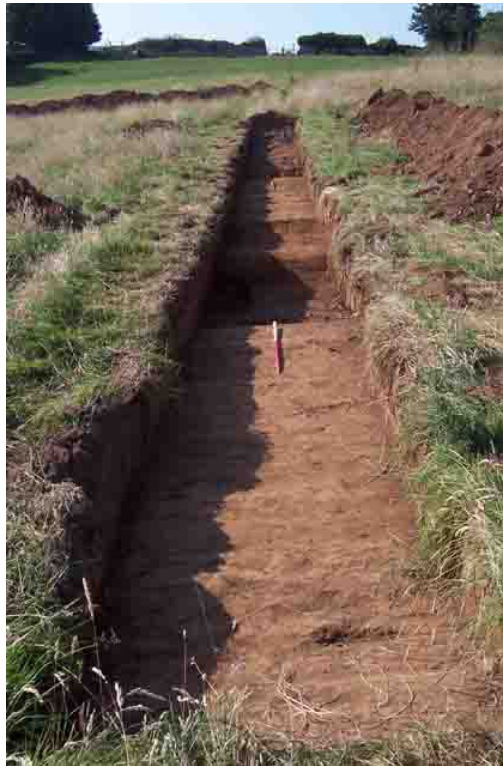
**Photo 4:** Trench 2 looking south

This trench was cut to a length of 25m and to a general depth of 0.45m. It was located to evaluate an essentially blank area in the geophysical survey. A deeper excavation towards the north exposed bedrock at a depth of 1.0m. To the south bedrock was exposed at 0.30m. No features of archaeological significance were identified.

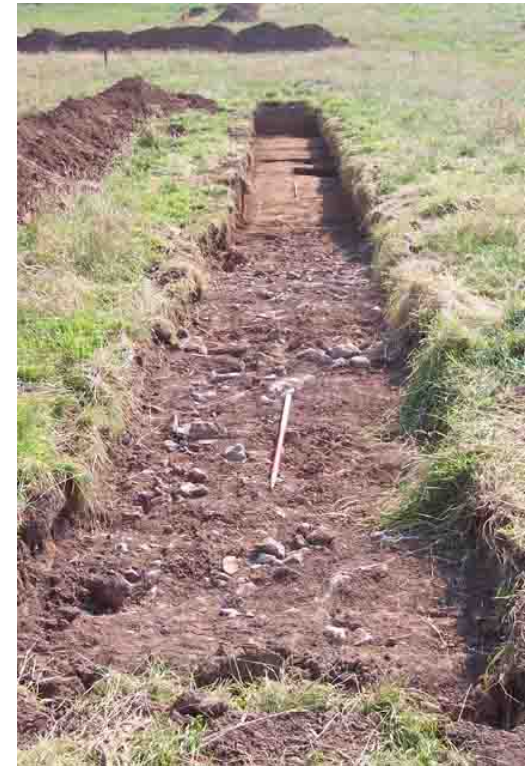
**Photo 5:** Trench 3 looking east

This trench was cut to a length of 32.0m. It was located to include part of a linear anomaly thought to be a possible enclosure ditch. To the west, limestone bedrock was exposed at 0.20m, sloping down to the east to a depth of 0.90m. No archaeologically significant features were identified. The linear anomaly is presumed to have been caused by the natural limestone geology.

Trench 3 illustrated that the limestone bedrock sloped downwards to the east. Where the limestone bedrock was not encountered at a high level, it was overlain by yellow clay silt. The soil profile consisted of an apparently homogenous mid yellow silt, with organic content and bioturbation diminishing with depth (up to 1.30m in the eastern part of the site). The silts became a paler yellow and more compact with depth. Occasional charcoal flecks were dispersed within the upper 0.45m or so of the silt, probably worked into the soil at the time of deposition or later through bioturbation. Directly above the limestone bedrock the soil changed to a much darker brown. This appeared to be a mineral or chemical phenomenon caused by contact between the silt and limestone rather than a buried organic horizon.

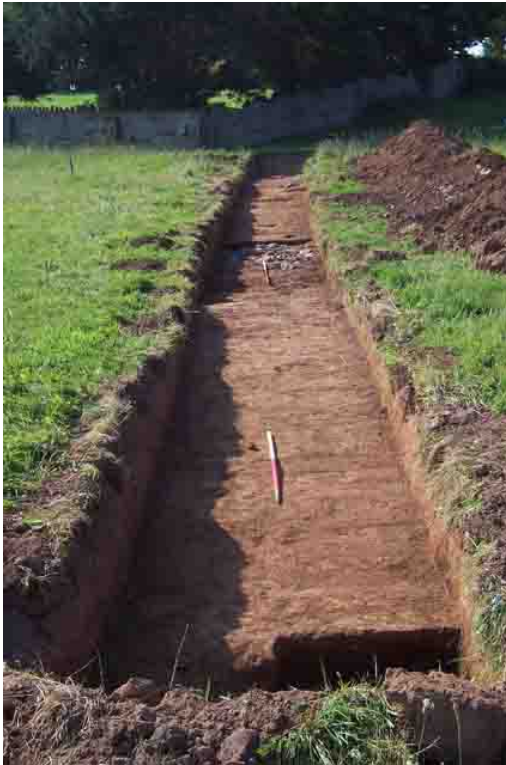
**Photo 6:** Trench 4 looking southeast

This trench was cut to a length of 24m and a general depth of 0.45m. It was located partly to evaluate a linear anomaly on the geophysical survey. Bedrock was exposed at 0.45m to the north and 0.30m to the south. The anomaly was found to correspond to an isolated outcrop of limestone bedrock surrounded by silts. No features of archaeological significance were identified.

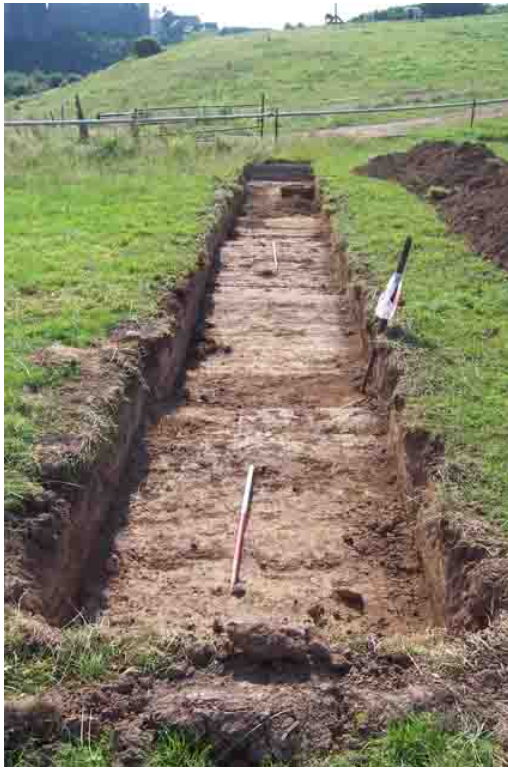
**Photo 9:** Trench 7 looking east

This trench was cut to a length of 16.50m and a general depth of 0.50m. It was located to evaluate the geophysical anomaly identified as a possible Iron Age enclosure and part of its interior area. A small portion at the eastern end was hand excavated to a depth of 0.90m. No bedrock was exposed within the trench. A linear feature within the trench that corresponded with a geophysical anomaly was found to be the cut for a modern water pipe. No archaeologically significant features were identified.

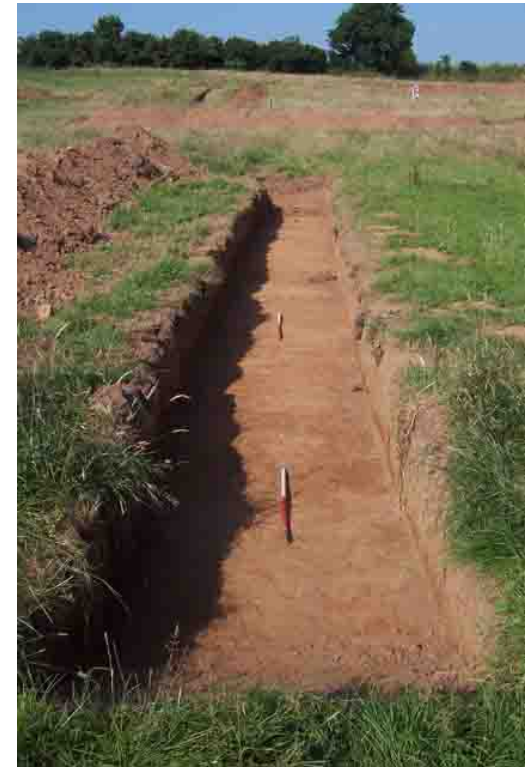
**Photo 11:** Trench 9 looking west

This trench was cut to a length of 17m and a maximum depth of 0.80m. It was located to evaluate a series of possible linear anomalies identified as possible archaeological features during the geophysical survey. No features of archaeological significance were identified. Bedrock was not exposed.

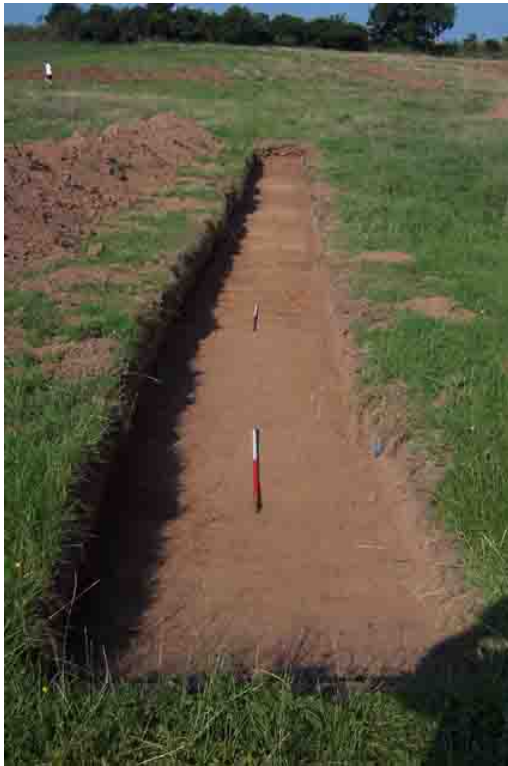
**Photo 12:** Trench 10 looking west

This trench was cut to a length of 25m and a maximum depth of 0.90m. It was located to evaluate a blank area in the geophysical survey. No archaeologically significant features were identified. Bedrock was not exposed.

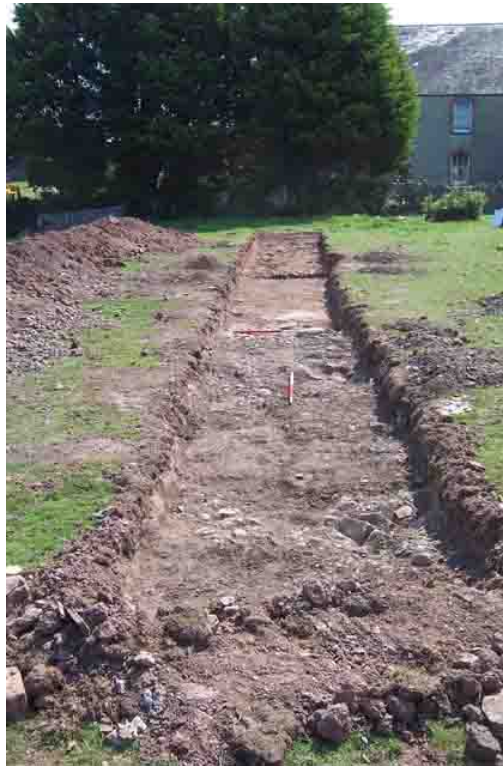
**Photo 13:** Trench 11 looking west

This trench was located to evaluate an area of high, level ground on the plateau to the west of Priory Farm. The location of Trench 11 was not included within the geophysical survey area because of the presence of scrap metal and other debris at the time the survey was undertaken. The remains of footings for two walls 0.70m wide, on a north south alignment were identified, separated by an area of beaten earth flooring 4.20m wide. The footings and floor appeared to be 'sunk' (excavated) into the natural bedrock. In places the wall footings actually consisted of the natural bedrock which had been faced with roughly dressed stones. There were traces of a loose gravel/sand mortar containing marine molluscs (including periwinkles). Directly above the floor surface was a layer of modern rubbish deposit, suggesting the structure may have been in use into the 20th century before its demolition. Because no direct dating evidence was recovered, the original construction date for the building remains uncertain. No building is represented in this location on any available maps.

The building revealed in Trench 11 is not represented on any of the available historic maps of Monkton Priory. Its exact character and extent is uncertain. The alignment of the building may, however, suggest that it is associated with the priory. Curiously, the deposit immediately above the beaten earth floor of the building appears to be of modern origin, perhaps suggesting the building was in use and demolished fairly recently. Alternatively, rubbish deposits overlying the building remains may have been removed and replaced with clean topsoil fairly recently. It is not impossible that other building remains may survive in this area. The easternmost of the two walls revealed in Trench 11 may be in alignment with a straight joint and wall scar observed in the wall that forms the southern boundary of the field. These features may relate to buildings represented on John Speed's 1611 map of Pembroke.

While the field evaluation has discounted the existence of an Iron Age enclosure and a pre-norman ecclesiastical site within the proposed development area, it has identified the survival of building remains of potential importance, should they prove to be associated with Monkton Priory. These remains, in addition to any surviving remains on the road frontage, are very close to the surface and will inevitably be impacted upon if the proposed development proceeds. It is therefore recommended that some degree of further archaeological recording of these remains is undertaken in advance of any development

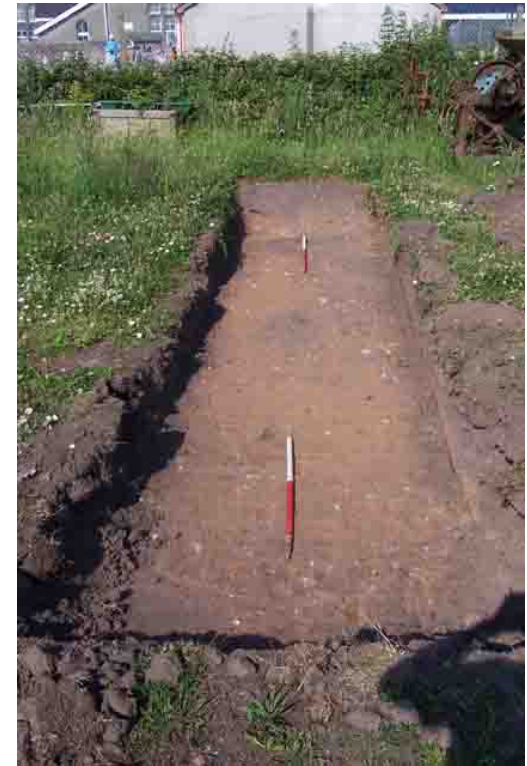
**Photo 14:** Trench 12 looking west

This trench was cut to 7.0m long and to a depth of 0.50m revealing natural clay silt deposits. It was located to evaluate the area between the farm and the main road. A new road from the existing main road running northwards along the western edge of the proposed development area is currently proposed. Below the turf layer, apparently undisturbed natural sandy clay was revealed. No features of archaeological significance were identified.

Trench 12 was located between the proposed development area and the main road roughly on the line of a proposed road to run northwards along the western edge of the proposed development. The existence or survival of medieval or post medieval building remains further south, along the frontage of the main road was not ascertained.

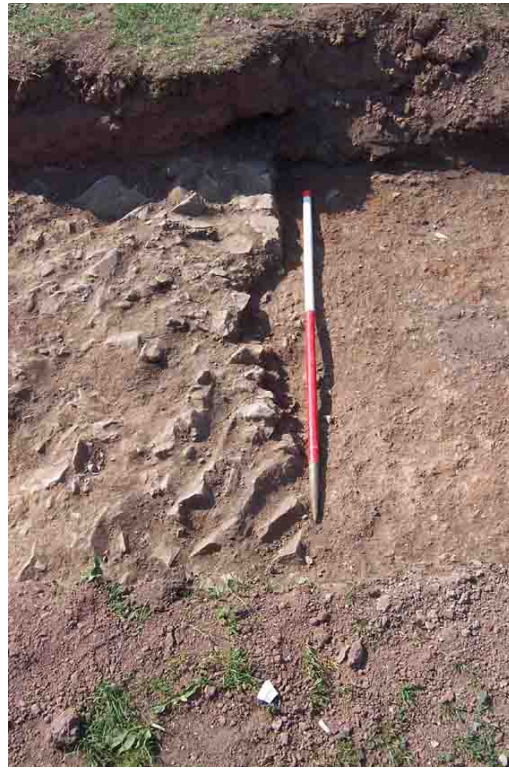
**Photo 15:** Trench 11 East wall looking south

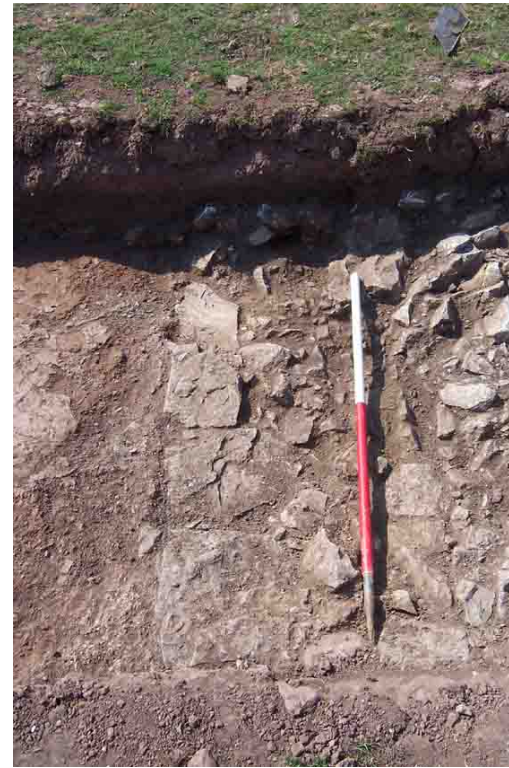
**Photo16:** Trench 11 West wall looking south
