68 MAIN STREET, PEMBROKE ARCHAEOLOGICAL WATCHING BRIEF

REPORT NO. 2005/87
PROJECT RECORD NO. 54921

September 2005

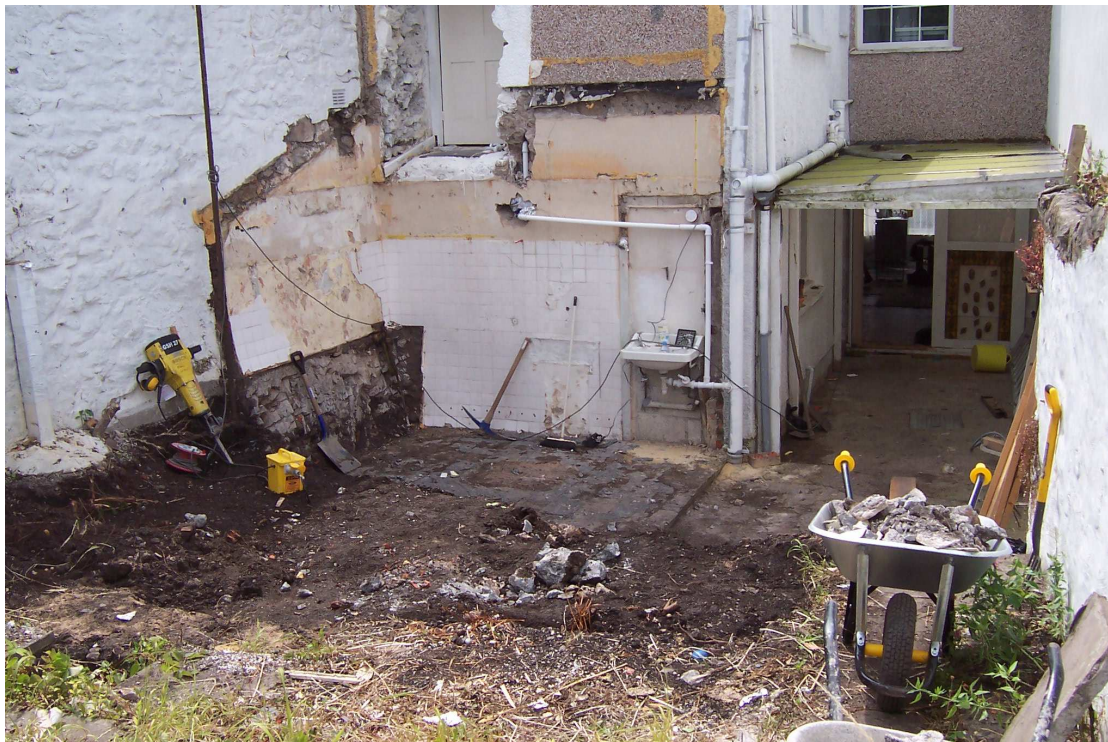
Plate 1: General view across the watching brief area.

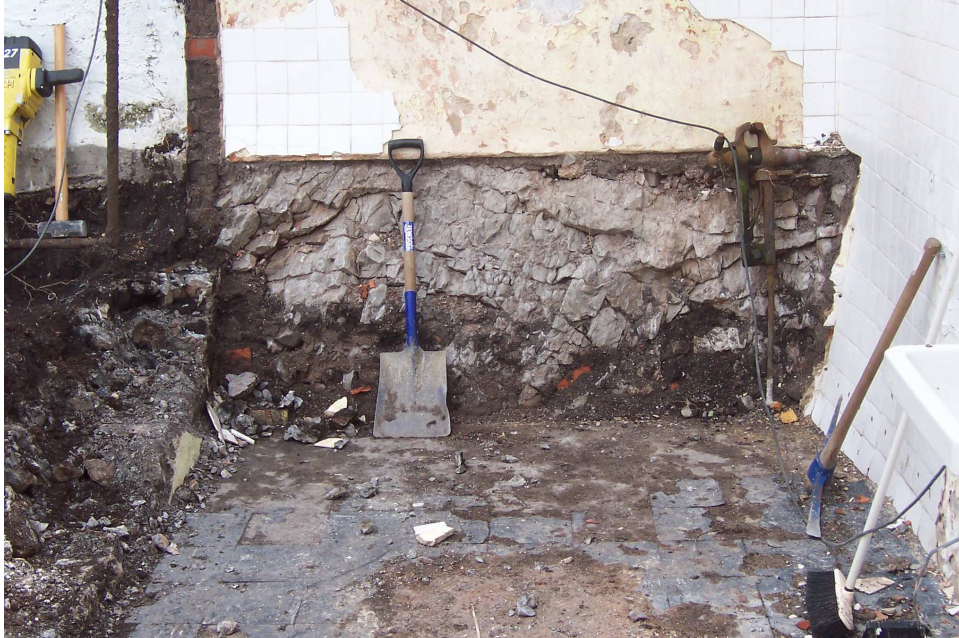
Visits were made during the demolition of a small lean-to structure on the rear of the property. The lean-to occupied a small area of level ground that had been formed by terracing into the bedrock (Plate 2).

Plate 2: The bedrock exposed in the side of the terrace for the former lean-to, The rear wall of the lean-to is visible on the left of the photograph.

The groundworks associated with the construction works revealed that the former lean-to had been built on a small terraced area cut into an outcrop of bedrock.

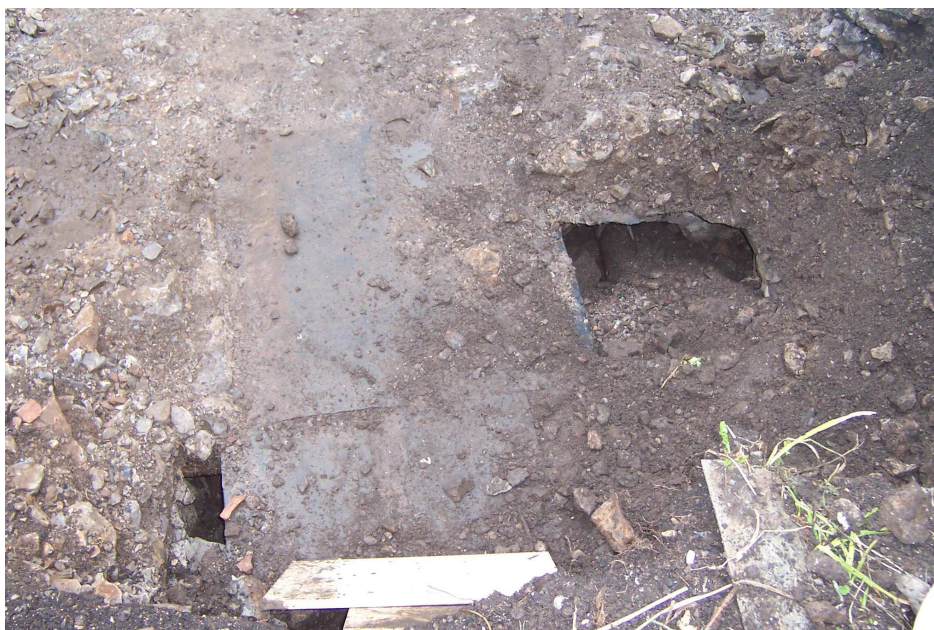
Removal of this material revealed a brick and stone drain capped with slate flags running across the site (Plate 3). Water was visible in the base of the drain, but it did not appear to have been part of the active drainage system.

Plate 3: slate covered drain.

The only archaeological structure or feature exposed by the works was part of a brick and stone drain capped by slate flags. This did not appear to be part of the existing drainage system. Its construction and form suggested a late post-medieval, possibly 18th century, date.
