# 14 AND 15 CHURCH STREET NARBERTH PEMBROKESHIRE

ARCHAEOLOGICAL WATCHING BRIEF  
2005-2006

RHIF YR ADRODDIAD / REPORT NO. 2006/1  
RHIF Y PROSIECT / PROJECT RECORD NO. 55175

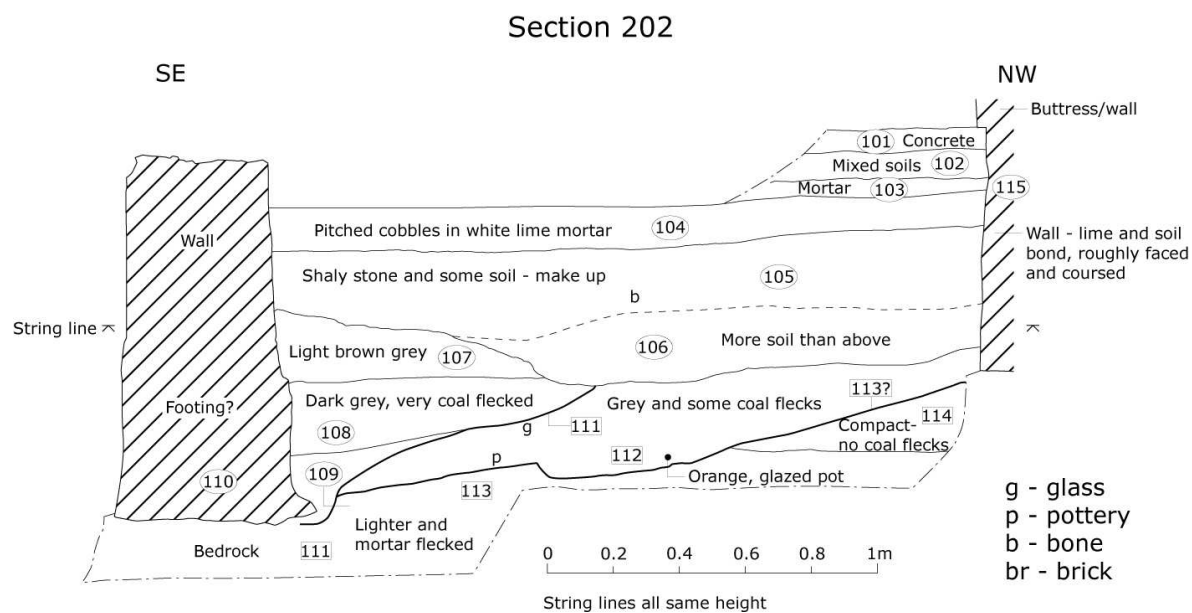
**Figure 3: Section (202) below rear extension floor**

The lower fill 114 in cut 113 (Fig. 3) was compact and contained no coal fragments, unlike those fills above. This fill predated the footings of the wall 115 of the house before it was extended, but no artefacts were recovered: this fill is probably primary and not deliberate infilling.

The fill above (112) produced: a one jug handle 17-18<sup>th</sup> century, 2 pottery sherds of probable North Devon Gravel Tempered Ware of late 17-18<sup>th</sup> century date, 1 un-diagnostic pottery sherd, one fragment of post medieval tile, and one fragment of thin window glass. This fill (112) is probably the same as the lowest fill 126 seen in the section of the rear trench (Fig. 4). The fills 125, 124 and possibly 121 were all deposited before the building of the house rear extension wall (110). This wall footing (110) was constructed with lime mortar bonding in a narrow trench - contexts 111 (Fig. 3) and 126 (Fig. 4). This construction trench was in-filled (109 and 126) before the house interior was in-filled (105-108). From one of the in-fills (106) there was 1 sherd of late 19<sup>th</sup> or early 20<sup>th</sup> century transfer printed china plus 1 plain sherd. Above the in-fills there was a pitched cobble floor 104. The surviving layers above this, 101-103, were all of late 20<sup>th</sup> century date after the houses were demolished.

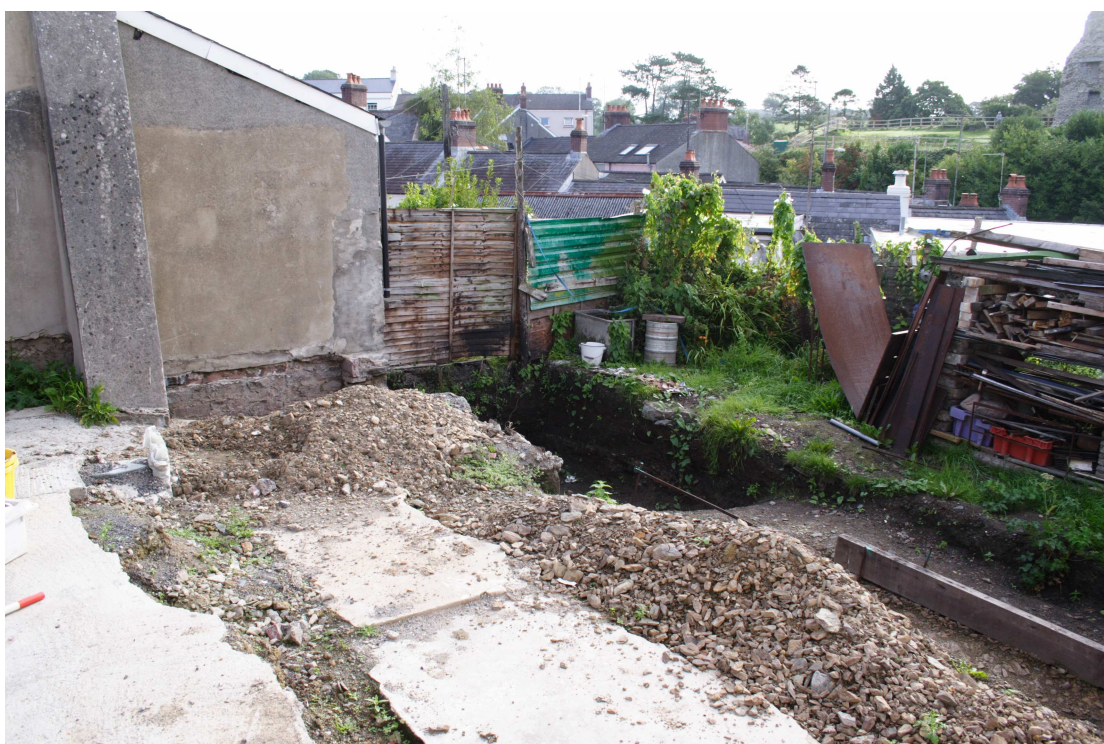
The owner had already excavated trenches for the rear footings of the new building. The soft soil had been removed from the site, but a large number of china and clay pipe fragments had been left beside the rear trench. The concrete rafts, for the builder's sheds were still intact (Photo 1).

**Photo 1:** Site as seen on arrival in September. View East

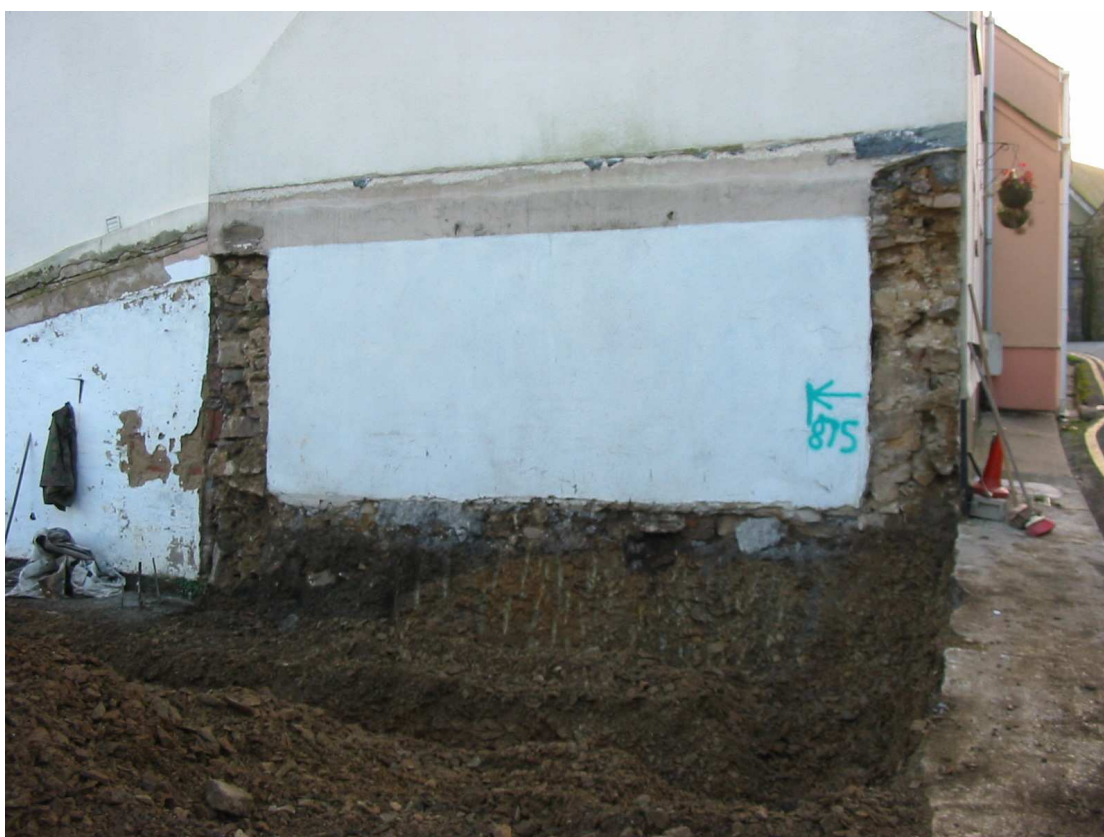
Were the rear trench footing had encountered softer material, it had been excavated to a greater depth of up to 1.2m. This softer material was the fill of a linear feature or large linear pit (cut 113), which ran at an angle to the rear of the buildings and road (Fig. 2). It is probable that this feature may have continued with its northern edge being observed below the gable wall of the property to the southeast (Photo. 2). However this cut below the gable end could be the edge of the hill-slope; but this is considered unlikely.

**Photo 2:** Cut with dark fill below gable end footing. View South West
