AN ARCHAEOLOGICAL WATCHING BRIEF AT THE NEW CYCLE BRIDGE CARMARTHEN

September 2005

RHIF YR ADRODDIAD / REPORT NO. 2005/104

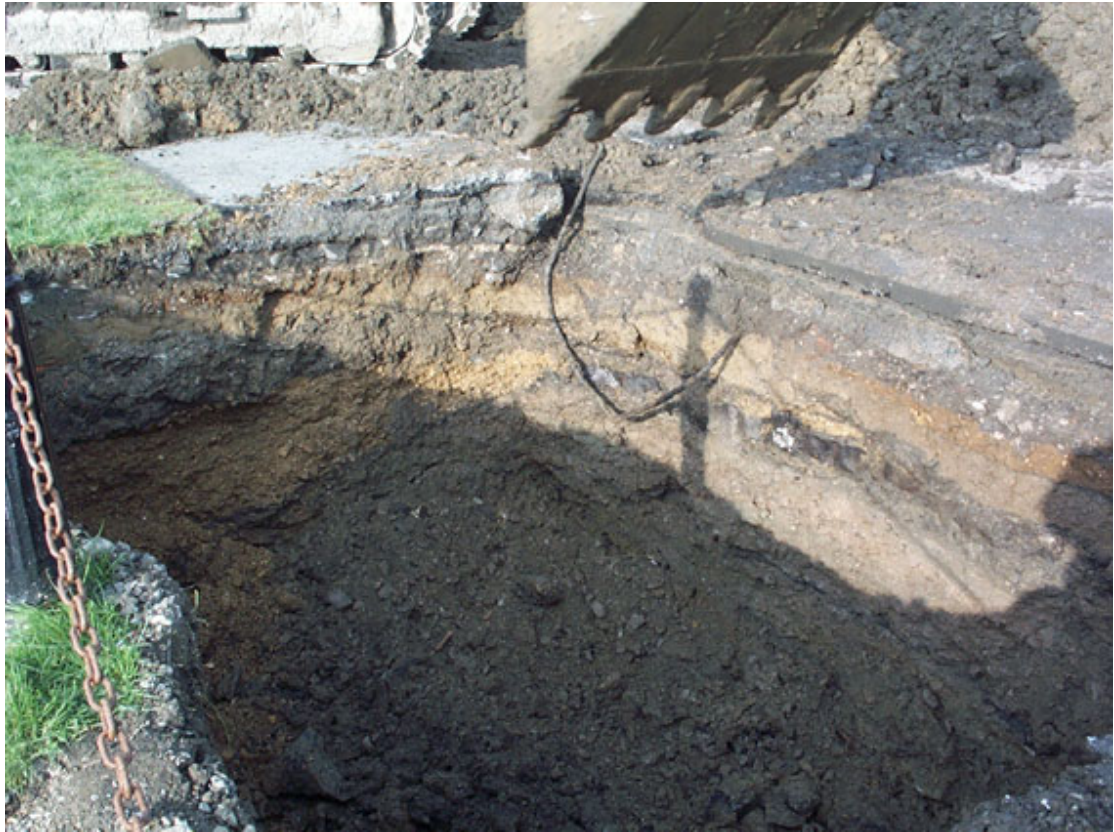
The area was found to have been heavily disturbed by services and contained evidence of several modern road re-surfacings. Beneath the modern deposits were a series of make-up layers of redeposited natural gravels overlying remnants of a cobbled surface associated with the quayside wall. Beneath the cobbles was backfill material, presumably related to the construction of the quayside wall. No other significant archaeological deposits or features were observed.

Photo 1: Make-up and backfill deposits revealed during preparation of bridge footings

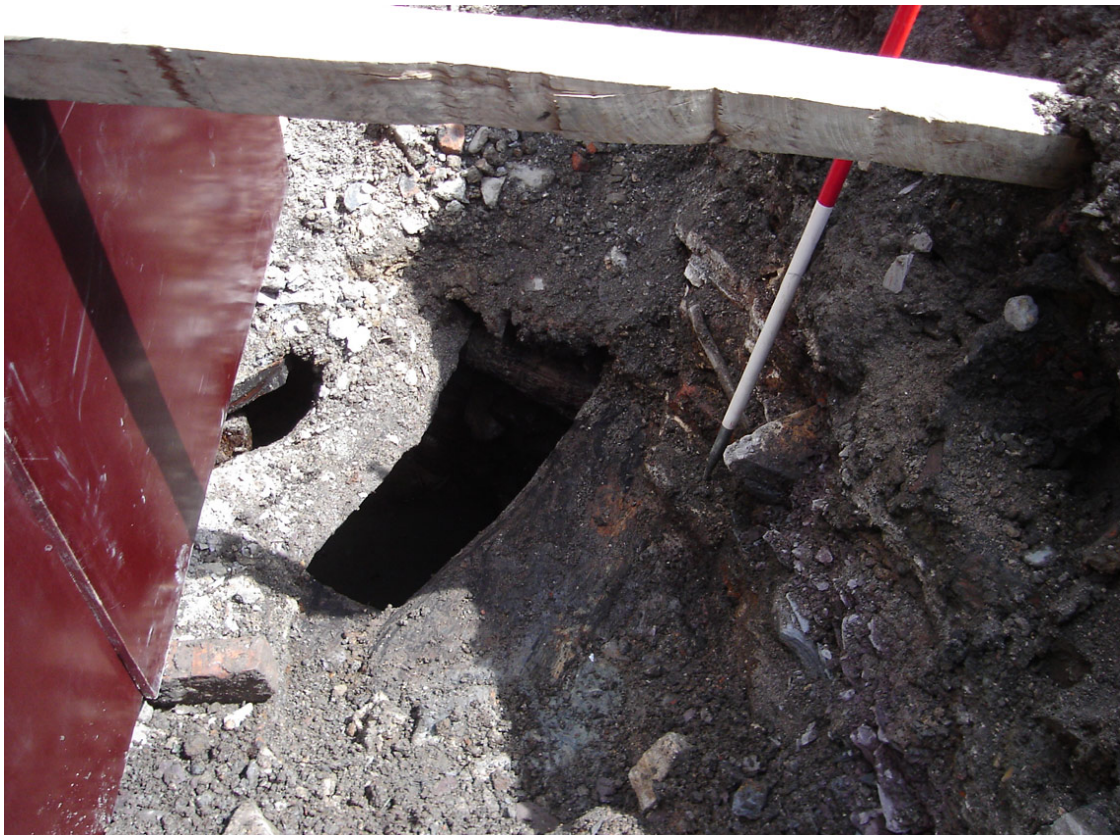
The top of the feature was approximately 2.50m below the current level of the roadside pavement, but also approximately 1.20m below the level of the old quayside. The ground in this location was sufficiently waterlogged to have resulted in the preservation of several timbers associated with the well. The well had been roughly capped using 3 pieces of waste wood from timber preparation, supported by two cross-timbers. Directly above the well capping was a sequence of layers of modern demolition rubble, containing crushed slate, concrete, bricks, and glass fragments.

Photo 2: Scrap wood capping the well revealed during preparation of bridge footings

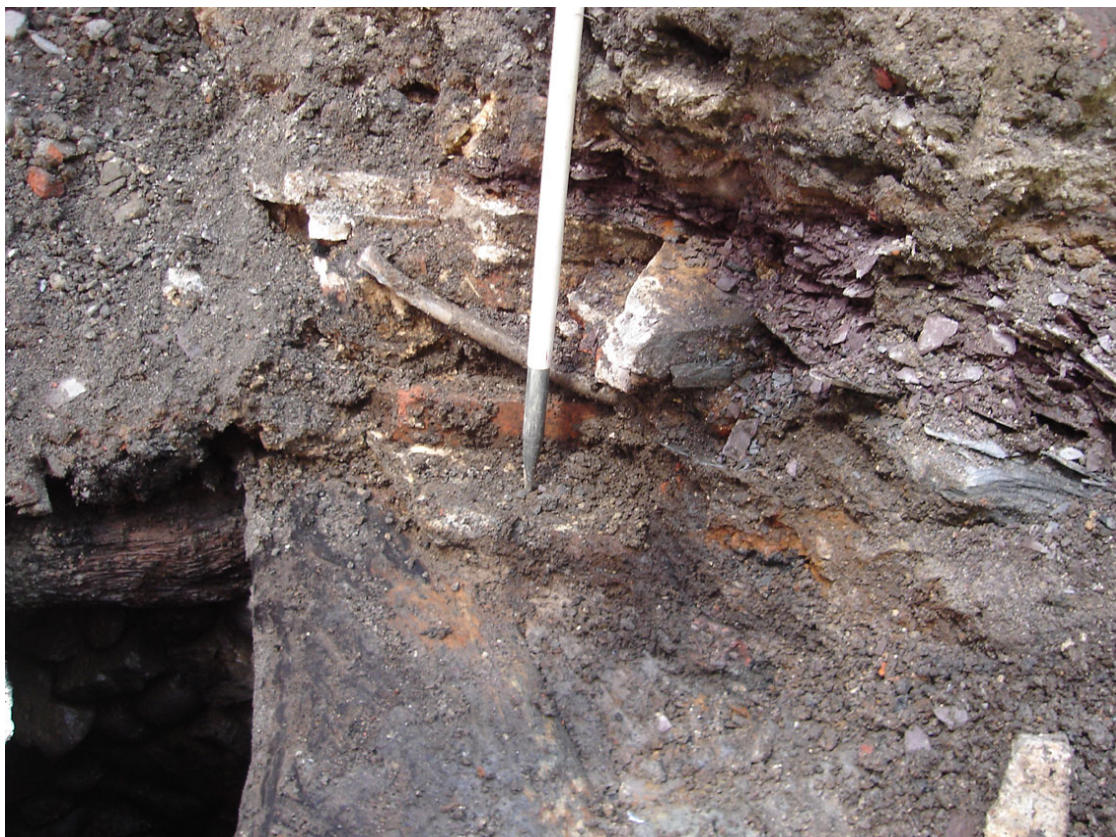
Photo 3: Demolition debris directly overlying the timber well capping

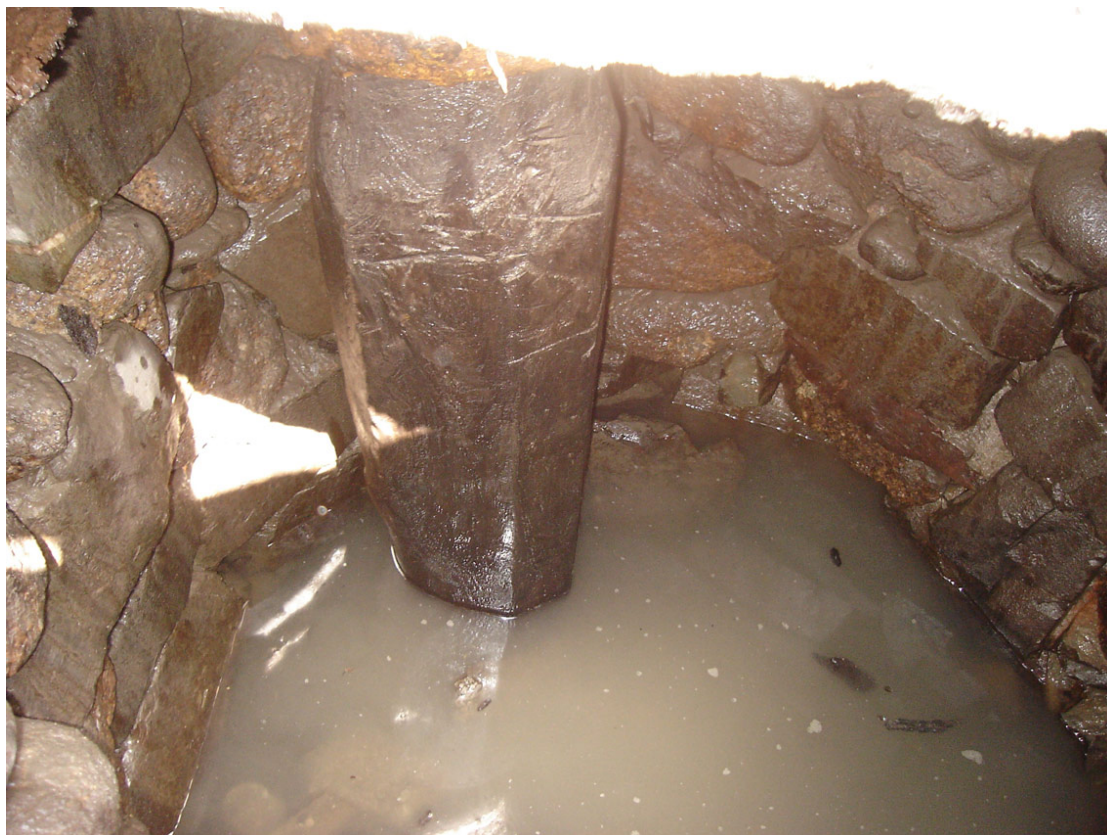
The well was slightly sub-circular and had a diameter of approximately 1.20m. After pumping out, approximately 1.0m of the structure was visible above the water level. The well was constructed in a rough and un-coursed style from a variety of stone types including large, irregular blocks of Old Red Sandstone and large river worn stones. The masonry appeared to be bonded with soft grey clay. No construction cut for the well could be discerned, but considering the size and character of the stones, it is likely to have been at least 2 m in diameter.

Removal of water from the well revealed a square cut vertical timber with chamfered edges, approximately 0.25m wide, lodged into the well backfill against the northern edge. The top end of this timber was tapered and was inserted into a separate block of shaped timber with an iron collar. The timber is presumed to have been hollowed out for use in pumping water from the base of well. No pump or associated structure survived in-situ above the well, although some of the timbers exposed may have been part of the original capping. Considering the deposition sequence, and the depth of the feature, any surfaces and structures associated with the well-head were probably demolished when the area was redeveloped. It is assumed that the well was re-capped at this time, using scrap wood.

Photo 4: Hollowed timber pumping column within well structure

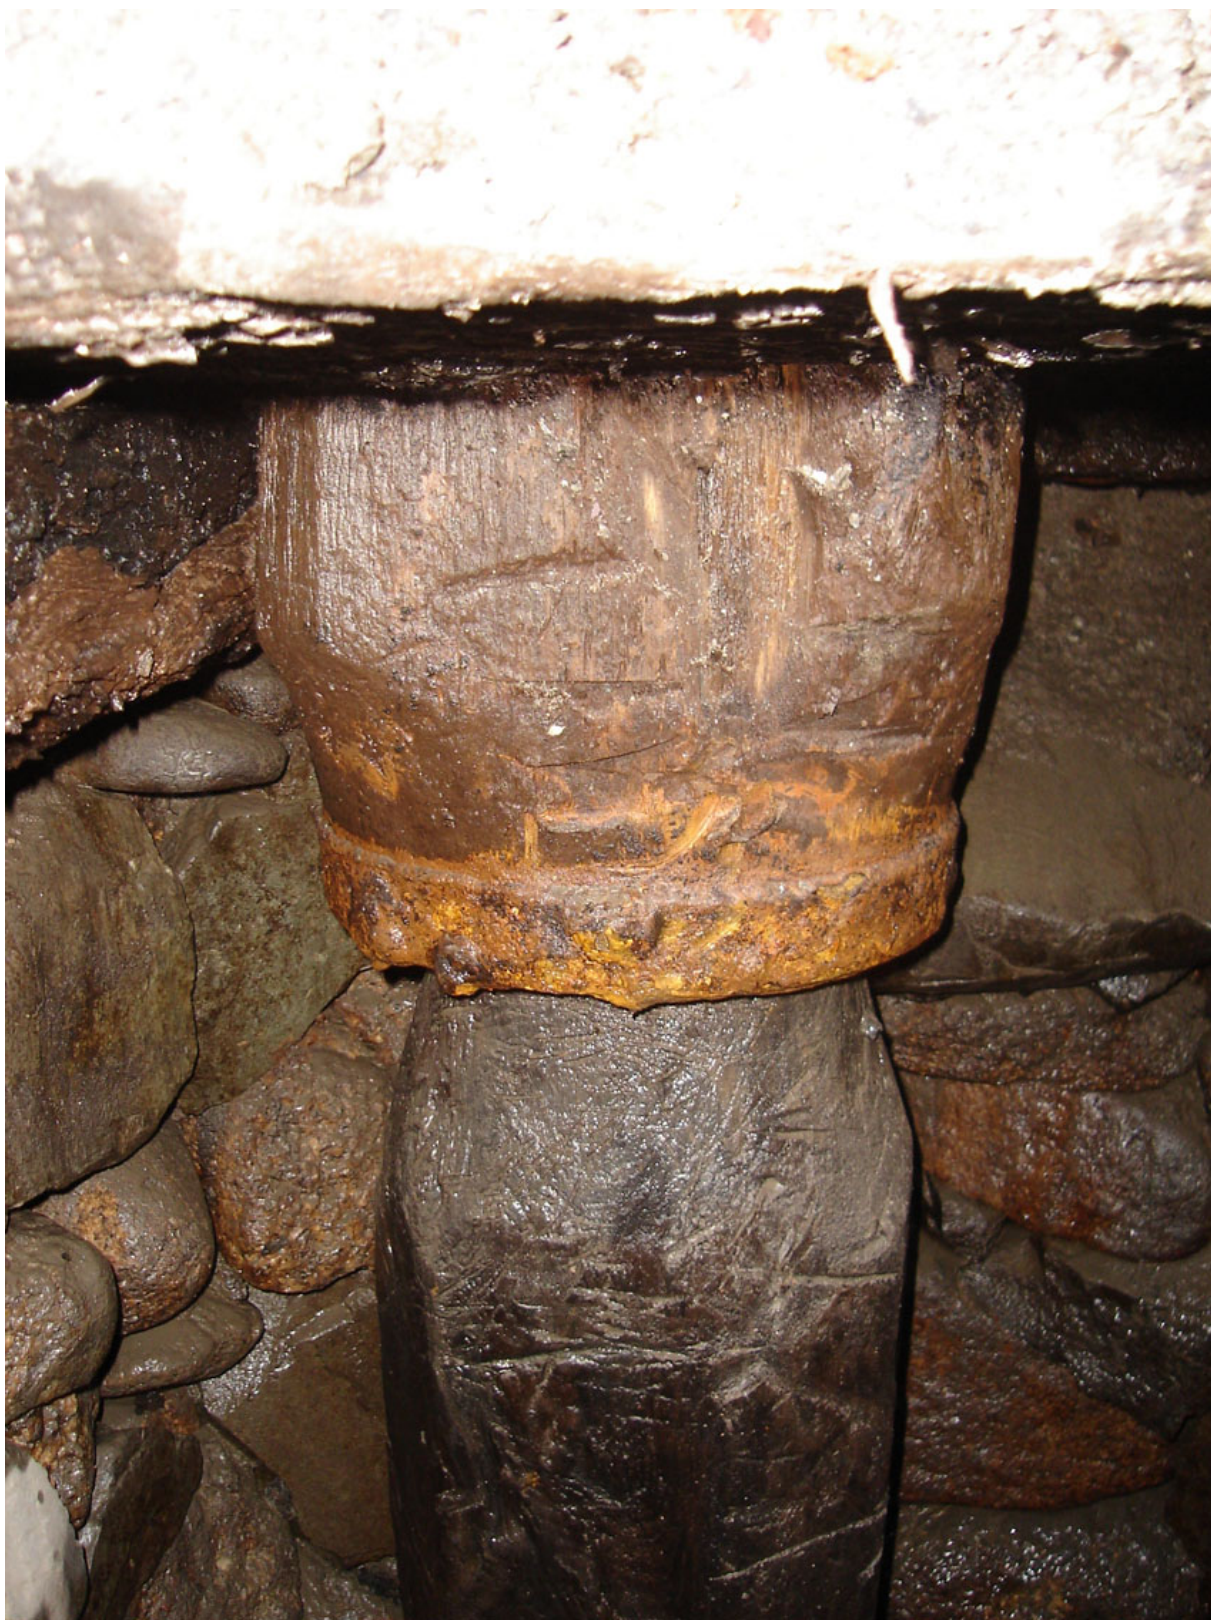
Photo 5: Detail of the pumping column
