TIR GOFAL MANAGEMENT PLAN: HERITAGE MANAGEMENT INFORMATION (HE2)

**Prepared for:
Pwllcalch**

**Tir Gofal Reference No
W/12/5385**

**ACA Report No. 2006/23
Project Record No. 55285**

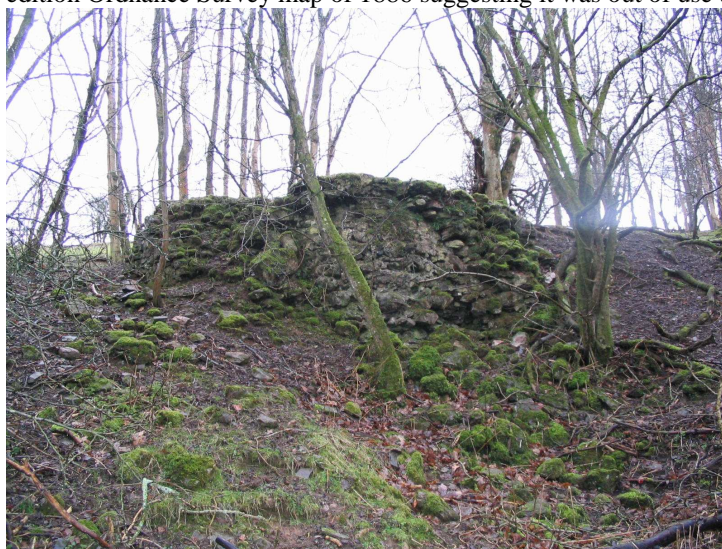
The remains of a limekiln standing in a small copse of woodland surrounded by small limestone quarries. The kiln is built into the slope of the hillside, constructed of mortared rubble. The well preserved circular crucible opening is clearly visible, accessed from the south, with a small build up of vegetation and rubbish inside. Many of the facing stones have fallen away from the front of the kiln revealing the crucible structure underneath but blocking the draw hole opening. Earth and stone banks extend down the hillside to the north, possibly forming a working enclosure or trackway, or they may just represent a build-up of spare or waste limestone. The kiln is located on a ridge of limestone, the stone has been quarried from the hillside immediately behind the kiln and also possibly from the outcropping rocks in the woodland to the west. The kiln was probably in operation during the 18th and 19th centuries but is marked as 'Old Limekiln' on the 1st edition Ordnance Survey map of 1886 suggesting it was out of use by that time. *Visited 07/03/2006 (PP)*

SSW facing shot of the limekiln remains.

The aim of the management for this site should be preservation of the upstanding remains of this limekiln. Kilns such as this were once a common feature of limestone rich areas but it is now rare to find upstanding examples such as this. The main crucible of the kiln still appears to be in a relatively good and stable condition, although the interior has filled up with some vegetation and rubbish. Many of the facing stones have fallen away from the structure, collecting at the base of the kiln. Some remaining facing are also loose. The site lies within a small copse of trees, trees growing close to or on top of the kiln structure could cause damage through root action or collapsing.

- The crucible should be cleared of rubbish and vegetative litter.
- Loose facing stones should be consolidated using appropriate materials and techniques.
- Trees that grow on the kiln should be removed, as should trees growing close to the upstanding remains of the structure if the roots are judged to be causing damage. Dead material should be removed from the site.

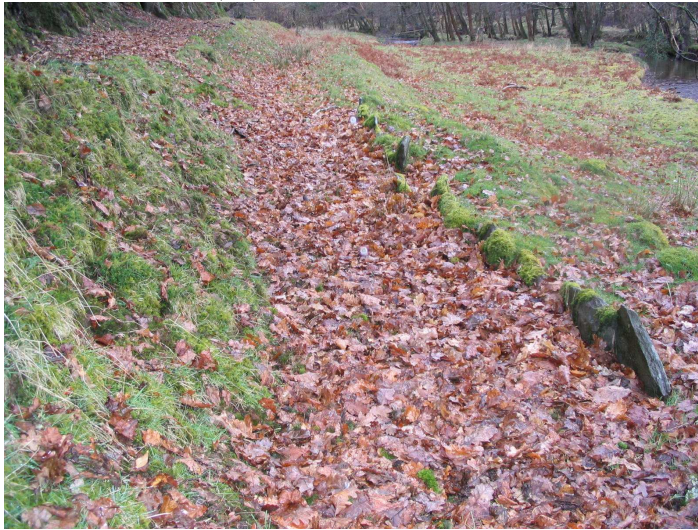
The 1st edition Ordnance Survey map shows a mill leat on the River Clydach. Part of a water management system to supply Aber Triphlwyf Woollen Mill (PRN 10238) with water power. The line of the leat is still

clearly visible running along the base of the hillside on the north side of the river. Stonework visible towards the western end indicates the leat was built of mortared stone with a slate lined channel, though the stonework is now covered by earth and vegetation along most of its length. A level platform runs along a large bank on the northern side of the leat which would appear to be the remains of an associated trackway. Visited 07/03/2006 (PP)

E facing shot looking along the dead-leaf filled and stone-lined mill leat.

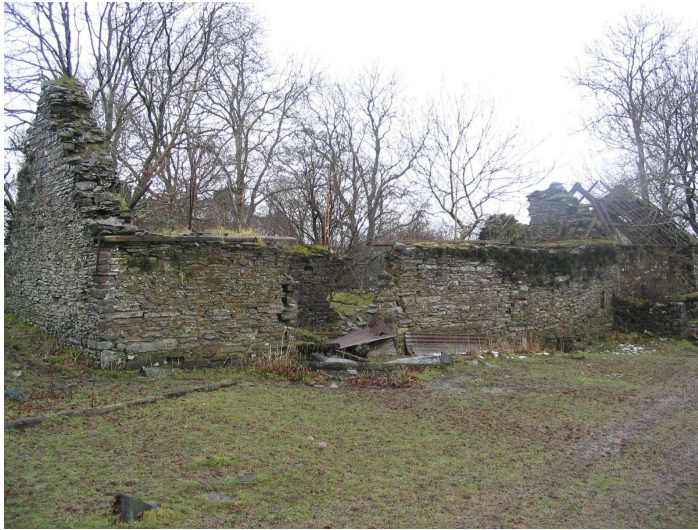
A small farmstead complex marked on the tithe map of 1840. The more detailed 1st edition Ordnance Survey map of 1886 shows the small complex consisting of a farmhouse with a farm building range facing it to the northeast. The farmhouse is still in occupation and not part of this farm holding. The farm building range is now ruinous but consists of a large barn at the south-eastern end built of mortared slate, roughly coursed, with large opposing doorways and remnants of slate roofing. Sections of the side-wall have tumbled and the roof has now gone, roofing timbers visible amongst the rubble inside the barn. The north-western part of the range is taken up by a smaller barn, formerly lofted, built of mortared random rubble suggesting it was a later addition to the original barn. The roof timbers are still in place, although exposed and deteriorating. Attached to the north-eastern side is a small mortared random rubble built lean-to, now mostly tumbled. The ruins are mostly fenced off and appear in a relatively stable condition with little vegetation, although the

walls and remaining roof timbers are exposed to the elements and some trees grow close to the walls. *Visited 07/03/2006 (PP)*

SSW facing shot of the ruined farm building range at Cefn Gwrych farmstead.

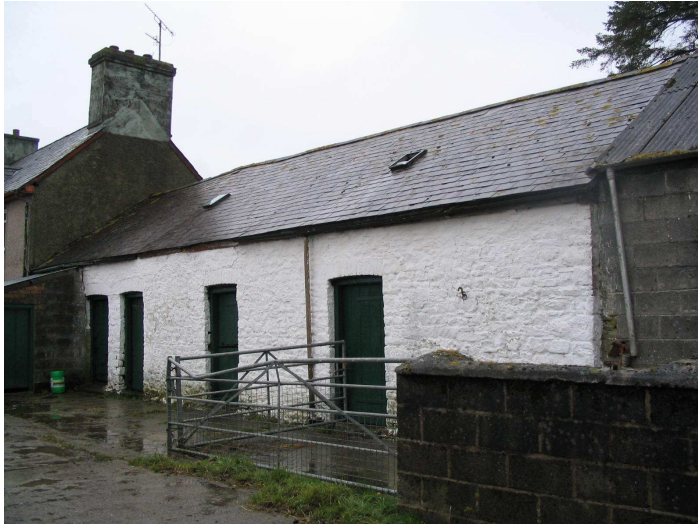
NE facing shot of the attached cow barn range.

The aim of the management for this site should be to ensure the survival of the traditional buildings and maintain the historic character of the complex of traditional farm buildings as a whole. This is a working farmstead complex and the traditional farm buildings are mostly still in use and in a relatively

good condition, however, stonework has fallen away from the rear of the attached cow barn range leaving a hole through the wall and loose facing stones. Ivy has established itself on the small farm building to the west of the attached cow barn range, which could be causing damage or hiding defects.

- The loose and tumbled stonework to the rear of the attached cow barn range should be consolidated and repaired using appropriate materials and techniques.
- Ivy covering the small farm building should be trimmed back, the ivy should only be removed when it is clear it will not damage the underlying structure.

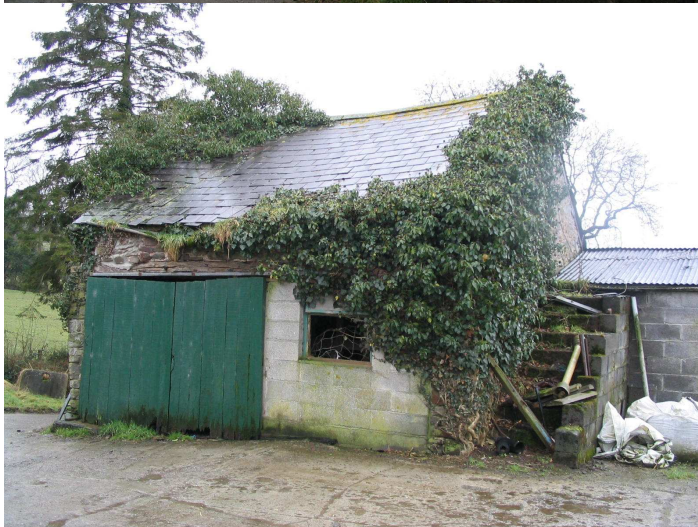
SW facing shot of the southern farm building.
