# A477 TRUNK ROAD ST. CLEARS TO RED ROSES IMPROVEMENT

# ARCHAEOLOGICAL DESK BASED ASSESSMENT 2005

Report No. 2005/110

September 2005

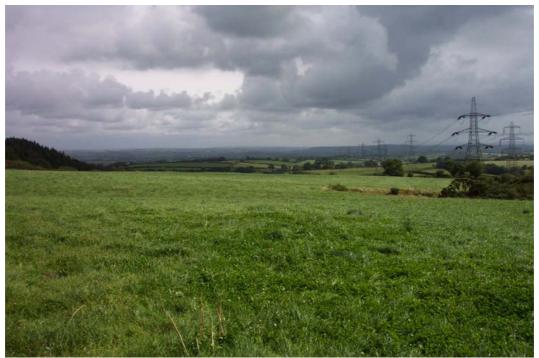
Plate 1: General view northeast from the summit of Brandy Hill along the line of route option segment E6. The bushes visible on the right of the shot are growing in quarry PRN 15015.

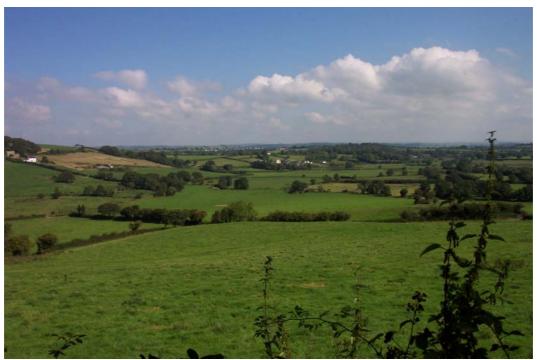
Plate 2: View northeast across the Afon Taf floodplain just west of Llanddowror. The proposed route option segments E4, E4.1 and E4.2 will cross this area.

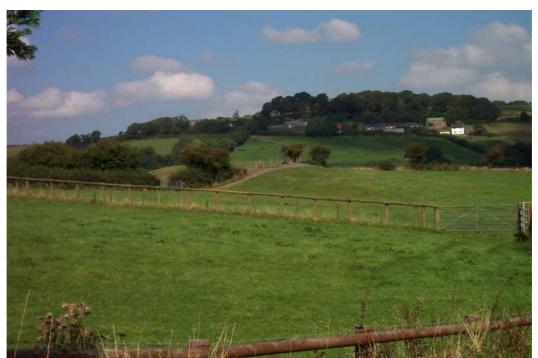
Plate 3: View north towards the remains of the motte at Llanddowror (PRN 5069). A medieval road (PRN 13306) and track, known as the Pilgrims Way (PRN 12060) ran along a line now followed by the hedge running from centre left of the shot. Proposed route option segments E4 and E4.2 will affect this site.

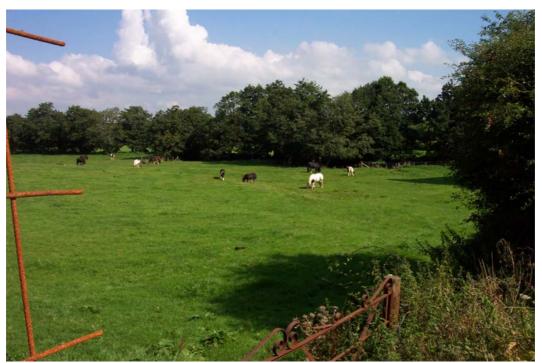
Plate 4: Earthworks (PRN 55311) visible in the field between the motte (PRN 5069) and Llanddowror, which may be the remains of a deserted medieval settlement. Proposed route option segment E4 will cross and remove these earthworks.

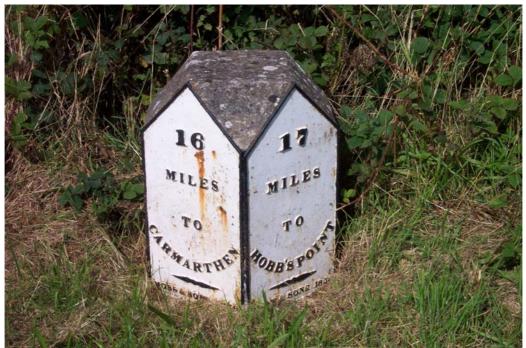
Plate 5: Milestone (PRN 54895) alongside the present A477. This is one of a number of Thomas Telford's original milestone that survive along the road side. The milestone is a Listed Building. This milestone would be affected by route option segments W4 and W4.2.

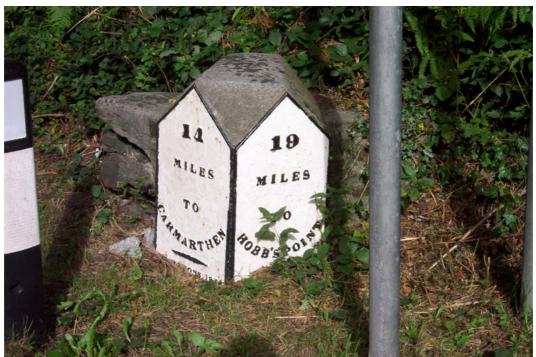
Plate 6: Another of Thomas Telford's original milestone (PRN 54898). This milestone does not appear to be Listed, but it is of equal quality and value as the listed examples. This milestone would be affected by route option segment C5).

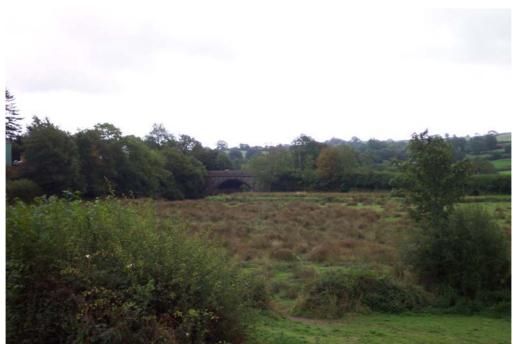
Plate 7: View south of Pont Newydd (PRN 15068), part of Thomas Telford's original road. Route option segments E4.1 and E4.2 would affect this bridge. The bridge is a Listed Building.

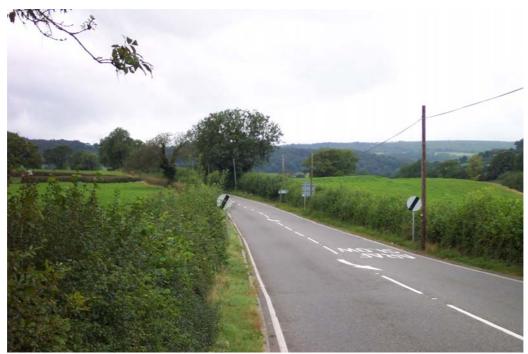
Plate 8: View west along the A477 from Pont Newydd towards the earthwork remains of what may be a medieval moated enclosure (PRN 3884). The enclosure is clearly visible on the right hand side of the road. It is not so clear on the laft side of the road. This site is a Scheduled Ancient Monument. Proposed route option segments E4.1 and E4.2 may impact on the enclosure.

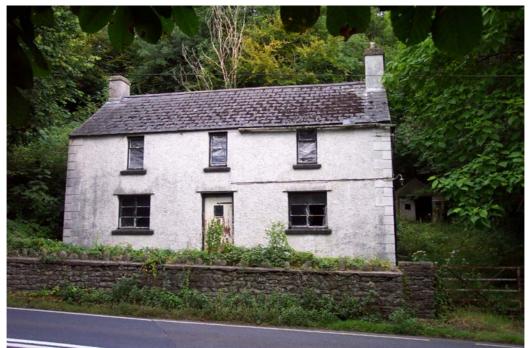
Plate 9: Rhyd-y-Wrach cottage (PRN 54899). This is a typical post-medieval roadside settlement, now abandoned, which developed alongside the road. Route option segment C5 may have an impact on this cottage.

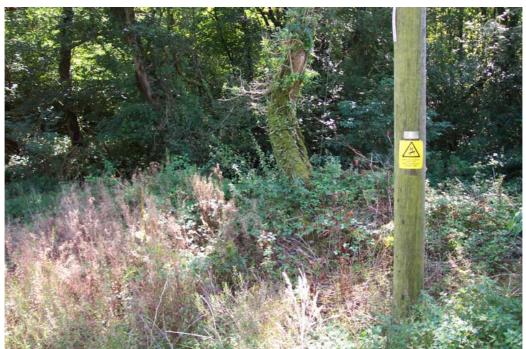
Plate 10: The site of another roadside settlement, Pont-Parciau (PRN 54903), which has been abandoned and demolished. It is not certain whether anyevidence of the buildings survive within the vegetation. This site lies within the 50m buffer zone of route option segment C5 and it may be unaffected.

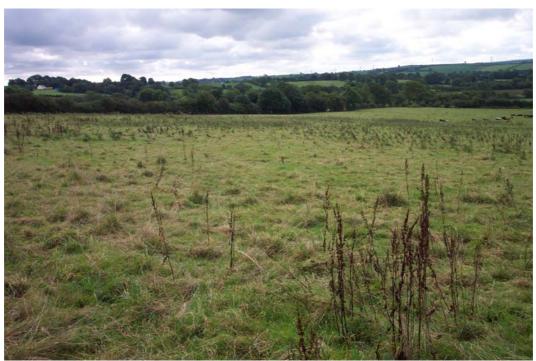
Plate 11: General view southeast across the site of cropmark (PRN 8035). Proposed route option segments E6 and E6.1 will cross the area.

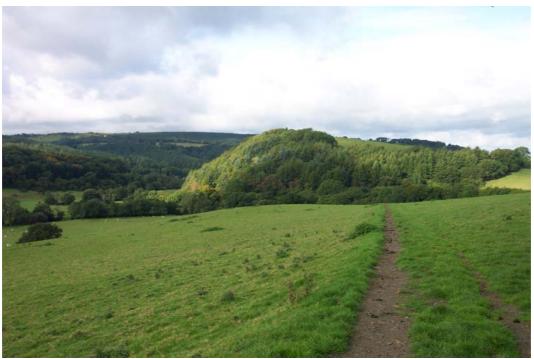
Plate 12: view west across the site of possible hillfort PRN 9829. Proposed route options E6.1, E6.2 and E6.4 will cross this area from right to left, passing over the prominent ridge in the centre of the shot.

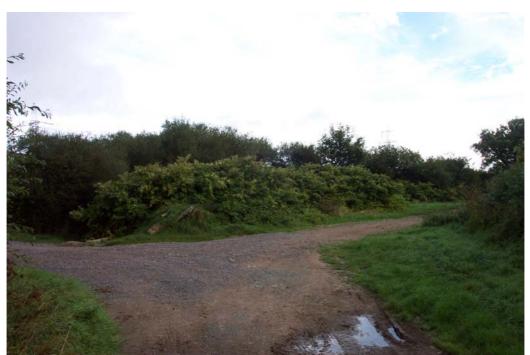
Plate 13: The presumed site of a small post-medieval settlement (PRN 21603). This site lies just within the 50 buffer zone of route option segment W4 and will probably be unaffected.

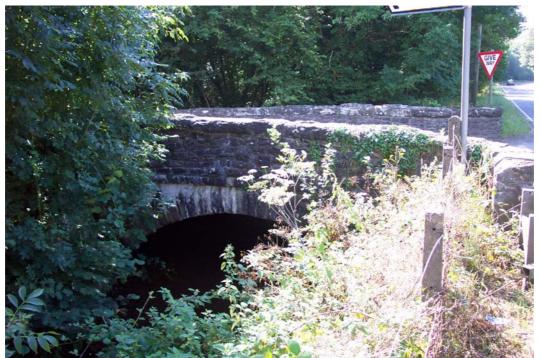
Plate 14: The Bont (PRN 15028). This small single arch stone bridge is within the buffer zones for route option segments C1 and C5. It could be affected by road widening or changes in alignment.
