QUAKER FRIENDS MEETING HOUSE MILFORD HAVEN PEMBROKESHIRE

ARCHAEOLOGICAL WATCHING BRIEF 2005/6

RHIF YR ADRODDIAD / REPORT NO. 2006/58
RHIF Y PROSIECT / PROJECT RECORD NO. 55693

QUAKER FRIENDS MEETING HOUSE MILFORD HAVEN, PEMBROKESHIRE ARCHAEOLOGICAL WATCHING BRIEF 2006/06

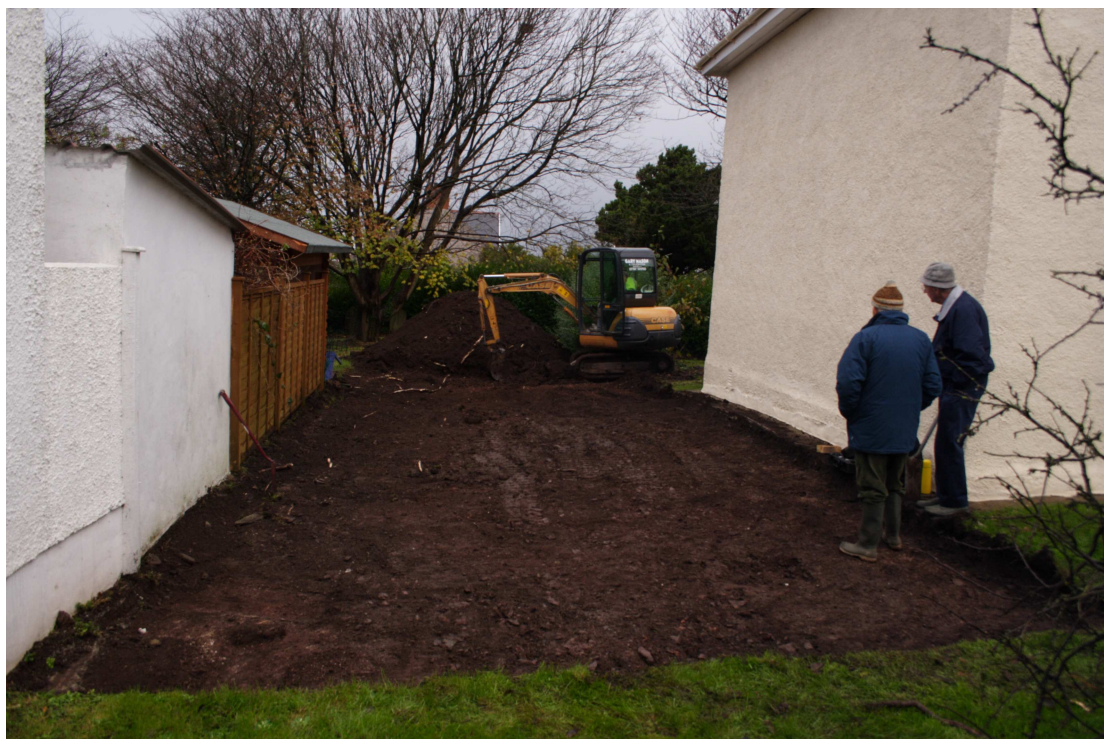
Front cover: Site near the end of topsoil stripping

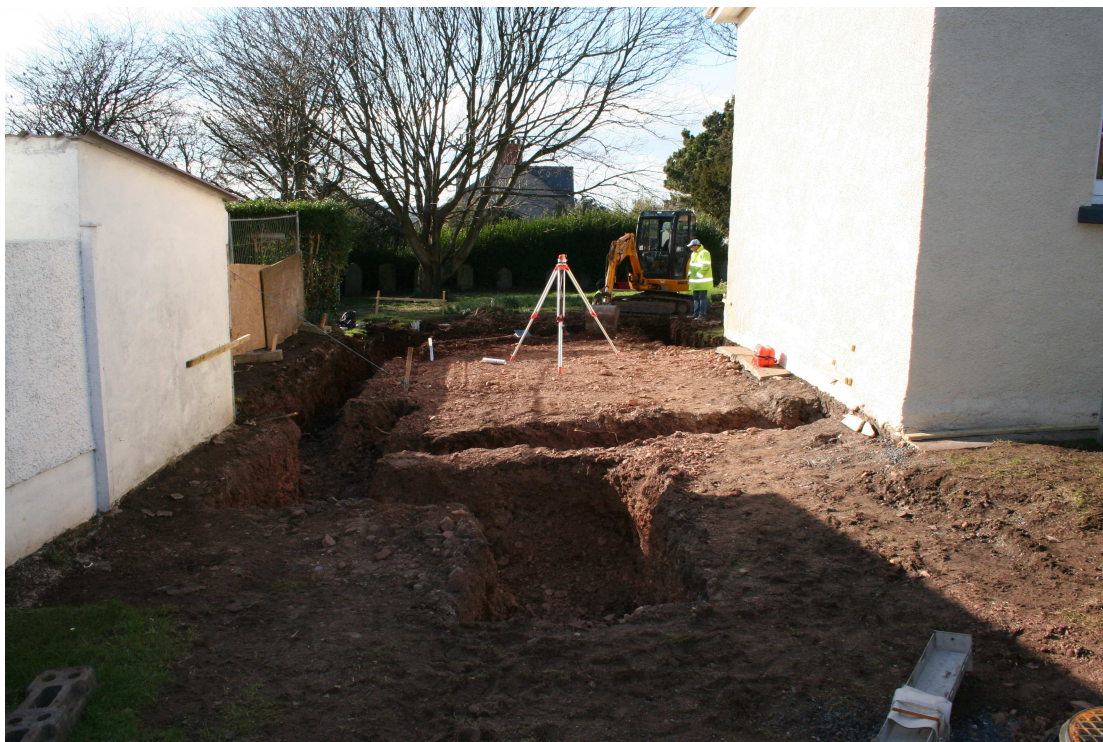
Photo 1: Footing trenches almost complete. View W

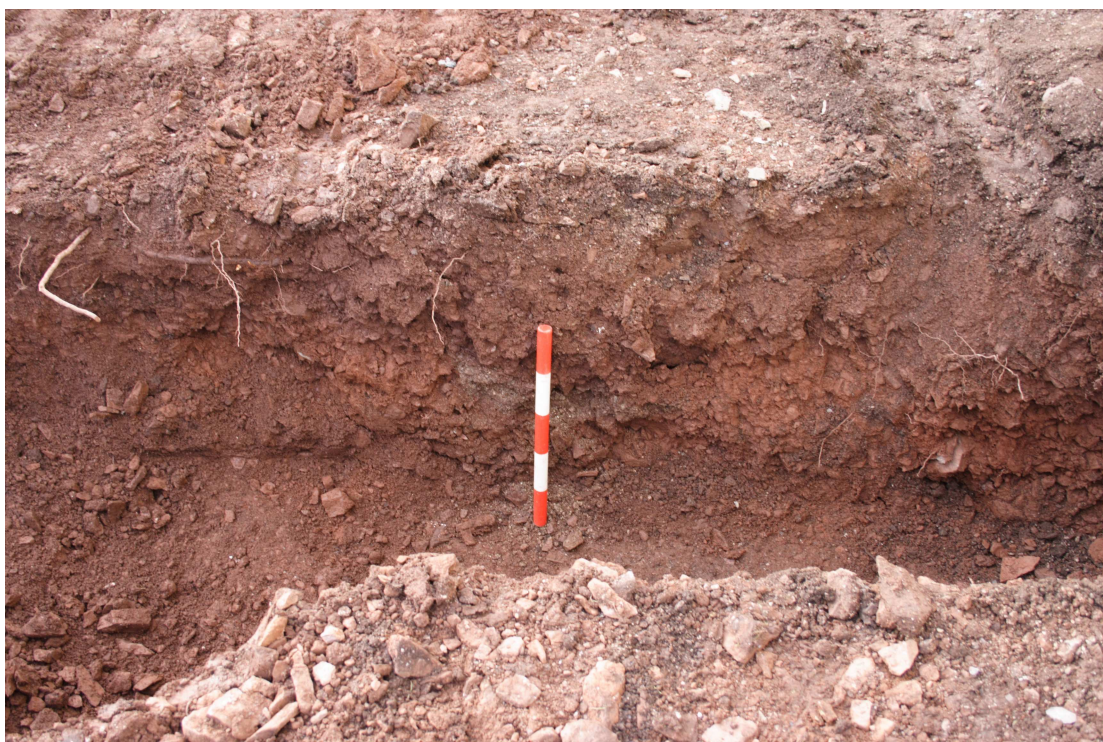
The footing trenches were between 0.75m and 1m wide and also between 0.75m and 1m deep (Photo. 2). Except where there were grave cuts the entire bottom of the footing trenches cut into the shaley Old Red Sandstone bedrock.

In the eastern wall footing, on the western side only and 1m to 1.5m south of the Meeting House wall there was a feature (Photo. 2) cut into the bedrock. This could be the end of a grave but, given the cement in the lower fill, it is more likely to be a construction feature, possibly for timber scaffolding. This feature and the grave cuts (see below) appeared to all have been cut through a lower old "topsoil" layer approximately 0.2m to 0.3m above the shaley bedrock.

Photo 2: Eastern wall footing trench. Feature behind 0.5m scale. View W

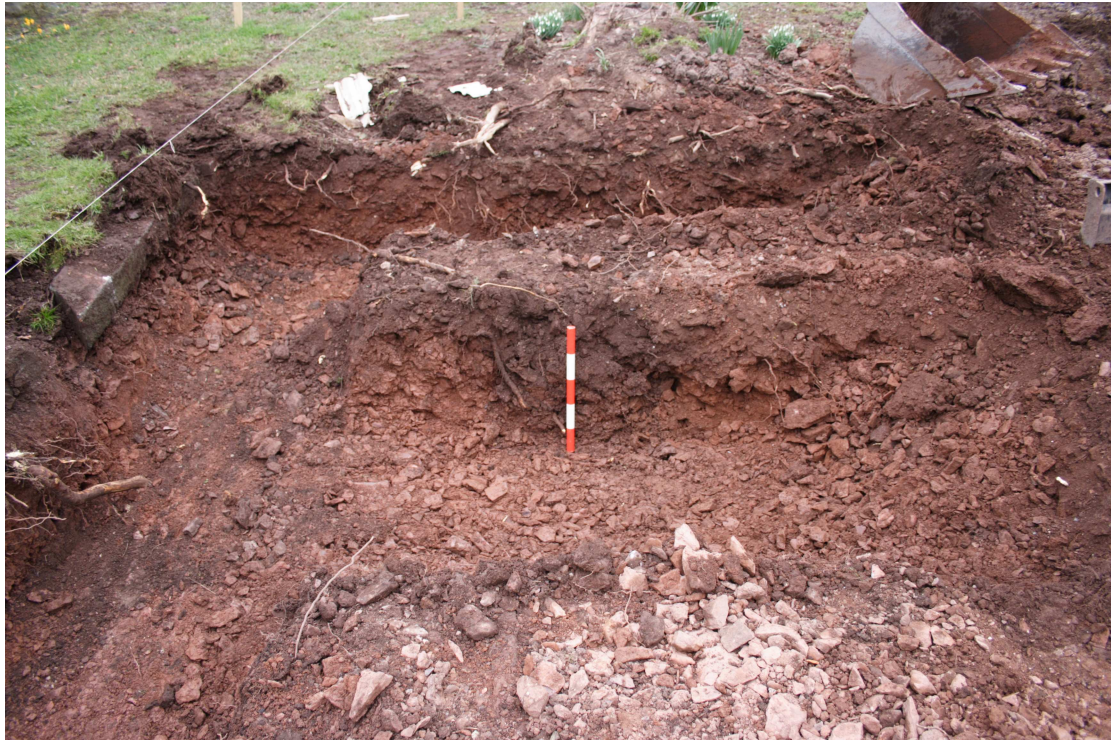
The kerb for one grave (102; Photo. 3) was located adjacent to the southwest corner of the new building footing trenches. This kerb was possibly of green granite. The machine removed a small part of this, possibly along an old break or construction joint.

A grave cut (104) was located 1.75m to 2.35m north of the grave kerb (102), and the southwest corner of the footing trench. This grave cut extended beyond the western footing trench with the eastern end extending 0.35m into the footing trench for a pillar. The fill, excavated only down to the base of the footing trench, was fairly root-disturbed.

Photo 3: Grave kerb (102) far left. Grave cut 104 behind 0.5m scale. View W

One of Acanthus Holden's architects examined the grave cuts and confirmed that the foundations would be able to go over the grave cuts without disturbance to the burials themselves.

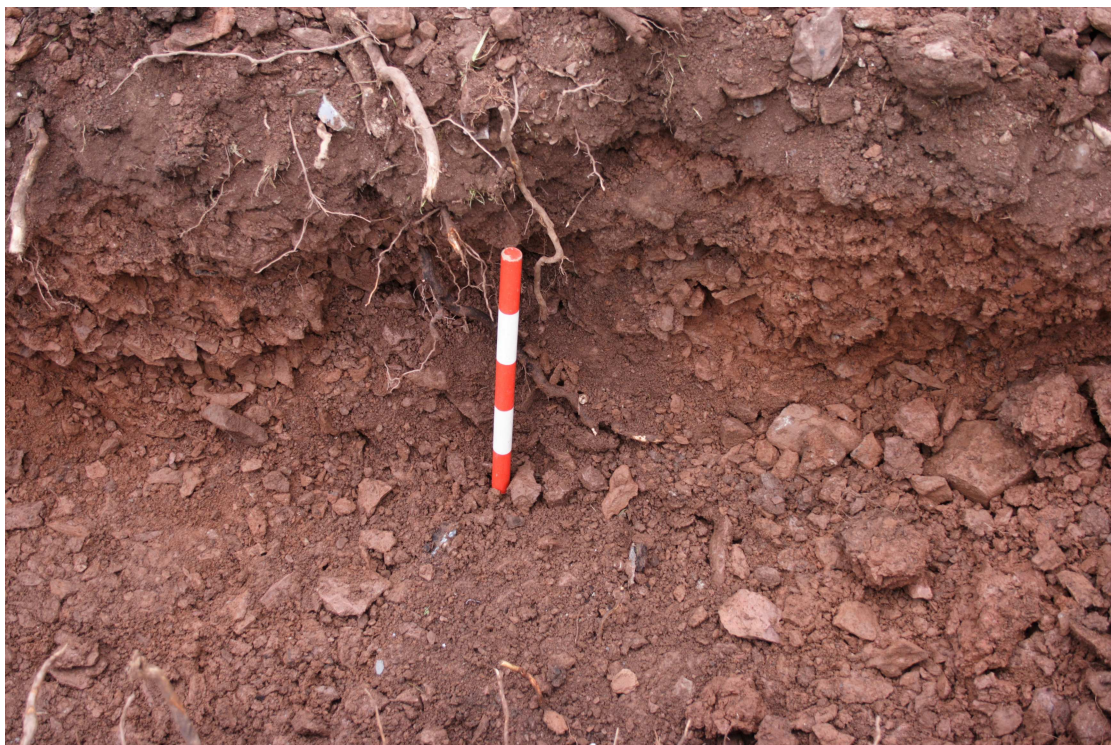
Another grave cut (106; Photo. 4) was located 3.3m to 3.9m north of the grave ckerb (102). This cut extended east and west of the footing trench. At the bottom of the footing trench in the grave fill there were two coffin fittings that appeared to be disturbed, possibly by the extensive tree roots in the fill of this grave. It is probable that the coffin/body remains are just below this level. No investigations were carried out. Five fragments of bone recovered from just above the base level of the trench were animal, one of which appeared to be cow and had butchering marks.

Photo 4: Grave cut (106). Two coffin fittings located just in front and to either side of 0.5m scale. View W

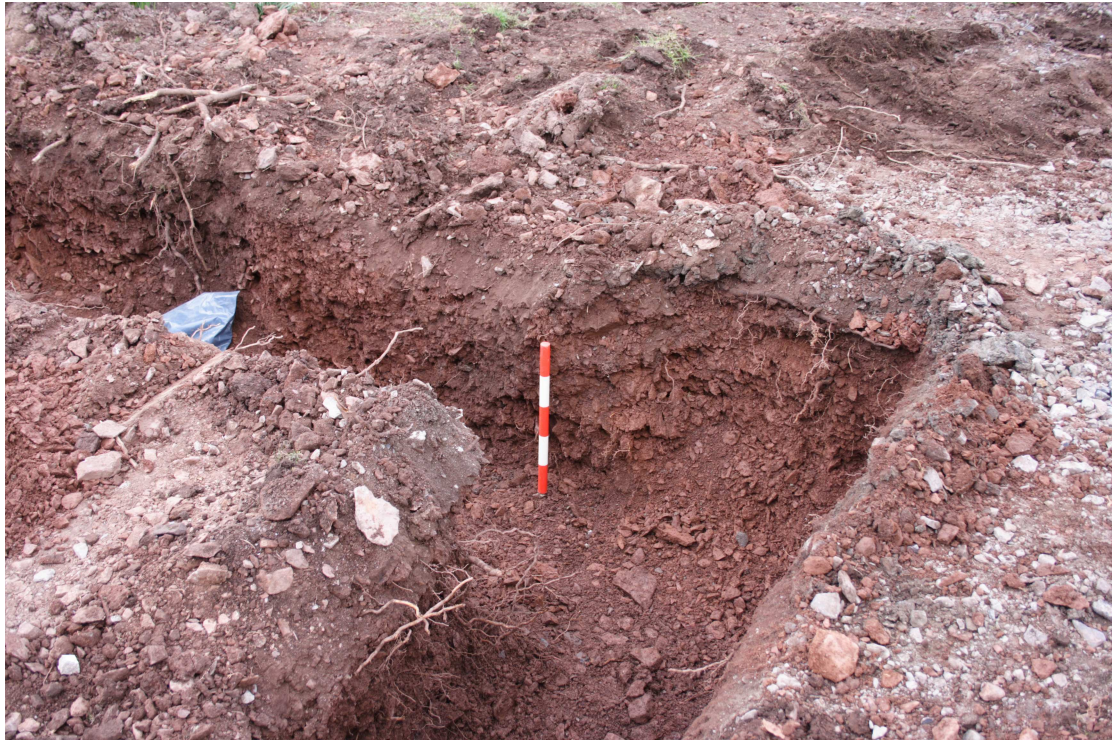
A further probable grave (108; Photo. 5) was located 5.15m to 5.75m north of the grave kerb (102). The cut for this grave extended westwards of the footing trench and also just through the southern side of the north footing trench. Its eastern extent could not be firmly established but appeared to be similar to that of grave cut (104). However, this feature could be just disturbance of the subsoil by the former hedge above this location.

Photo 5: Grave cut? (108) to either side of 0.5m scale. View WSW
