# EGLWYSWRW WATER MAIN ARCHAEOLOGICAL WATCHING BRIEF

Prepared  
by  
Cambria Archaeology  
for  
DWR CYMRU

REPORT NO. 2005/134  
PROJECT RECORD NO. 55697

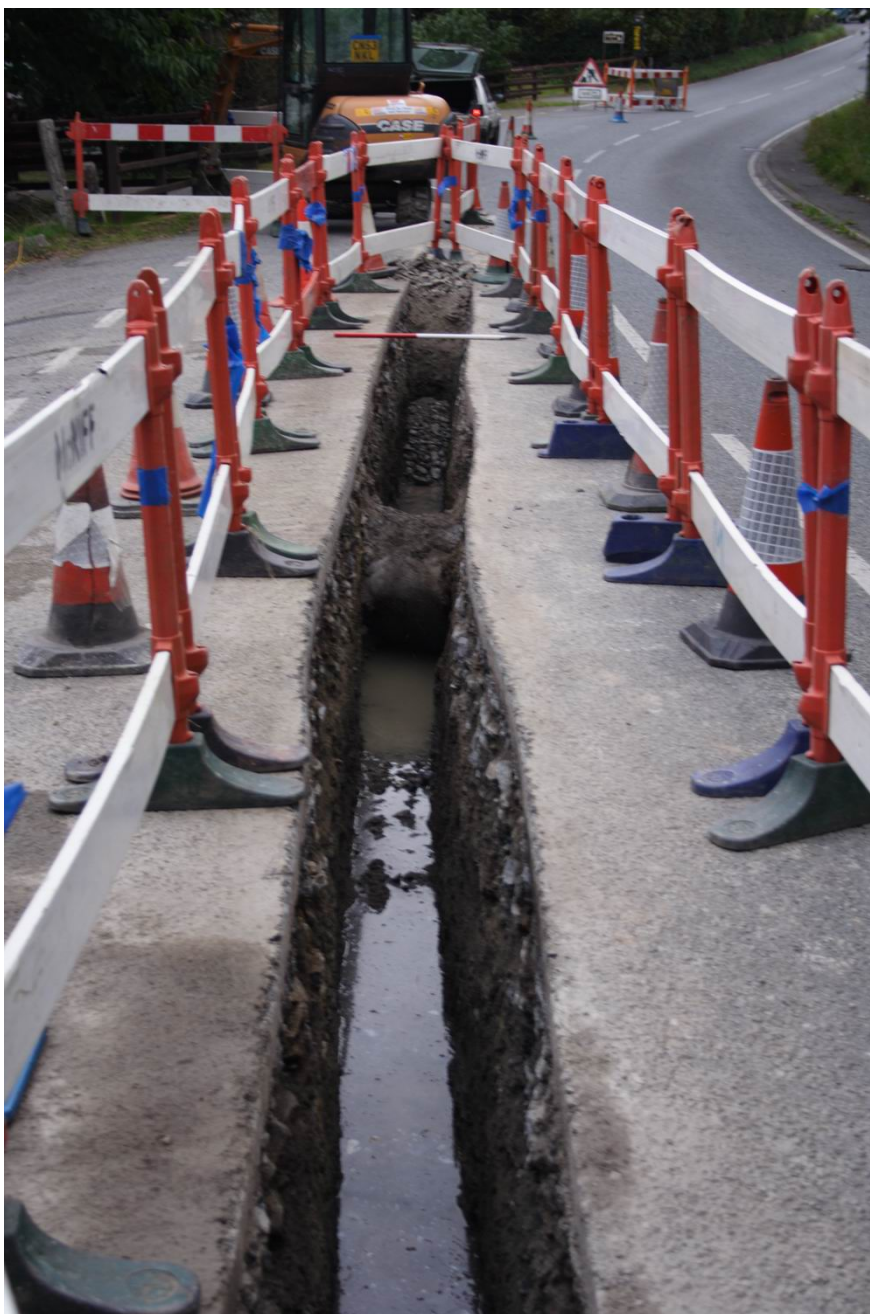
Plate 1: view northeast along the southern end of the new water main trench.

Dwr Cymru replaced a water main at Eglwysrw, Pembrokeshire (NGR SN13943835 - SN14113848). The new main runs for c.200m along part of the A487(T), through the centre of the village (Fig 1; Plate 1). Archaeological work carried out in Eglwysrw during recent years has revealed evidence of medieval burials during road widening works along the south side of the church (Ludlow 1998). There is a strong local tradition that burials have been found in other parts of the village, suggesting that the original churchyard may have been substantially bigger than present (Ludlow 1998, 44; Schlee 2005, 1). The new water main trench was also starting in close proximity to the castle. Therefore, given the archaeological potential of the village a watching brief was required on the works to record any archaeological features or deposits exposed in the new water main trench. Cambria Archaeology Field Operations were commissioned to carry out the watching brief in September 2005.

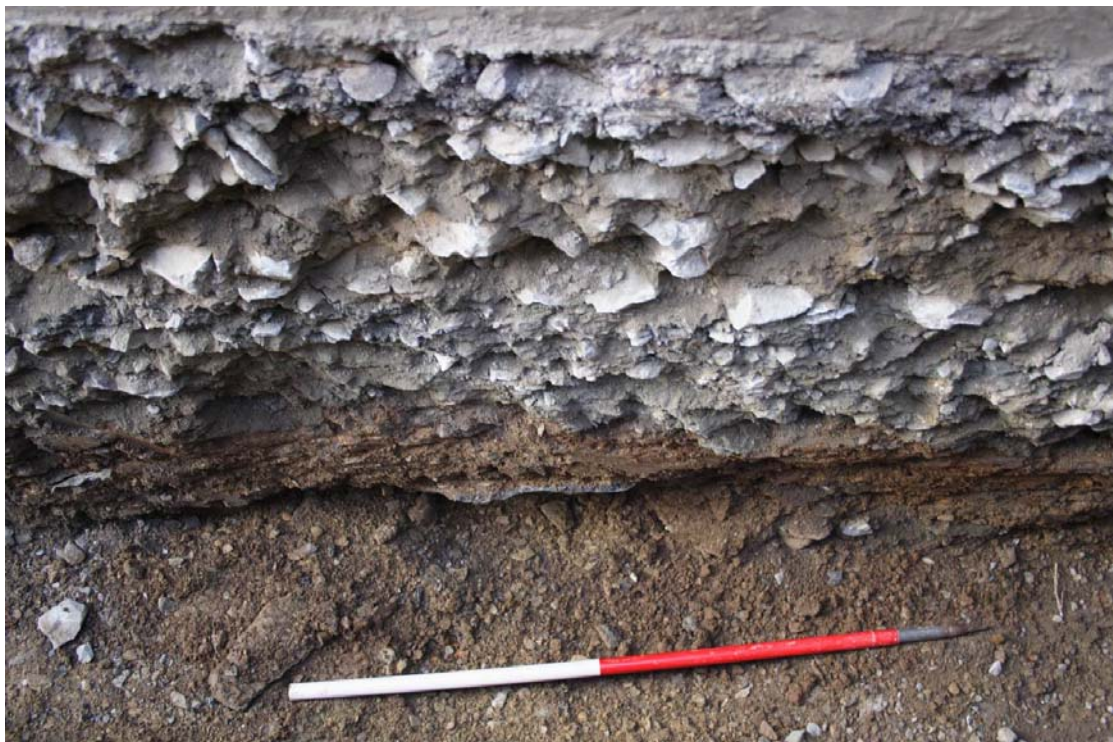
### **Possible stale slab structure (Plate 2)**

The slate slab was of the same local slate used for 25 cist, or stone-lined, graves that were recorded close to the church in 1996 (Ludlow 1998, 28). There was not enough evidence recovered during this watching brief to make any interpretation regarding the slab.

*Plate 2: The slate slab exposed in the side of the water main trench.*

Site visits were undertaken throughout the excavation of the new water main trench. These revealed only one possible archaeological feature, a pitched slate slab at approximately NGR SN13963837. Even though only a small portion of the slab was visible its form and position were sufficiently at variance with the surrounding deposits for it to be considered of archaeological potential.

The only possible feature of archaeological interest was a single slate slab partially exposed in the side of the new water main trench. There has been enough evidence from elsewhere in the village of slab lined cist graves to have made this slab worthy of note. However, there was no other associated evidence, such as a visible grave cut or other stones, to suggest that this was part of a grave or any other type of structure.
