PEMBROKE COMMONS FLOOD ALLEVIATION SCHEME PEMBROKE

ARCHAEOLOGICAL EVALUATION JANUARY 2006

RHIF YR ADRODDIAD / REPORT NO. 2006/35
RHIF Y PROSIECT / PROJECT RECORD NO. 55921

PEMBROKE COMMONS FLOOD ALLEVIATION SCHEME ARCHAEOLOGICAL EVALUATION

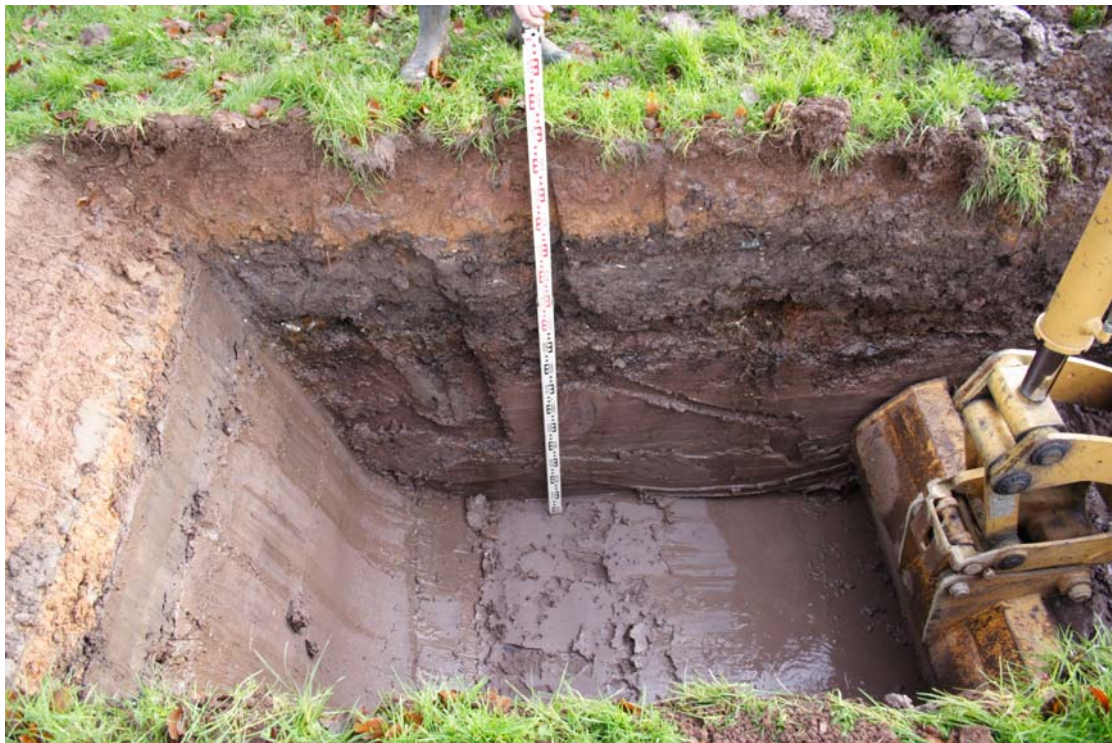
Front cover: Trench 1. View east

Trench 1 (Cover Photo): This was located at the southern end of the Upper Common just above the bridge separating it from the Lower Common. It was excavated down to c. 1.8m deep. The lowest layer encountered at 1.3m was grey marine silt. Above this, from 0.7 m to 1.0m deep, there was a layer of mottled reddish brown and dark silt. Above this, from 0.35m to 0.7m deep, was a layer of dark sandy silt with a lot of domestic rubbish, including china and glass, probably dating to the late nineteenth century and with an iron foundry deposit smell. Above this, from 0.1m to 0.35m deep, there was a layer of mixed clay and small angular stones, possibly quarry scalplings, and also a few fragments of china. Above this, from the surface down to 0.1m, there was dark grey topsoil and turf.

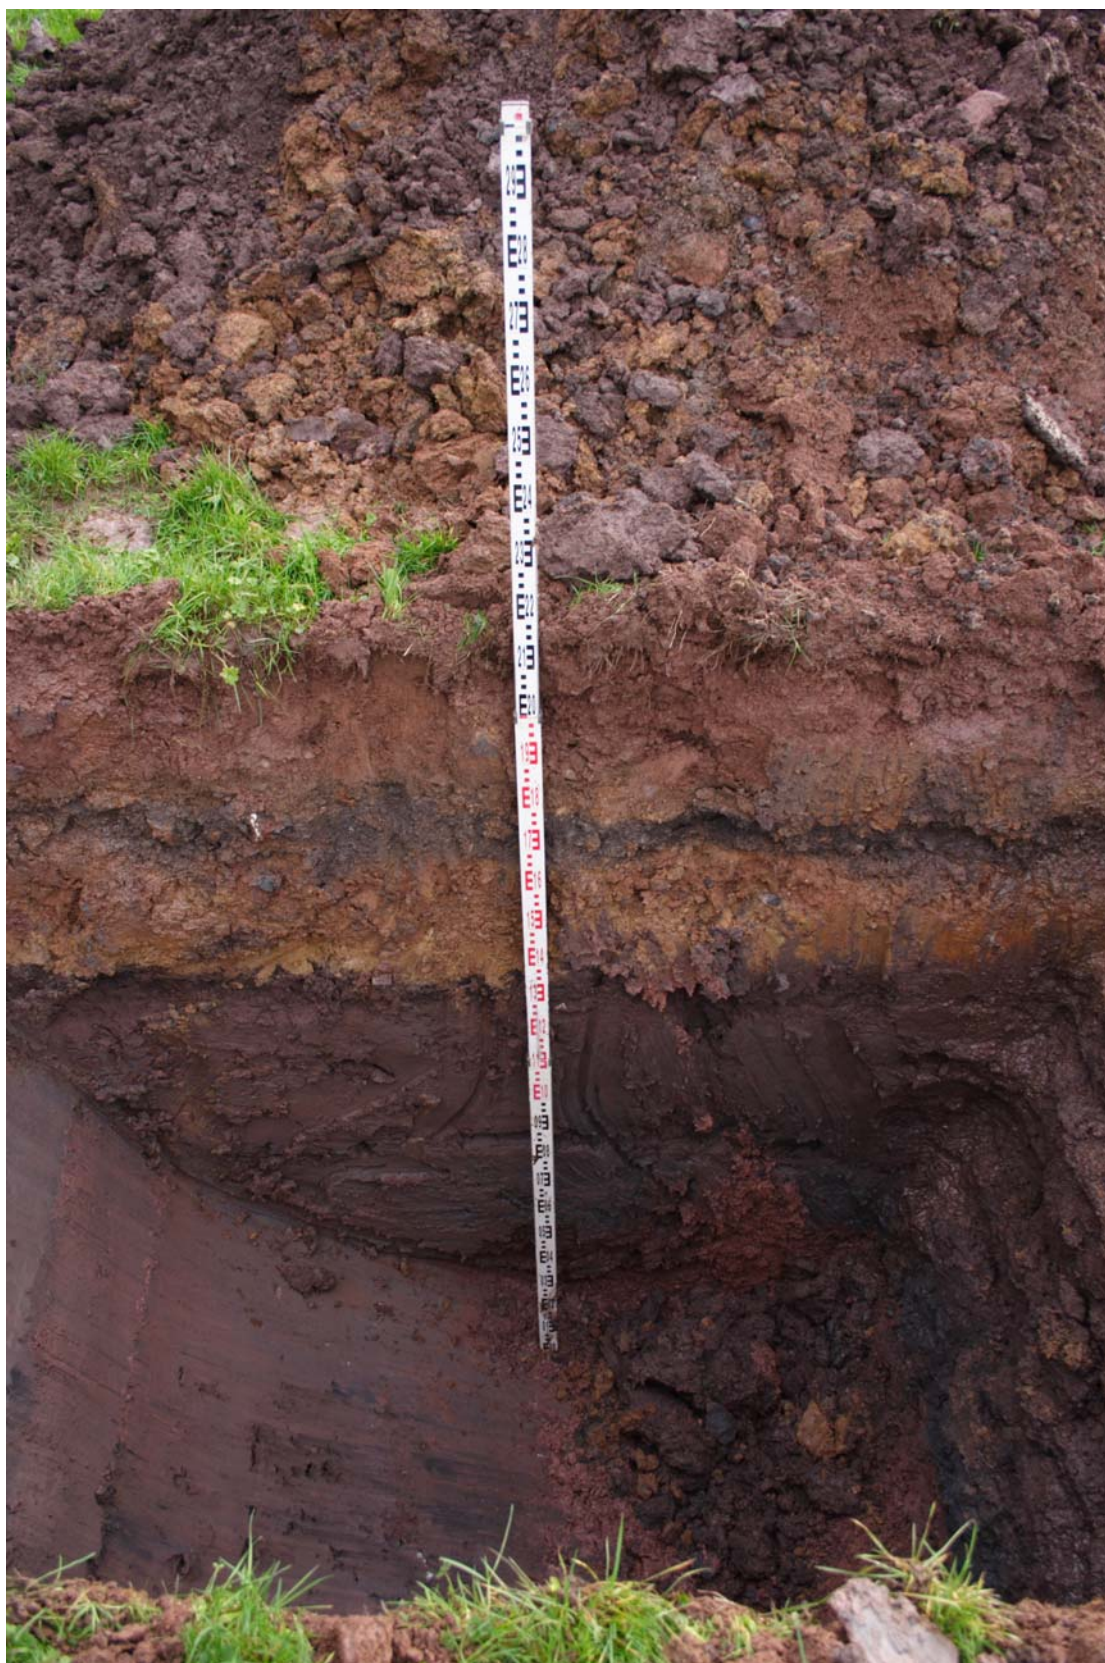
Photo 1: Trench 2. View East

Trench 2 (Photo 1): This trench was located about 70m downstream from the footbridge crossing the middle of the Upper Common and 9m south of the stream edge. This trench was excavated down to a depth of 2.4m. The lowest layer encountered, at 2.1m deep, was a sandy layer, probable deriving from Old Red Sandstone. Above this, from 0.95m to 2.1m there was a layer of grey brown marine clay, similar to that seen in the bottom of Trial Trench 1. Within this

marine clay there was some organic material at 1.8m, possibly roots and limited in extent. Above the marine clay, from 0.8m to 0.95, was a layer of peaty clay that contained china. From 0.65m to 0.8m ran a layer of orange clay. Above this, from 0.5m to 0.65, there was a layer of orange brown clay with angular limestone fragments. From 0.35m to 0.5m was a grey soil layer, overlain from 0.1m to 0.3m by orange brown slightly sandy clay. The uppermost layer, from the surface down to 0.1m was topsoil and turf.

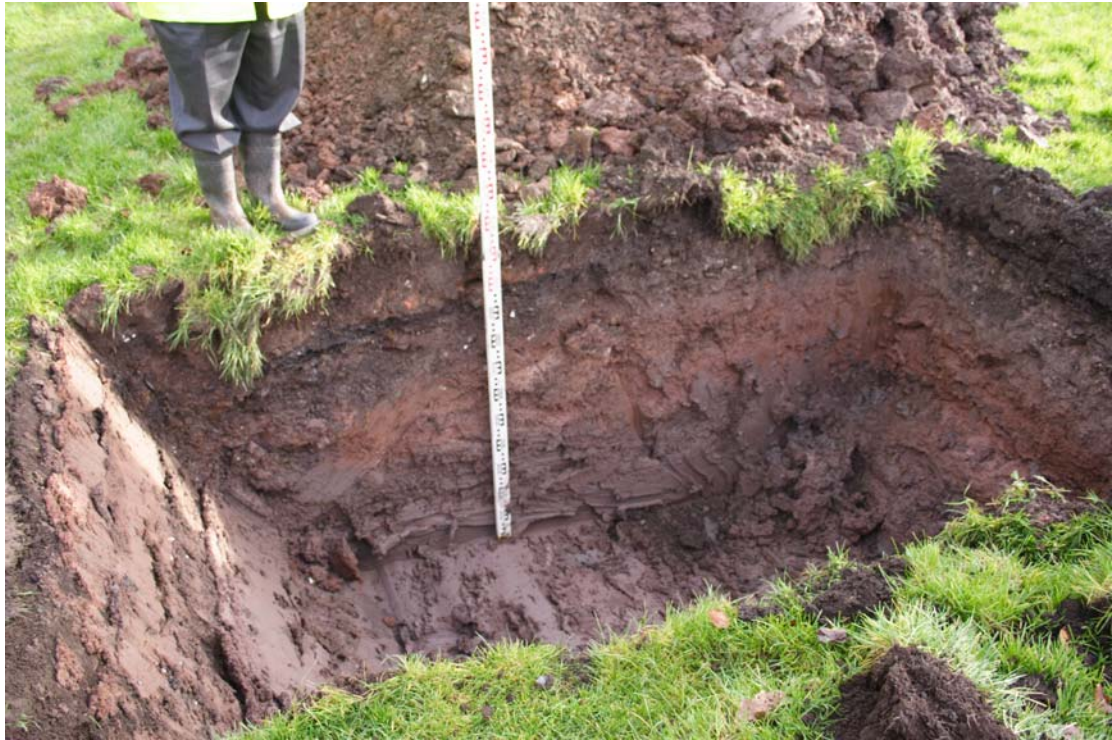
Photo 2: Trench 3. View East

Trench 3 (Photo 2): This trench was located opposite a tower on the town wall, and about 24m above the footbridge crossing the Upper Common and 1m south of the stream edge. This trench was excavated to 1.2m deep. The lowest layer encountered was grey marine clay at 0.8m deep. Above from 0.45m to 0.8m there was a layer of orange brown clay, cut on its northern side by the streambed (before the stream was artificially edged). Over this, from 0.1m to c.0.45m, and also filling the stream cut, was a layer of topsoil mixed with hardcore and modern china. The topmost layer, from the surface down to 0.1m, was topsoil and turf.

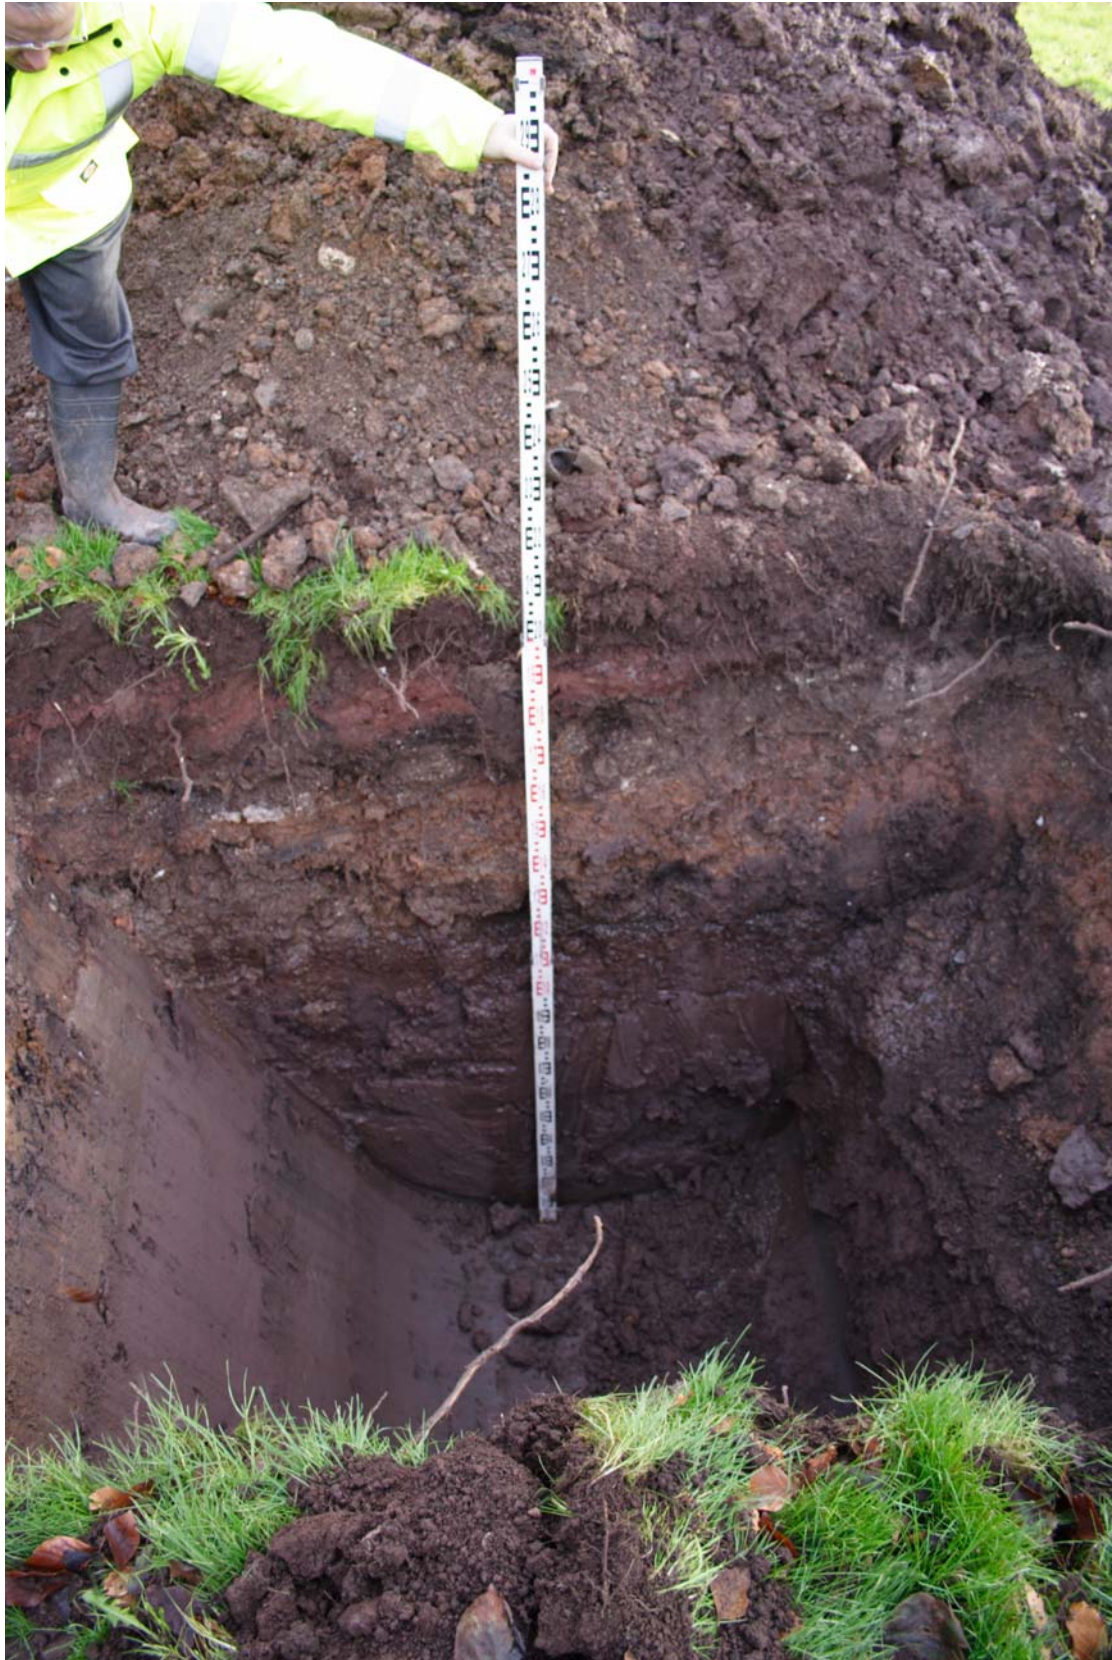
Photo 3: Trench 4. View East

Trench 4 (Photo 3): This trench was located about 40m south of Grove Bridge and 10m south of the existing watercourse. This trench was slightly shorter, c.3m, than the other trenches and was excavated down to 2.1m deep. The lowest layer encountered, at 1.3m deep, was grey marine clay. Above this, from 0.8m to 1.3m, there was a layer of dark grey organic silt. From 0.6m to 0.8m was a layer of hardcore and detritus of late nineteenth century date. Above this, from 0.25m to 0.6m, there was a layer of soil and scalpings. The topmost layer, from the surface down to 0.1m, was topsoil and turf.
