## **TIR GOFAL MANAGEMENT PLAN: HERITAGE MANAGEMENT INFORMATION (HE2)**

**Prepared for:  
Dolebolion**

**Tir Gofal Reference No  
W/11/5742**

**DAT Report No. 2008-100  
Project Record No. 55981**

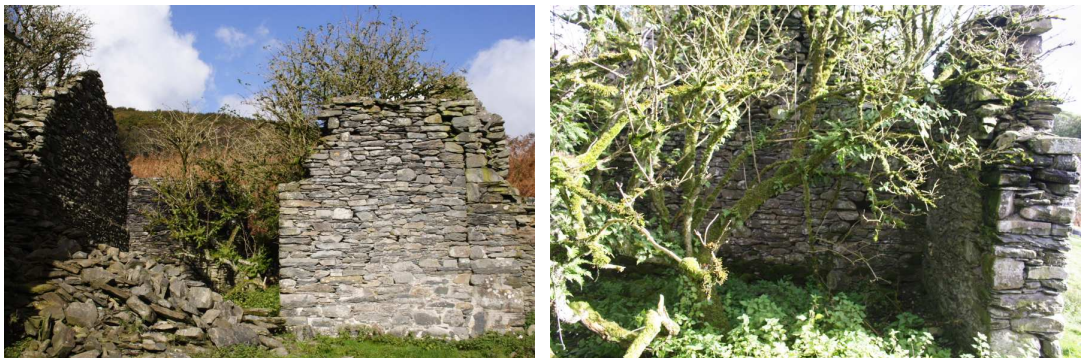
(Left), Front of building PRN 94340, looking north. (Right), interior of building, looking east.					
<b>2</b>	<b>BRON-Y-BERLLAN</b> <a href="#"><u>(41080)</u></a>	<b>Post-Medieval farm building</b>	<b>SN74606628</b>	<b>B</b>		<b>Specific</b>

The long farmbuilding (PRN 94340) is in a poor state of disrepair, with the roof collapsed and a mature tree growing within the walls, dislodging the masonry and making the structure somewhat unstable, suggesting that restoration would be prohibitively expensive. This report cannot advise whether the building is repairable but the current remains are now under threat.

- Monitor mature trees close to the building and consider felling mature trees that are at risk of windthrow and remove branches that pose a threat from falling. The oak tree is damaging the building and ideally needs to be removed.
- Consider cutting back vegetation on the walls, leaving the roots in situ. Spot treat to prevent re-growth.
- Consolidate areas of loose masonry using a traditional lime mortar mix, trying to follow the original mix and appearance as far as possible.
- Consider capping the wall tops of derelict and ruinous structures in order to prevent water from washing out lime mortar bonds and accelerating collapse.

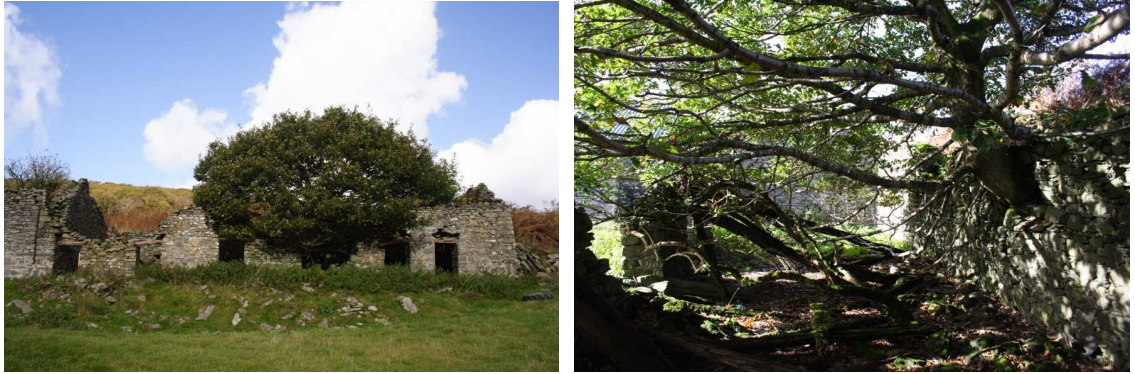
Rectilinear building with lime rendered masonry, no remaining roof, roofing material on floor of building consisting of wooden beams and purple slate. Fallen rubble to the front of the building (UWCL 2000). Recorded during the Tir Gofal archaeological farm visit, aligned approximately east-west along the southern boundary of farmstead PRN 41068. The two-storey building is in a poor state, with the roof gone and a large oak tree growing within the walls, rooted into the bank behind the northern, rear wall. This has collapsed part of the building frontage and the stonework here appears to be leaning outward. Five entrances are identifiable within the frontage, with wooden lintels but no interior details could be determined due to the damage caused by the tree and the collapsed roofing material.

(Left) frontage of long farmbuilding (PRN 41080) and (right) looking west, the interior.

The stone building is completely roofless and a tree growing within the walls is causing damage to the structure. Ideally the building would be restored and made weathertight, preferably with a slate roof. Grant aid is available through Tir Gofal for the maintenance and repair of traditional buildings. Future maintenance should consider how best to keep the character of the farmstead group as a whole, rather than focussing on one particular building at the expense of the others.

- Consolidate areas of loose masonry using a traditional lime mortar mix, trying to follow the original mix and appearance as far as possible.
- Consider capping the wall tops of derelict and ruinous structures in order to prevent water from washing out lime mortar bonds and accelerating collapse.
- Consider cutting back vegetation on the walls, leaving the roots in situ. Spot treat to prevent re-growth.

- Monitor mature trees close to the building. Here, the tree growing within the walls needs to be removed as its branches are causing damage to the stonework.

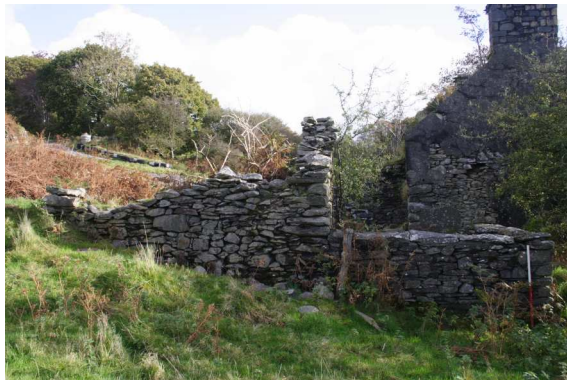
Pigsty complex. UWCL 2000. Recorded during the Tir Gofal archaeological farm visit (21/10/2008) as measuring approximately 7 metres X 4.5 metres, comprising a house (4 metres long) and open pen. The gateway to the pen is in the southeast corner and the walls are of lime-mortared, undressed stone. The west and south-facing walls of the pen stand to a height of approximately 1 metre but the top courses of stone of the east-facing wall have been dislodged. The southern gable-end of the pig-house stands to full height but the northern end has largely collapsed. The roof is completely gone and there is no sign of roofing material. If the pig-house was slated it seems possible that the tiles have been removed for use elsewhere. The sty is located on a north-south boundary wall to the southwest of farmhouse PRN 41082.

Looking east, the Bron-y-berllan pigsty

Although the walls of the pigpen are in generally good condition, with the exception of the eastern side, the walls of the pig-house have tumbled and the roof has gone. Structural restoration and re-roofing of the building would therefore seem prohibitively expensive. The current ruins are now under threat from encroaching vegetation and some control of this would be advised. The remaining wall tops might also benefit from consolidation.

- Monitor mature trees close to the building and consider felling mature trees that are at risk of windthrow and remove branches that pose a threat from falling. The oak tree is destroying the building and ideally needs to be removed.
- Consider cutting back vegetation on the walls, leaving the roots in situ. Spot treat to prevent re-growth.
- Consolidate areas of loose masonry using a traditional lime mortar mix, trying to follow the original mix and appearance as far as possible.
- Consider capping the wall tops of derelict and ruinous structures in order to prevent water from washing out lime mortar bonds and accelerating collapse.

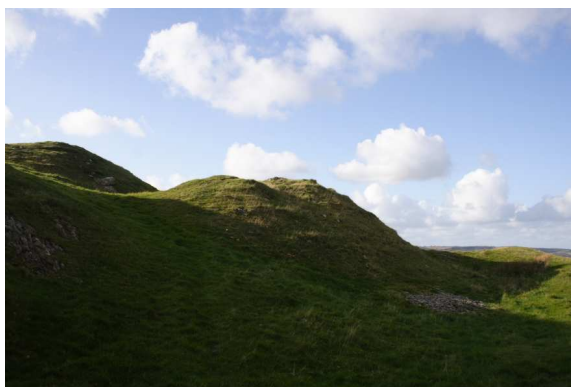
Small, strongly defended Iron Age hillfort on top of a steep sided ridge. Several hut circles are visible inside the defences. Hillforts are generally recorded as having being constructed in the Iron Age (circa 600 BC - 100AD) but scientific dating of some archaeologically excavated sites has indicated that they may be Bronze Age in date (c2000 - 500BC). Hillforts are usually viewed as defensive structures built with the intention of defending and securing property. They are also locations for dwellings that were used on a seasonal or permanent basis. Sites such as these may have been used over very long periods of time and, therefore, were probably put to many different uses.

Looking northwest, the rampart banks and ditches defending the northern entrance of the enclosure.

A Cadw field visit in 2000 recorded that the site was in very good condition under short turf grazed by sheep. Erosion previously noted on the middle bank, to the west of the entrance, had recovered somewhat and the rabbit hole on the inside of the bank no longer looked active, although there appeared to be rabbit activity elsewhere, immediately alongside the entrance. (H.B. Burnham, 2000).

No problems with the site were noted during the Tir Gofal farm visit (21/10/08). It remains under a stable cover of low grass and vegetation that is, presumably, still grazed although no livestock were in the area during the visit. There were no obvious signs of animal burrows or erosion.

Pen-y-bennau Camp is a Scheduled Ancient Monument and, as such, possibly subject to specific recommendations from Cadw.

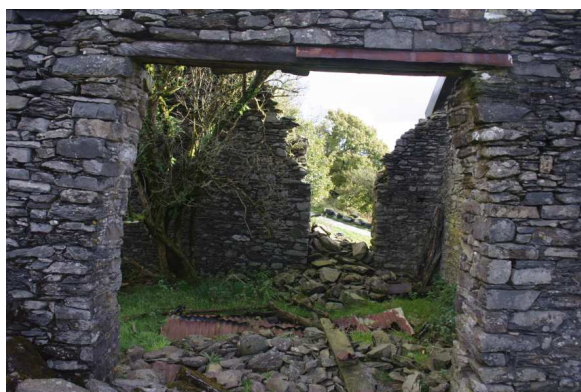
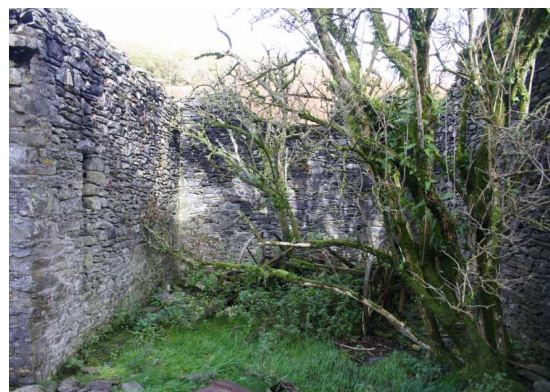
Two-storey threshing-barn, part of the Bron-y-berllan farmstead (PRN 41068). Recorded during the Tir Gofal farm visit (21/10/2008), in the northwest corner of the farmstead, to the rear of the cart-shed (PRN 41079) and adjacent to barn PRN 94340. Wheel-pit (PRN 41069) is adjacent to its exterior western wall, with remnant of the iron wheel still within it. A ventilation slot is located within the barn wall above the wheel-pit. The main, wide entrance to the building is from the west with gently tapering sides and a wooden lintel. The undressed stone, lime-mortared walls generally stand full height but the roof is completely gone. A series of sawn-off wooden blocks protrude from the inner western wall at the height of the main entrance, probable remnants of roof supports or loft beams. The doorway in the eastern wall, opposite the main entrance, is blocked by fallen stones, dislodged from the wall edges by the branches of trees growing within the building. The north-facing interior wall is also the rear wall of the cart-shed and appears to have been consolidated as part of the restoration of that building. A rusting iron ?seed-hopper is parked within the barn.

(Left), looking east through entrance of threshing-barn PRN 94339. (Right), interior of barn, looking north.

The threshing barn is completely roofless and trees growing within the walls have dislodged masonry from the eastern sidewall. Ideally the barn would be restored and made weathertight, preferably with a slate roof. Grant aid is available through Tir Gofal for the maintenance and repair of traditional buildings. Future maintenance should consider how best to keep the character of the farmstead group as a whole, rather than focussing on one particular building at the expense of the others.

- Consolidate areas of loose masonry using a traditional lime mortar mix, trying to follow the original mix and appearance as far as possible.
- Consider capping the wall tops of derelict and ruinous structures in order to prevent water from washing out lime mortar bonds and accelerating collapse.
- Consider cutting back vegetation on the walls, leaving the roots in situ. Spot treat to prevent re-growth.
- Monitor mature trees close to the building. Here, the trees growing within the walls need to be removed as their branches are causing damage to the stonework.

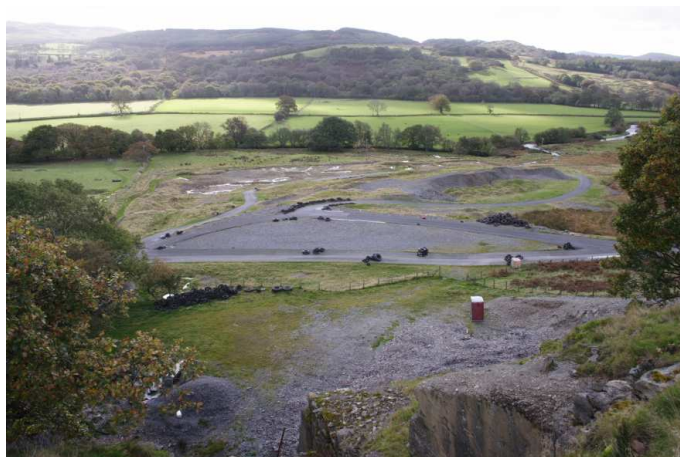
Small metal mine complex. Recorded lead ore output-1500 tons; Zinc ore output-2000 tons. In operation throughout the 19th century. The area of the mine complex was recorded during the Tir Gofal archaeological farm visit (21/10/2008). The northern part of the area is now under a modern motoring track and a modern trackway crosses the area from northeast to southwest, the levelling for which appears to have created numerous stone spoil heaps.

Looking south, area of mining complex showing modern trackways

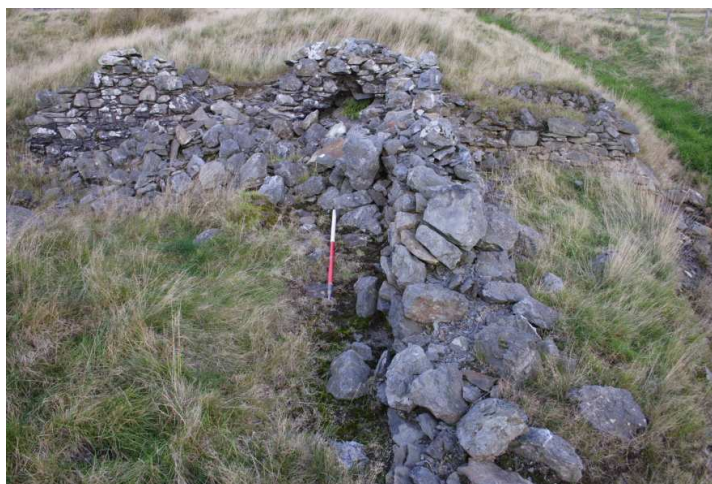
The leat (PRN 41095) runs north-south to the east of the area. A few remnants of stone structures still survive that presumably date to the 19th century mine, including the corner of a building and a possible boundary wall.

Surviving stone walls dating from the 19<sup>th</sup> century mining complex

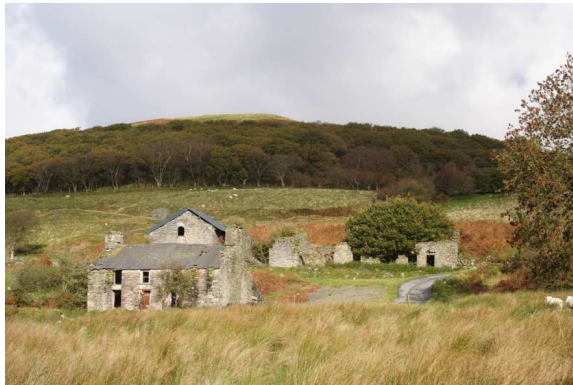
A deserted farmstead complex with the farmhouse and outbuildings in poor condition when seen in 2000. Recorded on the 1888/1889 1st edition Ordnance Survey map as an 'L'-shaped complex of farmbuildings, comprising a cart-shed with hayloft (PRN 41079), threshing-barn with associated wheel-pit (PRN 41069) and a long farm-building - probable cow-barn. The farmhouse (PRN 41082) is located to the south with, to the southwest, a nearby pigsty (PRN 41081). On the western edge of the farmstead is a sheepfold (PRN 41070).

Looking north, Bron-y-berllan Farmstead

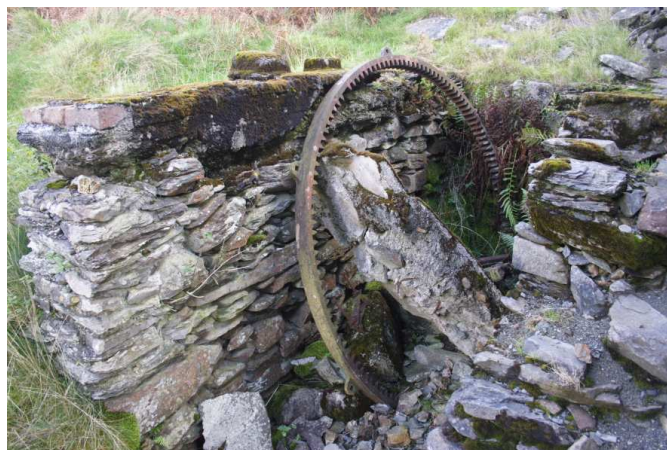
Small wheel pit adjacent to Bron-y-berllan farm cart house building, 3.5metres x 2.2metres x 2metres deep. Lime mortared walls, in state of collapse. Part of the cast iron wheel frame still stands in the pit. Fed by leat, with water running off via the subterranean tailrace. UWCL 2000. Wheel-pit recorded during the Tir Gofal archaeological farm visit, located alongside the threshing barn to the rear of the cart-shed.

The wheel-pit PRN 41069, looking northwest.

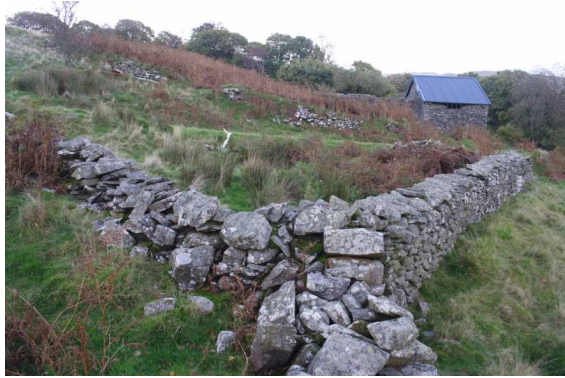
Drystone wall approximately 7 metres (East), 18 metres (South), 15 metres (West). Evidence of northerly wall. Entrance on east side. Early 20th century agricultural machinery in enclosure. 1919 horse drawn rake. UWCL 2000. Recorded during the Tir Gofal archaeological farm visit, on the western side of the farmstead (PRN 41068), lying on northern field boundary.

Looking east, corner of the sheepfold with Bron-y-berllan cartshed in background

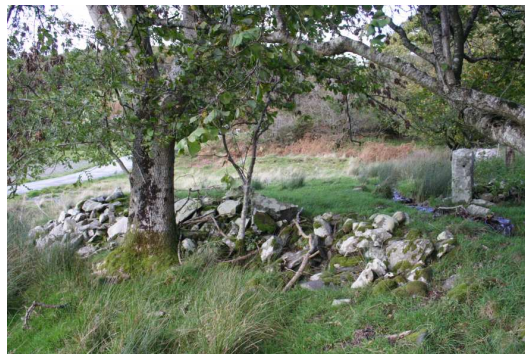
Rectangular enclosure 12 x 15m covered by fairly matured trees. Lies east of the farm building (PRN 41082). Probably drystone walling and contemporary with farmstead. Associated trackway and Spoil heap. Recorded during the Tir Gofal archaeological farm visit (21/10/2008) as a levelled platform demarked by wall-tumble. A standing stone gatepost, with a hole drilled through it, is located to the east of the enclosure and a stream runs alongside it. The area is under short grass and reeds and surrounded by mature trees.

Looking northwest, enclosure PRN 41083 with gatepost to the right

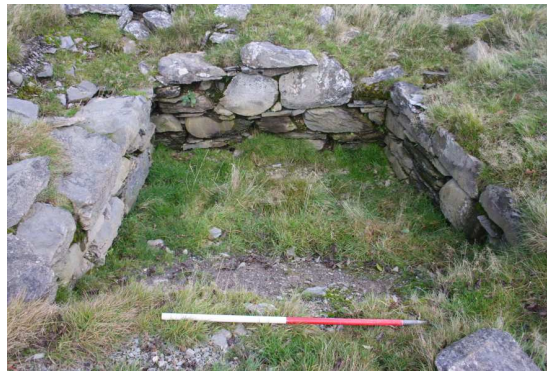
Recorded during the Tir Gofal archaeological farm visit (21/10/2008) as a stone-lined pit approximately 2 metres square within an area of low-intensity grazing. No immediate threats apparent to the structure.

Looking east, ?wheel-pit PRN 41090.

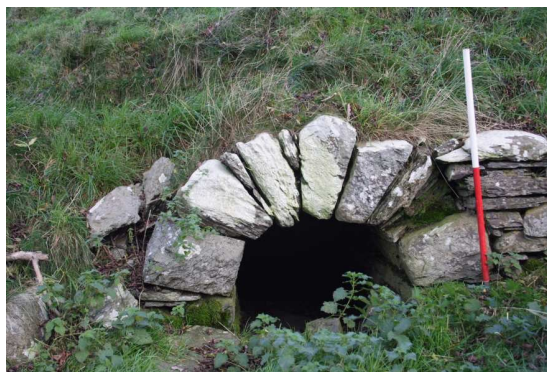
Possible stone lined leat. Width of entrance 80cm, height 60cm, width of stone border 40cm, stone arch at entrance. UWCL 2000 Site was recorded during the Tir Gofal archaeological farm visit (21/10/2008), within an area of low intensity grazing. No immediate threats apparent to the structure.

Arched entrance to leat PRN 41092, looking north.

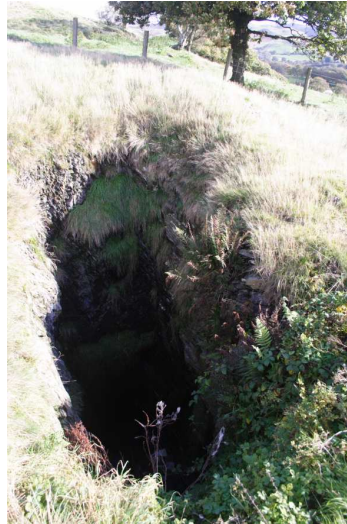
2 metres in length north-south, 7 metres east-west. UWCL 2000. Recorded during the Tir Gofal archaeological farm visit (21/10/2008) as a fenced off, deep, vertically cut open shaft.

Looking east, open shaft PRN 41094

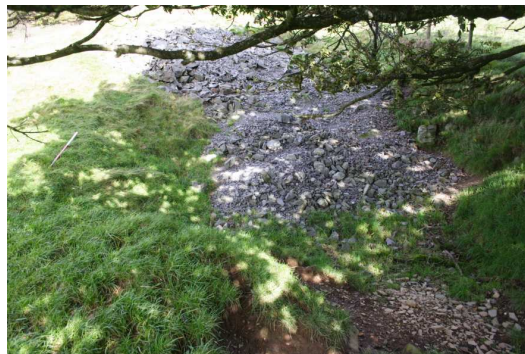
Marked on 2nd edition 25" Ordnance Survey Map. UWCL 2000 Recorded during the Tir Gofal archaeological farm visit (21/10/2008) on the line of leat PRN 41095. Feature is approximately four metres square with steeply cut edges into the bedrock. The east and west edges are grassed over and there is a pile of loose stones that appears to have washed down from exposed rock to the north.

Looking north, square-cut reservoir on line of leat PRN 41095

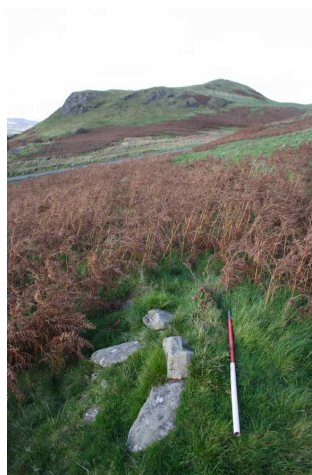
Possible cairn or clearance cairn. Located on the Eastern side of hill and is roughly 2m in diameter. Grassed over (UWCL 2000). Site located, during Tir Gofal archaeological farm visit (21/10/2008) on hillslope, under short grass and bracken. Most of the cairn remains grassed over but several exposed stones are apparent on top of the feature.

Looking north, cairn (largely grassed-over) PRN 41329, with Pen-y bannau Camp in background

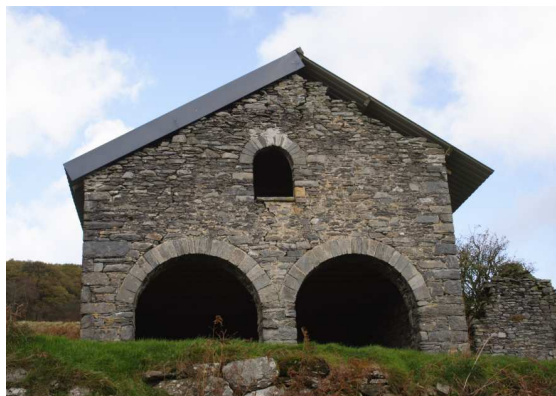
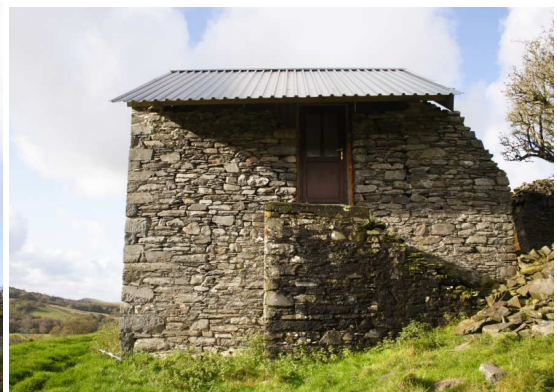
A two-storey lime-mortared stone building comprising a cart-shed, with dressed stone arches, and a hayloft accessed by external stone steps. The building was recorded during the Tir Gofal archaeological farm visit (21/10/2008) as having undergone some restoration work. This includes a new roof of box-profile corrugated-iron, supported by a steel frame, and a modern door fitted into the hayloft entrance.

Looking north, cart-shed PRN 41079, with modern roof and looking west, showing hayloft entrance.

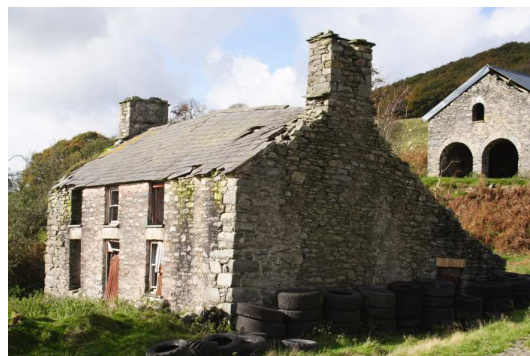
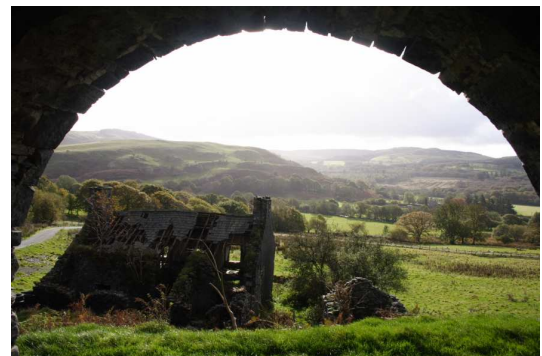
Farmhouse in an advanced state of decay, remains of roofing and internal structural material. Constructed of stone, with combination of lime mortar and earth bonding in the walls. Brick-built oven range. A range of outbuildings to the north and a small garden to the front.

Bron-y berllan farmhouse (PRN 41082) with cart-shed behind, looking northwest, and looking south, from the cart-shed.
