**TIR GOFAL MANAGEMENT PLAN:  
HERITAGE MANAGEMENT INFORMATION  
(Call Out)**

**Prepared for:  
Llwyncelyn (Dolebolion)  
Tir Gofal Reference No: W/11/5742**

**Project Record Number: 55981  
Report Number: 2009/21**

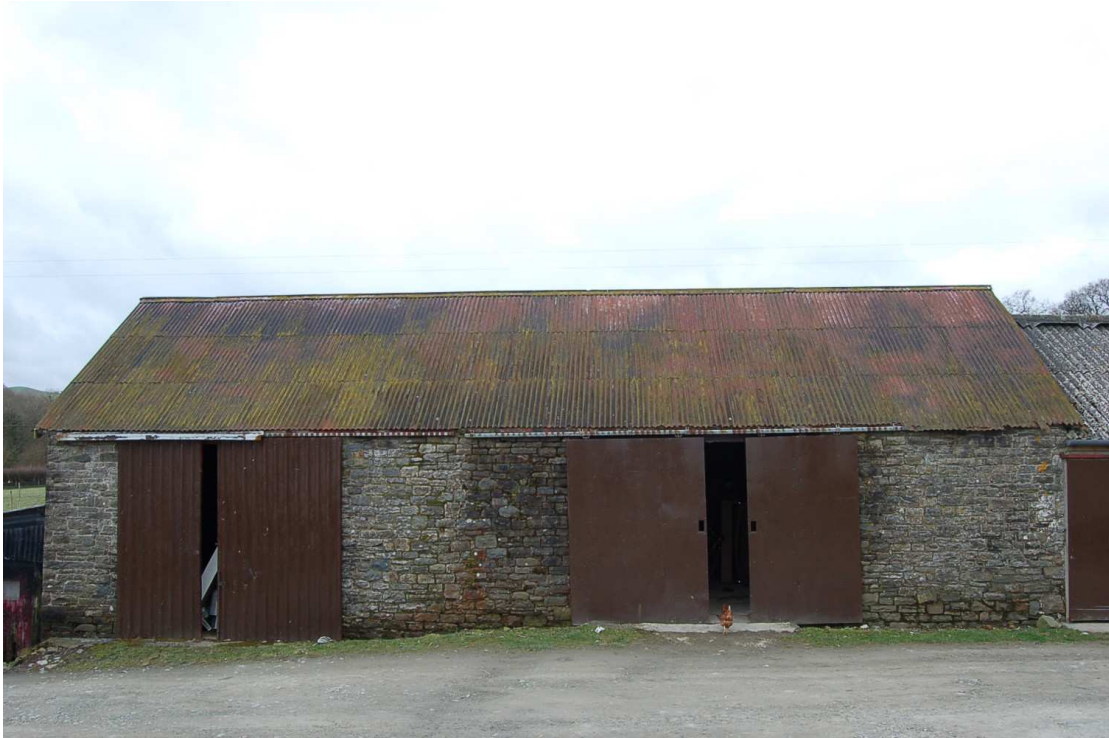
The focus of the call-out to Llwyncelyn farm was the threshing barn, which dates to at least 1839. It is gable-ended, constructed from dressed stone blocks and now roofed with corrugated-iron, presumably fitted after 1906.

*The façade of the threshing barn*

The double door entrances within the façade now have sliding metal doors covering them, with runners affixed to the outer wall just below the eaves. The corrugated-iron has been trimmed in places to accommodate this. Redbrick dressing on the inner wall edges possibly represent consolidation of the masonry after the original wood-plank doors were removed. A pitching hole is inserted into the rear wall, covered by a split, wood plank shutter that has a remnant of red paint.

- Ideally the metal sliding doors would be removed and the entrance consolidated, with traditional solid wooden plank doors reinstated, in keeping with the style and age of the building. Contact the Dyfed Archaeological Trust for further information if necessary.

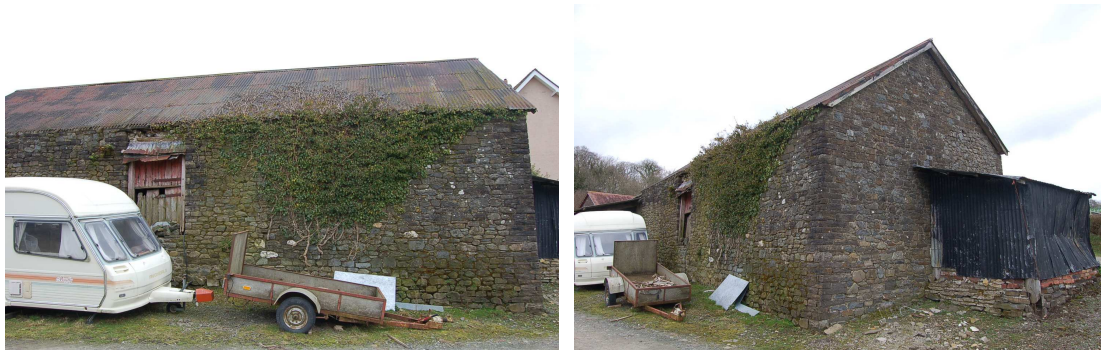
*(Left) rear of the barn showing pitching hole and (right) south-facing gable*

There is an area of differing masonry within the south-facing gable, comprising rounded river-worn stones. It may represent patching for failed stonework or the infilling of an aperture such as external access to a former granary loft. A corrugated-

iron and wooden lean-to is attached to this wall. It stands on a mortared stone and redbrick plinth, the base to which may once have formed part of external steps. A gable-ended, concrete rendered, corrugated-iron roofed building abuts the opposite, northern gable.

- A correct historic finish in this region would favour the use of an estate paint colour. The paint remnant on the pitching hole shutter suggests that red paint (known locally as 'ox blood red') would be appropriate. Stained or varnished finishes are not appropriate.

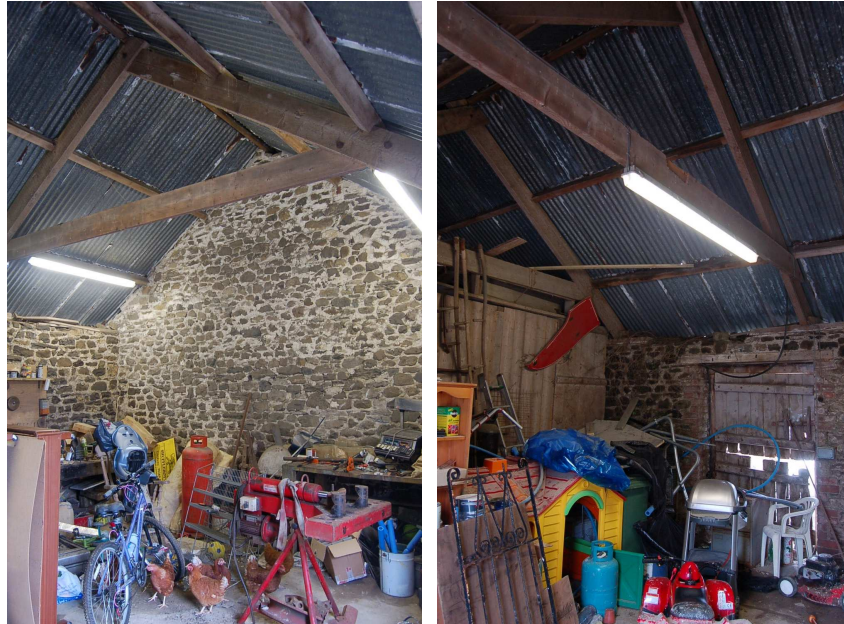
*Interior of the threshing barn*

Internally the barn is divided to the height of the wall tops by timber panelling and the whole building is open to the roof timbers. This wooden framework sits on the level wall tops and looks to have been replaced at the time of the building's re-roofing, showing little sign of deterioration. The southern end of the building may originally have been lofted for grain storage, accessed via the possible external steps, although no internal evidence for this was noted. There are flagstones on the thresholds of the two entrances and the remaining floor space appeared to be concreted. No original internal features were noted during the call-out, although both sides of the barn were full of stored items.

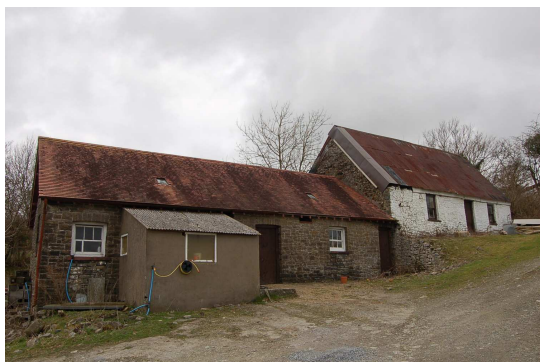
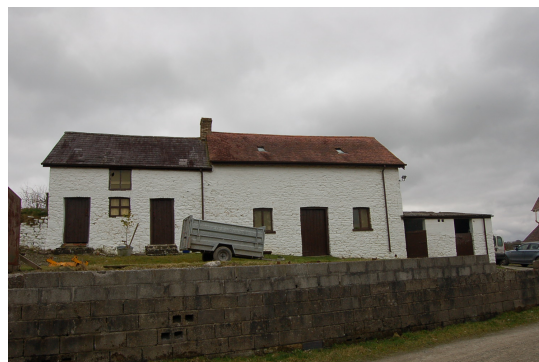
The threshing barn, cowshed and old farmhouse are the earliest buildings in the farmstead but none are currently roofed in slate, two being covered in corrugated-iron and one in red clay tile. These were not likely to be the original roofing materials, however; the pitch of the roof of the early farmhouse suggests that it was formerly thatched. Evidence for earlier roofing materials on the threshing barn and cowshed have not yet been identified.

The range of buildings, including a possible brewhouse and stable, may also be contemporary as they appear on the 1887 OS map. These include another red-clay tile roof and one in slate. Although having slate elsewhere on the farmstead could lend weight to an argument in favour of re-roofing the threshing-barn in slate, it is not known whether it is the original roof. The red-clay tiles are likely to date to the early 20<sup>th</sup> century but are of interest in that they may represent links to the Dinefwr estate, where several other buildings are similarly roofed.

*(Left) the original farmhouse and cow shed and (right) the possible stable, brewhouse and pigsty.*
