## **TIR GOFAL MANAGEMENT PLAN: HERITAGE MANAGEMENT INFORMATION (HE2)**

**Prepared for:  
Plaspaun**

**Tir Gofal Reference No  
W/12/5772**

**ACA Report No. 2006/50  
Project Record No. 55990**

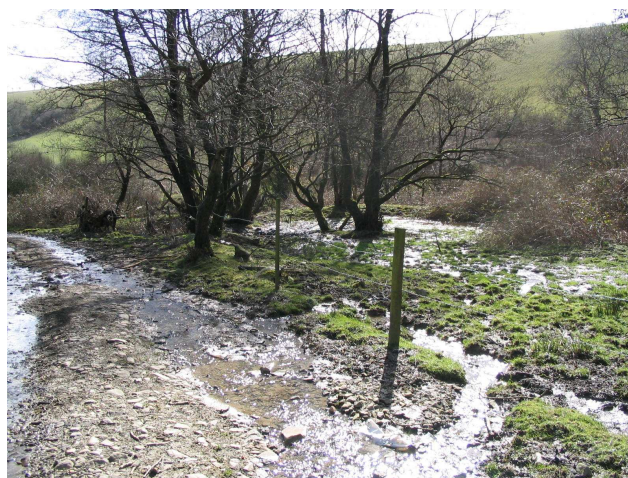
**(56200)**      **Post Medieval  
pond**      **SN2916523390 C**      **Generic**

A subrectangular shaped pond, shown on the 1st edition Ordnance Survey map of 1889 (Carms sheet 30.14). Large earth banks survive on the south and east sides. The pond is heavily silted up and trees (mostly alder) have colonised the interior while brambles have colonised the southern banks. There is little standing water but water flows through it. The pond is thought to have been a holding pond to supply the water wheel in the farmstead. No trace of a leat or pipe is visible although the farmer has come across a subsurface pipe may have supplied water to the wheel whilst carrying out works to the west of the farmyard. *Visited 10/03/2006 (Alice Pyper)*

*The pond has largely silted up so there is no standing water and has become populated with trees.*

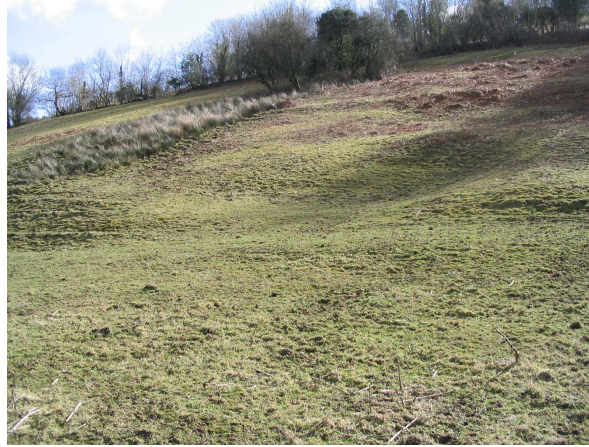
**(56201)**      **Post Medieval  
cottage**      **SN2990923441 B**      **Generic**

A 'Cottage & Garden' is recorded in 1844 on the Tithe for Meidrim Parish in a parcel of land which was belonging to 'Pandy Mill'. There are no upstanding remains of the cottage which was orientated N-S, however there is a levelling out of the slope c 8m wide (E-W) near the field gate. *Visited 10/03/2006 (Alice Pyper)*

*A slight depression at the foot of the slope is the only visible evidence of the cottage which was recorded on the Tithe map*

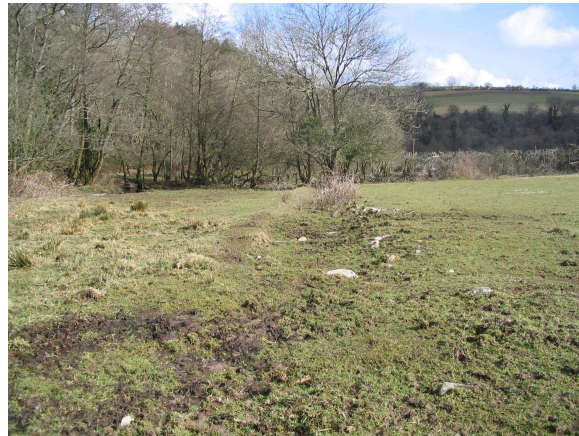
(56202)

A linear earthwork channel c 1.5 m wide running E-W parallel with the stream, evidence of stone rubble lining on S side. Low bank of earth on N side. Relic field boundary? Drainage channel? *Visited 10/03/2006 (Alice Pyper)*

*A linear depression running across the field, is of unknown function, but may be a drainage channel*

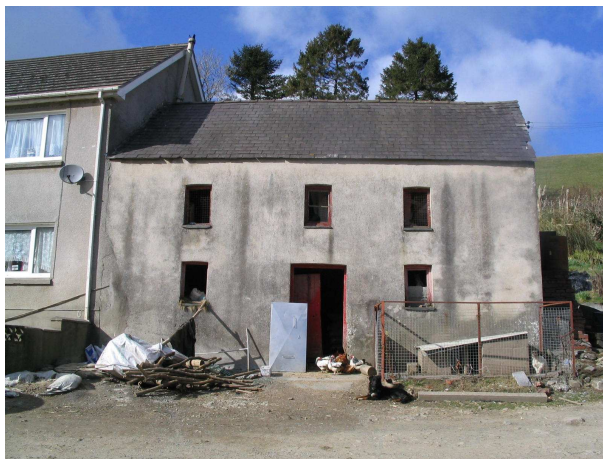
Historically the farmstead was composed of two opposing ranges, almost parallel to each other. The northern range occupying the higher ground is now two adjoining farmhouses, the western house is a later 19th century rebuild. That to the east has been modernised. At the eastern end of the range is a two storey stable block, with a central doorway and flanking windows to either side and three openings above. The upper floor is accessed by external steps at the eastern gable. The roof is slated and the external walls rendered. Although in a fair condition at present, this building is in need of some repair. The scheme would present a welcome opportunity to undertake some remedial work, which would put the building in good order for the foreseeable future.

*The stable range at Plaspaun*

Although the stable is in a reasonable condition at present, it is in need of some repair. The scheme would present a welcome opportunity to undertake some remedial work, which would put the building in good order for the foreseeable future.

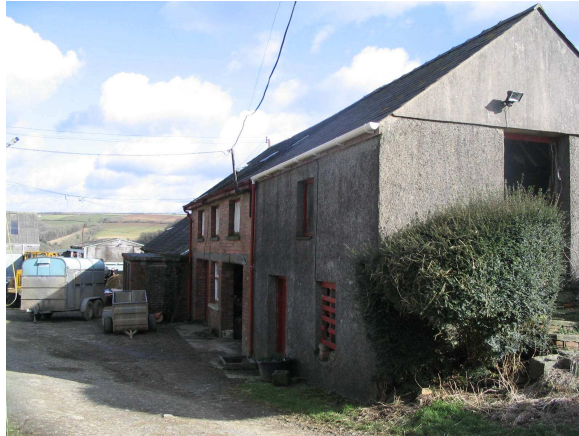
The opposing, southern range consists of a brick built range which would appear to be a later build, probably early 20th century, although it probably replaced an earlier building shown on the 1st edition. At the western end is a stone faced rendered building with a granary accessed by external steps at the gable.

*The southern range of buildings at Plaspaun, right of these buildings was a waterwheel, now dismantled*

The farmer recalls a wheel pit formerly located to the south of this range, although this has been obscured with the erection of a larger shed to the south of the building. *Visited 10/03/2006 (Alice Pyper)*

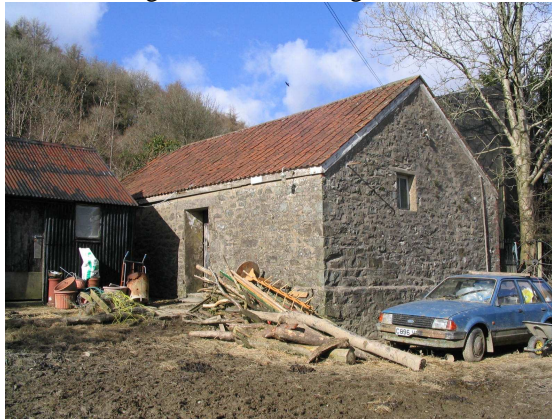
**SOAR (55914)**

A single building is shown located by the roadside on the 1st edition Ordnance Survey map of 1889 (Carms sheet 30.14). This building is stone built with ceramic tile roof with a single doorway on the southeastern elevation. Currently used as an outbuilding of Cenllaith cottage. *Visited 10/03/2006 (Alice Pyper)*

*The building named 'Soar' on the 1<sup>st</sup> edition Ordnance Survey map is currently used as an outbuilding to the cottage at Cenllaith.*
