NEWTON HOUSE, DINEFWR BILLIARD ROOM RAPID BUILDING RECORDING

REPORT NO. 2006/24
PROJECT RECORD NO.56262

**NEWTON HOUSE, DINEFWR
BILLIARD ROOM
RAPID BUILDING RECORDING**

SUMMARY

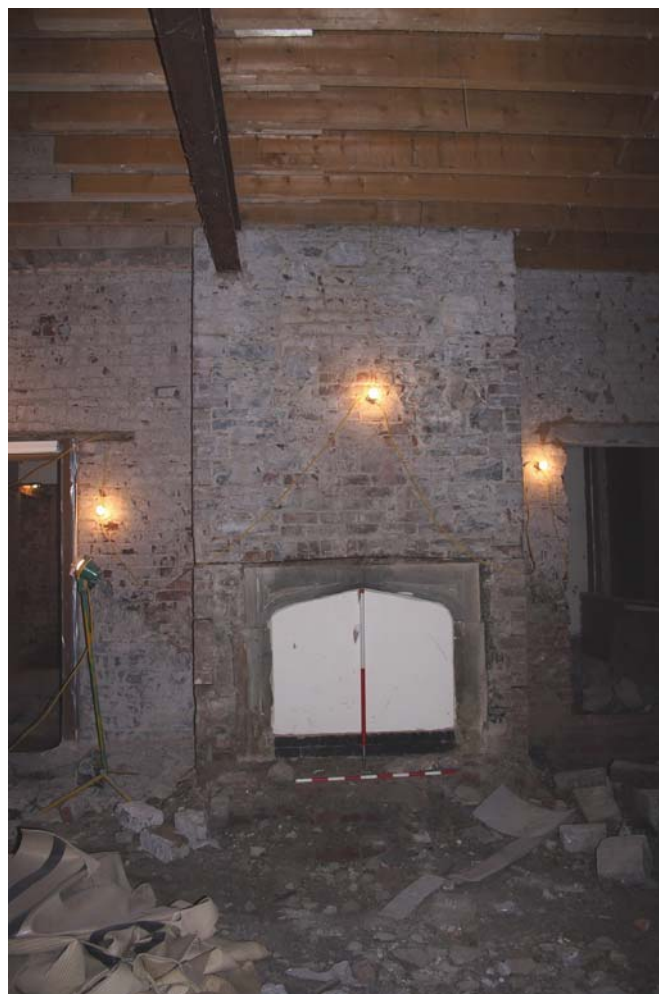
North wall (Fig. 2; Plate 1)

A predominately red brick wall with a central fireplace and chimneybreast. The chimney breast is a combination of red brick and coursed stonework. The chimneybreast is flanked on either side by doorways, 2.23m high x 1.13m wide, that lead to Room 2. The western opening was original but the eastern opening new.

Figure 2: North wall of Room 1, including attic.

Plate 1: The central fireplace in the North wall of Room 1.

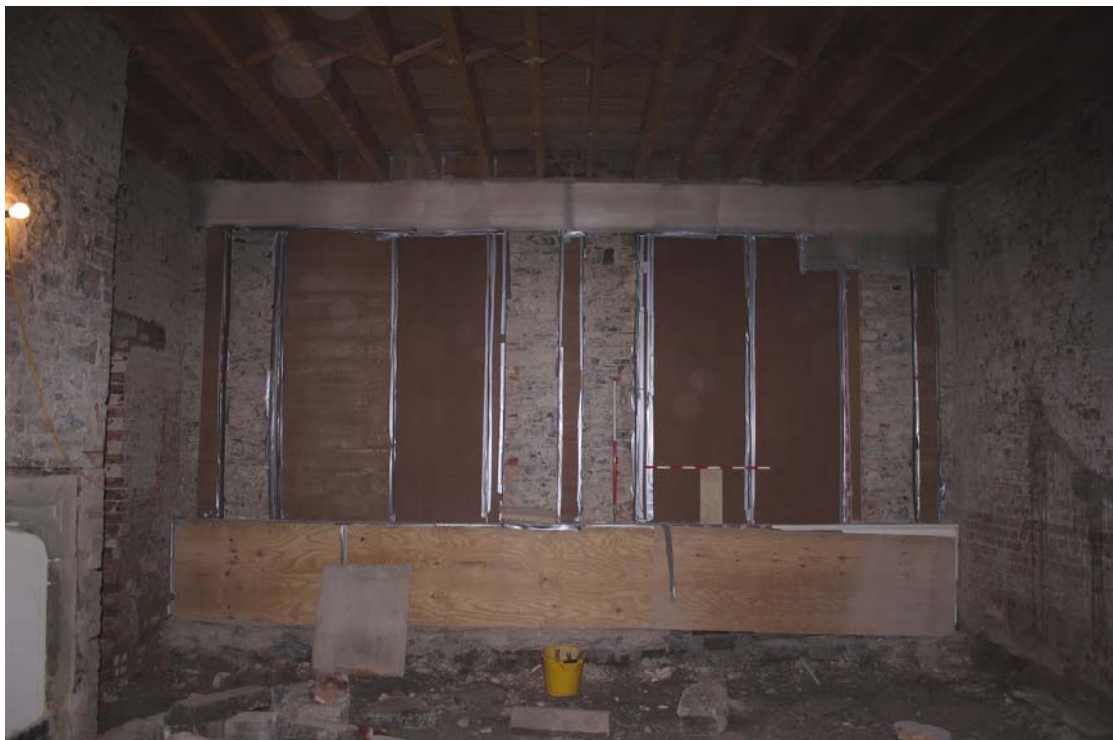
East wall (Fig. 3; Plate 2)

The east wall contained two large square headed windows, 2.35m high x 1.84m wide. Wooden panelling survived below the windows and a decorative plaster cornice survived at ceiling height. The wall was constructed from coursed rubble stonework with brick relieving arches over the windows. The timber window frames survived, but were covered for protection during this survey.

Figure 3: East wall of Room 1, including attic.

Plate 2: The large covered windows in the east wall of Room 1.

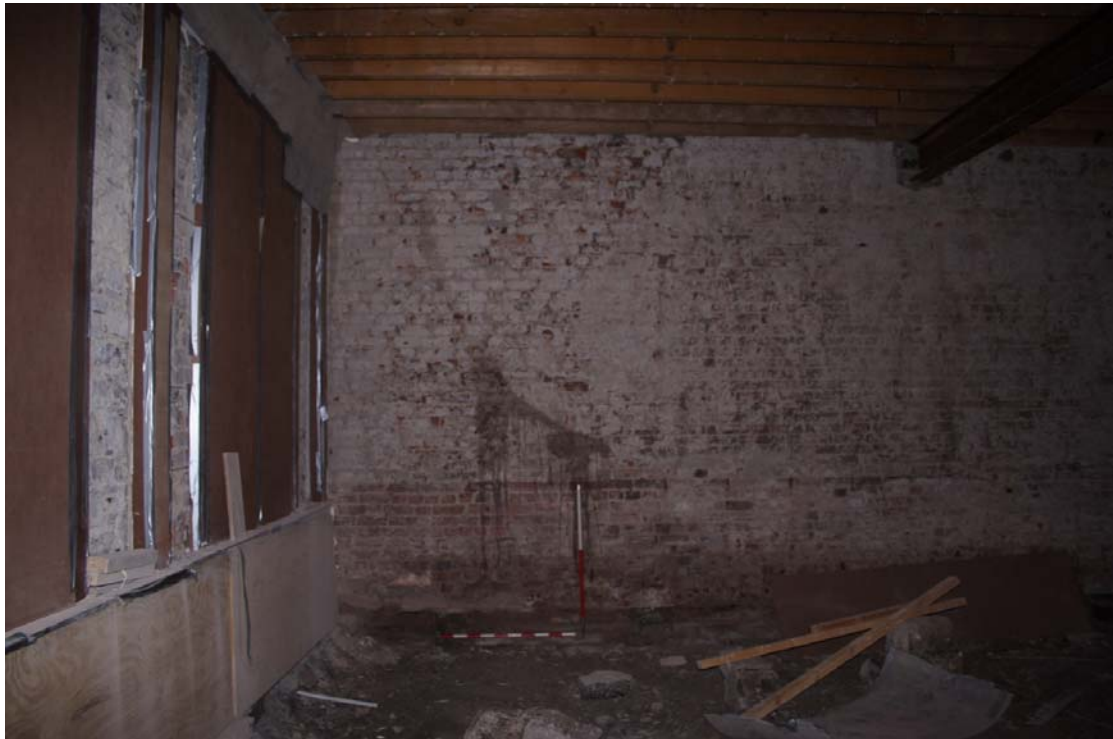
South wall (Fig. 4; Plate 3)

The south wall was constructed from red brick and contained no evidence of any former openings. Three small square ventilation holes were present below the original floor level.

Figure 4: South wall of Room 1, including attic.

Plate 3: The east end of the south wall of Room 1.

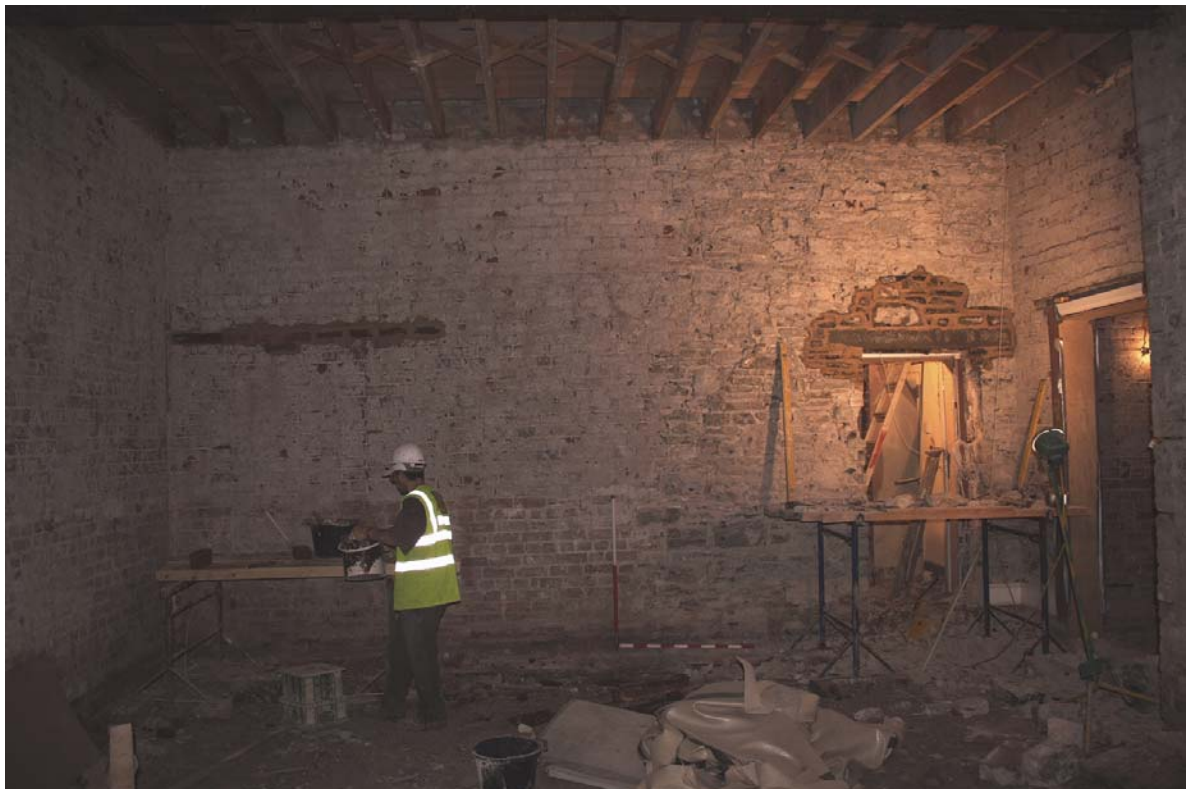
West wall (Fig. 5; Plate 4)

The west wall was a mixture of coursed stonework and red brick. The northernmost 3m were constructed from coursed stone, whilst the southern half was red brick. There was a doorway to a neighbouring room (Room 3) at the northern end of the wall and a blocked doorway at the south end of the wall. Interestingly, this doorway had been bricked-up so that it blended almost perfectly with the brick courses in the surrounding wall.

Figure 5: West wall of Room 1, including attic.

Plate 4: The west wall of Room 1.

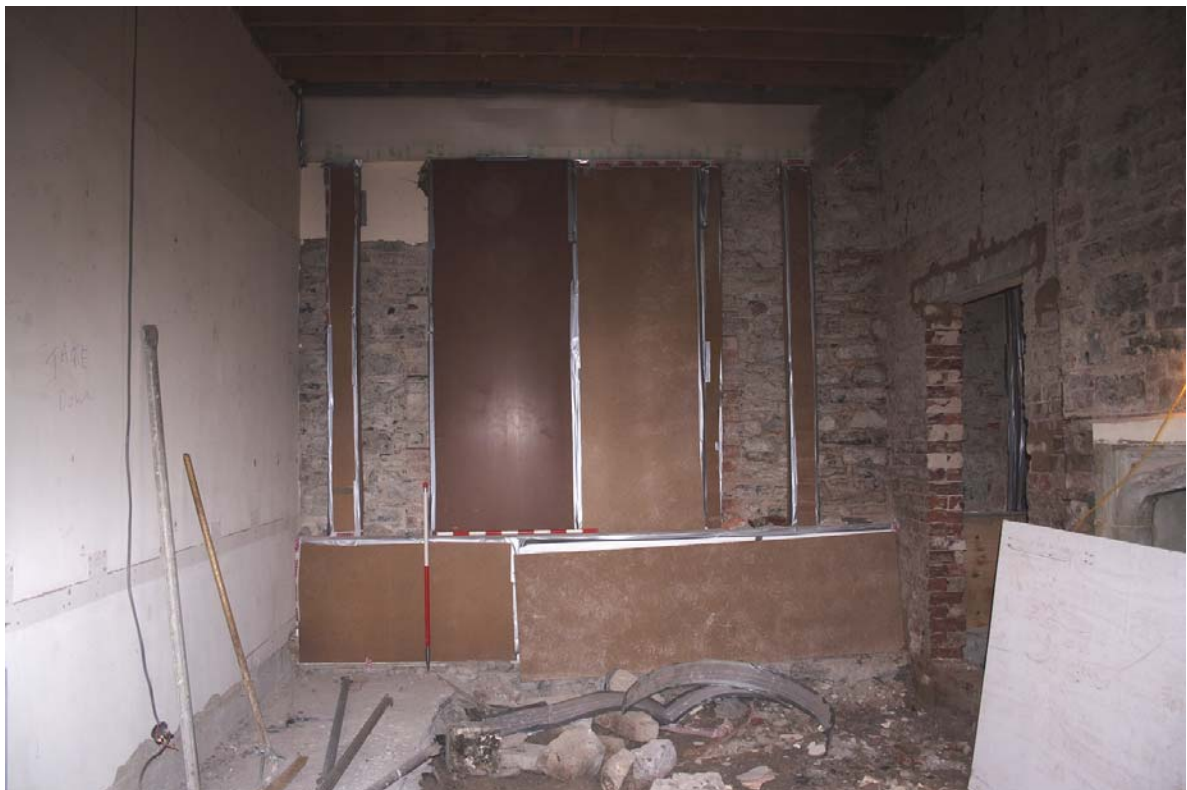
East wall (Fig. 7; Plate 5)

The east wall contained three large square headed windows, 2.35m high x 1.84m wide. Wooden panelling survived below the windows and a decorative plaster cornice survived at ceiling height. The wall was constructed from coursed rubble stonework with brick relieving arches over the windows. The timber window frames survived. This wall matched the east wall in Room 1.

Figure 7: East wall of Room 2, including attic.

Plate 5: Blocked window in the south end of the east wall of Room 2.

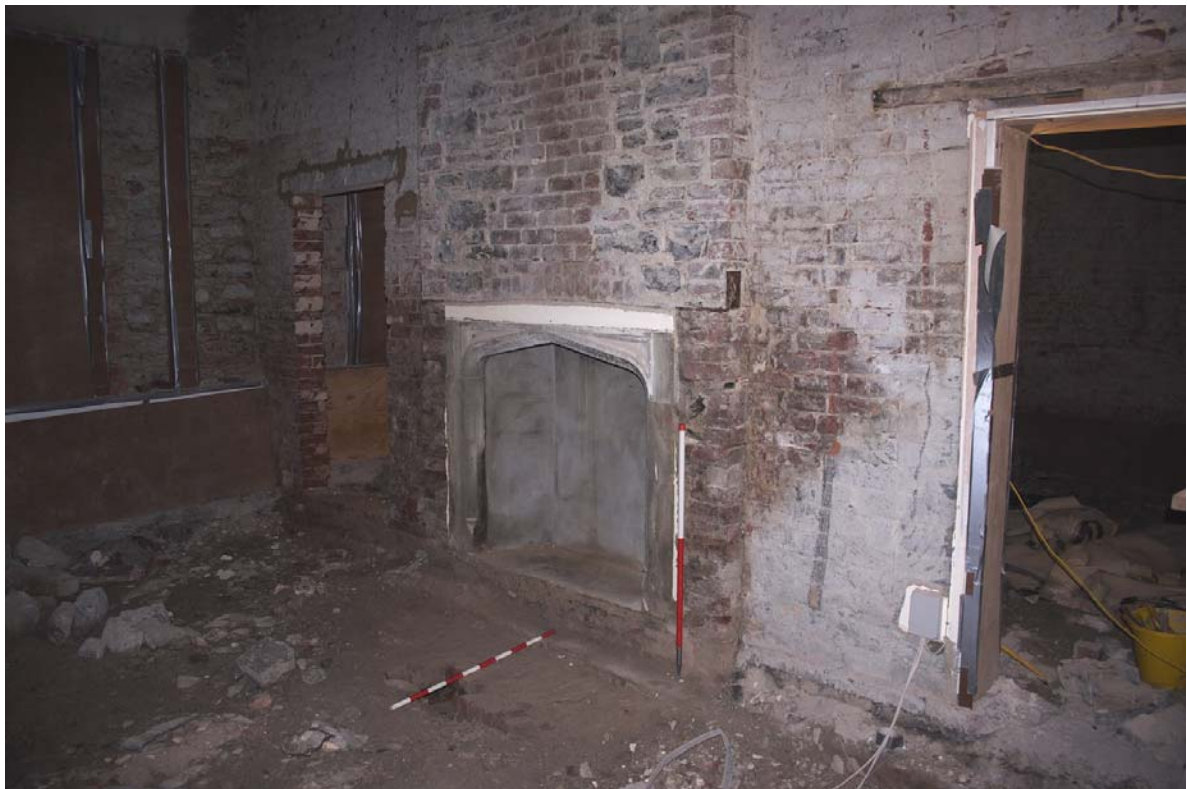
South wall (Fig. 8; Plate 6)

This wall is the rear of the North wall of Room 1. It is, therefore, constructed from red brick and it has a central fireplace and chimneybreast. This chimneybreast is

also a combination of red brick and coursed stonework. The chimneybreast is flanked on either side by doorways, 2.23m high x 1.13m wide, that lead to Room 1.

Figure 8: South wall of Room 2, including attic.

Plate 6: The central fireplace in the south wall of Room 2.

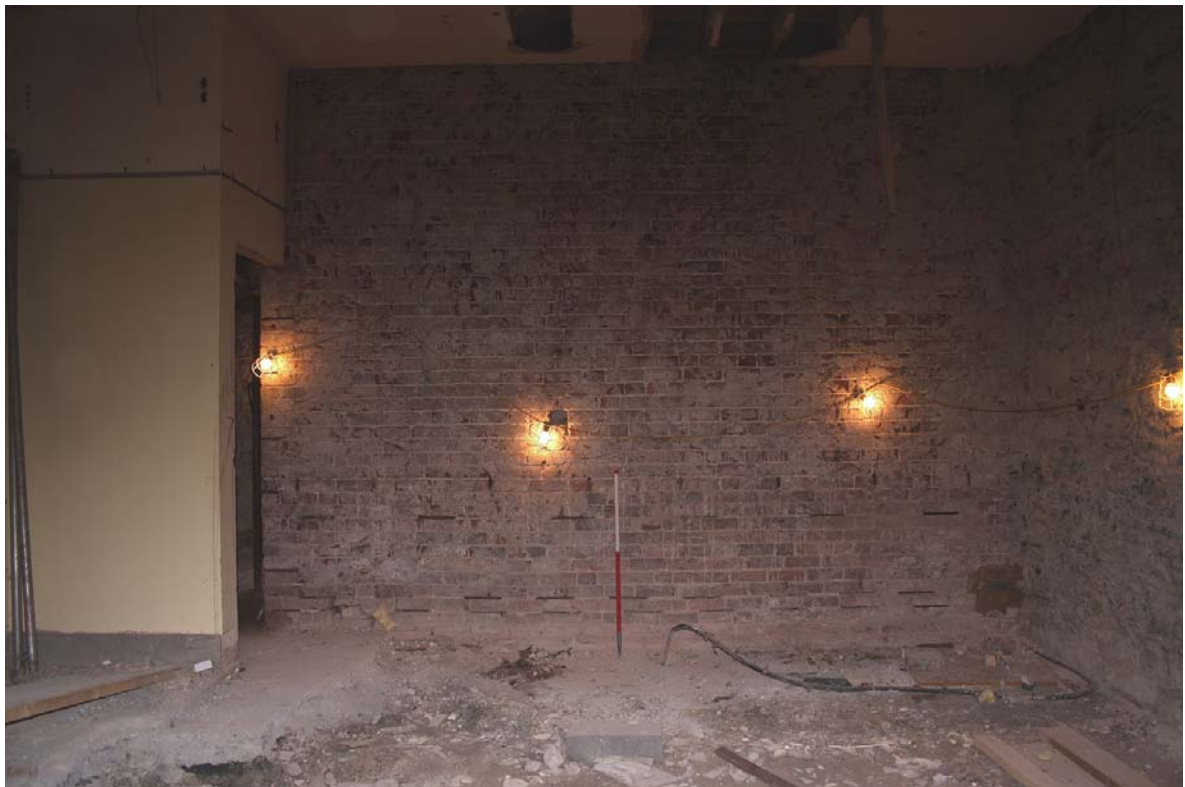
West wall (Fig. 9; Plate 7)

A plain wall constructed using red brick. There is a central doorway and from the north side of the door opening the wall is stepped in by c.0.5m.

Figure 9: West wall of Room 2, including attic.

Plate 7: The west wall of Room 2.

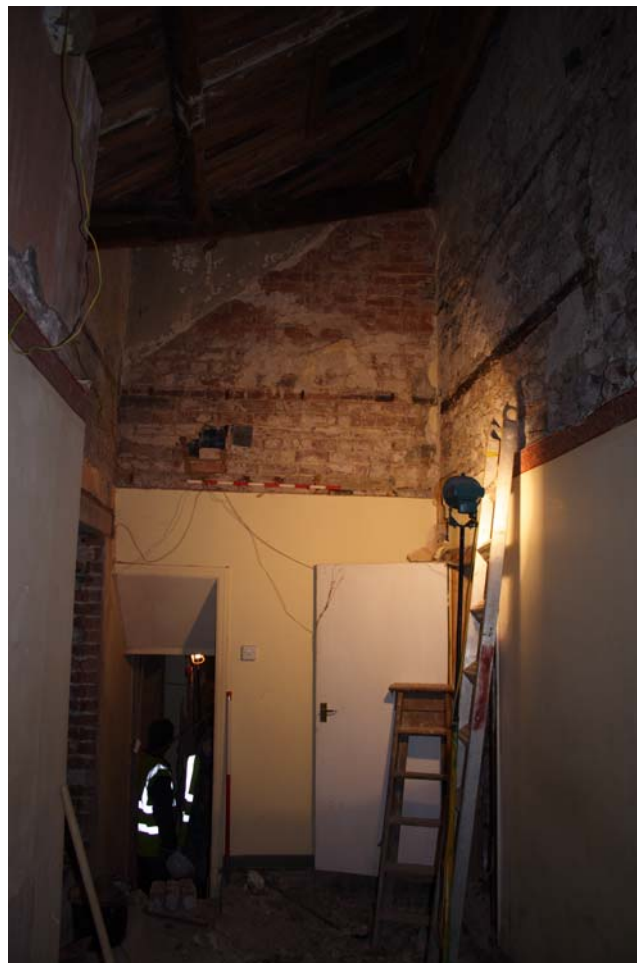
North wall (Fig. 10; Plate 8)

A narrow rectangular wall measuring c.2m wide x 4.5m high. A former ceiling line shows the upper floor level. The lower section of the wall is rendered and painted a yellow/cream colour. A door in the west side of the wall led to a short flight of steps to the main corridor.

The upper levels of the wall (above the former ceiling level) also exhibited what appeared to be a scar from a timber floor, approximately 0.75m above the former ceiling line, and the line of a former sloping roof. The former roof line sloped from east to west and it was marked by a change from render (above the roof line) to brick (below the roof line). An area of stonework and a void were exposed in the space between the former ceiling line and possible floor level.

Figure 10: North wall of Room 3.

Plate 8: The north wall of Room 3, showing the old roof scar.

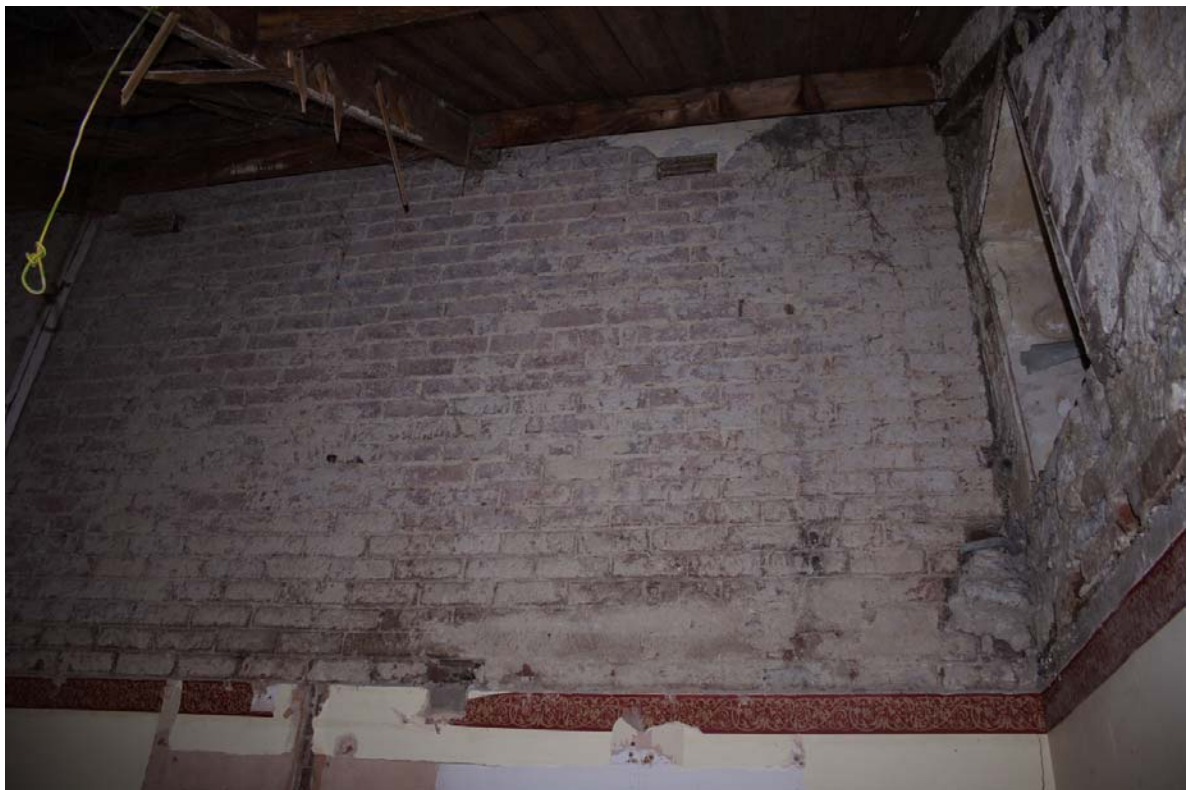
East wall (Fig. 11; Plate 9)

The east wall measured 6.7m x 4.5m. The lower half was rendered and painted yellow and white up to the former ceiling height. The upper half was a mix of stone and red brick and it exhibited a vertical wall scar from a removed partition. A horizontal timber and a single course of bricks let into the stonework corresponded to the possible former floor line in the north wall.

Figure 11: east wall of Room 3.

Plate 9: the upper portion of the east wall in Room 3.

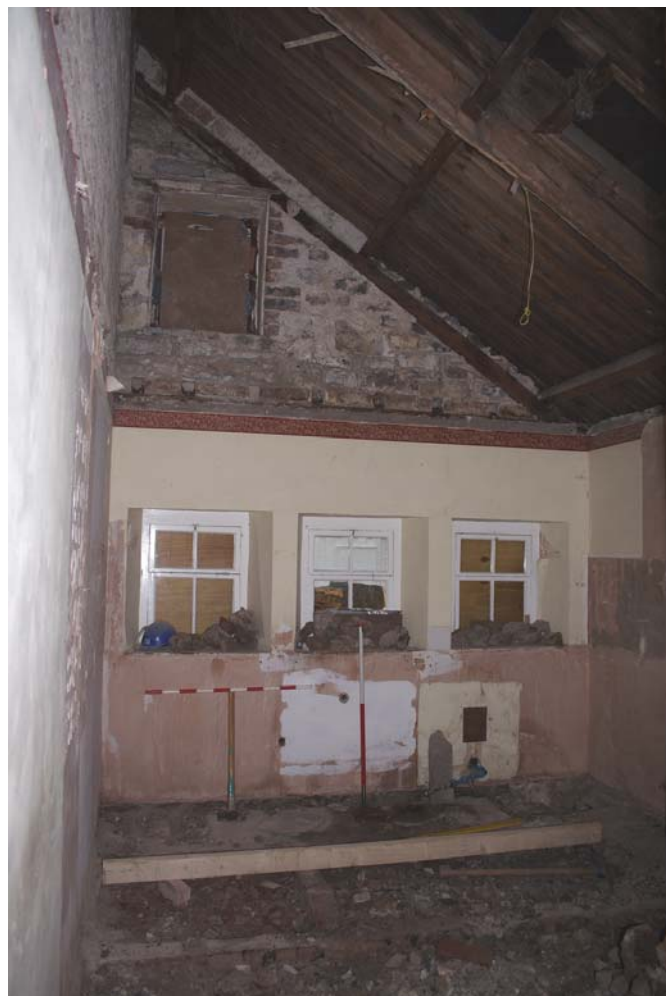
South wall (Fig. 12; Plate 10)

The south wall had a sloping roof that whilst sloping in the same direction did not match the former roofline on the north wall. The lower half of the wall, up to the base of the roof slope, was rendered and painted cream. The base of the roof slope also corresponded to the former ceiling height of the room. The lower half had three identical square-headed windows with internal splays and wooden frames. A blocked opening in the upper part of the wall was square-headed and had brick quoins.

Figure 12: South wall of Room 3.

Plate 10: The south wall of Room 3.

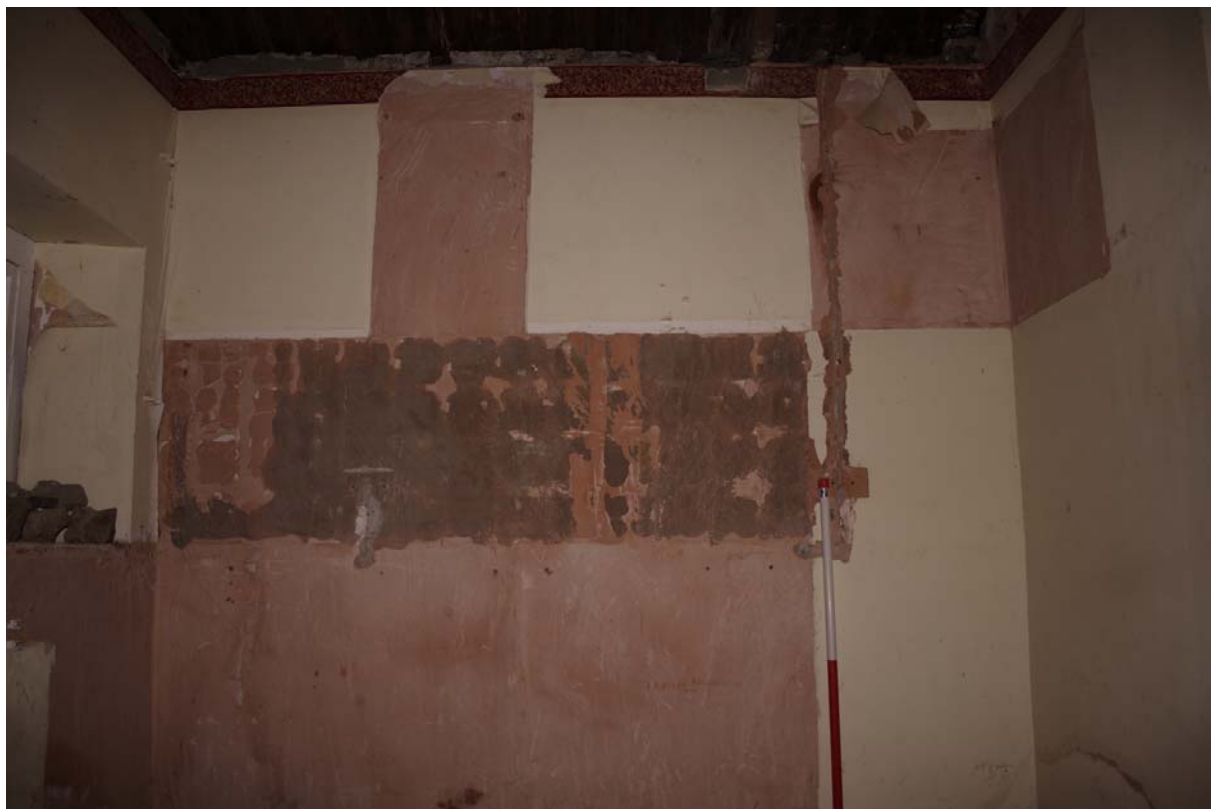
West wall (Fig. 13; Plate 11)

A plain rendered wall with a new doorway in the north end. The southern half of the wall is set back by about 1m. The corner of the return wall is chamfered. Steps at the northern end lead to the main corridor.

Figure 13: West wall of Room 3.

Plate 11: The south end of the west wall of Room 3.

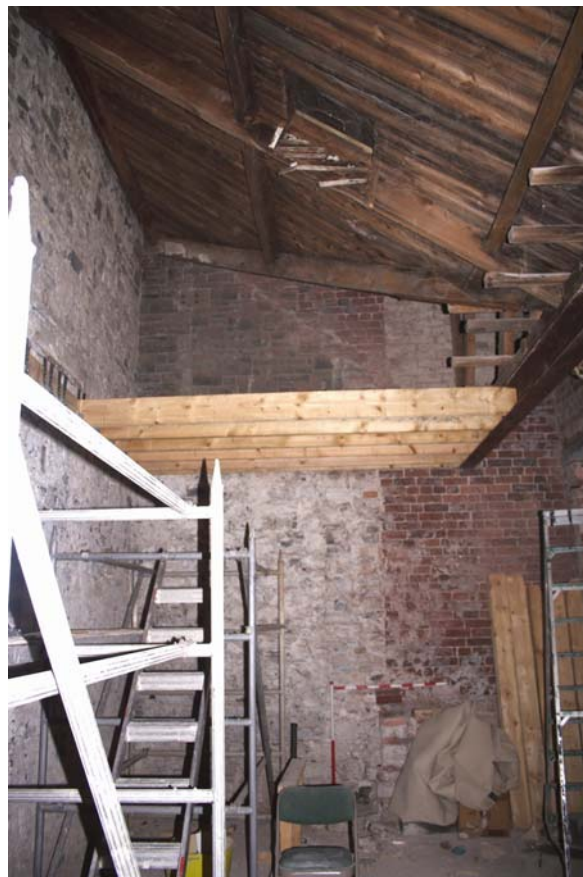
North wall (Fig. 14; Plate 12)

The north wall was constructed from rough coursed stonework, although the top right hand corner and some of the right hand side had been infilled with red brick. A former sloping roof scar was evident, which also marked the join between the stonework and the brick infilling at the top of the wall.

The former roofline and the areas of brick infilling suggest that part of this area was originally external and that it was converted by the raising of the roofline and blocking the gaps in the wall.

Figure 14: North wall of Room 4

Plate 12: The north wall of Room 4.

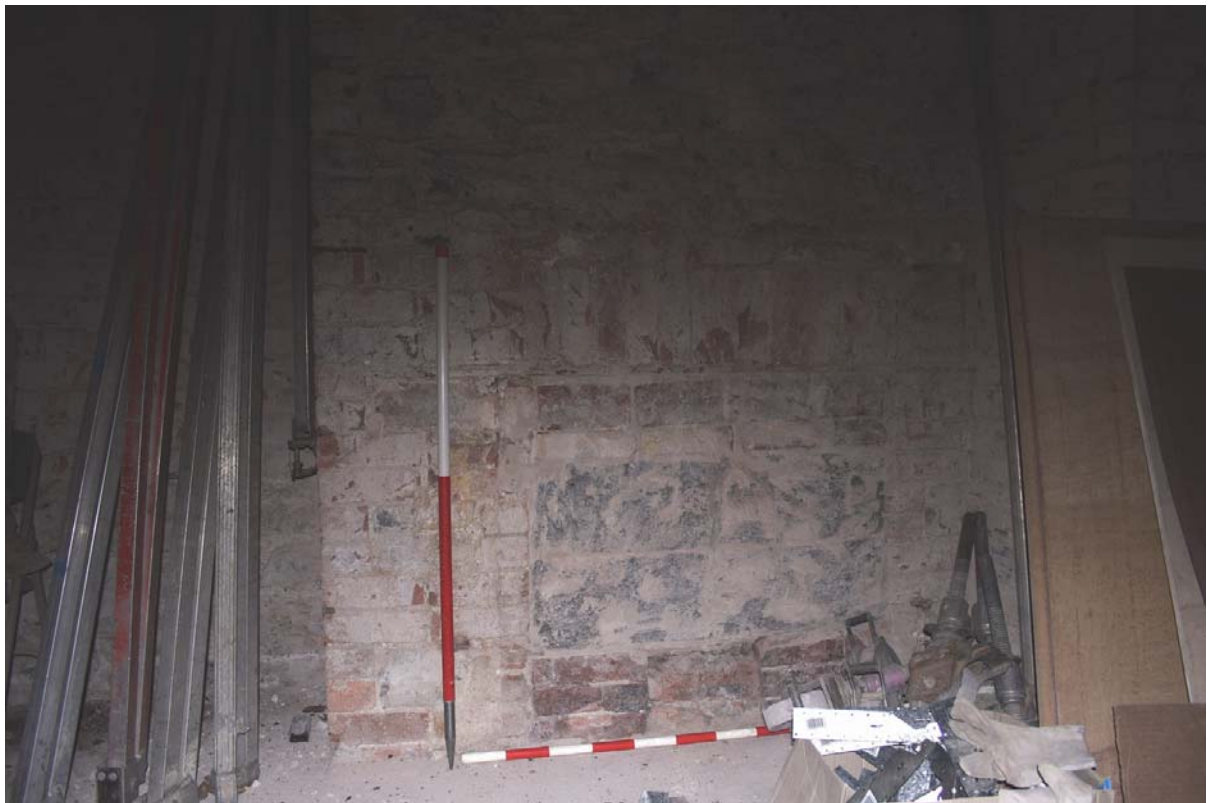
East wall (Fig. 15; Plate 13)

The east wall is staggered, stepping back twice by approximately 0.5m on each occasion. This divides the wall into three, with the only feature of note a blocked fireplace in the central section. The height of the southern two-thirds of the wall matches the bottom of the sloping roofline of the north and south (see below) walls. The roofline of the northern third of the wall rises to match the full height of the north wall.

Figure 15: East wall of Room 4.

Plate 13: The blocked fireplace in the east wall of Room 4.

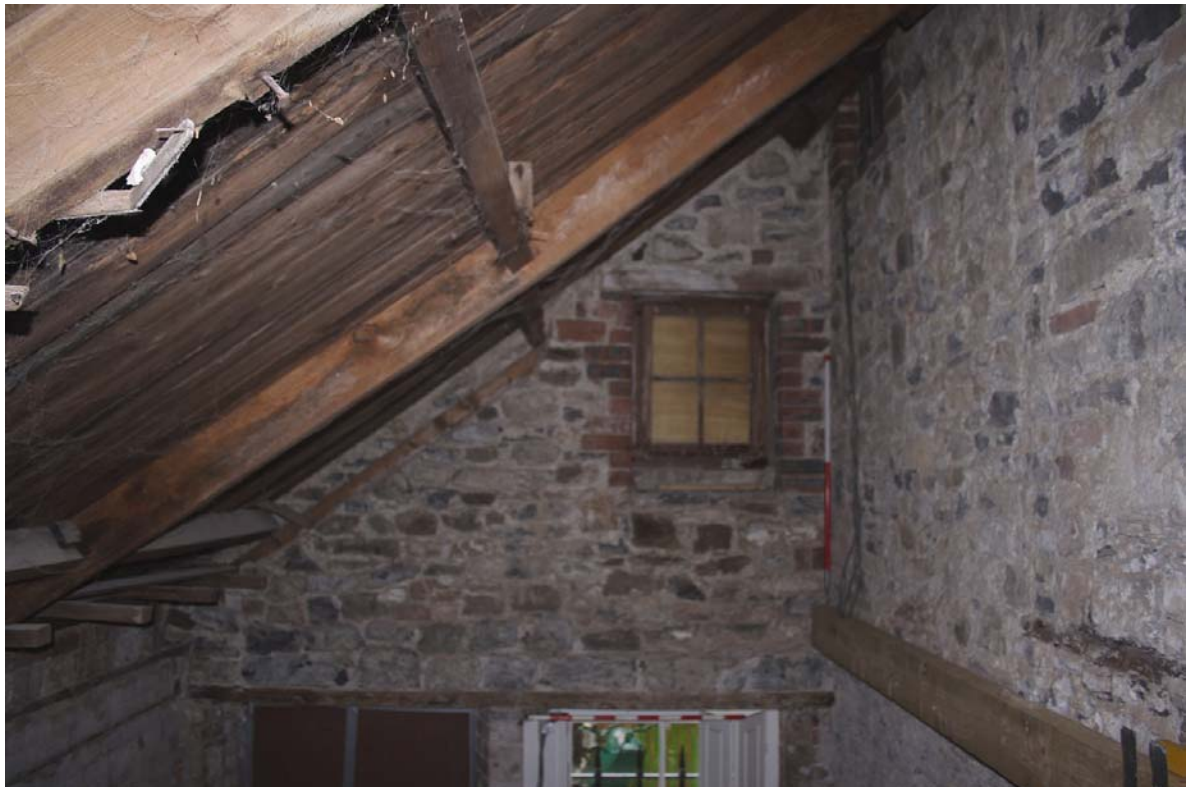
South wall (Fig. 16; Plate 14)

This is a narrow stone-built wall with a sloping roofline. It contained three square-headed windows, all with brick surrounds. Two large windows occupied the full width of the central section of the wall and may have been later insertions. The openings for the two large windows were formed in red brick and were splayed on either side. The third window was smaller and occupied the space below the sloping roofline.

Figure 16: South wall of Room 4.

Plate 14: the upper window in the south wall of Room 4.

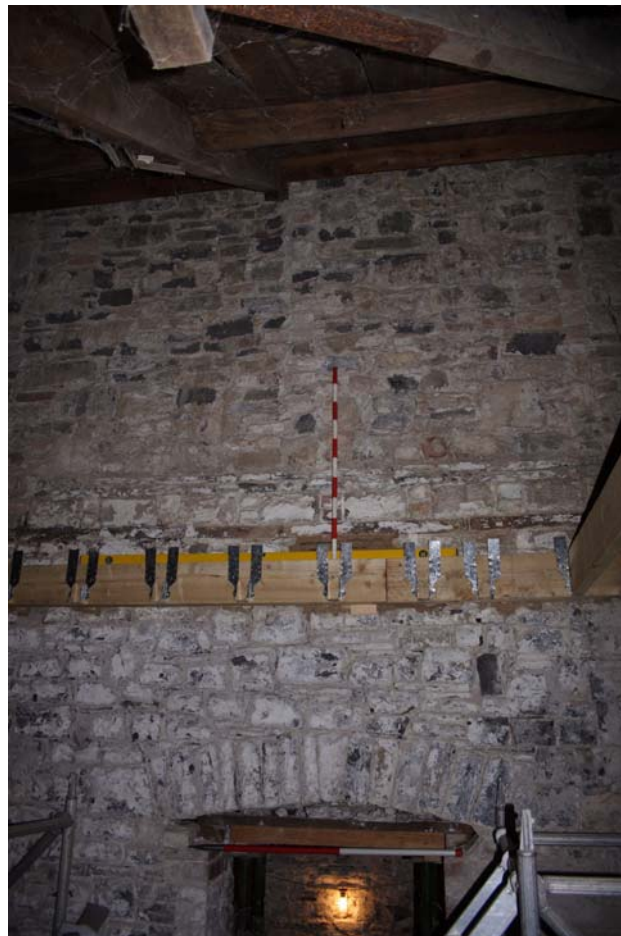
West wall (Fig. 17; Plate 15)

The west wall measures c.7m long x 5.6m high. The only feature in the lower half of the wall is a door to the main corridor (Room 5). The door opening has a timber lintel and stone relieving arch and is positioned just north of central in the wall. A former ceiling line – which matched the height of the lower portion of the east wall – was marked by redundant floor joist hangers for a timber floor of an upper room.

The lower part of a blocked window was recorded in the upper left hand corner of the wall and several wall scars from light partitions shows that the upper room was sub-divided at some point in its history.

Figure 17: West wall of Room 4.

Plate 15: A section of the west wall of Room 4.

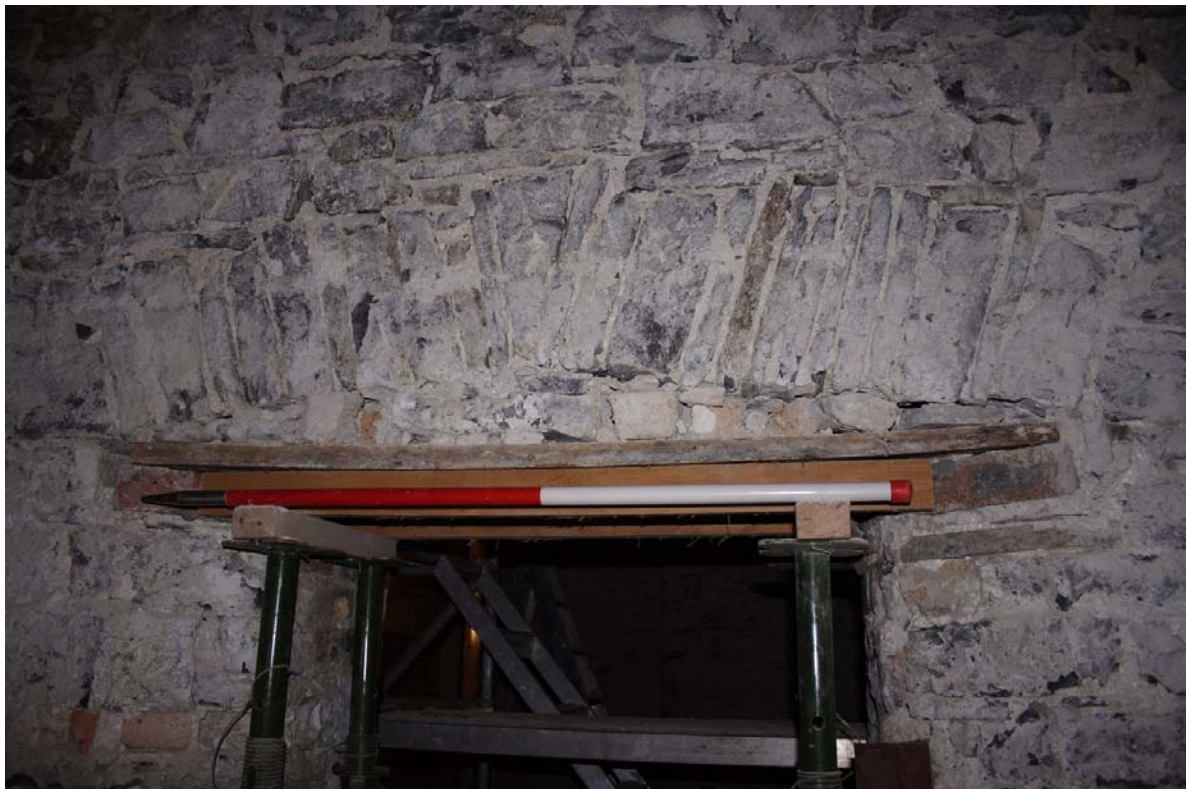
East wall (Fig. 18; Plate 16)

A plain coursed stone wall. This wall was recorded as a double height wall because the floor to the upstairs had been removed. A plain square-headed door with a timber lintel and stone relieving arch leading into Room 4 is the only feature in the lower half of the wall. The door jambs are chamfered.

The wall of the upper floor has part of a blocked window in the top right hand corner. This is the same window that was recorded in the west wall of Room 4. The only other feature visible in this part of the wall was a vertical wall scar from a former lightweight partition.

Figure 18: east wall of Room 5.

Plate 16: The stone relieving arch above the doorway to Room 4 in the east wall of Room 5.

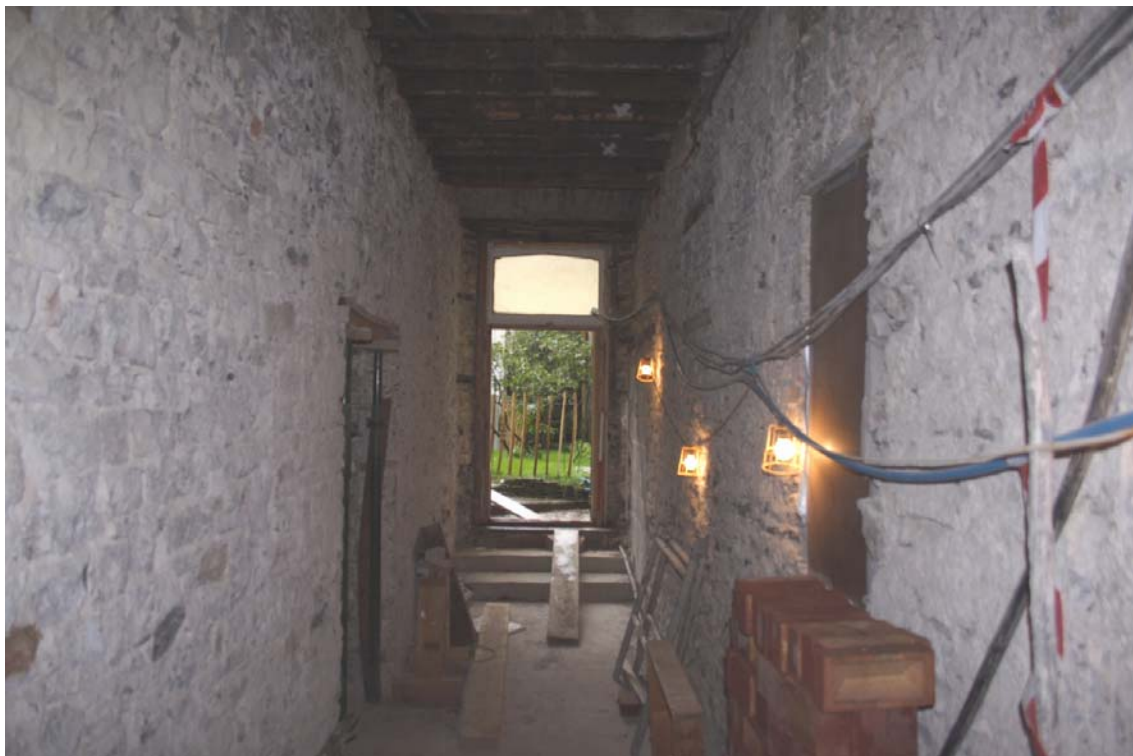
South wall (Fig. 19; Plate 17)

The south wall leads from an external door reached via a short flight of concrete steps. The door opening is square-headed with a stone relieving arch above and it has splayed jambs. There is a glass light above the door. A narrow square-headed window takes up most of the upper section of the wall.

Figure 19: South wall of Room 5.

Plate 17: the external door in the south wall of Room 5.

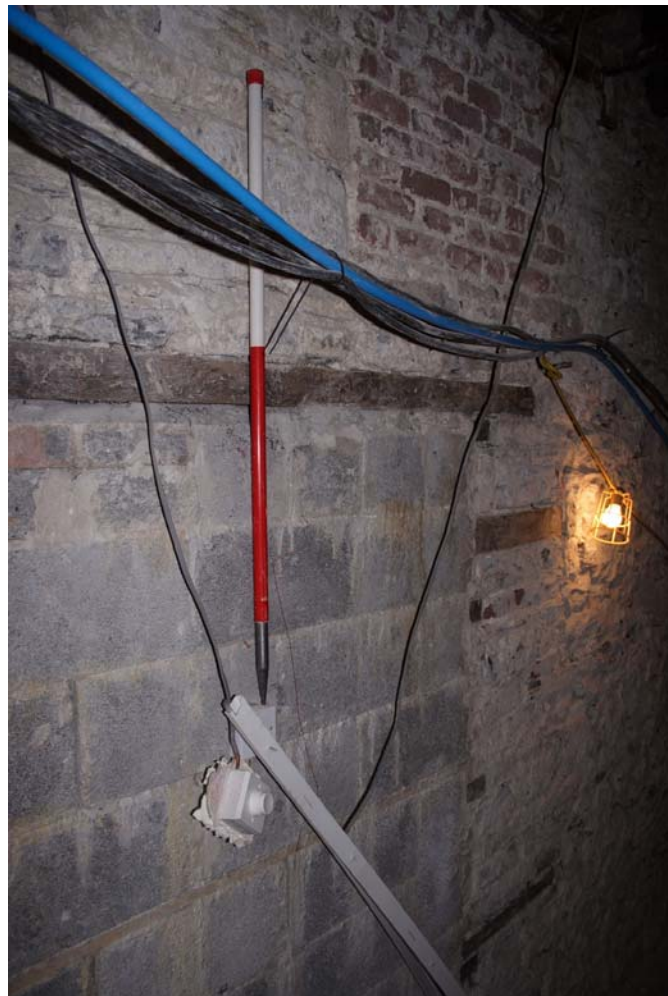
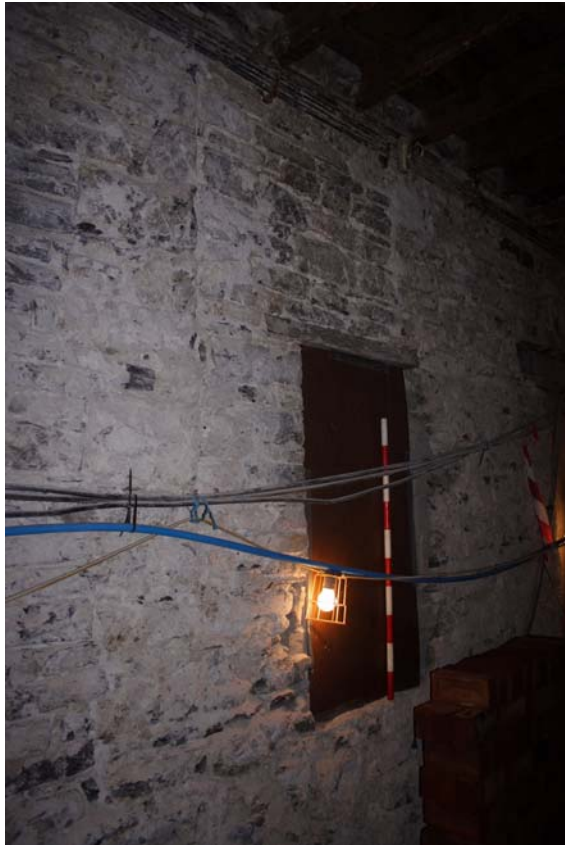
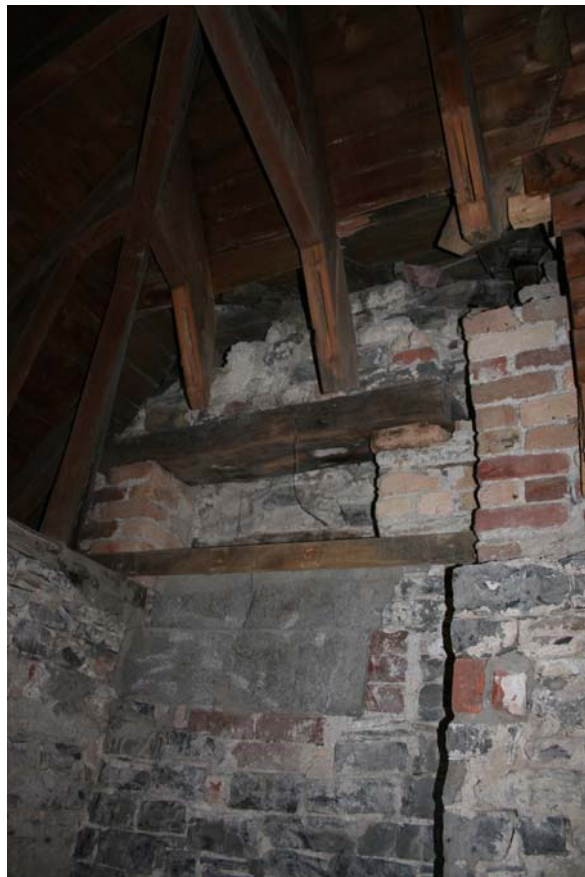
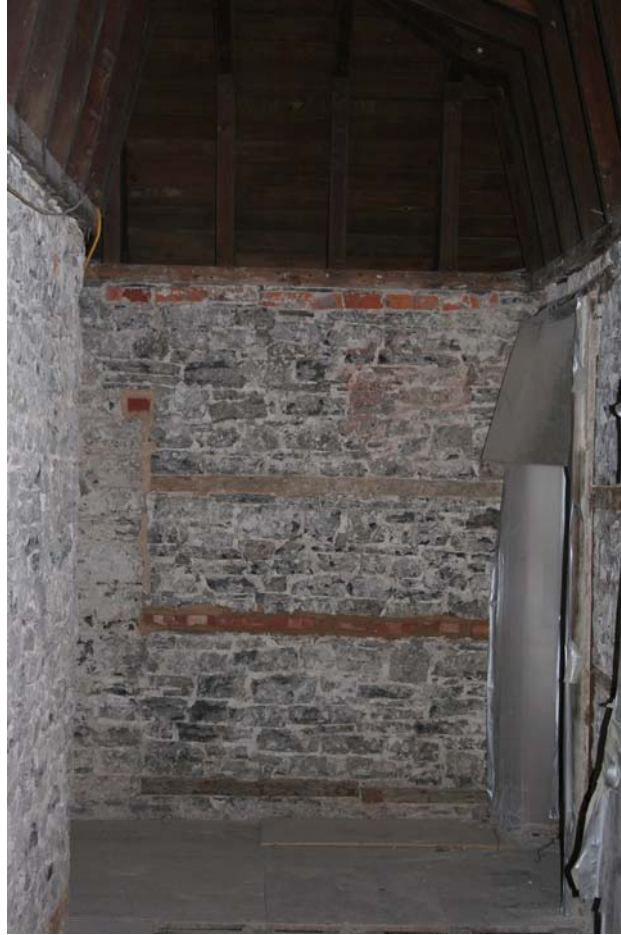
West wall (Figs. 20; Plates 18, 19, 20 and 21)

The west wall is very complex and shows several phases of construction. As with the east wall this was recorded as double-height wall because of the removal of the floor to the upper level. The wall will be described in ground and upper floors and from south to north.

A blocked square-headed doorway occupied the southern most 1.76m. The door had a timber lintel and the opening was blocked with breeze blocks. A small square blocked opening was located 0.21m above the right hand jamb of the blocked door. The top of the opening only extended as far as the former ceiling line and it did not extend into the upper floor level.

Approximately 1.5m north of the opening was a larger blocked opening, 1m wide x 1.8m high, probably a former window. This had a timber lintel and two horizontal timbers that separated the blocking into three sections, suggesting that the window may have been blocked in stages. There was an identical opening, also blocked 1.3m to the north.

This blocked window had had a smaller, later opening, also blocked, inserted into it. The later opening was 0.6m wide x 1.2m high.

A large blocked doorway, 1.65m wide x 2.4m high extended south from the north end of the wall. The doorway had a large timber lintel and stone relieving arch above.

Just like on the ground floor, a blocked opening – possibly a doorway – occupied the southern end of the wall. The opening measured 1.22m wide x 2.50m high and it was headed by a squared timber lintel. Above the lintel were two small brick piers constructed to support a wall plate for the decorative roof timbers. Stone blocking filled the gap between the piers. The upper left hand corner of the blocked opening had apparently been knocked through some time after the possible door was blocked. This later opening was subsequently filled by breeze blocks.

A second large blocked opening, also probably a doorway, was located 0.88m to the north of the first door. This second door was 1.28m wide x 2.45m high making it almost identical in size to the first doorway. The right hand edge of the door had been cut through a former window. The window was one of a pair, the other being 1.3m to the north. Both windows were blocked with stone coursed to match the surrounding wall.

The north end of the wall contained a blocked opening, probably a doorway to match the one on the ground floor. Part of the wall had been damaged at the top left hand corner of the former door, possibly when the lintel was removed.

Figure 20: West wall of Room 5.

Plate 18: The blocked doorway at the south end of the west wall of Room 5.

Plate 19: The northern of the two blocked windows, with the later opening in the west wall of Room 5.

Plate 20: South blocked doorway in the upper level of the west wall of Room 5.

Plate 21: North blocked doorway in upper level of west wall in Room 5.

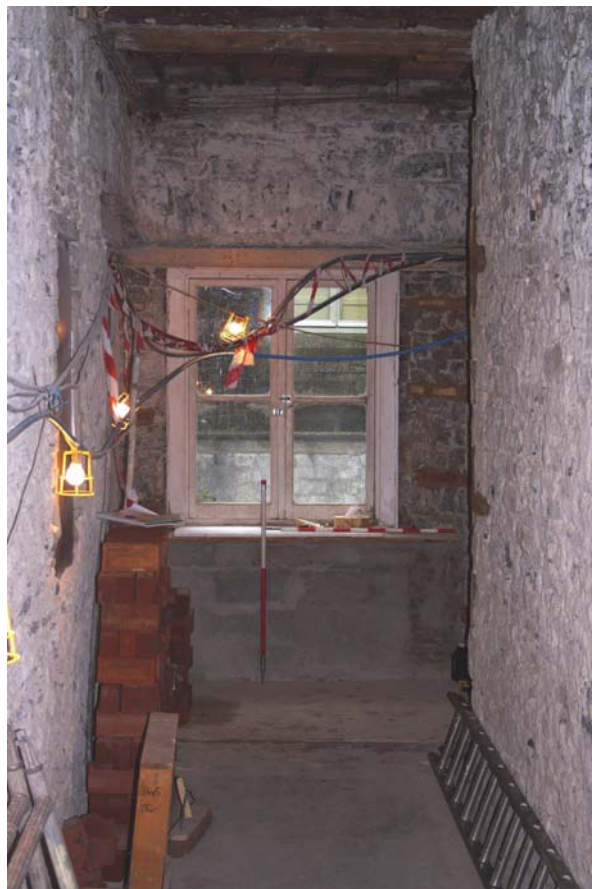
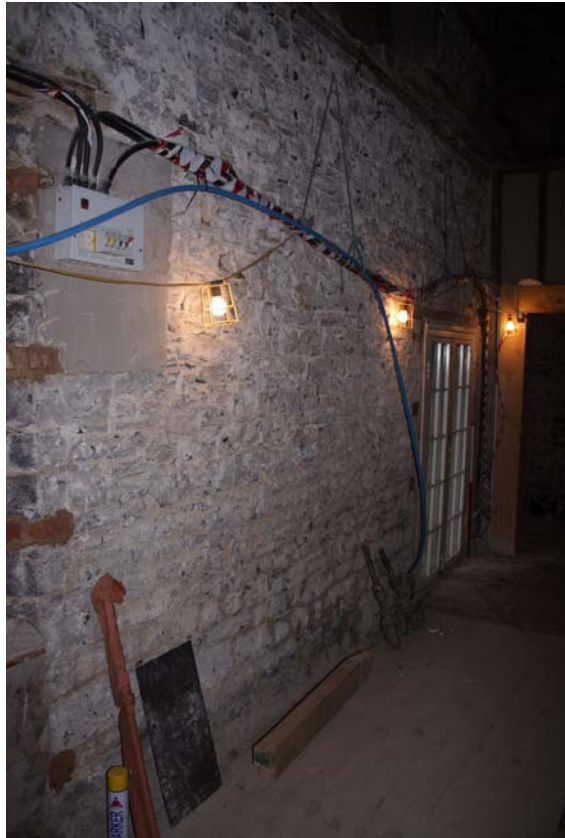
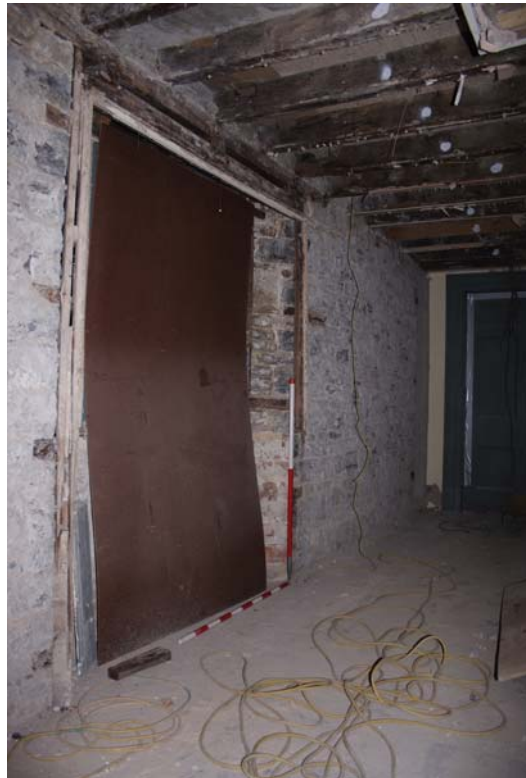
North wall (Fig. 21: Plate 22)

The north wall is stone-built and consists of an upper and lower floor.

The lower floor wall contains a window and a door, which opened onto the passage to the boiler room. The window, which was a partially blocked door, lies at the north end of the Room 5 opposite the external door. The door is located at the east end of the wall and consists of glazed French doors. Both the window and doors have a timber lintel and stone relieving arch above.

The upper portion of the wall, corresponding to the upper floor, contains two full height windows, which open onto the servants' hall. The windows were intact but covered during this survey. They were square headed and had flared internal reveals. The windows were of the same design but the opening for the eastern window was 0.6m wider than the westernmost window.

Figure 21: North wall of Room 6a.

Plate 22: A former door modified into a window in the north wall of Room 6a.

Plate 23: General view east along the north wall of Room 6a showing the French doors that lead to a central courtyard.

Plate 24: View east along the upper level of the north wall of Room 6a showing the two splayed window openings.

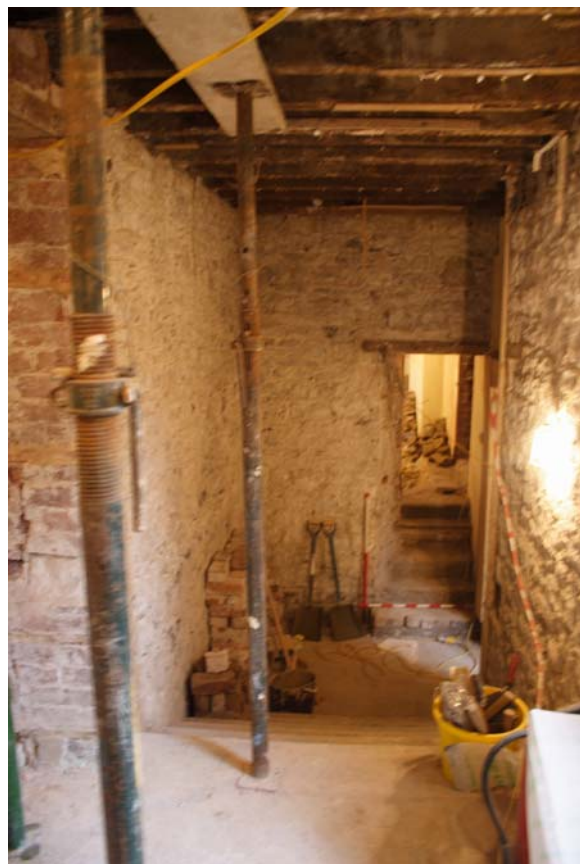
South wall (Fig. 22: Plates 23, 24 and 25)

A plain coursed stone wall with a short flight of concrete steps leading to the door leading to Room 3 at its east end.

Figure 22: South wall of Room 6a.

Plate 25: The door to Room 3 in the south wall of Room 6a.
