NEWTON HOUSE, DINEFWR BILLIARD ROOM RAPID BUILDING RECORDING

REPORT NO. 2006/24
PROJECT RECORD NO.56262

**NEWTON HOUSE, DINEFWR
BILLIARD ROOM
RAPID BUILDING RECORDING**

SUMMARY

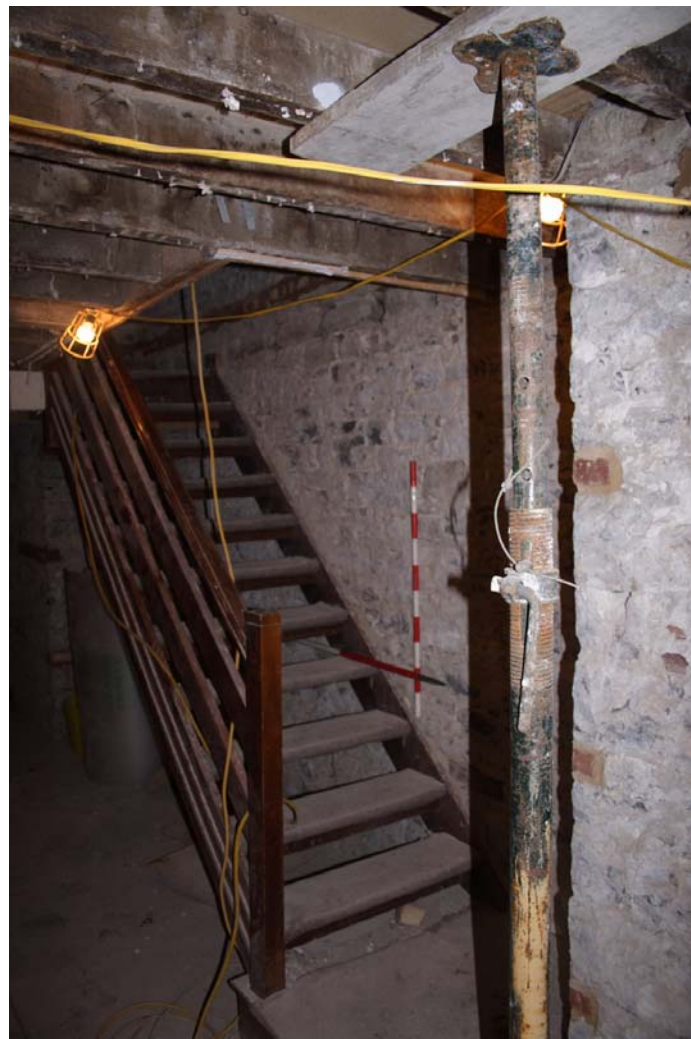
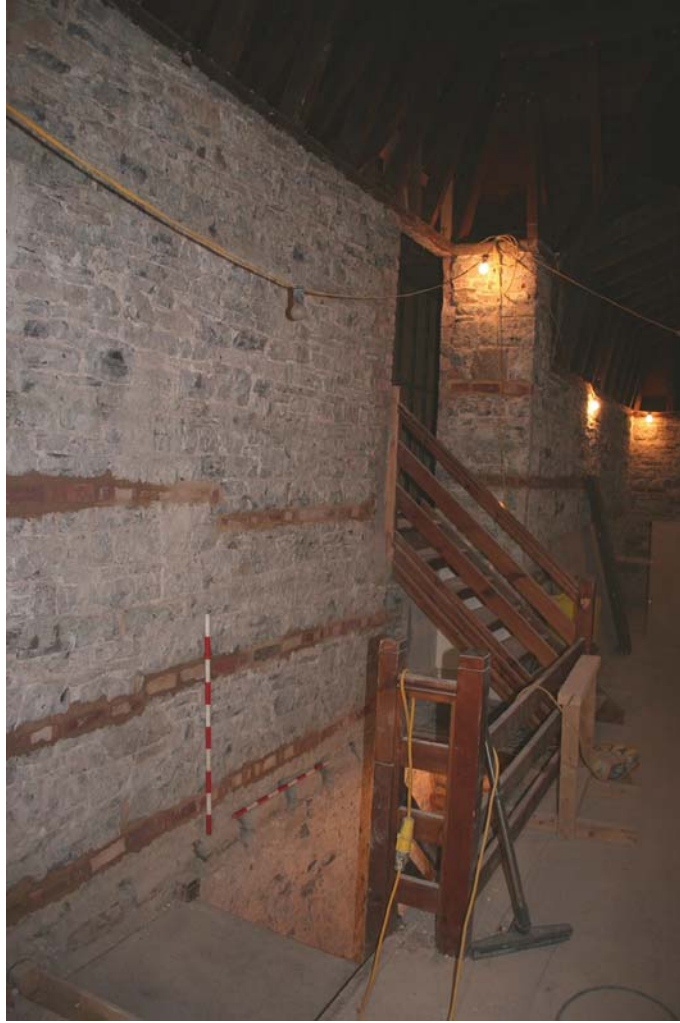
East wall (Fig. 23: Plates 26 and 27)

This part of the corridor is split-level, with a short flight of concrete steps leading up from Room 6a at the south end. The door to Rooms 1 and 2 is situated at the top of these steps. This is the only feature in the lower section of the wall.

The wooden stairs to the upper level of the corridor are fixed against the east wall. A door, reached by a short flight of wooden steps leads to the attic space above Rooms 1 and 2.

The wall was constructed from coursed stonework and the upper level had a number of single courses of brick. These courses were of varying lengths and were inserted to replace squared timbers. There was no consistent pattern to the positions of the brick courses (or former timbers) on this wall, although there were three regular horizontal courses in the west wall. The function of the former timbers is uncertain, but it may have been to hang wooden panelling.

Figure 23: East wall of Room 6b.

Plate 26: A view north along the east wall of Room 6b with the wooden stairs to the upper floor.

Plate 27: A view south along the upper part of the east wall of Room 6b showing the door to the attics above Rooms 1 and 2.

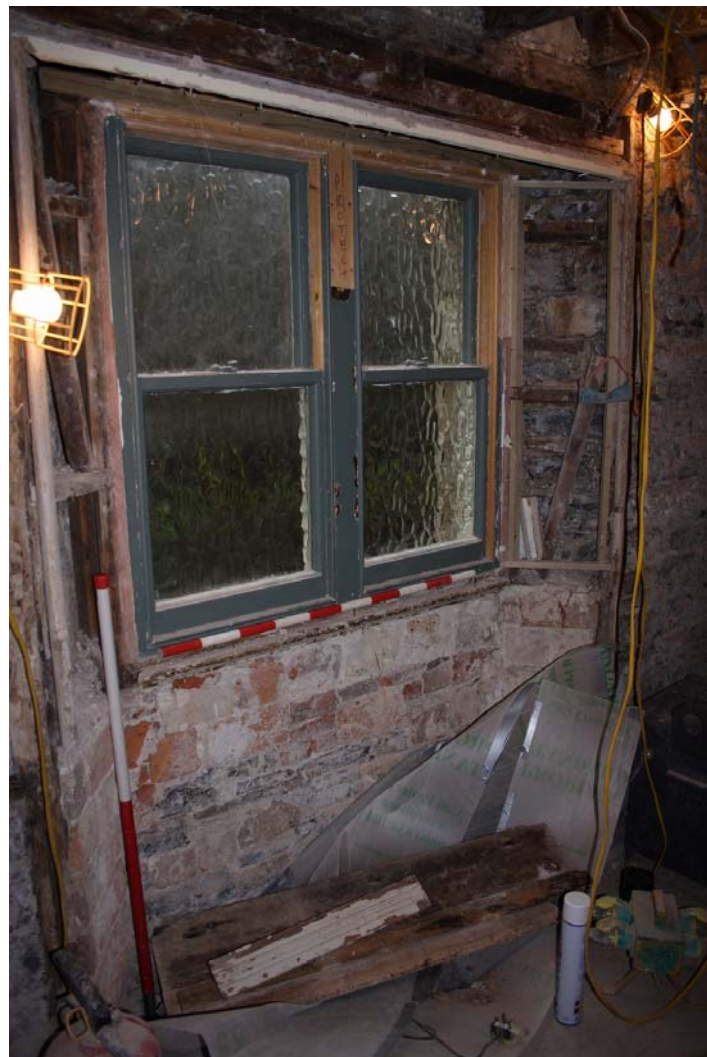
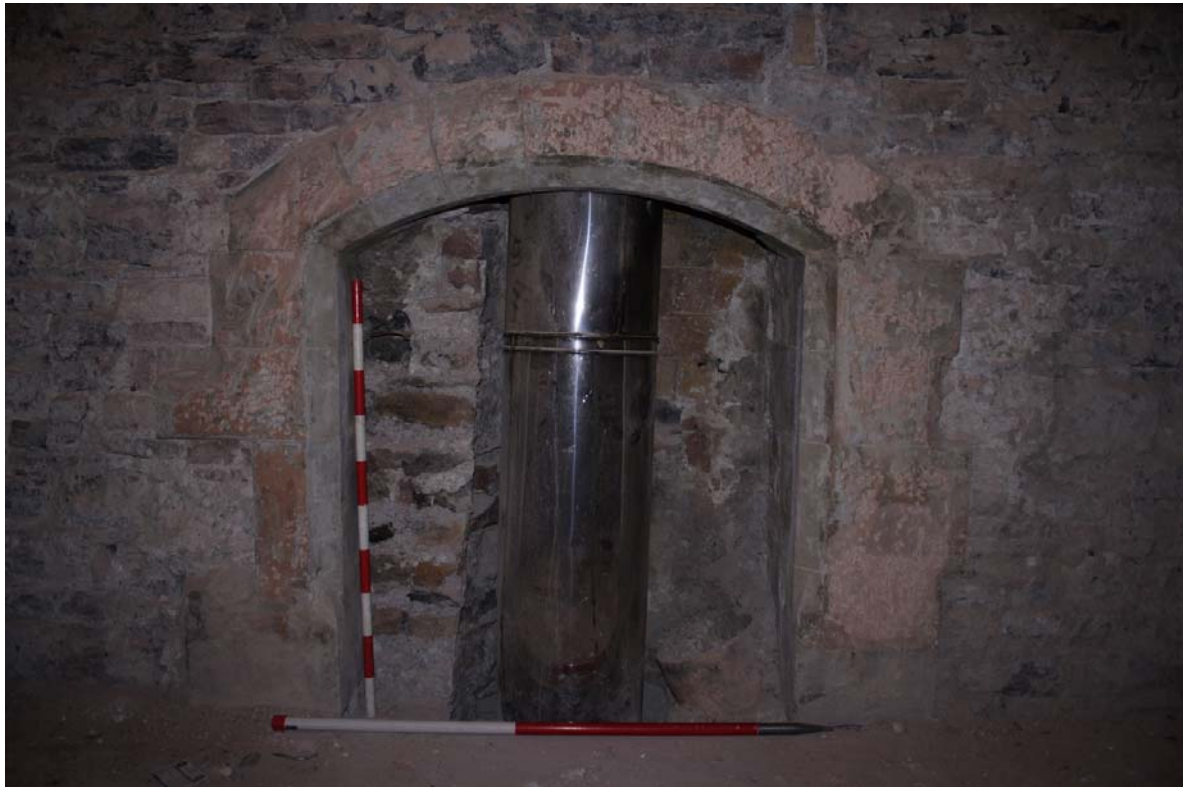
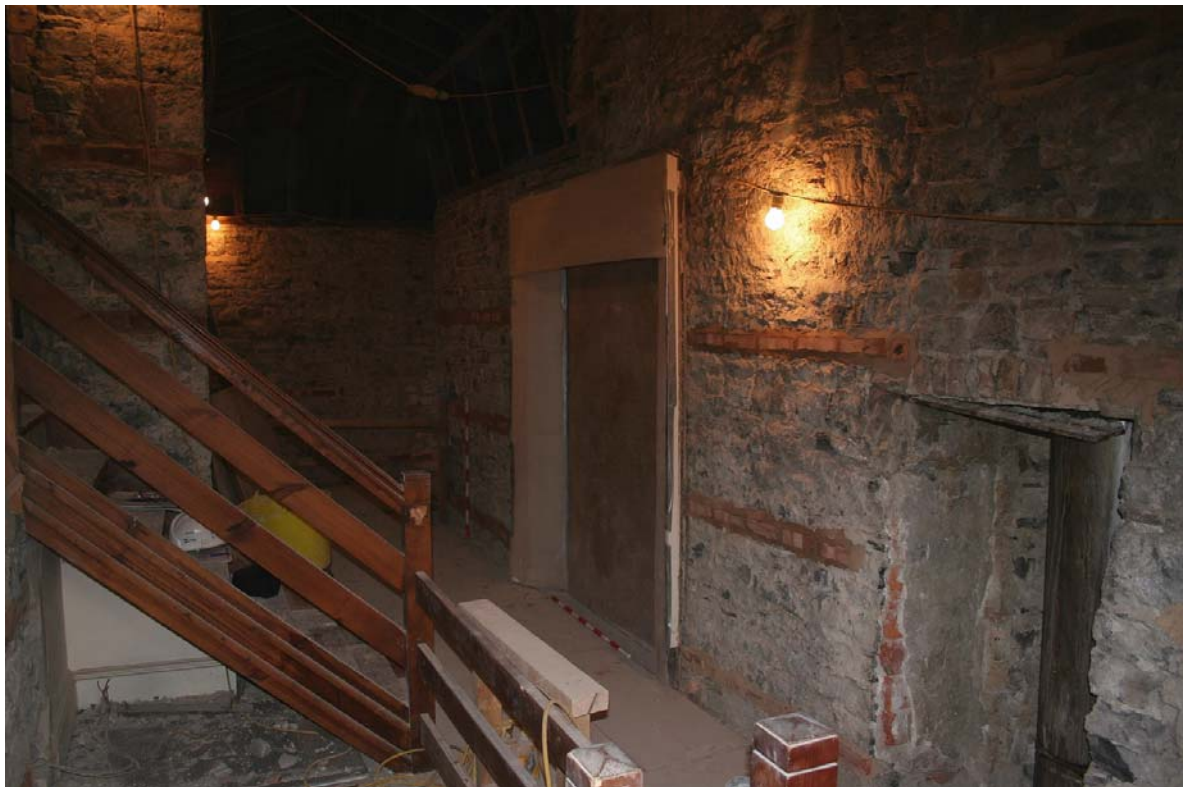
West wall (Fig. 24: Plates 28, 29 and 30)

The west wall is more complex than the east wall. The lower floor was split-level, with concrete steps down to Room 6a at the south end. There was a window that

looks out onto the servants' hall at the top of the steps. Another identical window was located c.3.4m to the north. Both the windows were full height with internal splays and wooden frames.

A partially bricked opening, possibly a fireplace, in the wall was placed centrally between the windows. The stainless steel flue from the boiler rises through the opening. The opening had a simple Bath Stone surround, which seemed out of character with the fireplaces in Rooms 1 and 2. It is possible that the opening was an earlier window converted to a fireplace before being utilised for the boiler flue. More detailed study of this feature may reveal more information about its construction and purpose.

The upper floor mirrored the lower floor with exactly the same arrangements of windows flanking a central opening, which like the opening on the lower floor was possibly a fireplace. The windows were covered, but were the same dimensions as those on the lower floor and were presumably the same design. The possible fireplace was a simple narrow rectangular opening with a flat brick arch, which may have been constructed to accommodate the insertion of the steel flue from the boiler. Again more detailed study in this area may reveal the construction sequence for the opening and its original function.

Figure 24: West wall of Room 6b.

Plate 28: The southernmost window in the west wall of Room 6b.

Plate 29: The fireplace in the west wall of Room 6b.

Plate 30: view south along upper level of the west wall of Room 6b showing the central fireplace and the southernmost window. Also shown are the courses of bricks inserted to replace horizontal timbers.

There are a few elements that cannot be easily explained, in particular the fireplaces in the west wall of the corridor (Room 6b), which seem out of place in a corridor, although it is possible that the downstairs fireplace may have been converted from an earlier opening in what was originally an external wall.

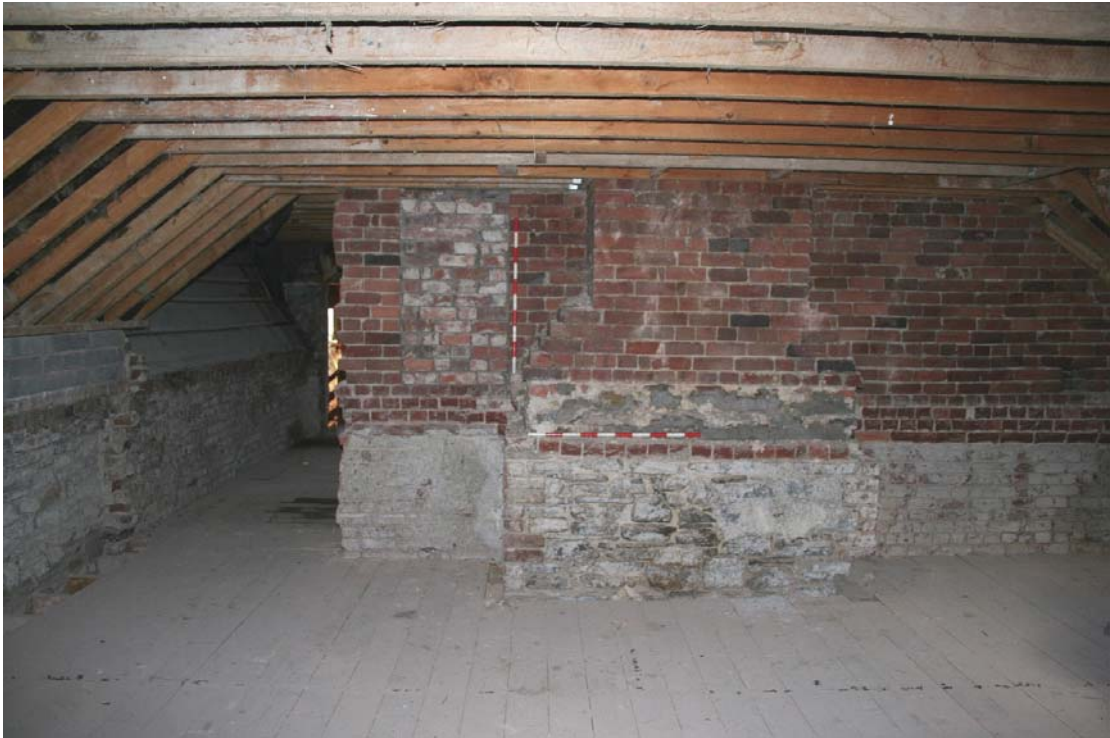
Plate 31: North wall of the attic above Room 1 showing top of chimney breast and blocked opening.

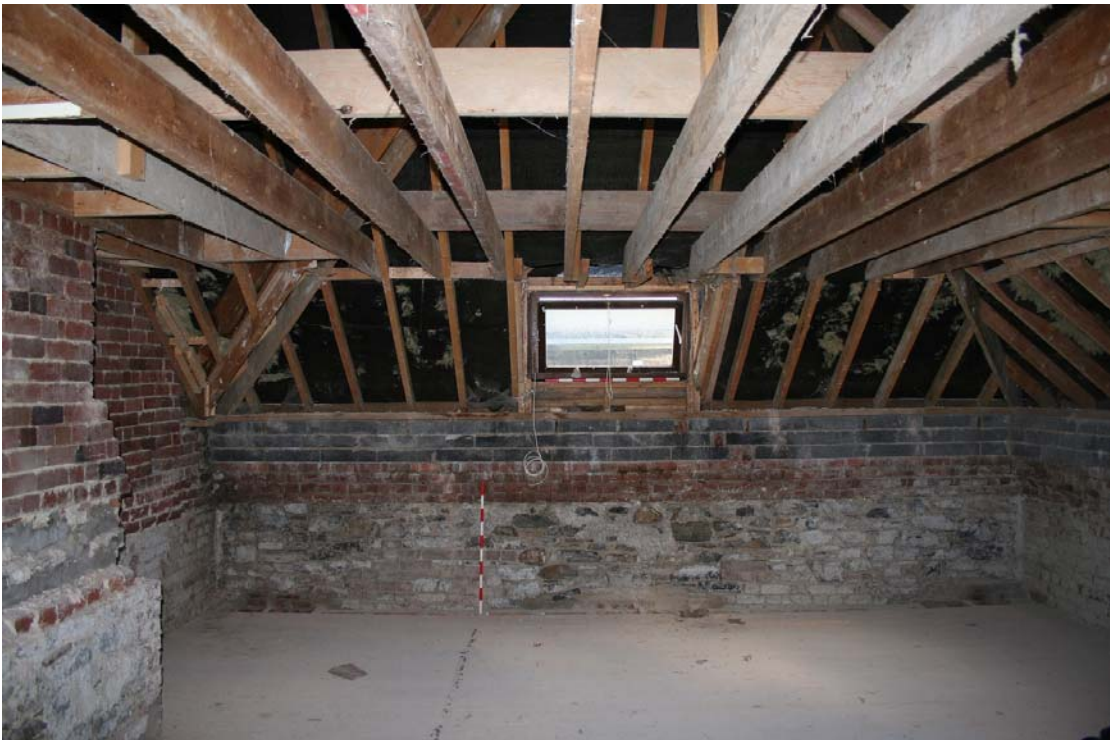
Plate 32: East wall of the attic above Room 1.

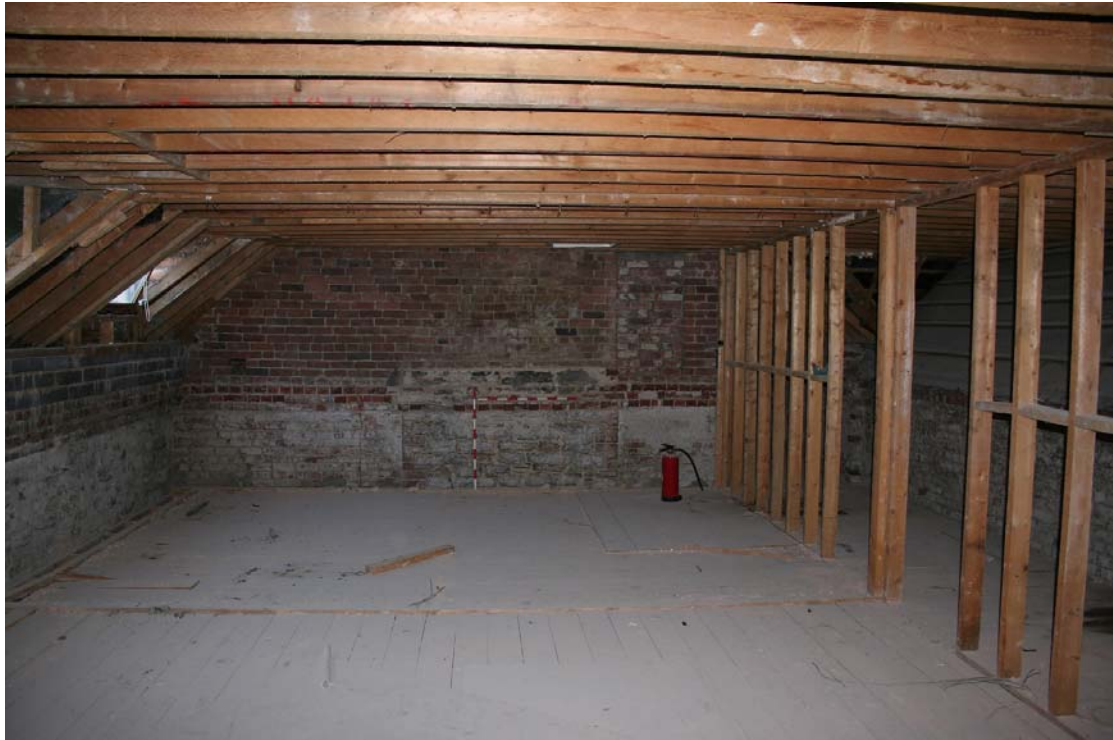
Plate 33: South wall of the attic above Room 2.

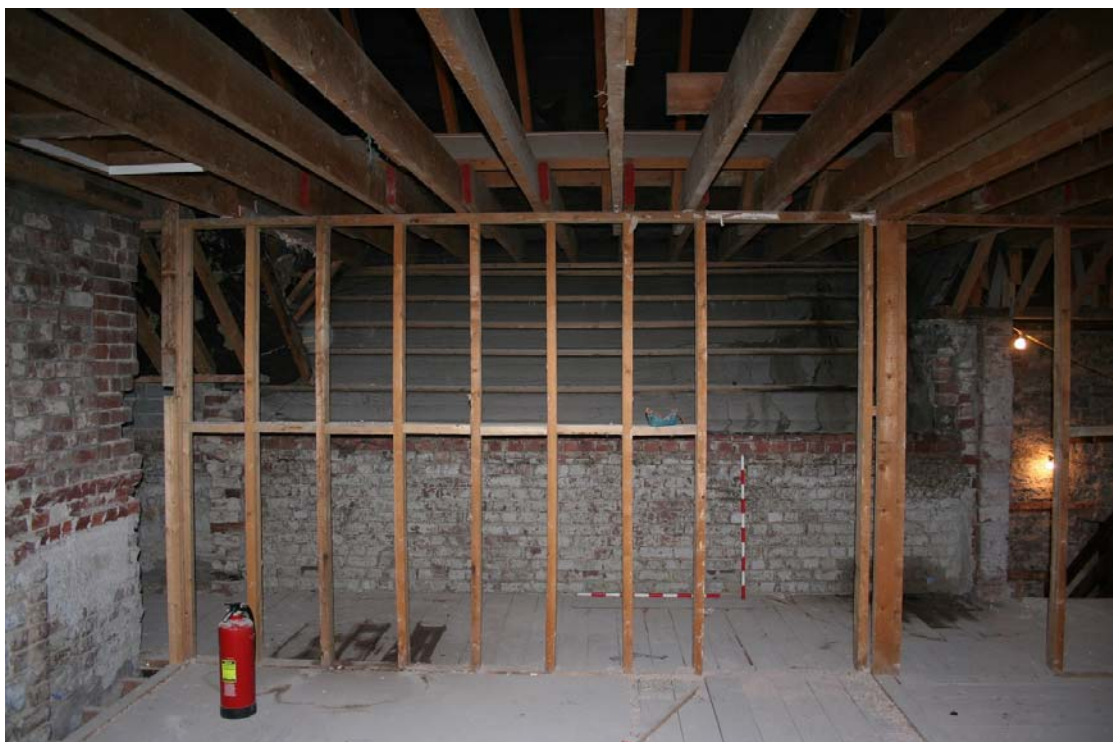
Plate 34: Section of the west wall of the attic above Room 2.
