**ARCHAEOLOGICAL RECORDING AT  
NORTH DRIVE AND  
SERVICES PIPELINE FOR HOME FARM  
DINEFWR PARK  
LLANDEILO CARMARTHENSHIRE**

RHIF YR ADRODDIAD / REPORT NO. 2006/29  
RHIF Y PROSIECT / PROJECT RECORD NO. 56365

### **ARCHAEOLOGICAL RECORDING AT NORTH DRIVE AND SERVICES PIPELINE FOR HOME FARM, DINEFWR PARK, LLANDEILO, CARMARTHENSHIRE**

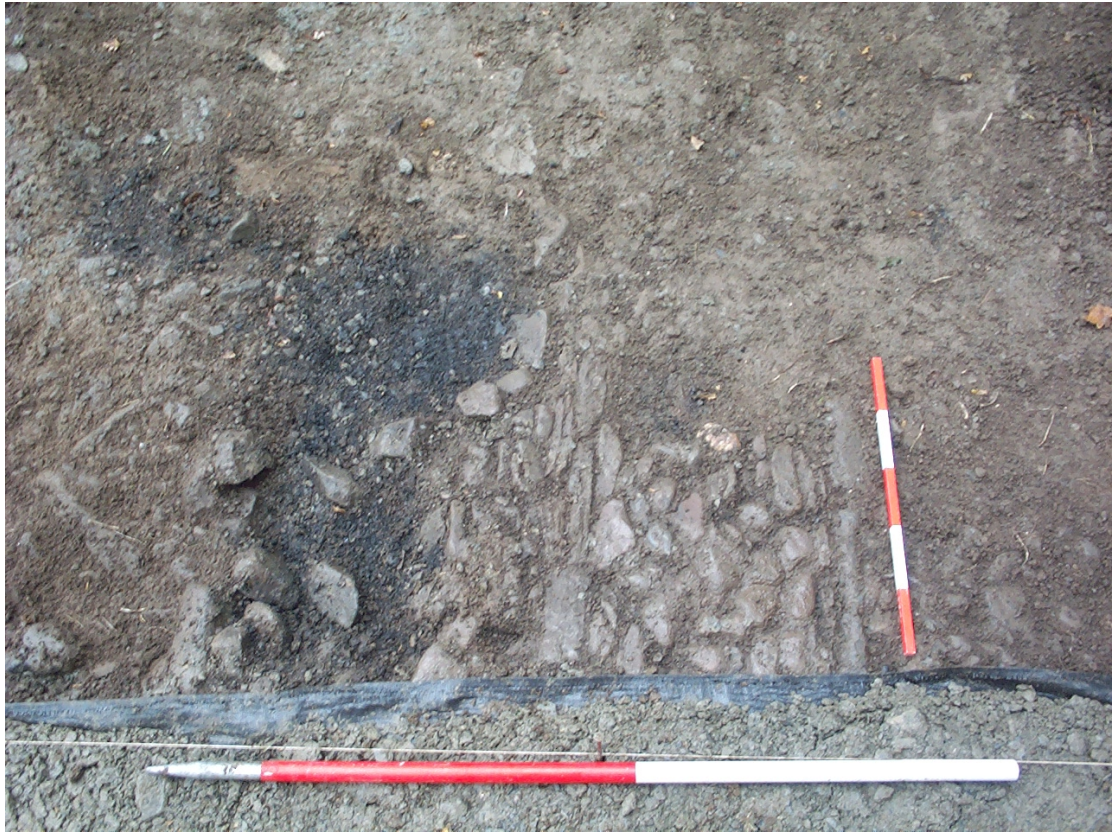
**Photo 1:** Pitched stone surface, direction of view west

The revealed pitched stone surface is approximately 1.0m wide N-S with its long axis aligned E-W and continuing due east across the North Drive beneath the newly laid geotextile matting and stone sub-base make up. A length of the pitched stone surface (Photo. 1) measuring some 0.9m was all that was left visible at the time that the archaeological record was made and this represented all that remained of the western end of the feature. A certain amount of machine destruction had taken place during the topsoil strip that made it impossible to establish with any certainty the original extent of the pitched stones to the west. Damage had also occurred on the southwest side of the pitched stones but enough remained *in situ* to establish the approximate width of the feature. The stone surface was made up of formally arranged sub-angular pitched stones with longer stones pitched on their sides along both outside edges of the feature with a similar configuration set lengthways along the centre. These linearly set stones, whilst being aesthetically pleasing to the eye, are actually functional in that they act as retaining components within the structure of the feature.

The damage to the pitched stone surface at its western and southwest edges showed that they were set in a yellowish brown silty-clay matrix above which lay a coal- and ash-rich sub-base layer. On their north side the pitched stones were

securely interfaced with the metallised stone western edge of the North Drive which suggests that they were built contemporaneously. This assertion could not be corroborated for the southern side due to the damage to the pitched stones and the displacement of the North Drive metalling.

The limited extent of the pitched stone surface crossing the North Drive and the fact that it quite clearly does not extend very far beyond either the east or west side of the drive suggests that it was not a trackway intended as a crossing point. The evidence suggests that it was an integral part of the original North Drive construction and probably served in a drainage or water runoff capacity, given also the circumstantial evidence of the cast iron grid drain cover. The curvilinear configuration of the gently sloping flagstones and their resemblance to a typical drainage arrangement also lends weight to that argument. Unfortunately, any evidence physically connecting the two features was lost either during the topsoil strip or earlier. The lack of evidence for a drain beneath the raised flagstone does not help the drainage hypothesis, but further investigation is required before that negation can be accepted as conclusive.

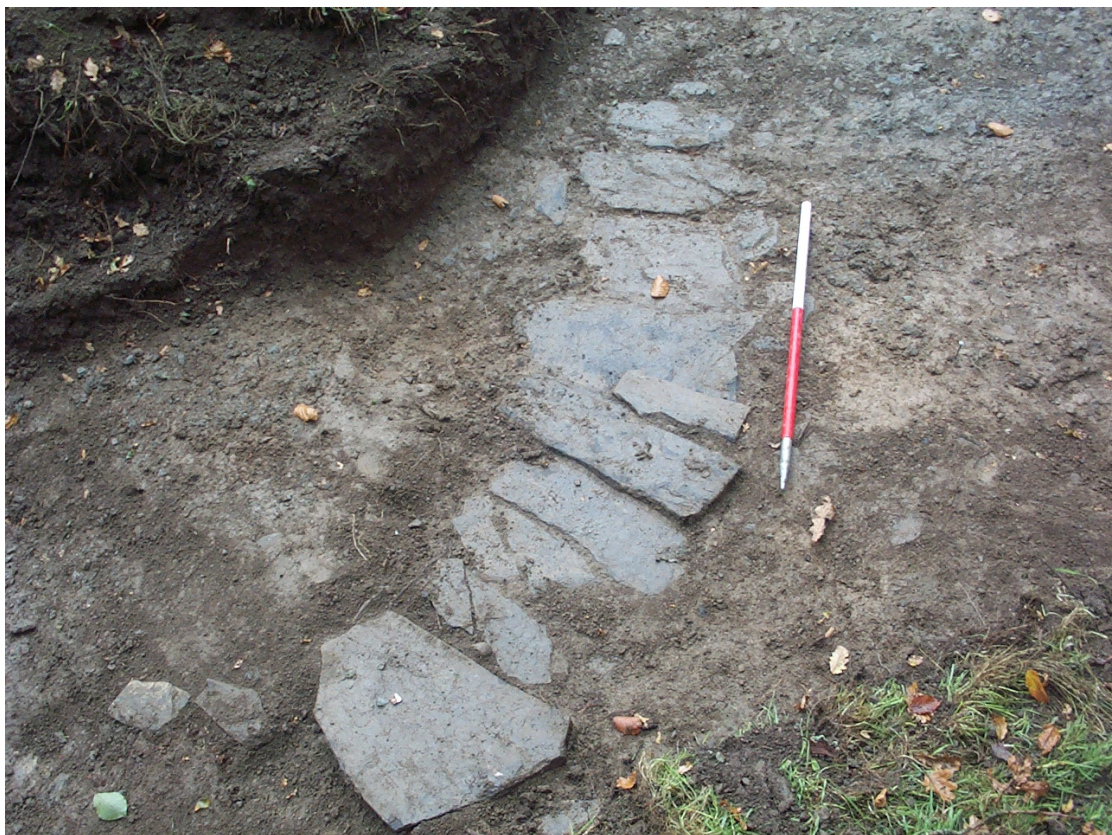
**Photo 2:** Curvilinear configuration of shale flagstones, looking southwest

Some 1.2m or so due west of the pitched stone surface a curvilinear configuration of shale flagstones (Photo. 2) was revealed at a depth of 0.45m below the present ground surface. This feature extended for 2.8m in a northeast to southwest alignment with an average width of 0.6m and sloped gently down to the southwest. It is possible that this feature extends further to the southwest but this was not determined during the archaeological recording due to time and weather constraints, the *prima facie* evidence, however, is that it does not. To either side of this feature there was what appeared to be a distinct foundation cut approximately 0.20m wide filled with a mixed friable reddish brown soil containing 30% small angular stone fragments. No attempt was made to remove the shale flagstones or to excavate their potential foundation trench, although the more north-easterly shale slab was lifted slightly to investigate what underlay it but there was no evidence of any silted up drain cut or upright side stones. The area immediately to the east of this flagstone appeared to have been truncated by the machine destruction between it and the pitched stone surface (Fig. 2) and it is possible that the iron grid cover came from this area, but no evidence for its former presence was identified.

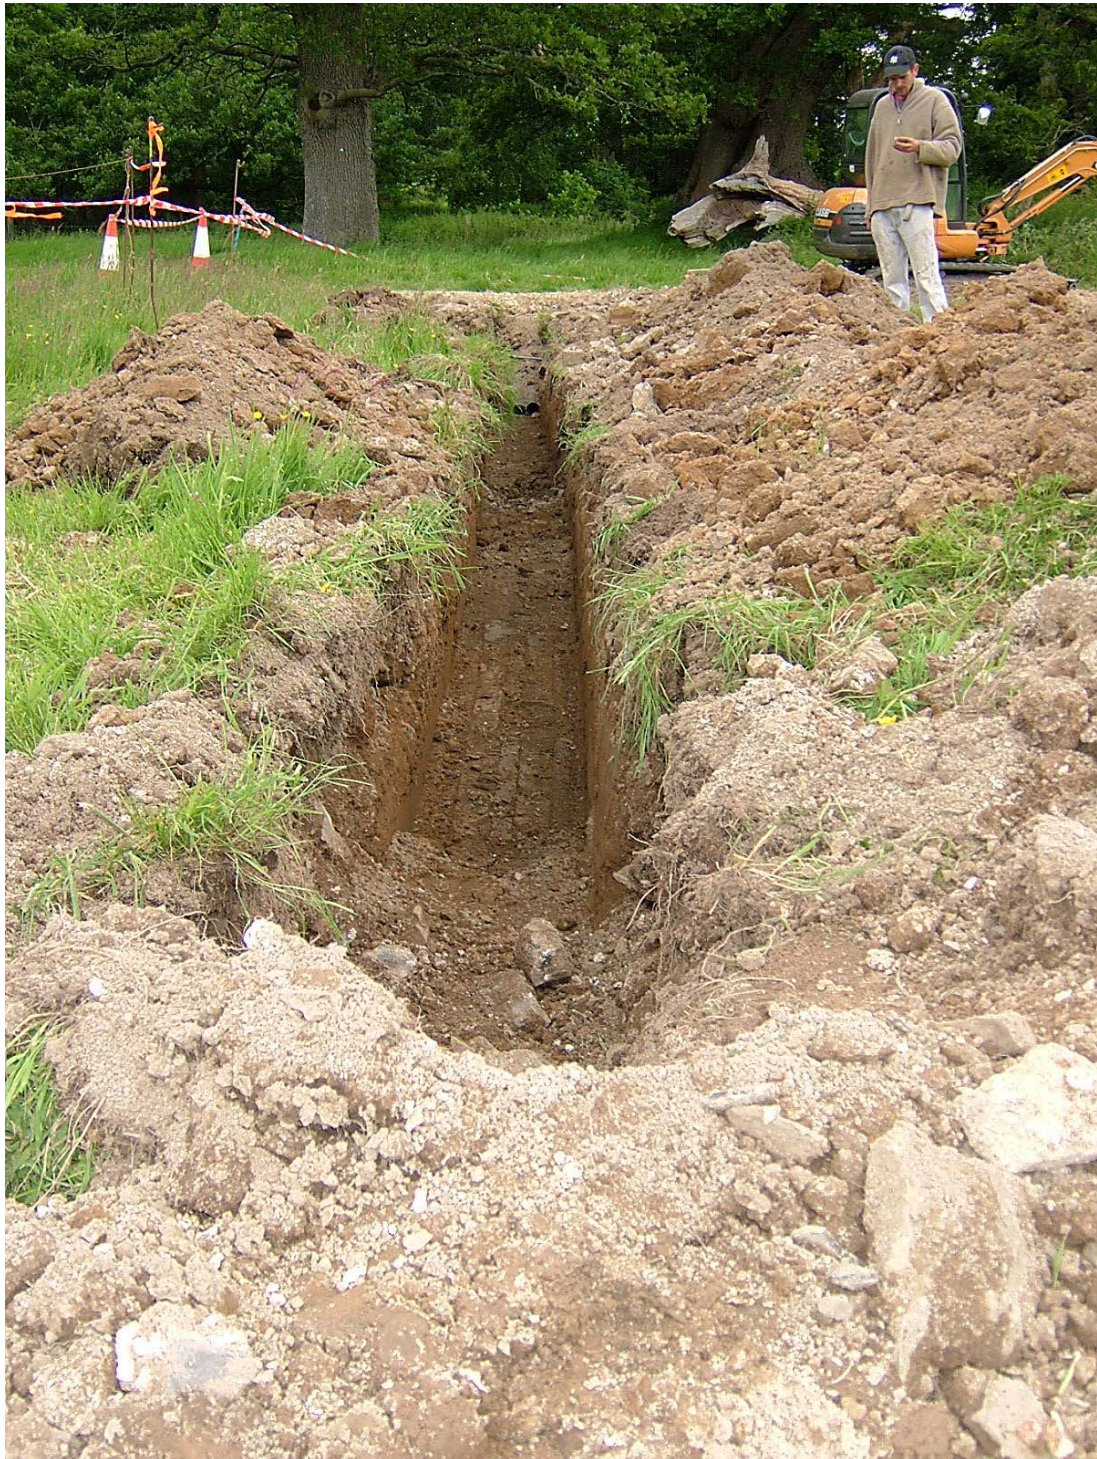
Photo 1. Looking north along the excavated trench

Photo 1 below shows the trench as first seen. The digger driver described how he first noticed the bucket going through some loose material, with the material towards the southern end of the trench becoming noticeably harder. A large

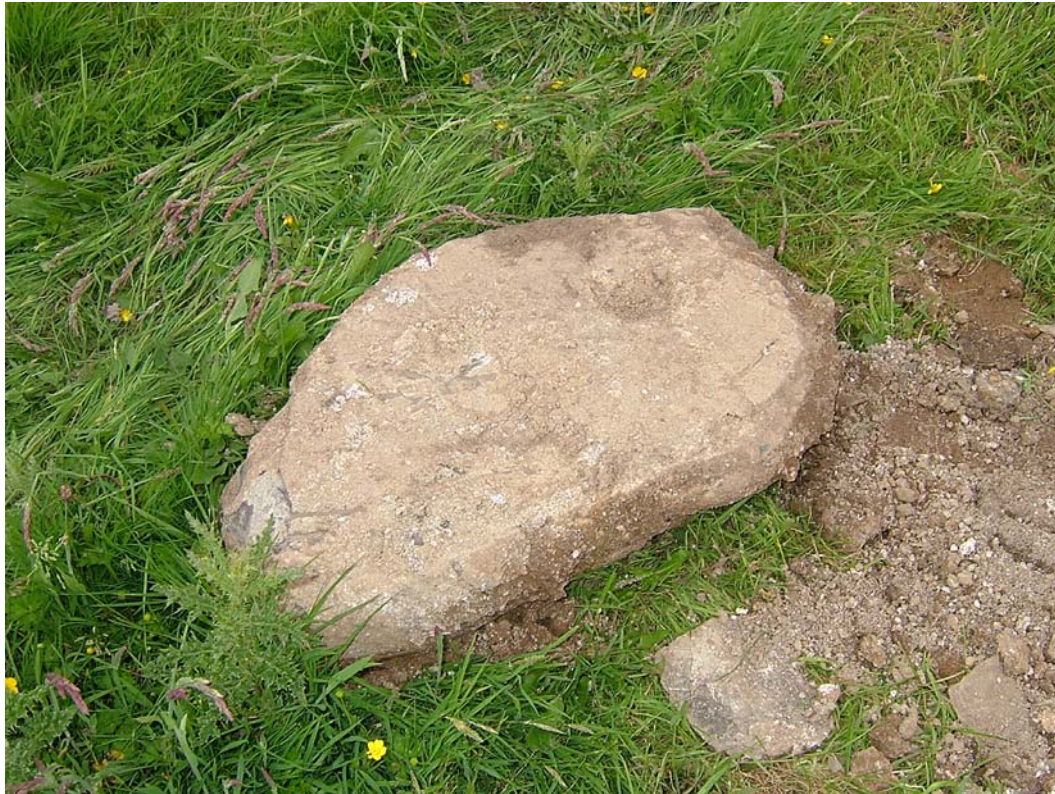
Photo 2. Large stone dumped outside the southern end of the excavated trench

stone, c.0.4m long, was encountered and dumped outside the trench at its southern end (see Photo. 2). At this point works ceased until the features were assessed and recorded by Cambria Archaeology on behalf of the National Trust.

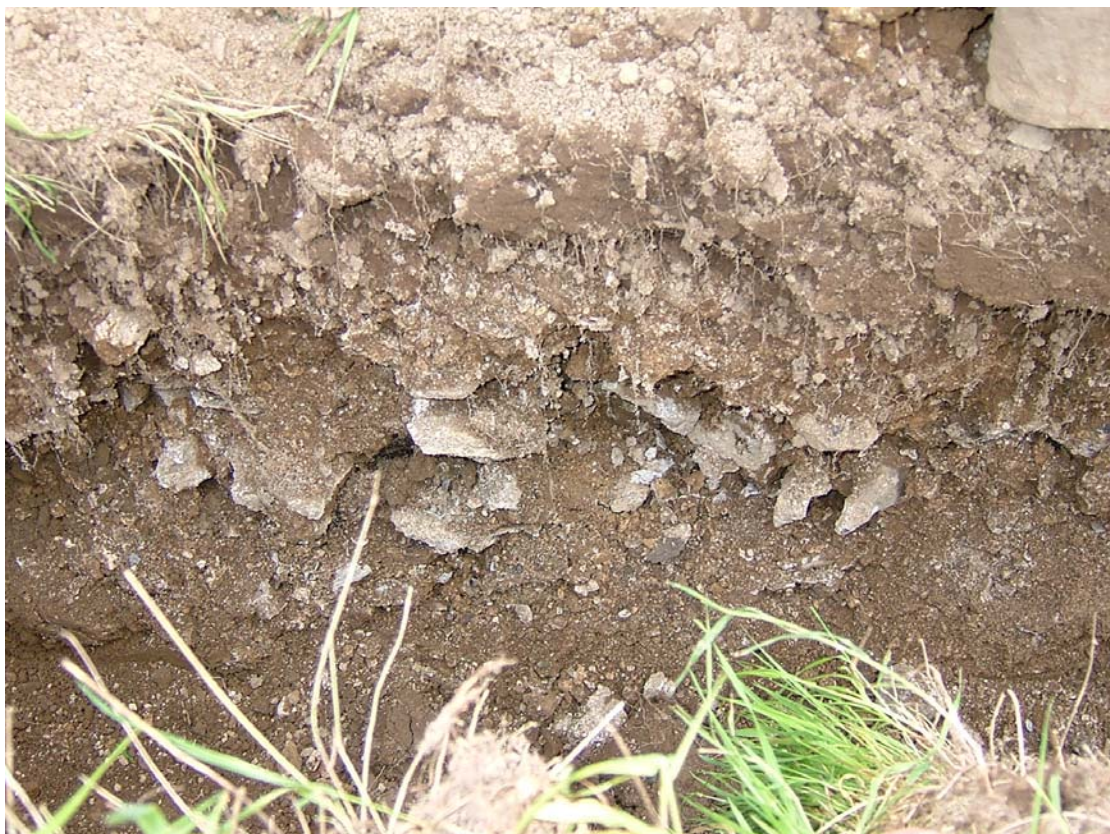
Photo 3. Area 1, looking east

*Area 1* consisted of a deposit of loose stones and rubble at a depth of 0.25m below the ground surface. The deposit extended for a maximum length of c.1.15m and was c.0.35m deep. This feature was encountered 5.6m in from the northern end of the trench, and was more clearly noticeable on its eastern side. The material, which was chalky in appearance, was clearly distinct from the more clayey, clean material visible on either side of the feature. This feature is illustrated in Photo. 3.

It would appear that Areas 1 and 2 within the excavated trench possibly represent the remains of two parallel walls, both approximately 1m wide and set c.6m apart from each other, running in a roughly east-west alignment. The most southerly wall is the more solid of the two, but neither of them appear to be very deep, both extending to a depth of only 0.35m at most.

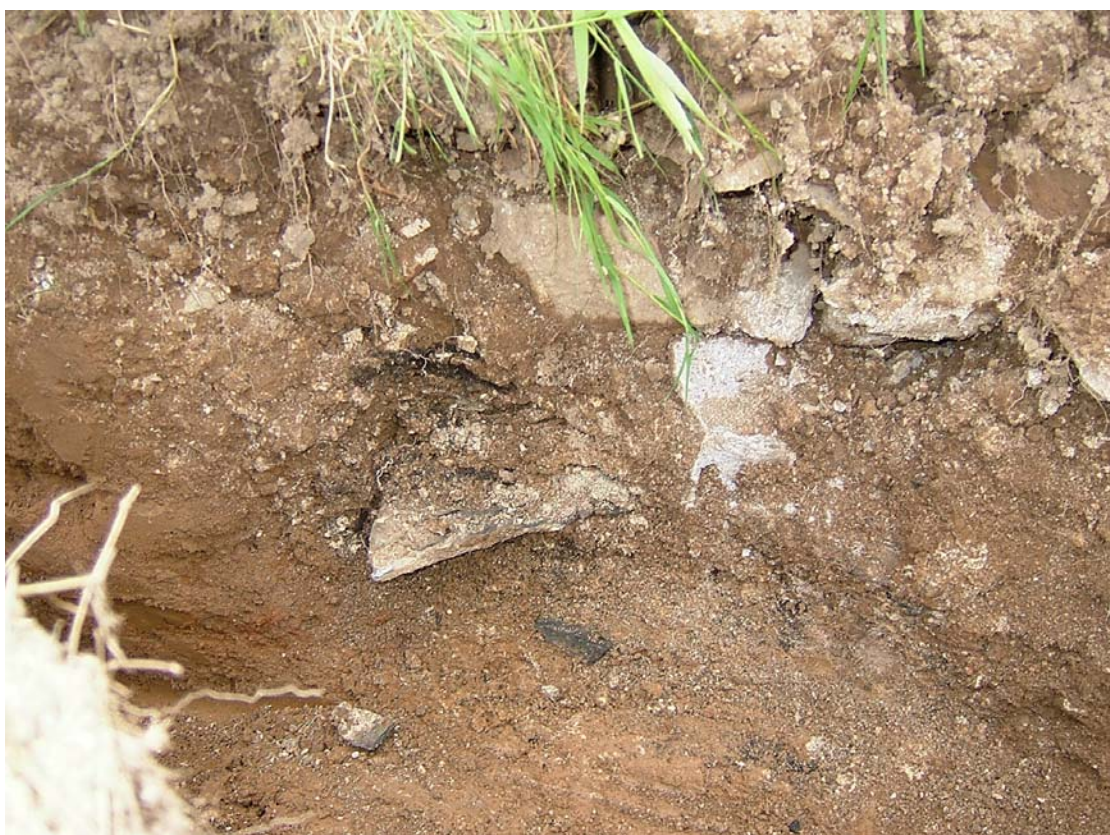
Photo 4. Area 2, looking east

*Area 2* was characterised by a large block of stone, 0.25m long x 0.10m deep, located c.0.18m below the ground surface and overlying an area of burning and other stones, 0.23m deep (see Photo. 4). Beneath this layer of material there was another deposit of burnt material, c.0.20m deep, which extends to the bottom of the trench. This stone and charcoal mix was encountered 12.85m in from the northern end of the trench, i.e. 6.1m south of Area 1, and measured c.0.9m in length. The feature was visible on both sides of the 0.5m wide trench, which extended to a depth of 0.71m at this point. The stones in this section were far more solid and more closely packed than those seen in Area 1.
