NARBERTH CASTLE

2003-2005 RECORDING

RHIF YR ADRODDIAD / REPORT NO. 2006/42
RHIF Y PROSIECT / PROJECT RECORD NO. 56474

A major programme of consolidation work at Narberth Castle, Pembrokeshire (NGR SN 1098 1440), was undertaken between 2003 and 2005, by Pembrokeshire County Council. The castle fabric was consolidated, underpinned where necessary, sympathetically repointed, and made safe. The work was accompanied by a full programme of archaeological recording.

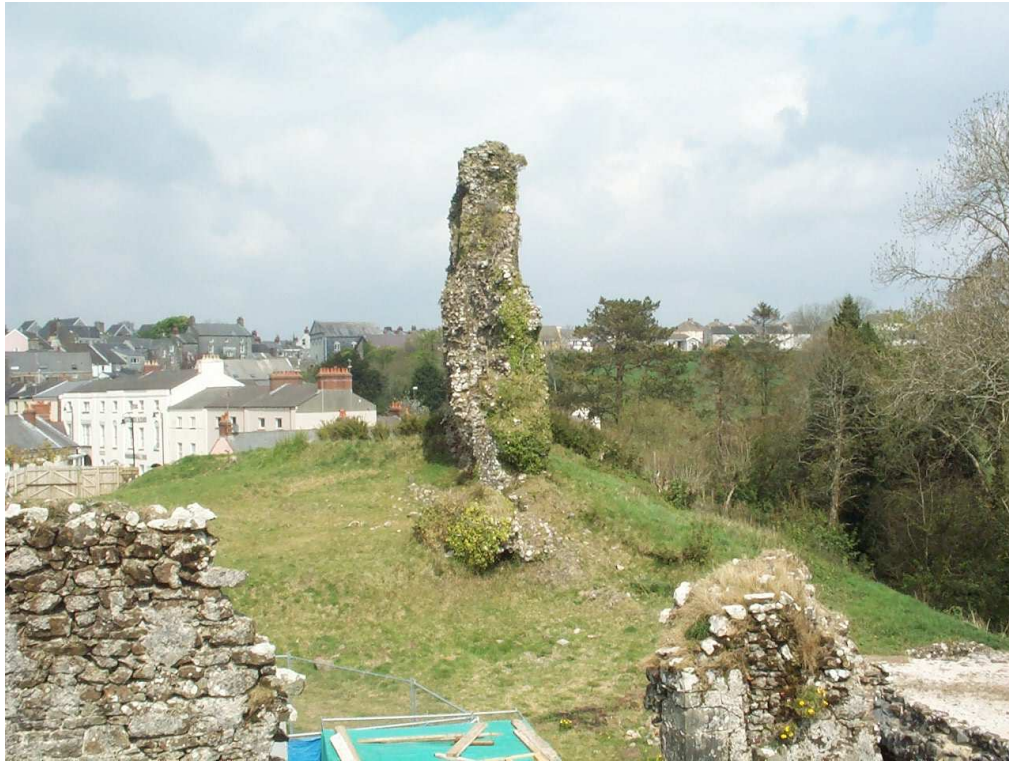
Plate 1 - Photo of Northeast Tower from Southwest Tower in 2003 (before consolidation)

Only the southeast quadrant of the Northeast Tower survives above ground, to a height of 13 metres, representing three storeys (Figs. 3-11; Plate 1), but in a very ruinous condition; very little internal facework survives. Though similar in plan, the tower is considerably larger than the other three, and the evidence suggested that unlike the two southern towers (and presumably the Northwest Tower), it formerly featured a third floor - the 1539 survey suggests that it contained three chambers over a dungeon, while a fourth storey appears to be shown on a print, by the Buck Brothers, of 1740. This was confirmed in 2004.

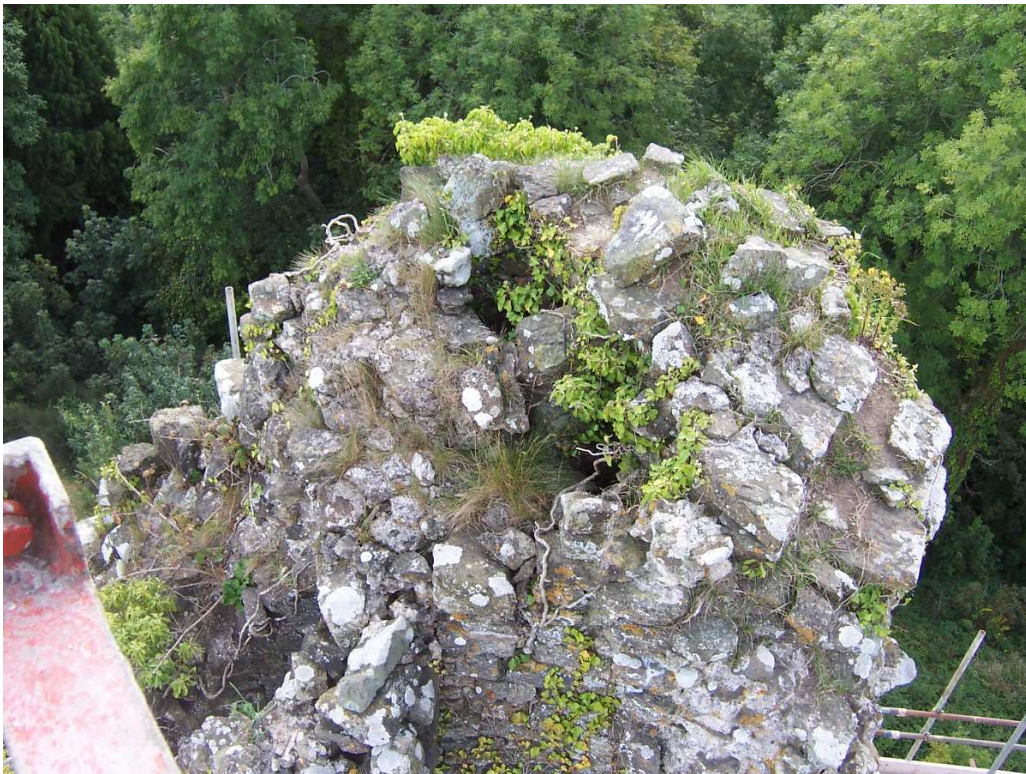
The presence of a fourth storey, suggested by contemporary source material, was confirmed during the initial inspection of the tower from the crane. The truncated southern end of the surviving section bore the very slight remains of the seat and sill of a further window embrasure (29), 0.5 metres beneath the summit, at third floor level (Fig. 11; Plate 2). This was unfortunately part of the section that had to be removed for safety. It was photographed and sketched, with rough measurements taken from the crane. No further features associated with this floor level appeared to survive.

Plate 2 - The summit of the Northeast Tower prior to its truncation, from the southwest, showing window embrasure 29, and flues

Prior to consolidation in 2004, the Northeast Tower was inspected from a crane (see Plate 2) to assess its condition. It was decided that 0.75 metres of masonry from the very summit of the surviving section would require removal, for safety reasons, before scaffolding could begin. The amount of fabric removed was kept to a minimum but did include the only surviving evidence for the fourth storey, in the form of the slight remains of a window embrasure (see below).

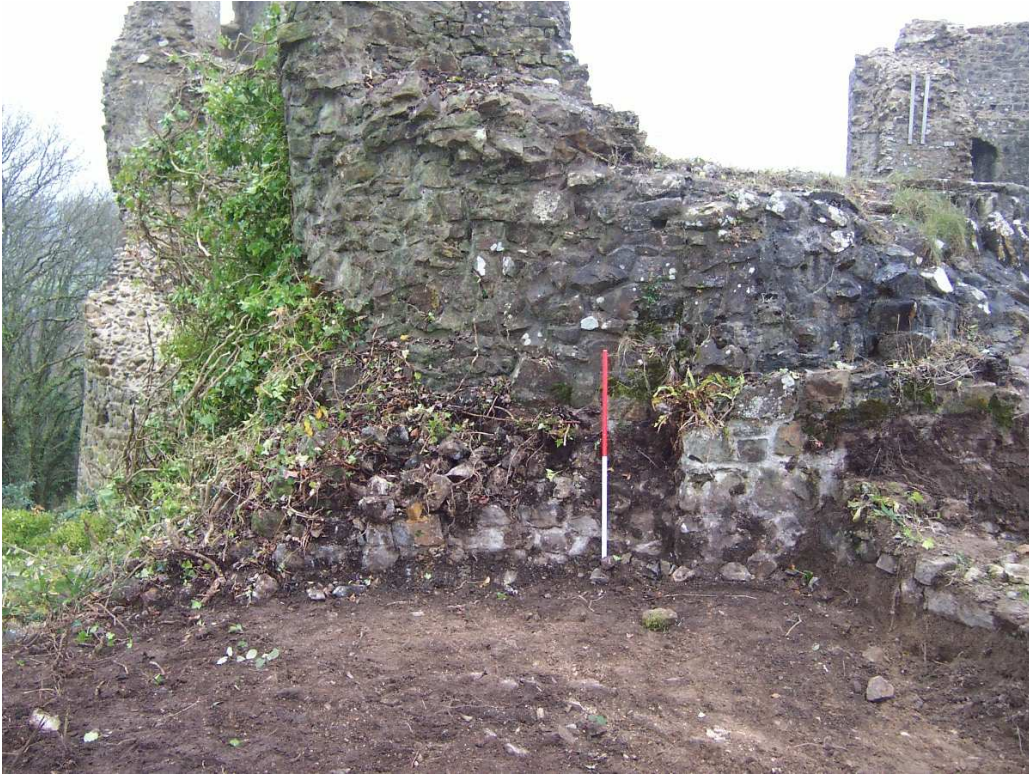
*Plate 3 - The south wall of the former East Tower from the north,
at its junction with the vaulted building*

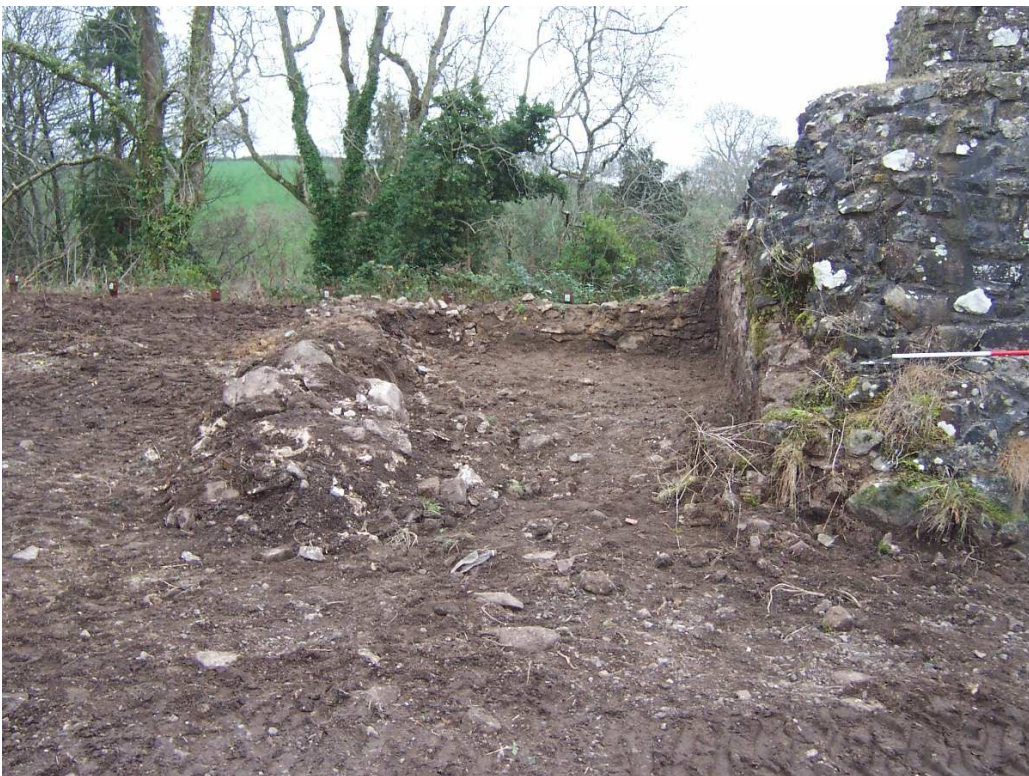
Plate 4 - The footings of the 'Parlour' from the west

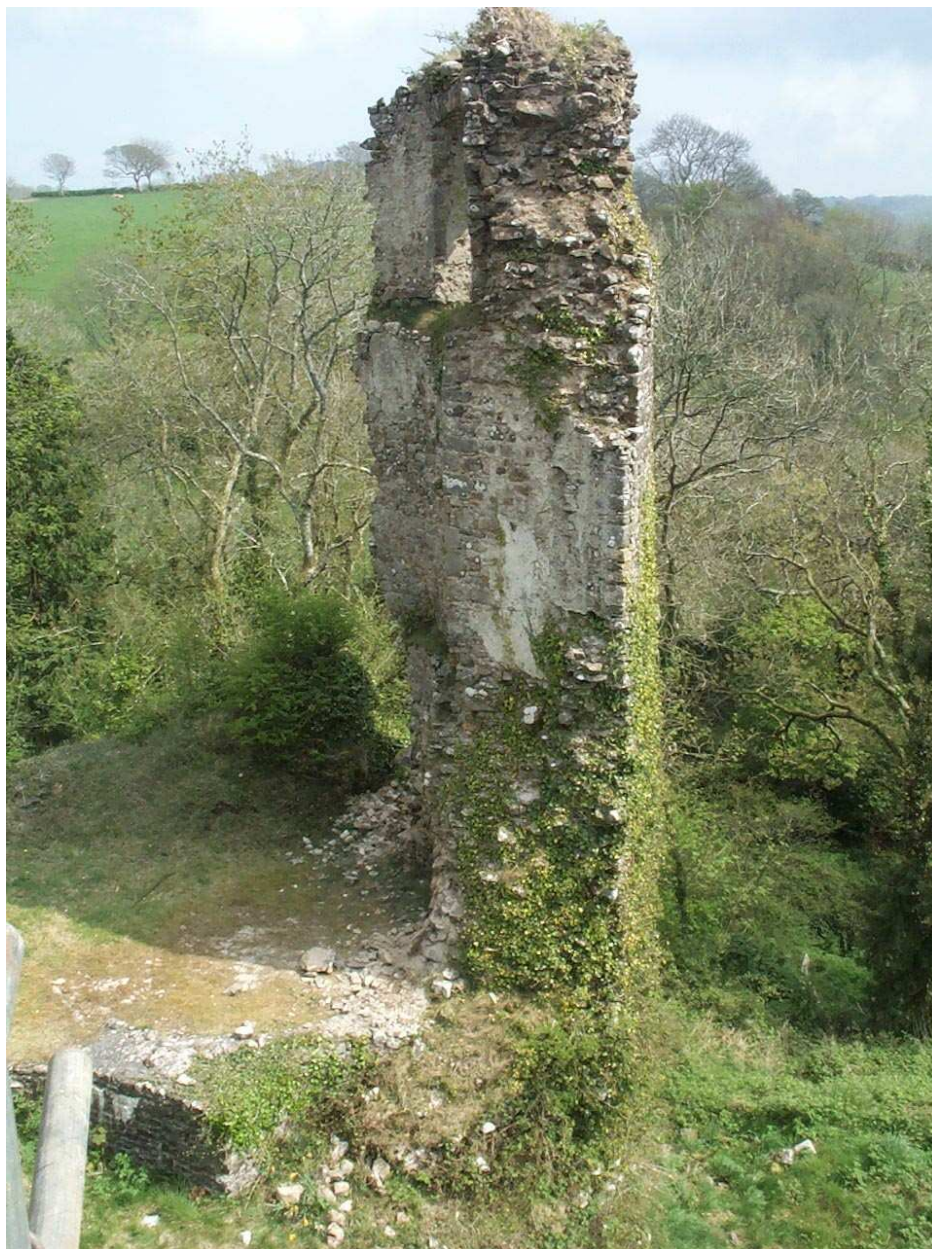
Plate 5 – The Southeast Tower before consolidation, from the Southwest Tower

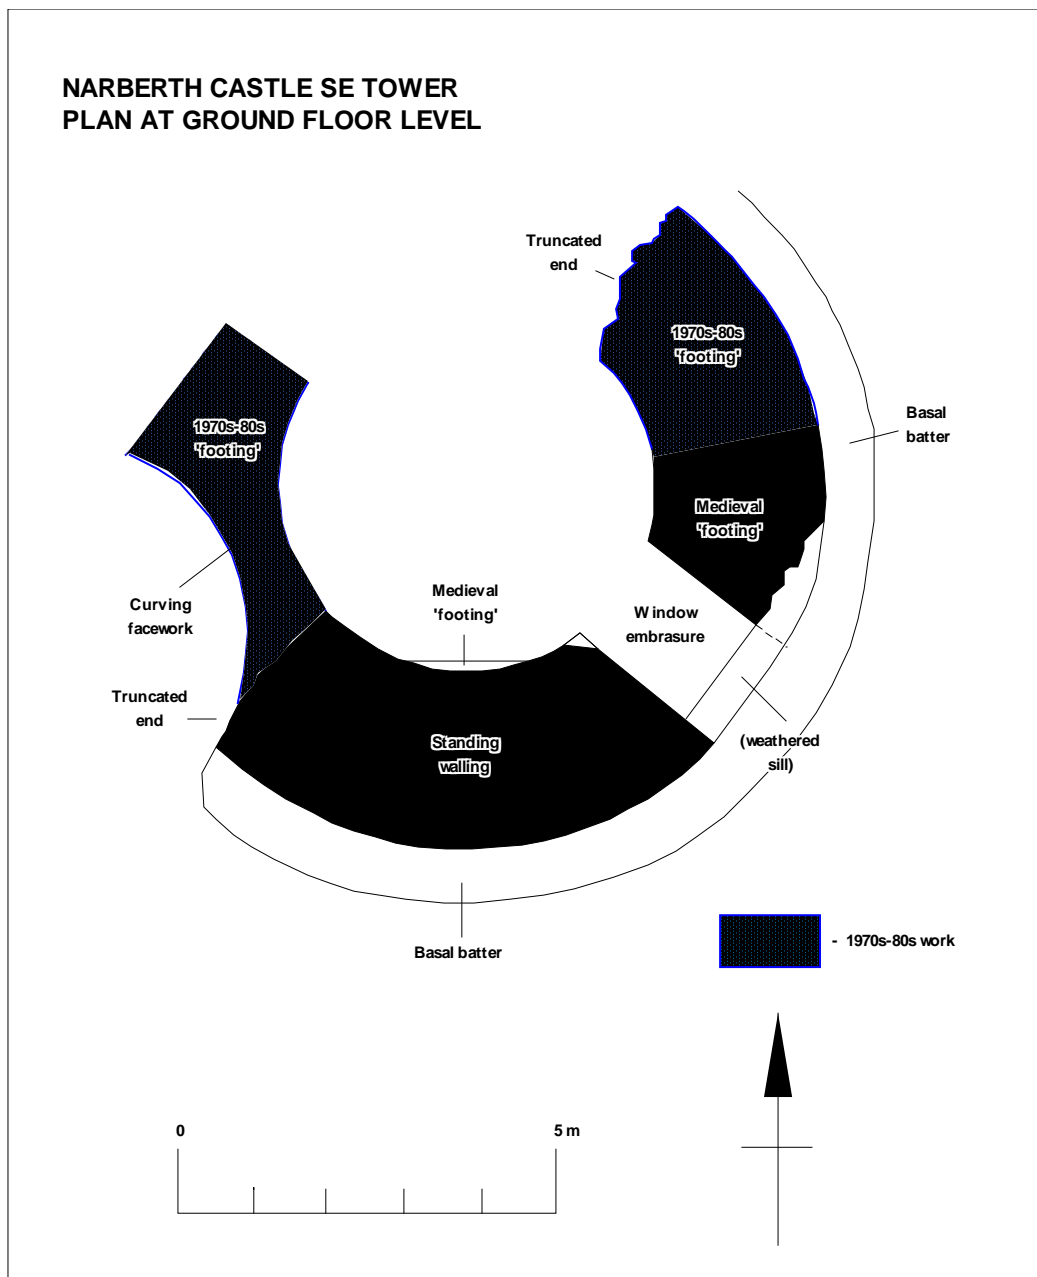
Fig. 13

Prior to its superficial clearance, the internal facework of the ground floor of the tower appeared to continue downwards beneath ground level, suggesting the possibility that an open basement had been infilled. However, clearance revealed a sill or area of 'footing' at present ground level. It formed a chord across the southern circumference of the tower, suggesting that it may represent medieval ground level rather than a floor offset.

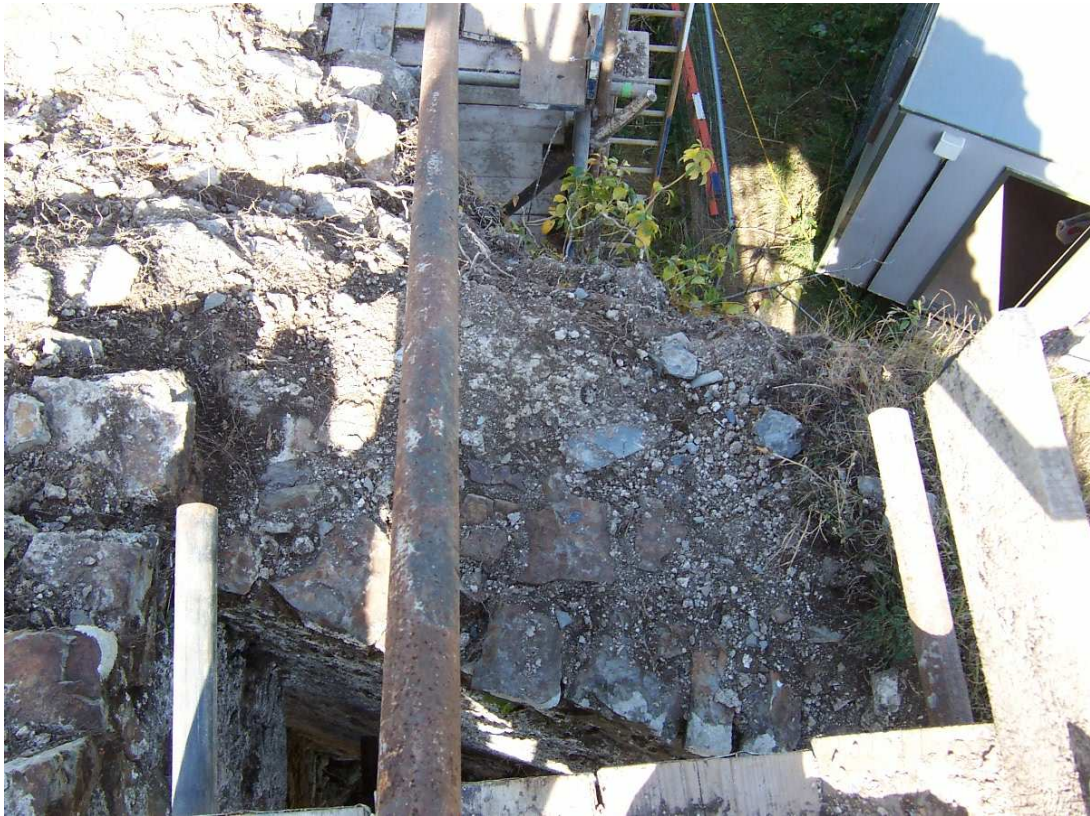
Plate 7 – The Great Hall north wall, from the south, showing mortar bedding and slates

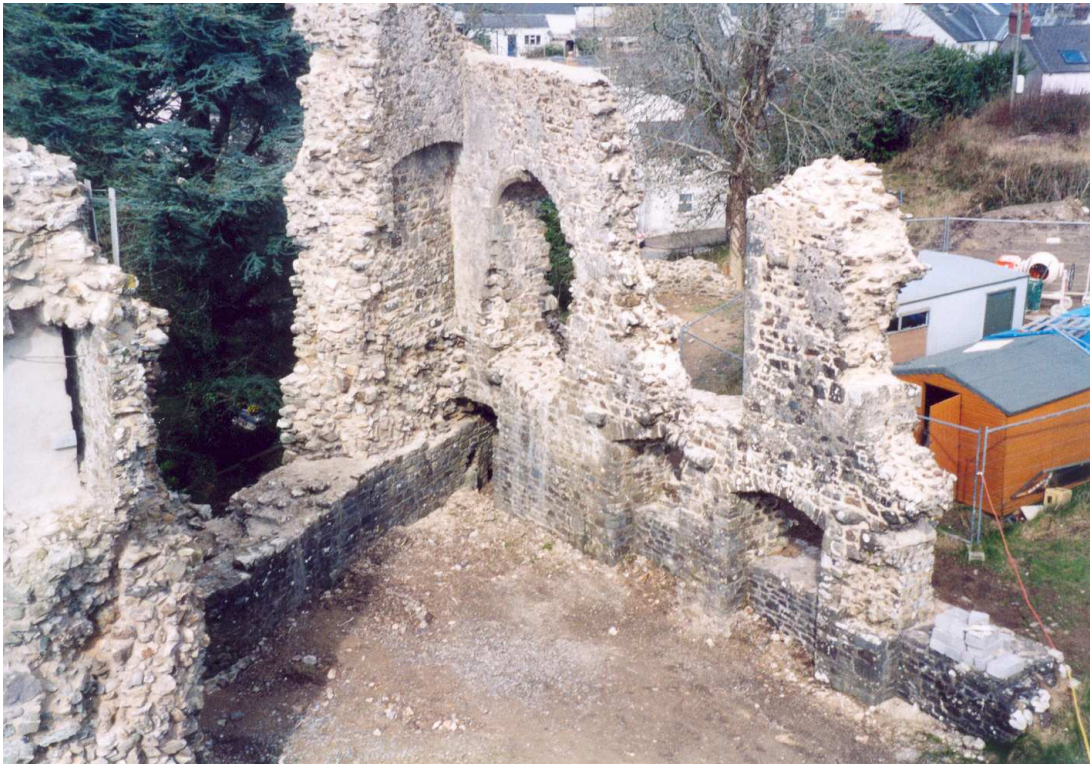
Plate 8 – The Great Hall from the southeast after consolidation

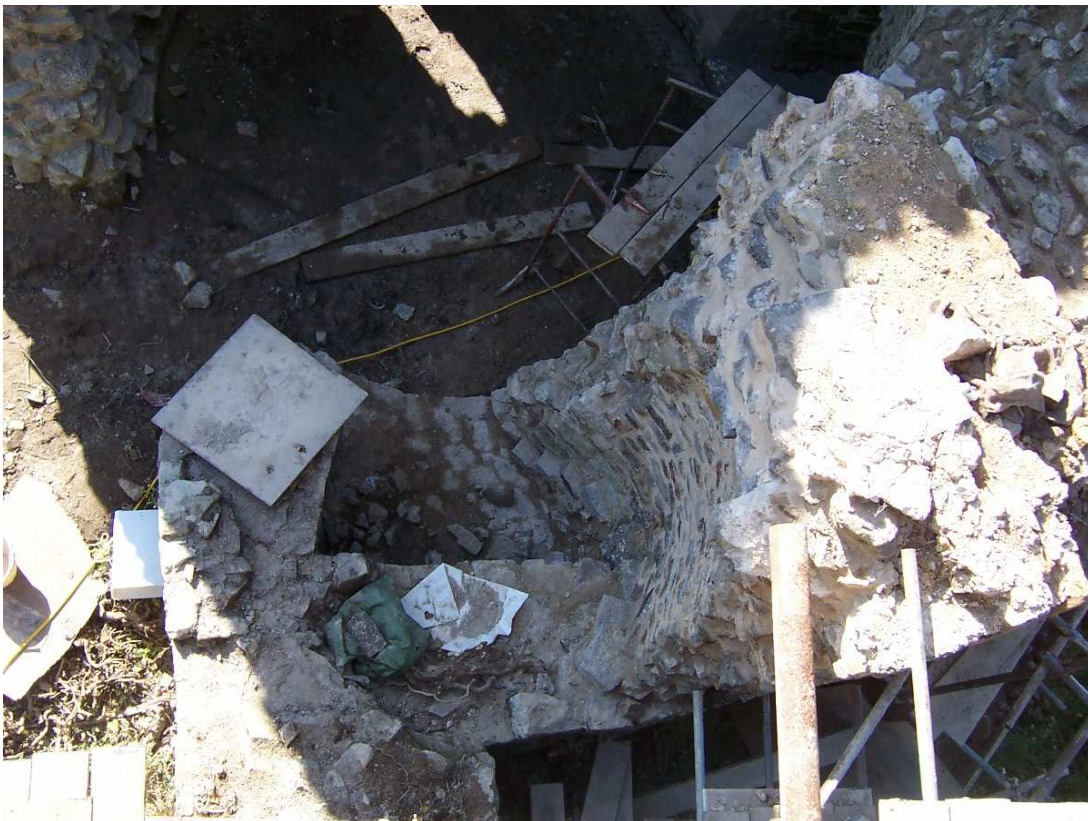
Plate 9 – Looking down on the Southwest Tower spiral stair, during consolidation, from the north

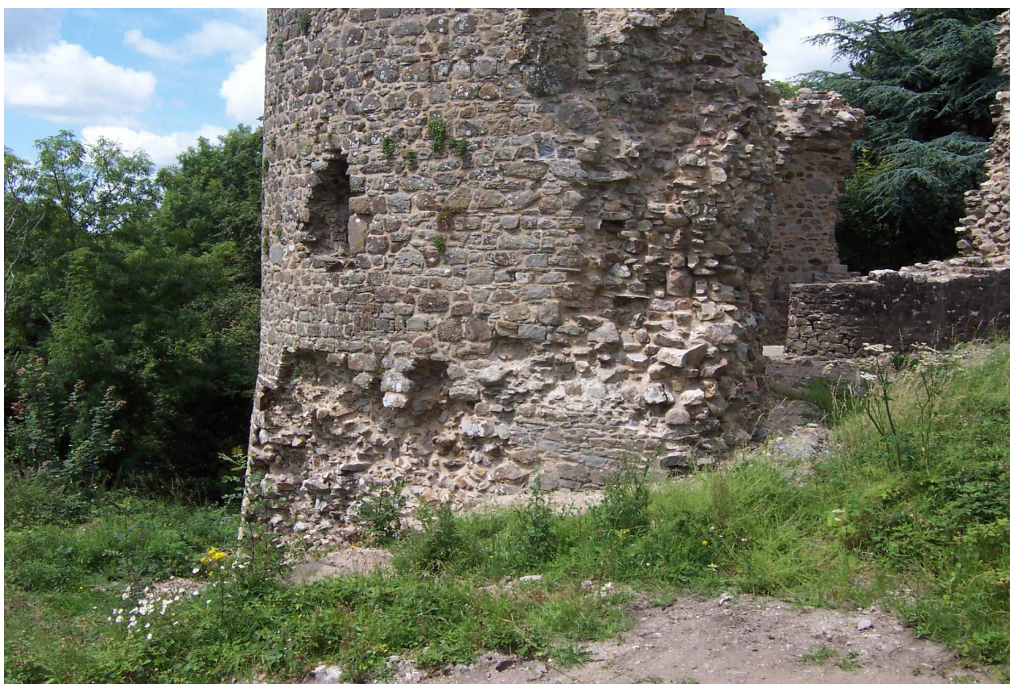
Plate 10 – The Southwest Tower from the east, after consolidation, showing facework in the area of the former ?postern

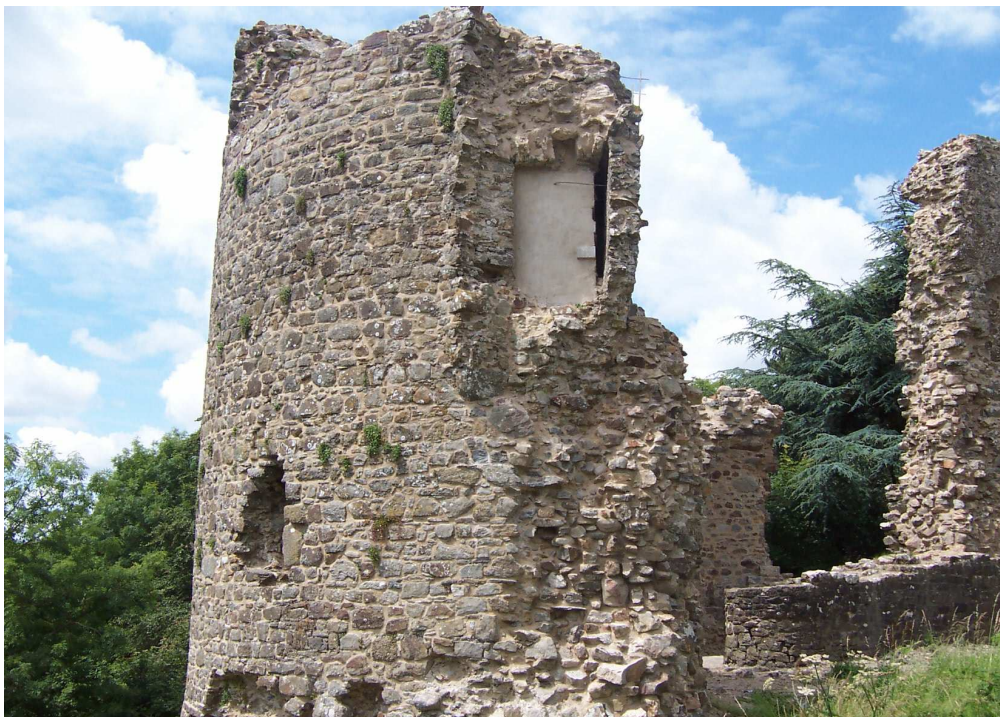
The north wall of this mural passage, (10), between it and the Great Hall, is however a later insertion. It was inserted to support the north end of the passage vault after the south curtain wall had been demolished. However the nature of both its limestone masonry, and of its mortar finish (which is almost identical to that within the tower), suggest that this prop-wall is a very early feature.

Plate 11 – The Southwest Tower from the east, after consolidation, showing entry 11, prop wall 10 and the site of the garderobe

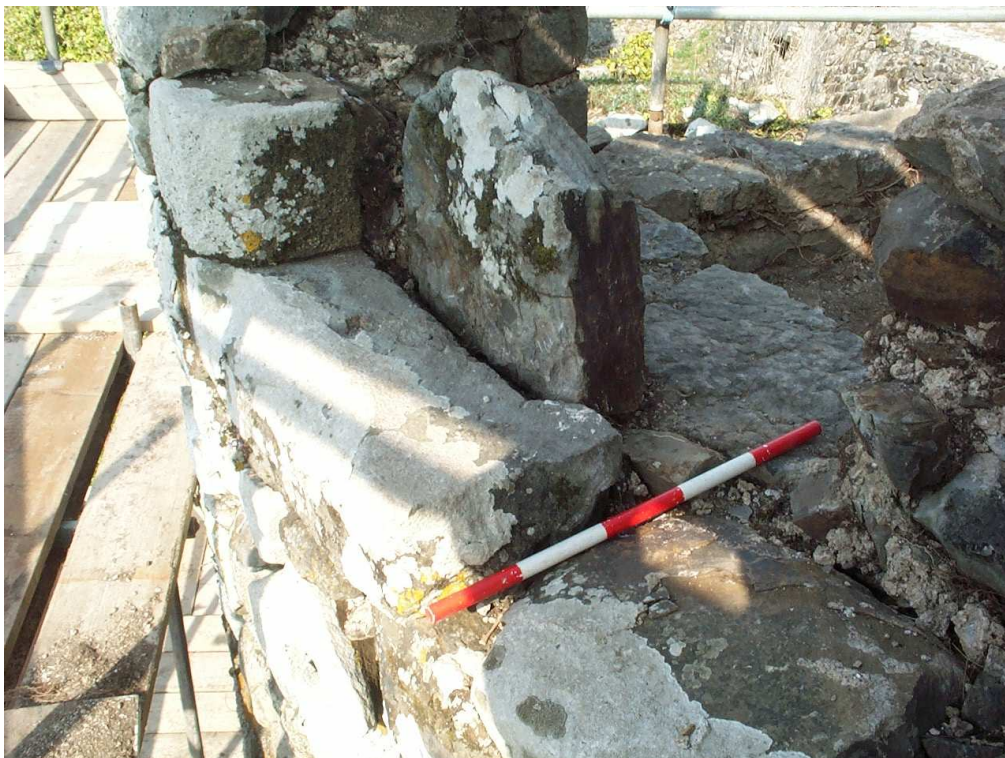
*Plate 12 – Southwest Tower second floor window 3,
showing the sill with in situ iron bar*

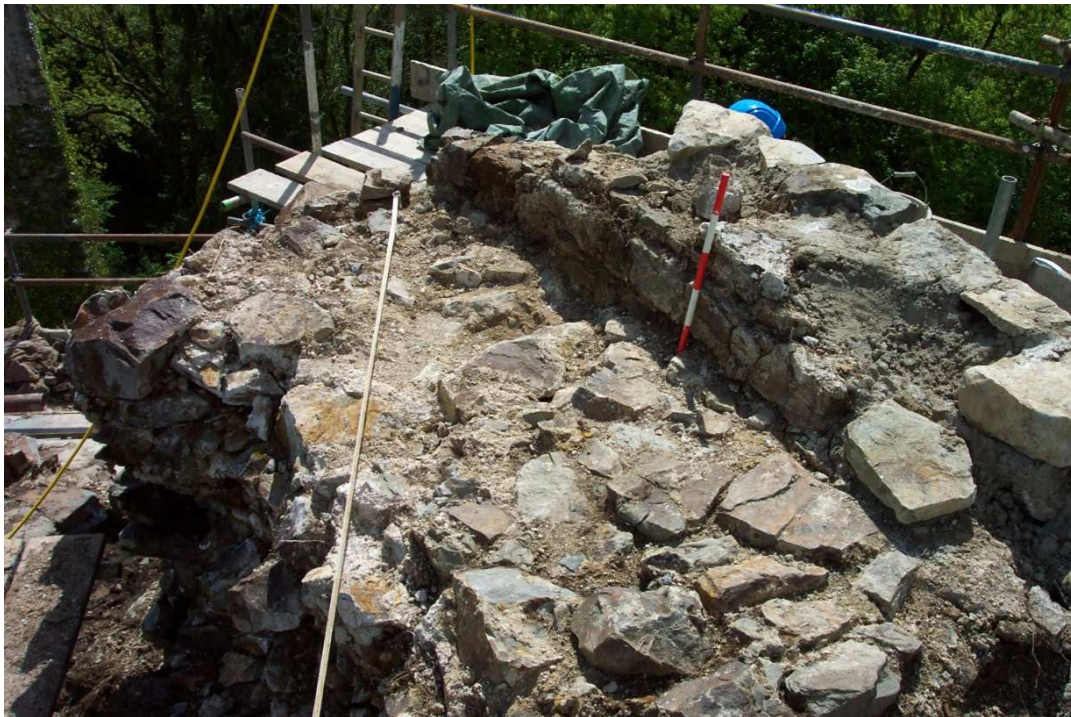
Part of the parapet and wall-top survived to the southwest, but had been obscured by thick vegetation during earlier surveys, and only came to light after removal of vegetation, and cleaning, in 2003. The width of the wall at this level was as on the second floor, with no evidence of an offset for the roof eaves, and the evidence suggests that, rather than the wall-top representing a wall-walk behind the parapet, the roof eaves continued across the wall-top to lie against the inner face of the parapet.

Plate 13 – The Southwest Tower: the inner face of the parapet, from the northwest, showing the offset and chase

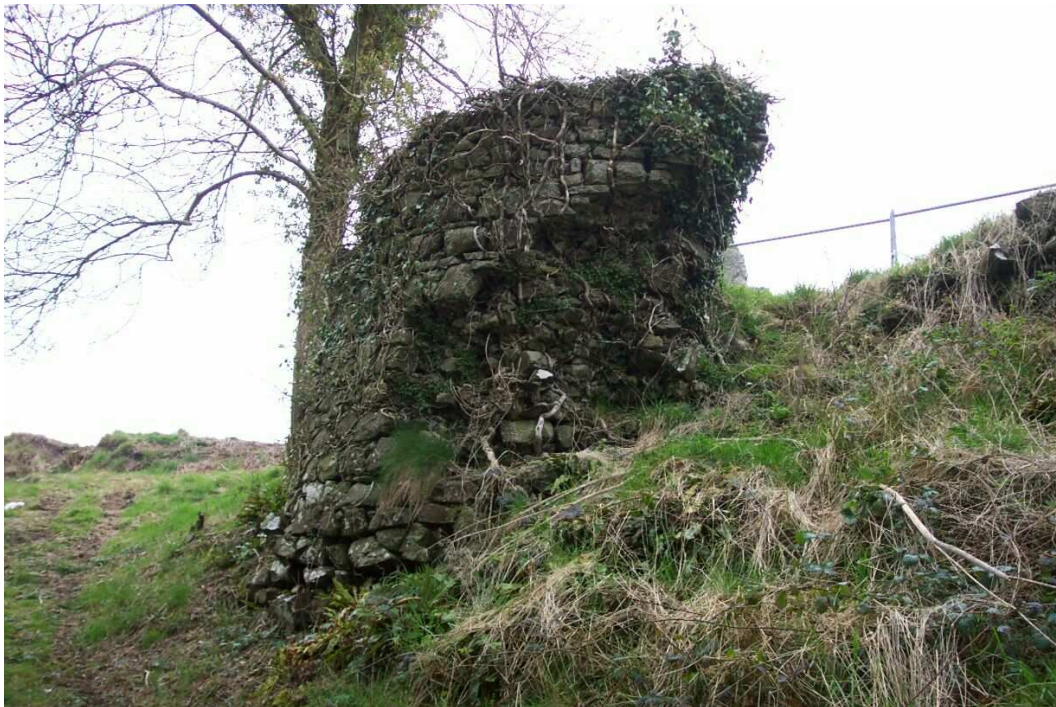
Plate 14 – The West Turret before consolidation, from the southwest

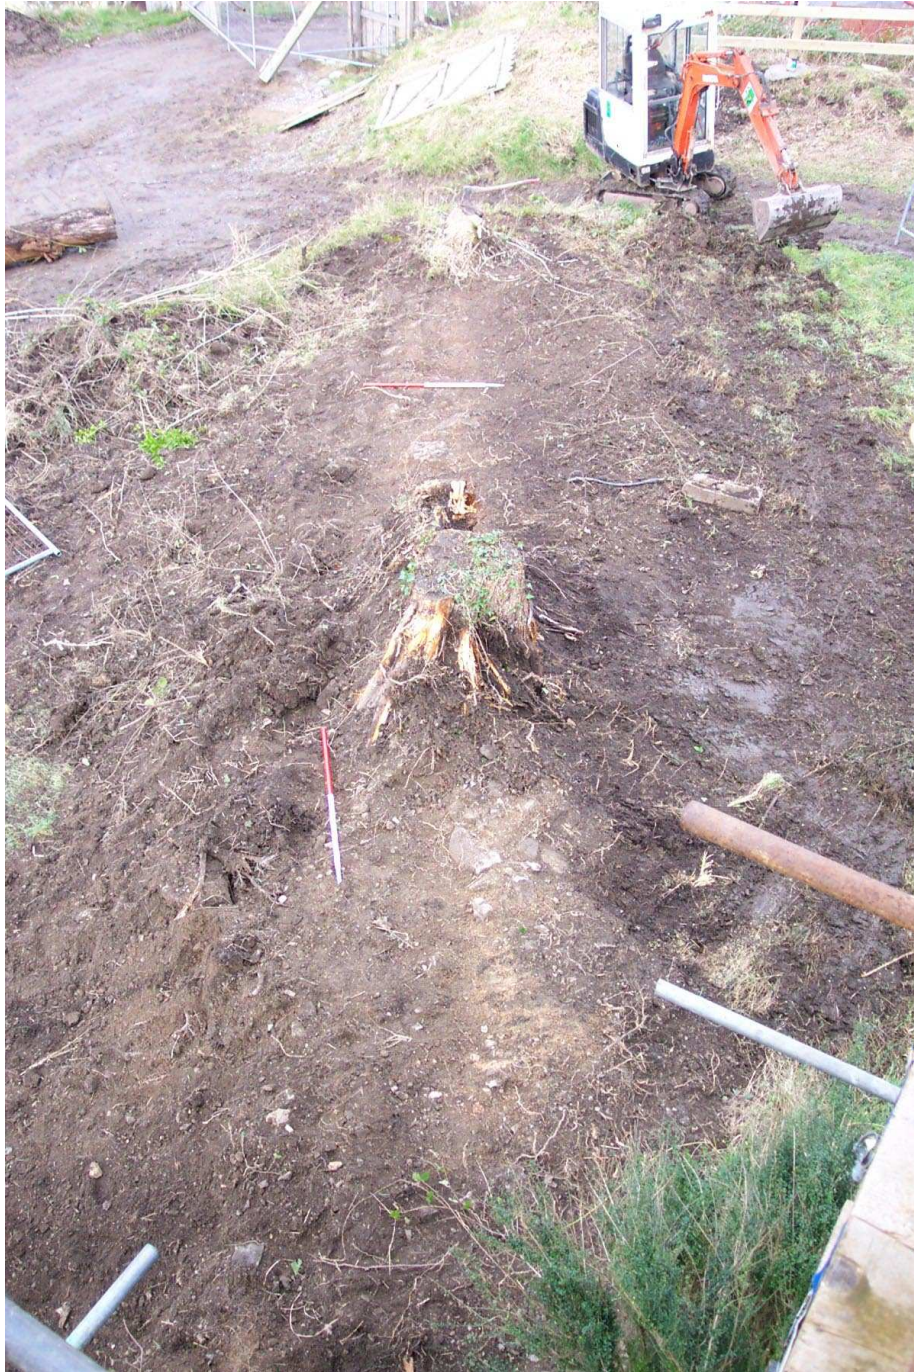
The hedgebank is assumed to be post-medieval. It would appear to overlie the burials that were excavated in 2001 and 2003 (Murphy & Crane 2002; Jamieson & Ludlow 2003), and also to lie within the circumference of the projected line of the Northeast Tower. It averages 0.30 metres in height and 2.89 metres in width, before running out at the present entrance path, and comprises an undifferentiated black soil of 'modern' appearance. However, it overlay a 9.57 metre length of loosely mortared masonry, level with the ground, which was 0.47 metres wide and may represent walling material (Fig. 2; Plate 15). This was not dated, but it too partly lies within the projected line of the Northeast Tower and is therefore interpreted as post-medieval.

*Plate 15 – The ?post-medieval walling beneath the hedgebank,
from the southeast*
