MONUMENT MANAGEMENT AT GORS FAWR STONE CIRCLE SAM Pe117

RHIF YR ADRODDIAD / REPORT NO. 2006/54
RHIF Y PROSIECT / PROJECT RECORD NO. 56591

Monument Management at Gors Fawr Stone Circle SAM Pe117

Polly Groom

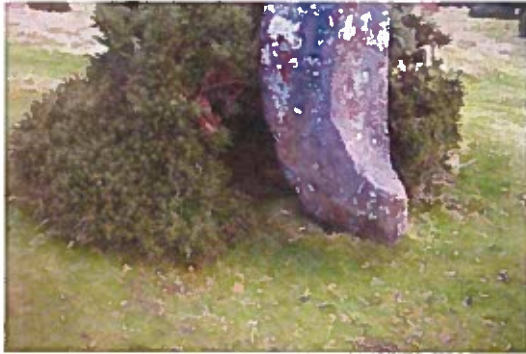
Picture 2 (above left) – one of the stones making up the stone pair, partly swamped by a gorse bush.

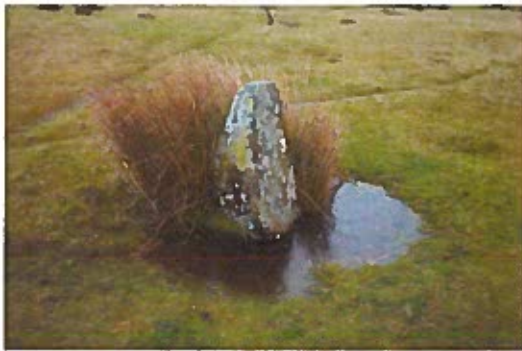
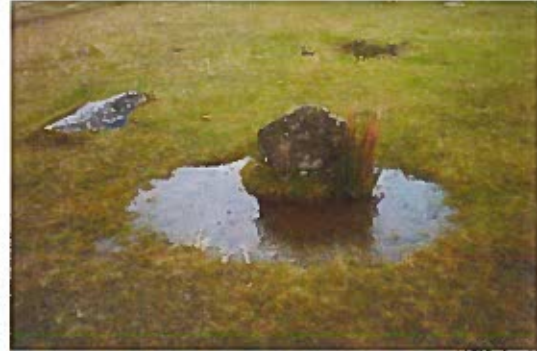
Pictures 4 and 5 (above) – erosion hollows around the base of two of the stones at Gors Fawr

Two erosion hollows were filled around the bases of stones on the southeast side of the stone circle. The hollows were first emptied of rainwater (which had collected over the previous night) and were then lined with a layer of Terram (a water-permeable geotextile). In this instance the Terram will principally act as a marker layer, indicating when any future erosion is reaching previous depths. The hollows were then infilled using soil sourced from a neighbouring field, and re-turfed using turf cut from a ditch close to the stone circle. Using local materials ensures that no undesirable seed stores are introduced into the SSSI.

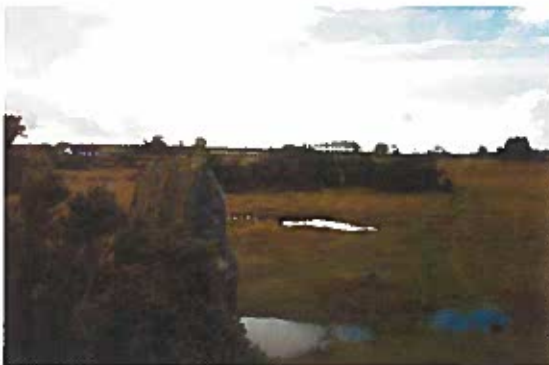
Picture 6 (above) – the view from one of the stones in the stone pair, towards the circle. The circle is hidden by the gorse.

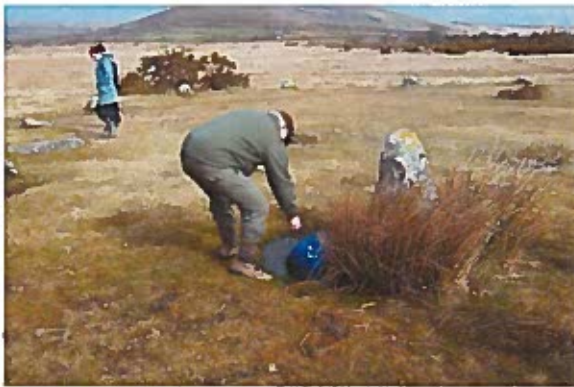
Picture 7 (above left) One of the volunteers 'bailing out'!

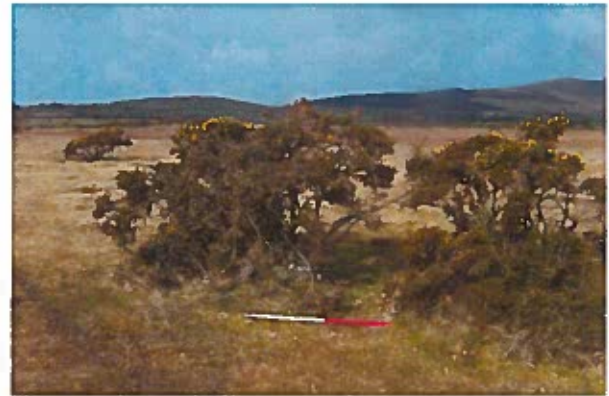
Picture 8 (above right) Gorse bush beginning to obscure one of the stones on the west side of the circle.

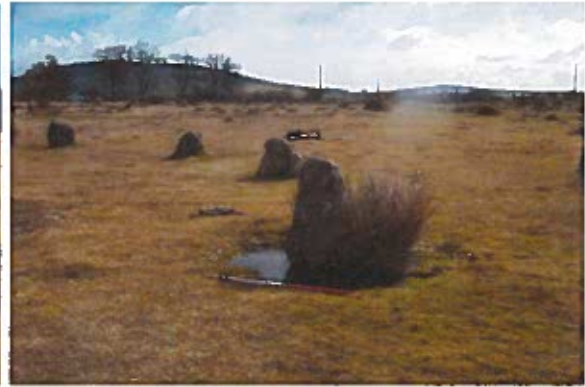
Picture 10 (above right) Erosion hollow waiting to be infilled

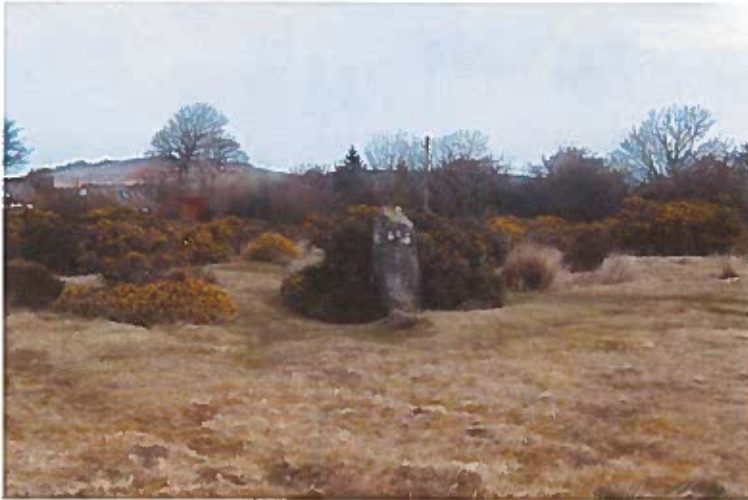
Picture 11 (above) Gorse surrounding one of the pair of standing stones and **Picture 12 (below)** Volunteers removing the gorse.

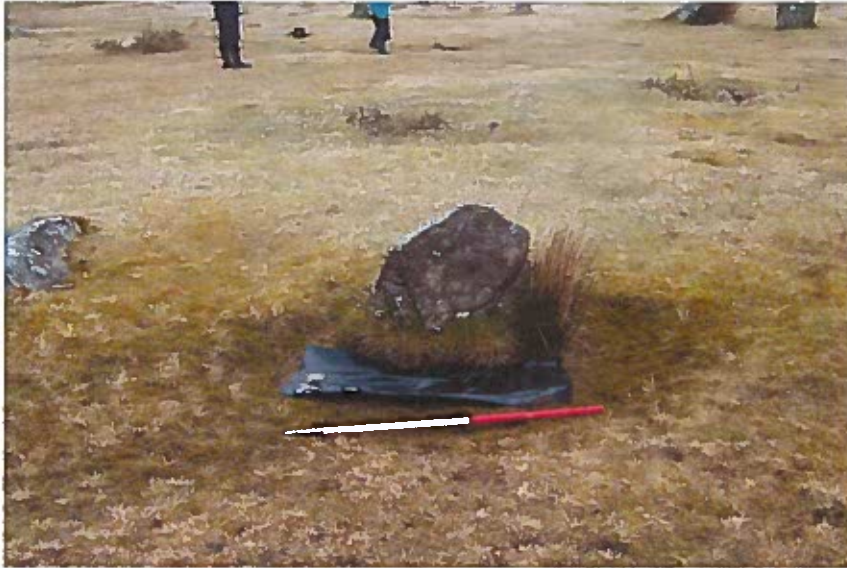
Picture 14 (above) A small piece of Terram in place as a marker, to monitor future erosion problems.

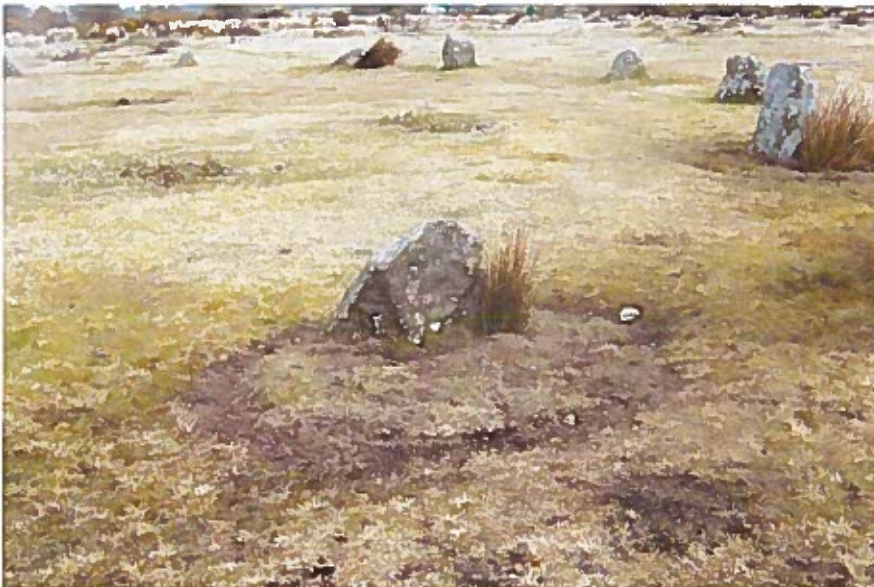
Picture 15 (below) The two infilled erosion hollows (stone at bottom of picture, and one above left). A light sprinkling of earth will help the new turf to 'take' more quickly.

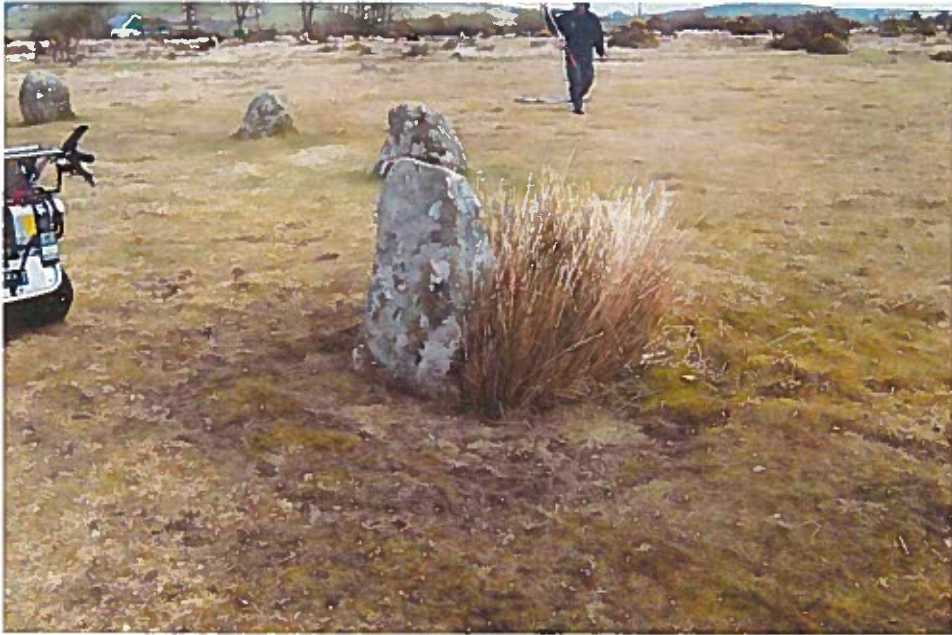
Picture 16 (above) Close-up of the restored profile.

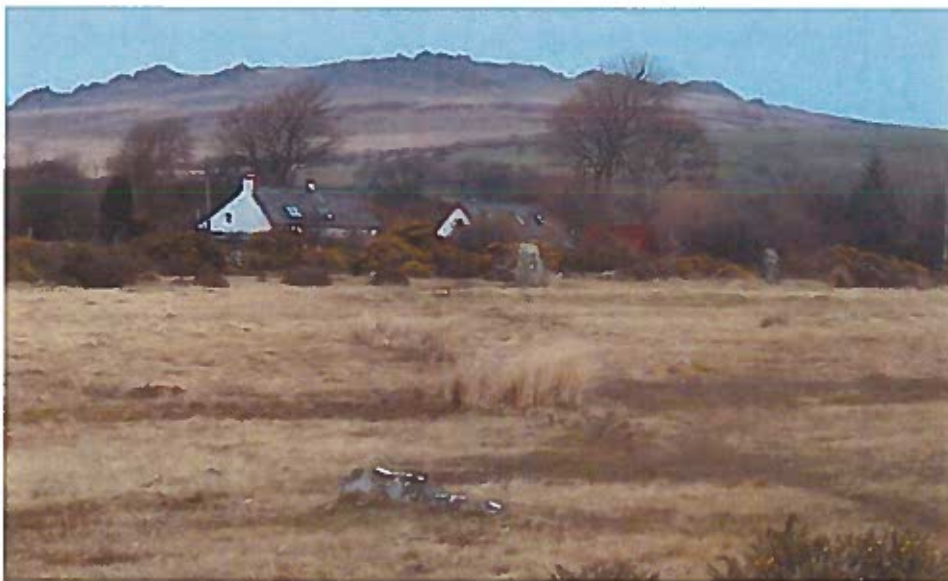
Picture 17 (below) The view from the stone circle to the outlying stone pair. With the gorse removed, there is now a clear viewline between the two sites, and the relationship between them is restored. Gorse removal has also enabled a clearer appreciation of the setting of Gors Fawr stone circle, highlighting the possible relationship between the stone circle, the stone pair and the bluestone outcrops of Carn Menyn – visible in the background of this picture.

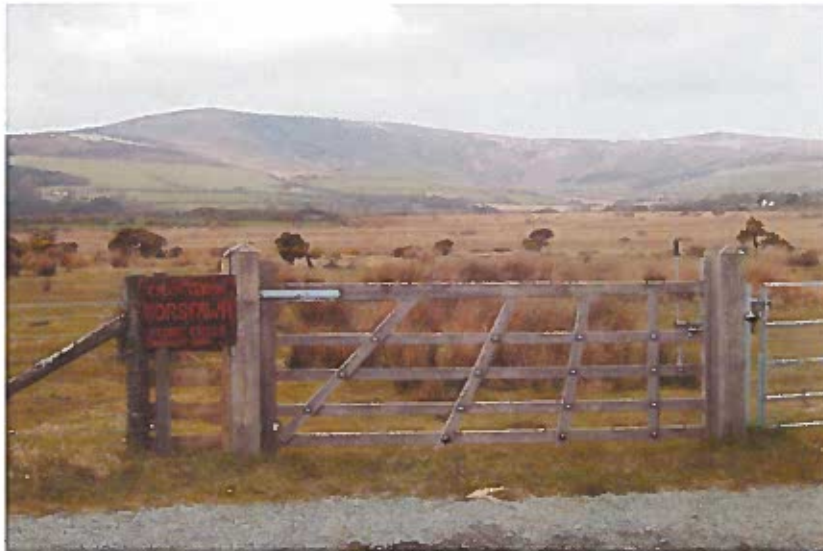
Picture 18 The current entrance into the Gors Fawr stone circle.

Currently, the site is indicated from the road by a sign which is difficult to see and contains no information. The location would be inappropriate for an interpretation panel, but PCNPA staff are investigating the possibility of erecting a new sign which contains basic facts about the circle – the name and its suggested age, for example.
