A SURVEY OF DEFENDED ENCLOSURES IN PEMBROKESHIRE, 2006-07: GAZETTEER OF ORDNANCE SURVEY GRID SQUARE SM92

RHIF YR ADRODDIAD / REPORT NO. 2007/01
RHIF Y PROSIECT / PROJECT RECORD NO. 54269

SITE GAZETTEER OF 10KM GRID SQUARE SM92

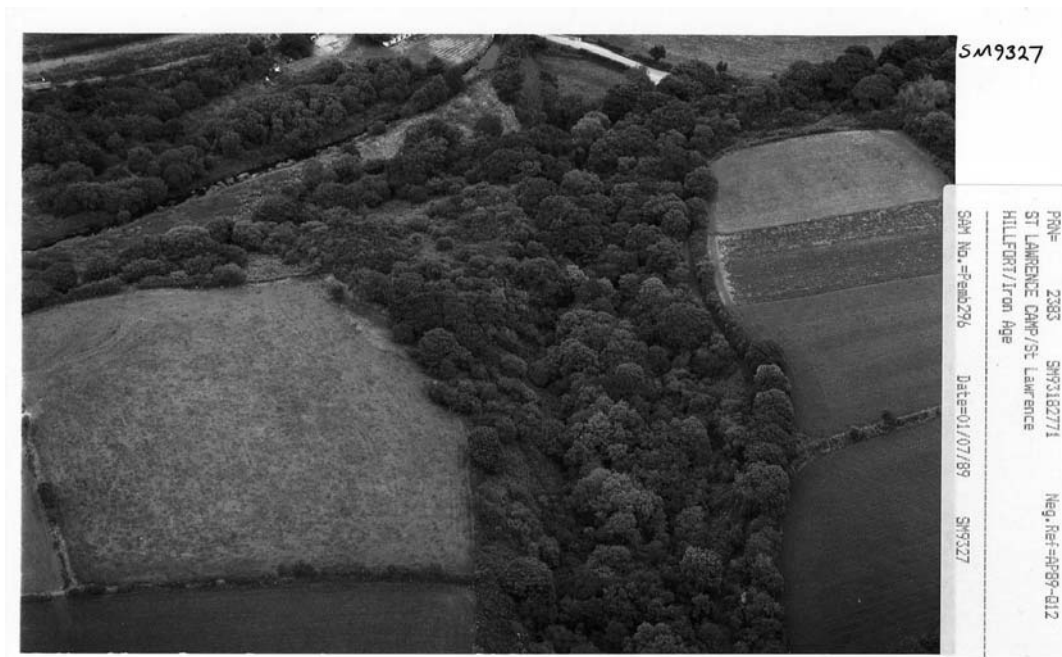
St Lawrence Camp is an inland promontory fort lying at 65m above sea level naturally defended by steep slopes to the north, east and west that fall away by 20m to valley bottoms. Land rises gently away from the site to the west. The roughly triangular internal area measures c. 40m E-W and 35m N-S. A rampart runs across the neck of the promontory for c.50m. The bank is 2m above the interior of the fort and 2.3m above the ditch. A low counterscarp bank runs along the outer lip of the ditch. The whole of this defensive system is c.15m wide. There is a much-altered entrance at the southern end of this defence. Cadw's field monument warden noted two further lines of bank and ditch outside the main defence, while Crossley has this as a bivallate fort.

The interior is under unmanaged deciduous woodland. The outer earthworks have been damaged by cattle trampling in the past.

Aerial photograph of 2383. Cambria Archaeology reference AP89-Q12.

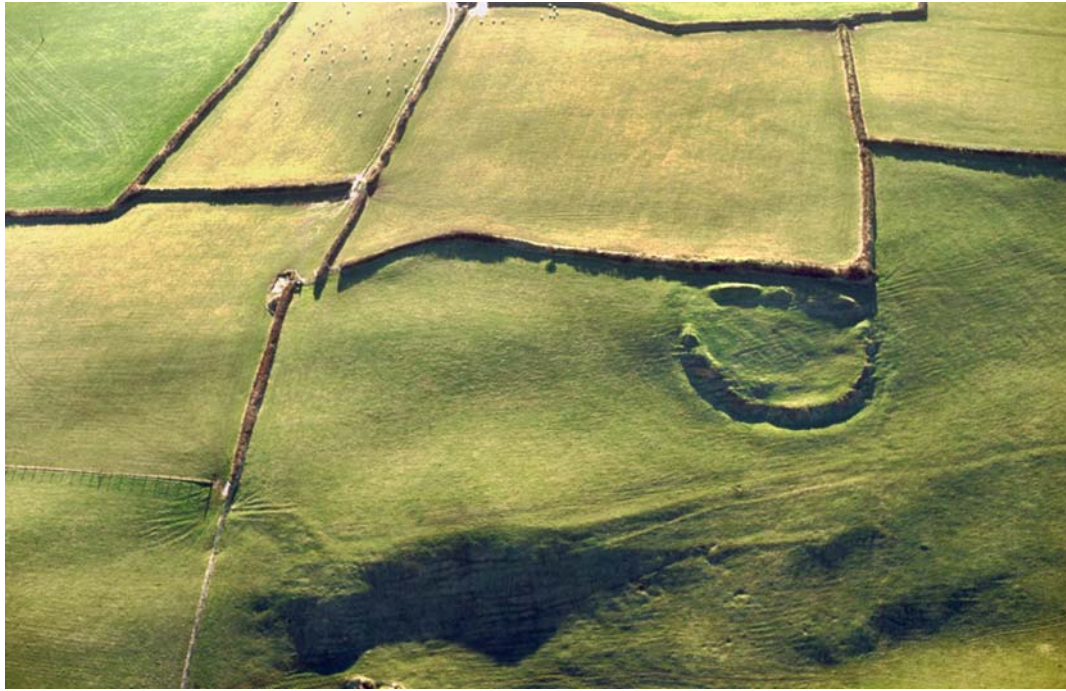
Ford Camp is a small, circular, earthwork defended enclosure lying on a north-facing slope at 60m above sea level. The sloping interior measures approximately 47m in diameter and is defined by a bank. The bank rises c.0.7m-1.0m above the interior and exterior, though in places is up to 1.7m high internally. Aerial photographs show a slight ditch on the north and west sides, but this is not readily visible on the ground. The entrance probably lay on the southwest side.

The bank is in poor condition, with several breaks in it and with animal erosion exposing the core of the bank causing it slip downhill. The interior is under pasture.

Aerial photograph of 2385. RCAHMW Crown Copyright ©
reference DI2006_0956.

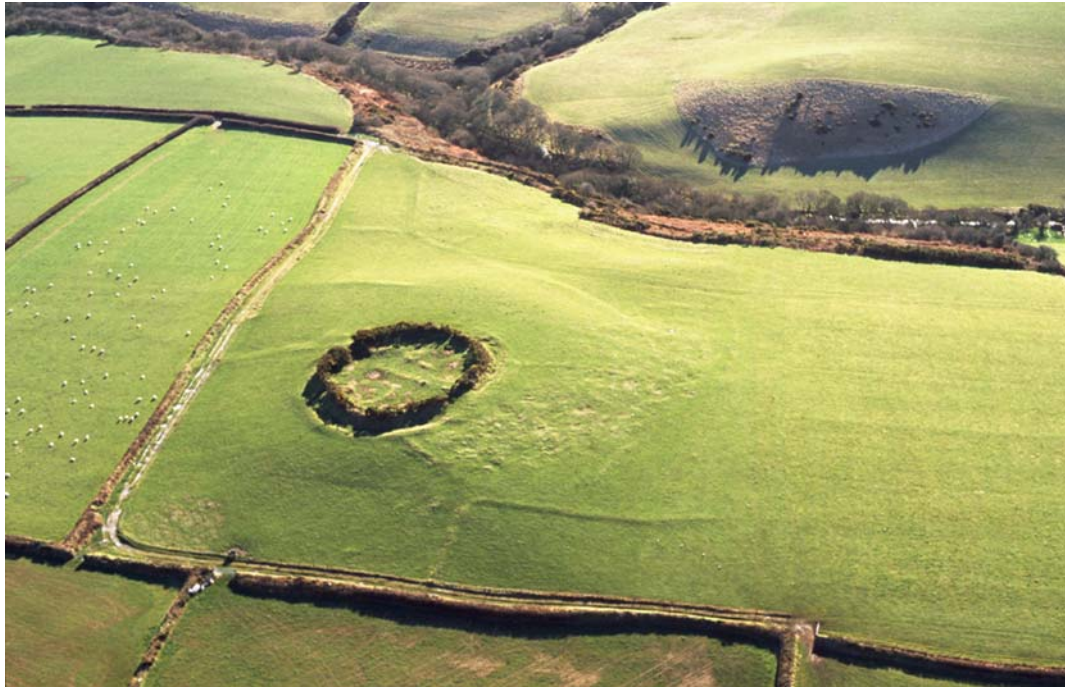
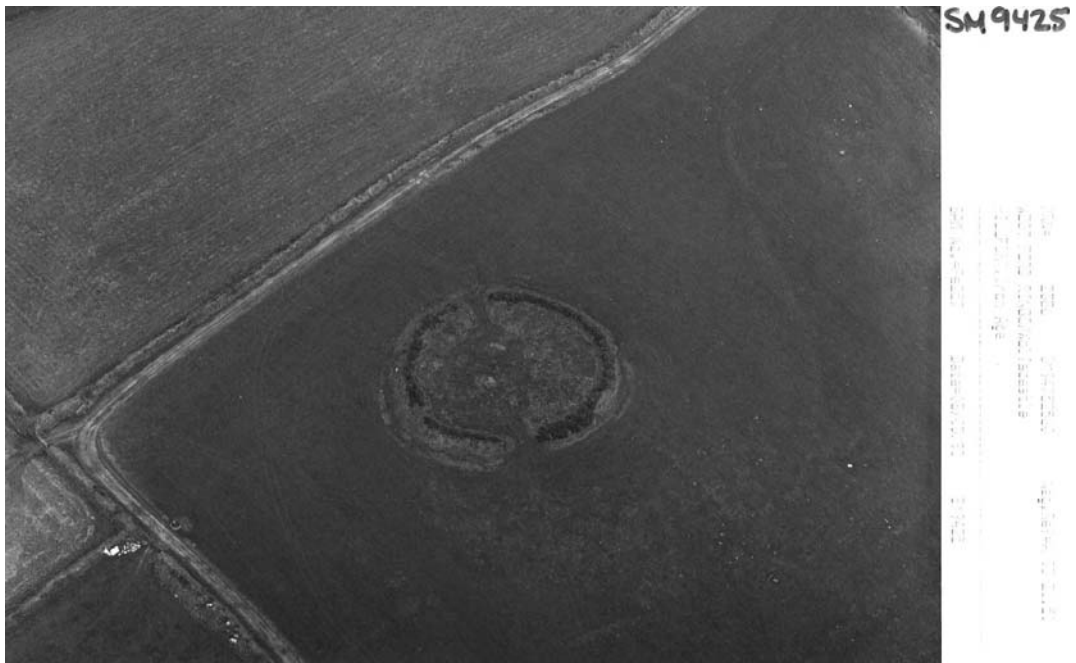
West Fort Rings is a small, sub-circular, earthwork defended enclosure lying on a very gentle southeast-facing slope at 85m above sea level. To the south of the enclosure the land falls more steeply away to a stream 30m below. The site is defined by an earthwork bank, ditch and counterscarp bank. The bank rises up to 1m above the interior and 2m above the ditch. The counterscarp bank is just 0.2m high. The whole system is c. 9m wide. There is a slightly in-turned entrance on the southeast side. The interior is c. 45m in diameter. The interior is now undulating. However, the Ordnance Survey in 1964 and 1966 recorded two earthwork, circular huts just inside the entrance, one on either side. At a later date only the northern most hut, 10m diameter was recorded, with the southern part of the enclosure containing a series of banks. These are not now readily detectable.

Aerial photographs show a series of small undulations outside the enclosure on the north and west sides, and possibly contemporary field boundaries to the south.

The interior and exterior of the enclosure are under improved pasture. The banks are under scrub.

Aerial photograph of 2386. RCAHMW Crown Copyright © reference DI2006_0737.

Aerial photograph of 2386. Cambria Archaeology reference AP93-21.50.

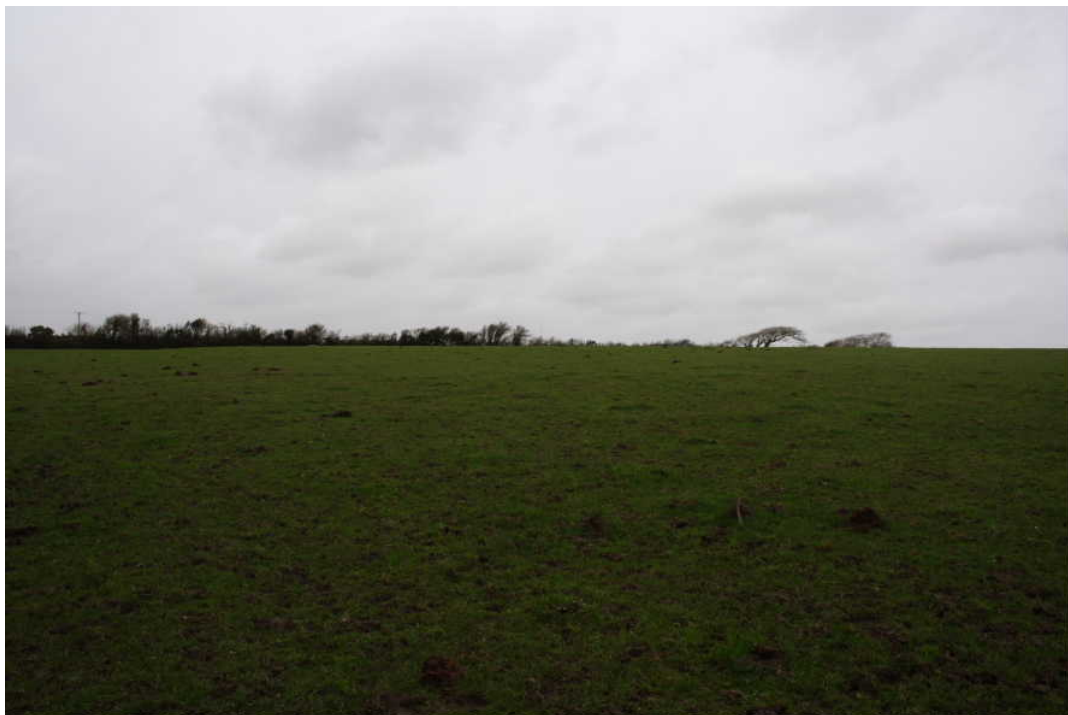
Vertical aerial photographs (Meridian 1955) show a crop-marked ditch defining a sub-circular enclosure. The enclosure is about 55m in diameter internally and has a clear east-facing entrance. The photographs seem to show a slightly raised interior.

On the ground the site is marked by low earthwork bank surrounding a slightly raised and dished interior. It has clearly been plough-levelled and very little trace of it now survives.

Ground photograph looking NE over low earthwork enclosure 2399.

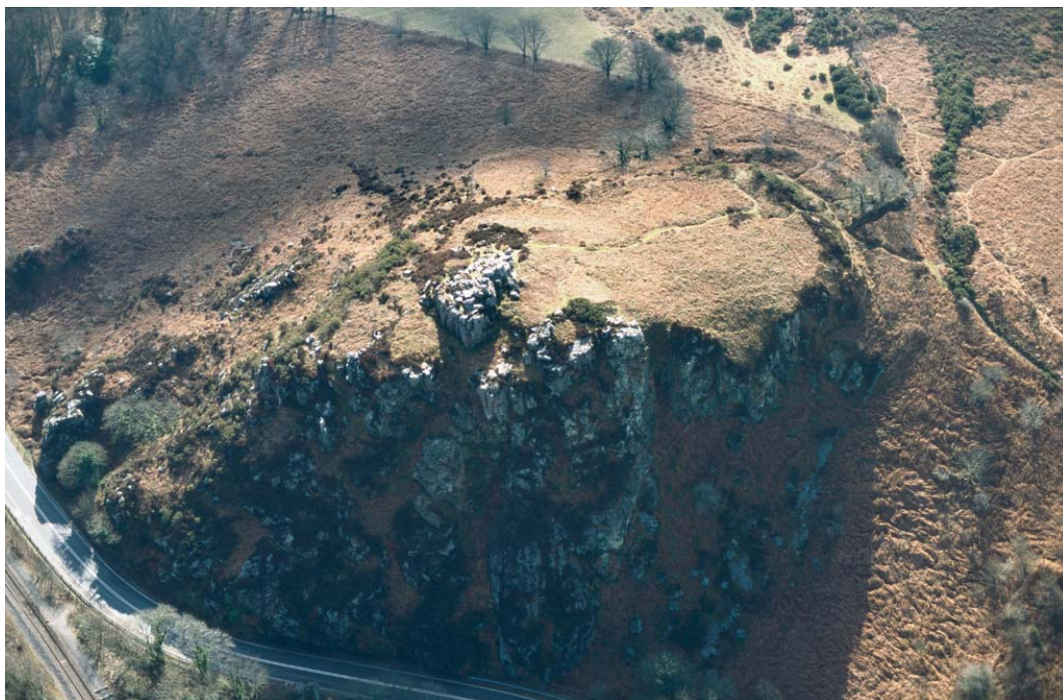
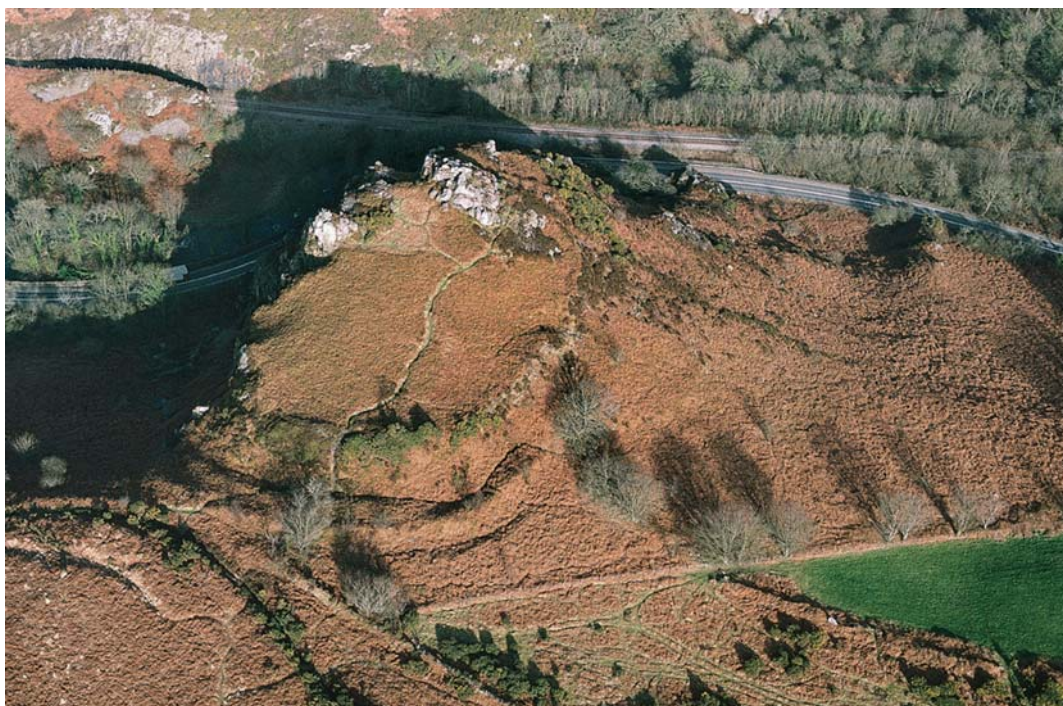
The hillfort at Great Treffgarne Rocks is dramatically sited on a rocky spur overlooking the valley of the Western Cleddau at 80m above sea level. To the north, east and southeast land falls precipitously away to the river 50m below. To the west land falls 10m into a saddle before rising again to a high point 1.5km away. The roughly oval interior, 75m E-W and 53m N-S, is defended by a single bank and ditch, and by a second bank and ditch on the easily approachable west side. On the east side the bank is incorporated into the rocky outcrop over vertical cliffs. The inner bank stands up to 4m on the west side, and the outer bank 1.7m. The ditches are well-defined. The entrance lies on the south side and is marked by a slight in-turning of the banks. The site is under bracken with scrub on the inner bank.

Aerial photograph of 2400. RCAHMW Crown Copyright ©
reference DI2006_1538.

Aerial photograph of 2400. RCAHMW Crown Copyright ©
reference DI2005_0293.

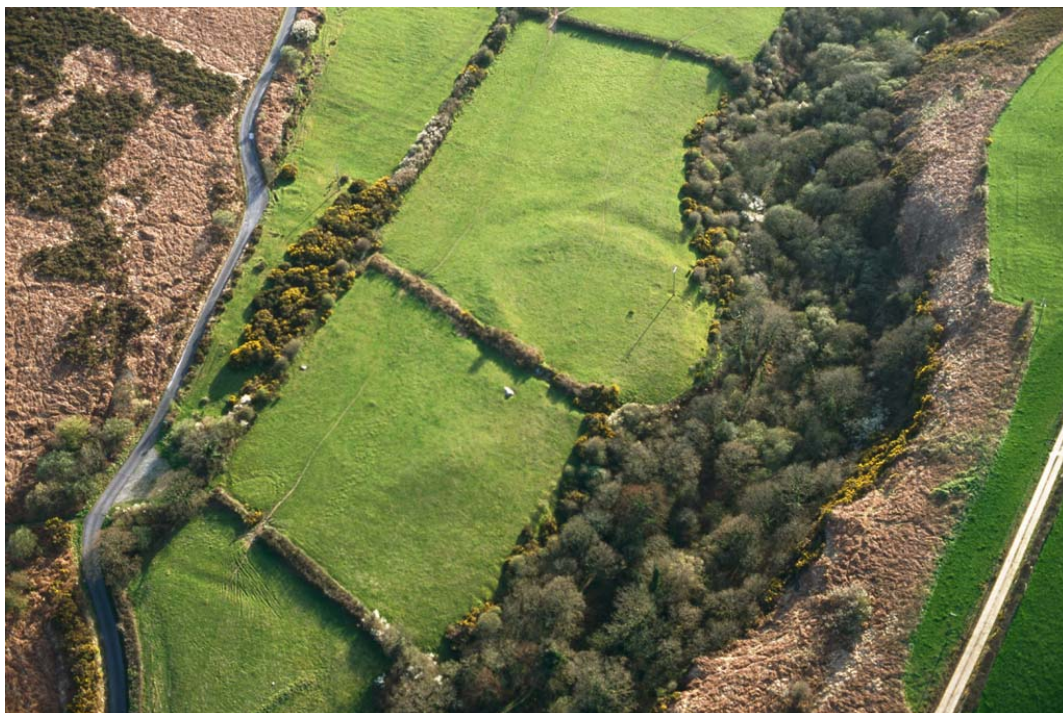
This is a small, earthwork, sub-circular defended enclosure lying on a north-facing slope between 40m and 50m above sea level. Immediately to the north the slope steepens as it falls away to Nant y Coy 10m below. The break of slope defines the edge of the enclosure on the north side and a hedge-bank lies along the defensive bank on the east side. Elsewhere the defensive circuit is marked by a curving bank c.0.3m high internally with an external ditch. Aerial photographs suggest that the rampart continues along the crest of the slope on the north side. There is no trace of an entrance on the ground, but the aerial photographs suggest it may be below the hedge-bank on the east side. The internal sub-circular area of the enclosure is c.45m diameter.

Slight, undefined earthworks on the west side of the enclosure may be evidence of outworks, aerial photographs, however, suggest a natural gully.

Aerial photograph of 2403. RCAHMW Crown Copyright © reference DI2006_1564.

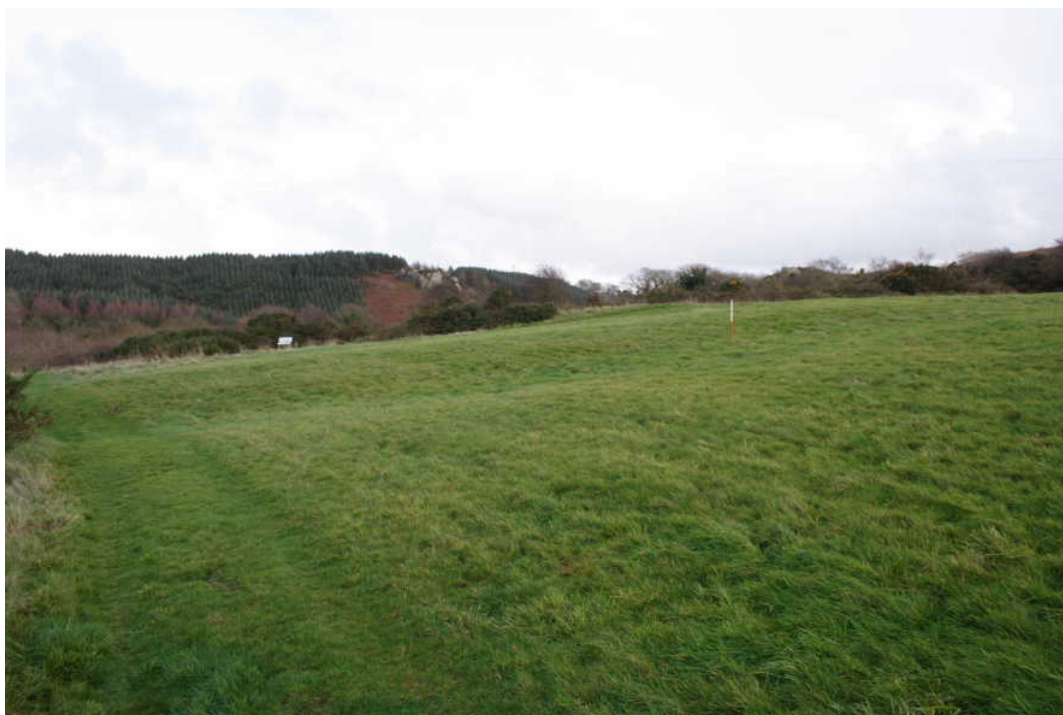
Ground photograph looking SE over enclosure earthworks.

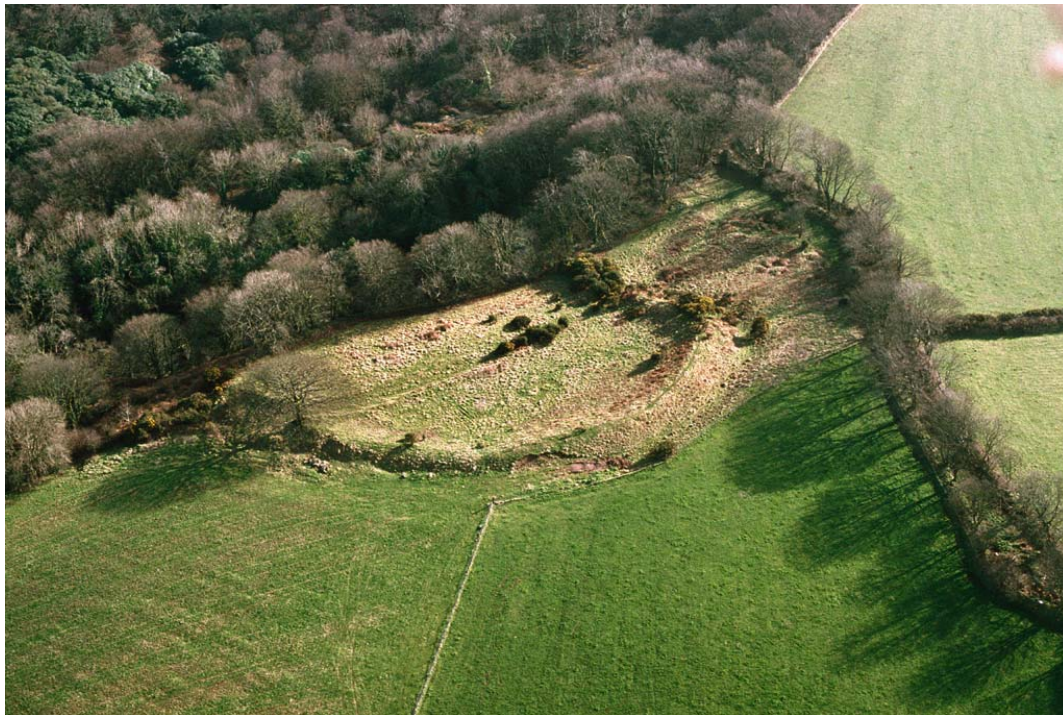
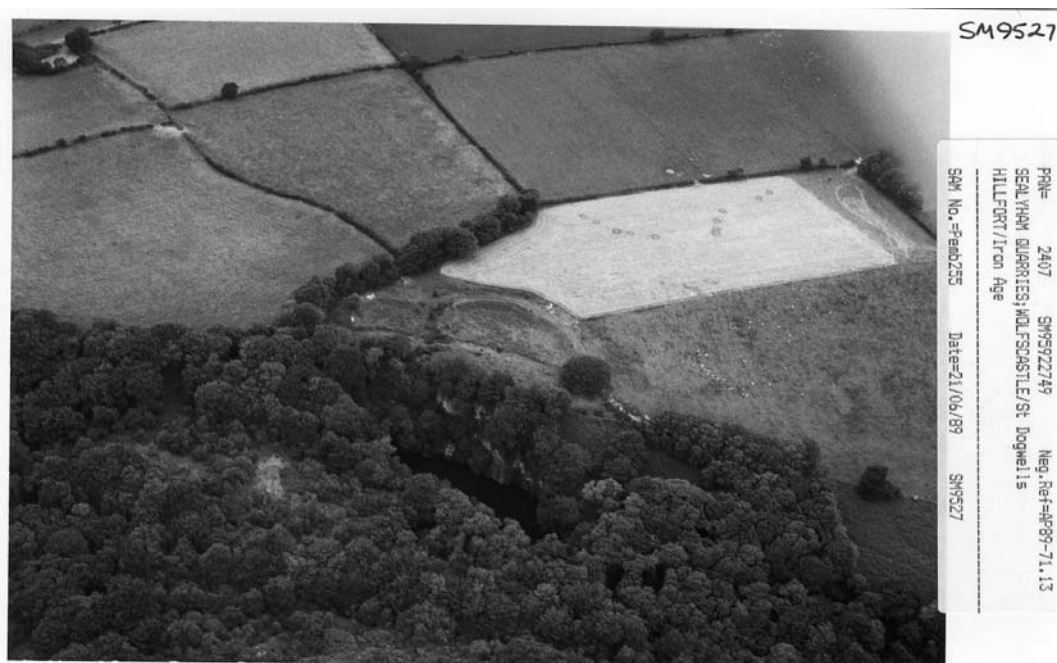
Sealyham Quarry is a fine example of a defended enclosure, albeit one that has been damaged by quarrying.

The main defence consists of a curving bank and ditch, enclosing a semi-circular area c.65m SW-NE and 38m SE-NW with the quarry face defining the east side. The bank is c.2m high and the ditch up to 1.2m deep. A rectangular annexe c.40m by 20m is attached to the southwest side of the main enclosure. This is defined by a low bank and ditch to the west, a low bank to the south and the quarry face to the east. In-line gaps through the south side of the annexe bank, and the bank on the north and south side of the main enclosure are from an old track. The location of the original entrance is unclear.

Aerial photograph of 2407. RCAHMW Crown Copyright © reference DI2006_1563.

Aerial photograph of 2407. Cambria Archaeology reference AP89-71.13.

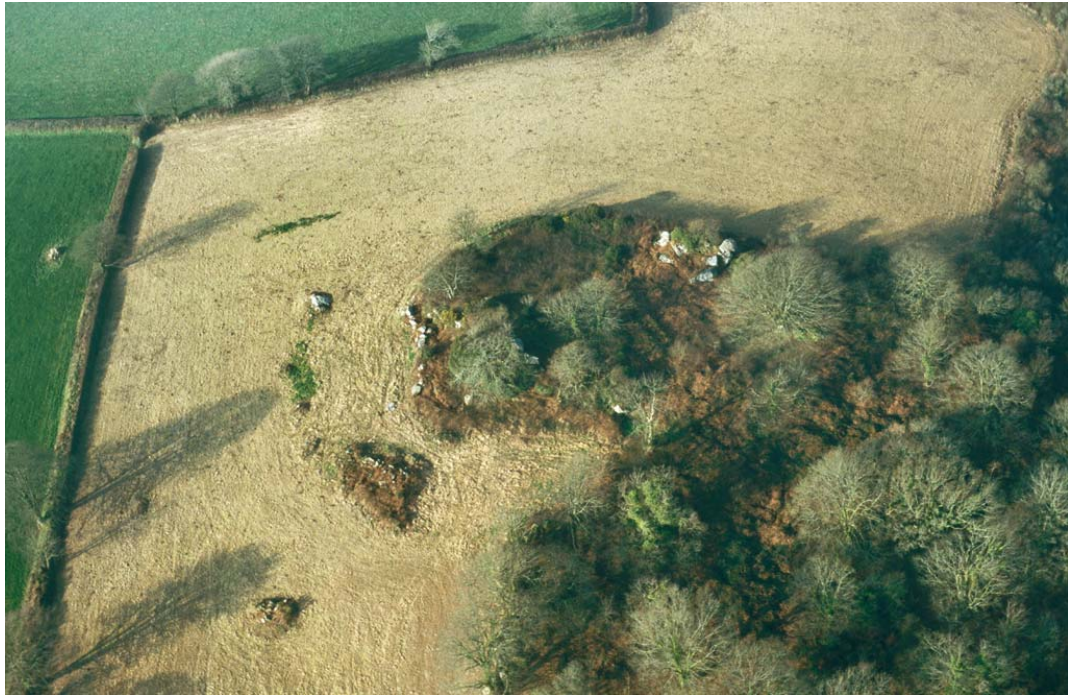
An oval, univallate defended enclosure c. 80m E-W and 40m N-S occupies a blunt inland promontory 85m above sea level, from which land falls away steeply to the north, east and southeast. The single rampart incorporates Sealyham Rocks in its circuit. The bank survives up to 2m high above the interior and 3m above the exterior. The defences are difficult to make out on the east side where they run into scrub. On the northwest side and south side the ditch to the bank has been plough-filled. In 1973, the Ordnance Survey noted a fragment of dry-stone walling in the bank on the northeast side. A break in the defences on the southeast side is probably the original entrance. The interior is uneven and bracken-covered.

Aerial photograph of 2408. RCAHMW Crown Copyright ©
reference DI2006_1547.

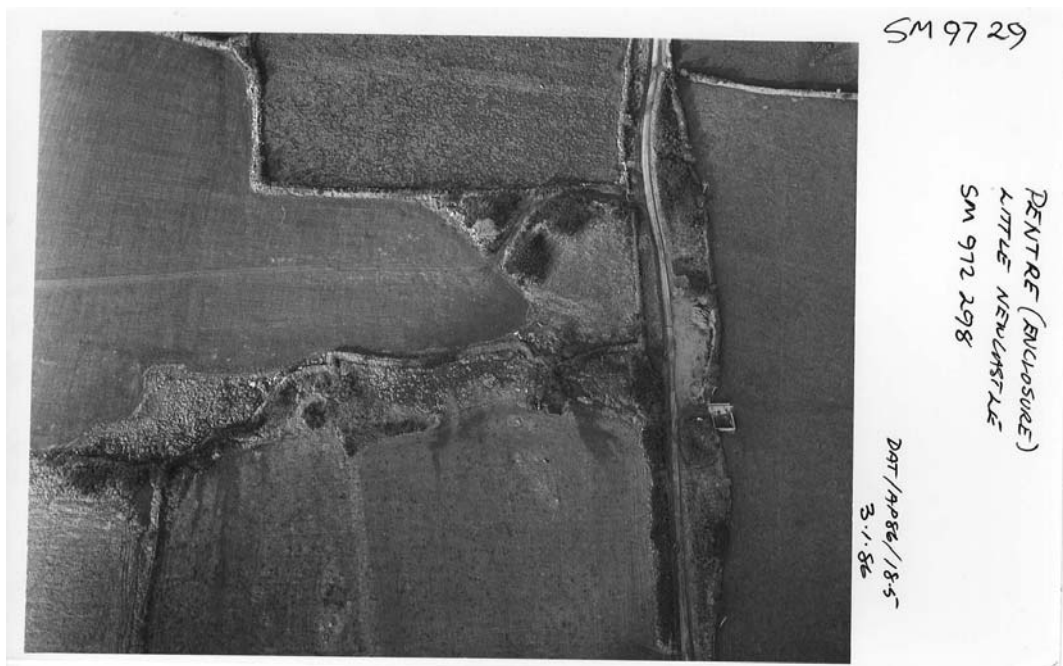
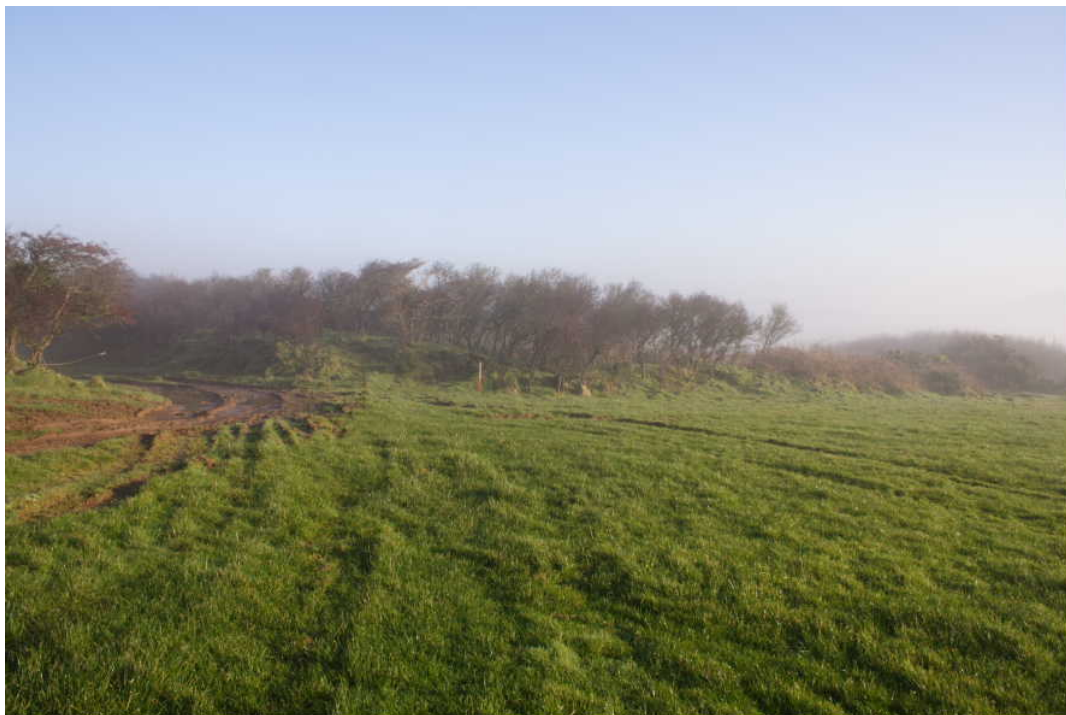
Castell Pentre is a small, sub-circular, earthwork defended enclosure, c.50m across internally, occupying a southeast-facing slope at 170m above sea level. The site is very overgrown with gorse, blackthorn and bracken and so is consequently difficult to characterise. The defences can, however, be made out. These consist of a bank and a ditch. The bank is best preserved on the north, northwest and west sides where it stands up to 1.5m high. A road has disturbed and probably destroyed the bank on the east side. An external ditch is visible on the south and southeast sides. A track runs along the location of the ditch on the northwest and north sides obscuring it. There is no obvious entrance.

The site is suffering damage from burrowing animals, particularly badgers, and also from cattle trampling.

Aerial photograph of 2413. Cambria Archaeology reference AP86-18.5.

Ground photograph looking E towards earthwork enclosure.

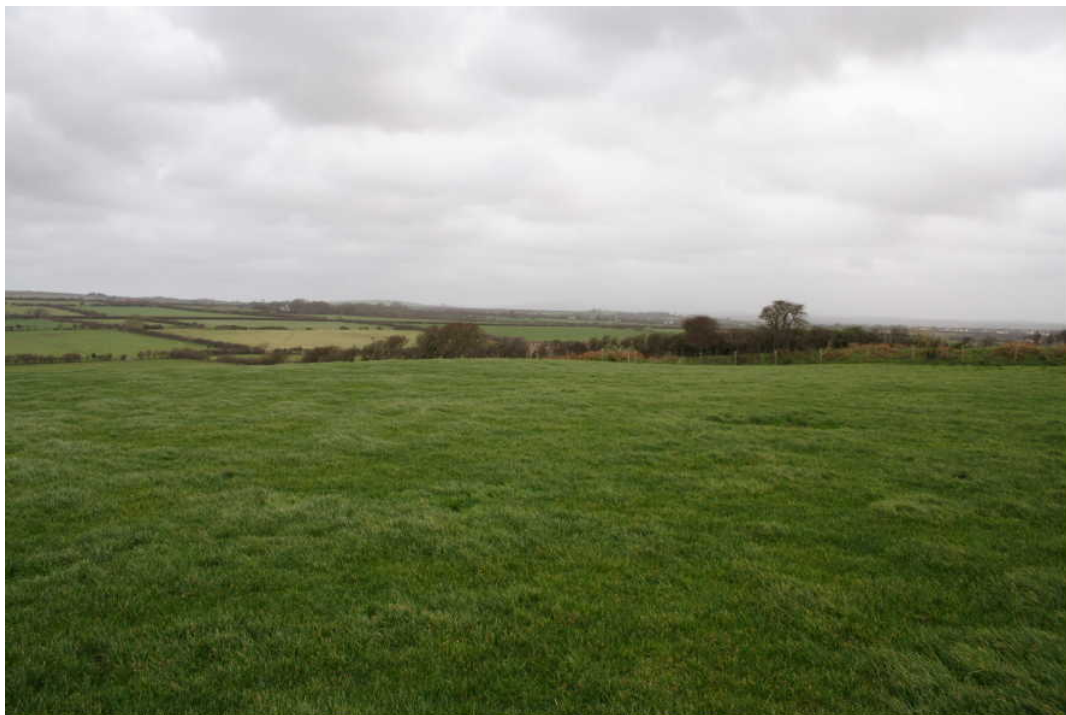
The Ordnance Survey state that this site was bulldozed in 1965, but would seem to have suffered severe plough-damage prior to this date. In 1925 the crescentic bank stood up to 6ft above the interior and 8ft above the exterior - there was no trace of a ditch. The site is under improved pasture.

Ground photograph looking NE over low earthworks of enclosure 2422.

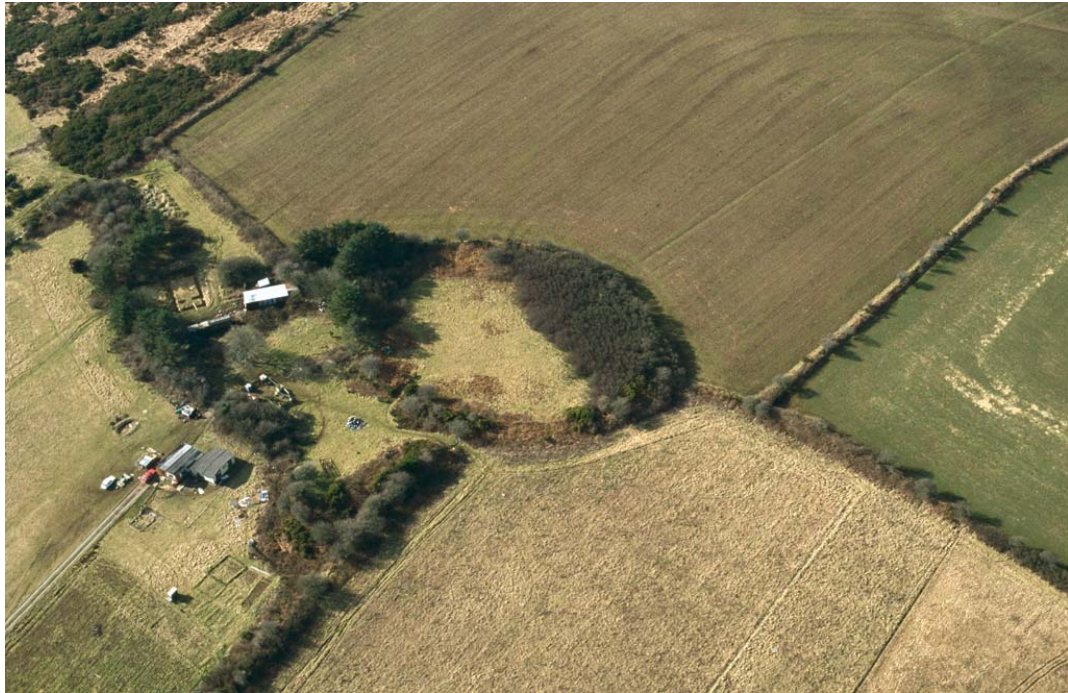
Plumstone Rath is a univallate, oval, earthwork defended enclosure, with a sub-rectangular annexe attached to its south side, occupying a gentle southeast-facing slope at 130m above sea level. The oval enclosure is 85m SW-NE and 55m SE-NW internally, and is surrounded by a bank that rises 1.3m to 1.6m above the interior and 2.6m to 3.3m above the exterior. There is no trace of a ditch. An entrance through the bank on the south side leads into the annexe. The annexe is c.70m E-W and 30m N-S and is defended by a bank which rises up to 1m above the interior and 3m above the exterior. There is no trace of a ditch. The western side of the annexe has been damaged by a house (now ruined) and its enclosures. There is no surviving external entrance into the annexe. The defensive banks are scrub-covered and the interior of the main enclosure and annexe are under improved pasture.

Aerial photograph of 2426. RCAHMW Crown Copyright ©
reference DI2006_1546.

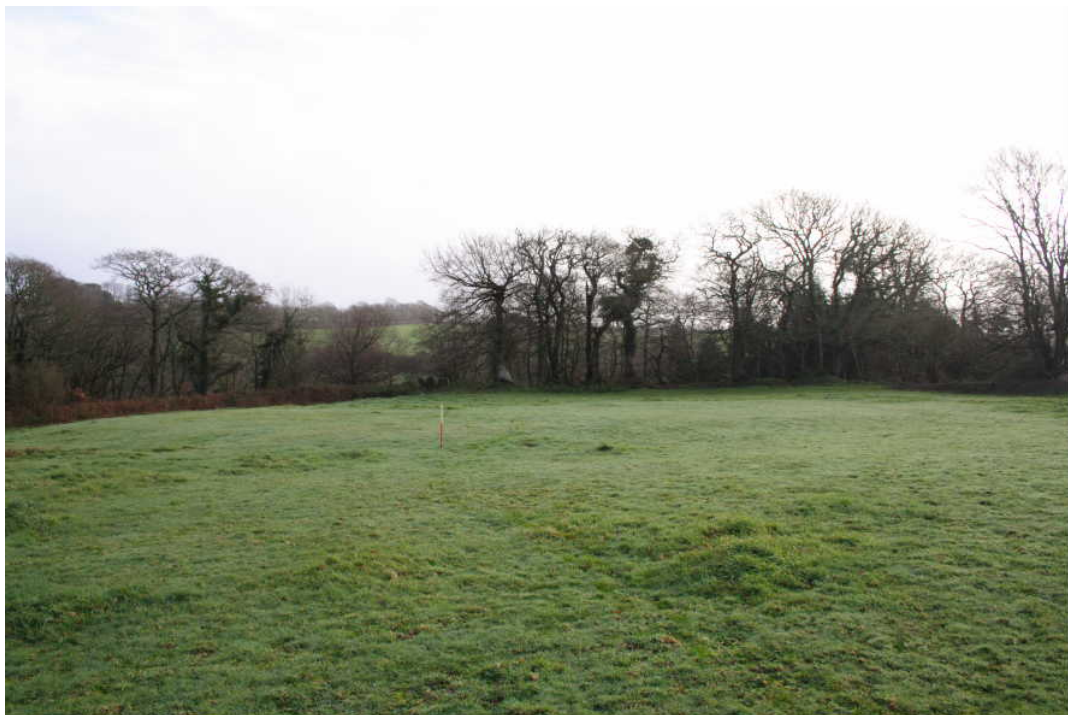
Cannon Hill is a small defended enclosure occupying an east-facing slope at 50m above sea level on the edge of a steep valley side that falls away immediately to the east of the site to a small stream c. 15m below. The enclosure measures approximately 48m N-S and 37m E-W internally, and is defined by a low earthwork defence. On the west side this comprises a 0.5m high, spread, curving bank with traces of an external ditch. On the south side a field-bank overlies the defence and on the north side the bank fades, but seems to have a gap, possibly an entrance. The east side is marked by a scarp with traces of an external ditch. The interior and most the defensive circuit is under improved pasture with deciduous woodland on the slopes on the east side of the site.

Ground photograph looking E over low earthwork enclosure 2459.

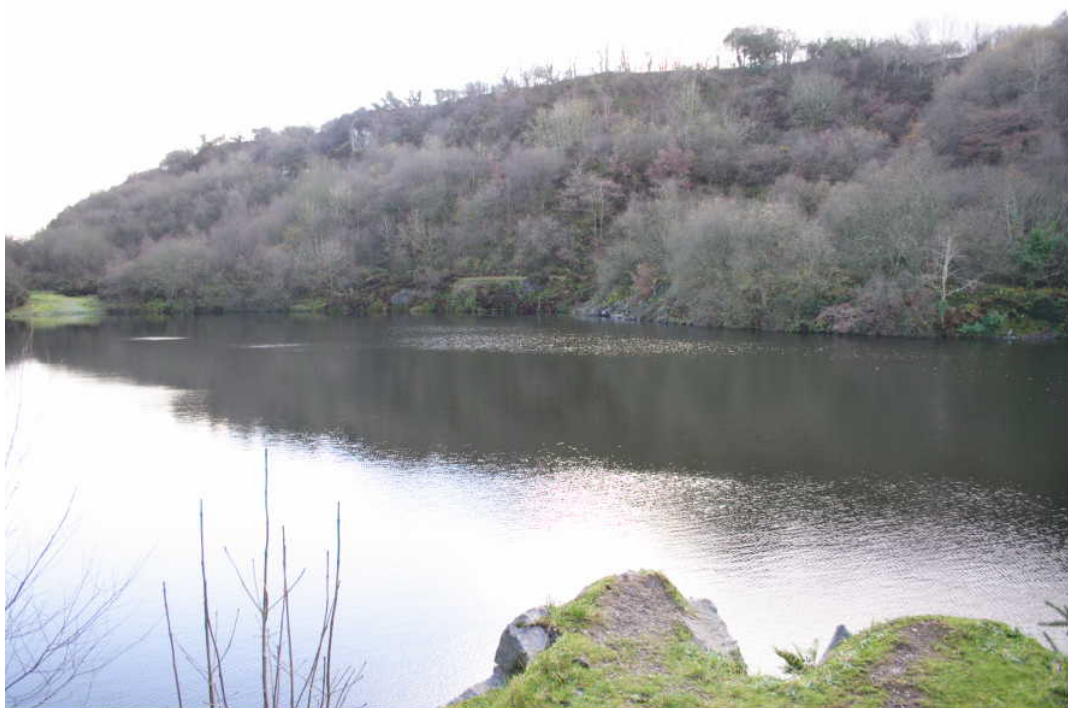
Ground photograph looking S over site of former earthwork enclosure 2461 destroyed by quarry.

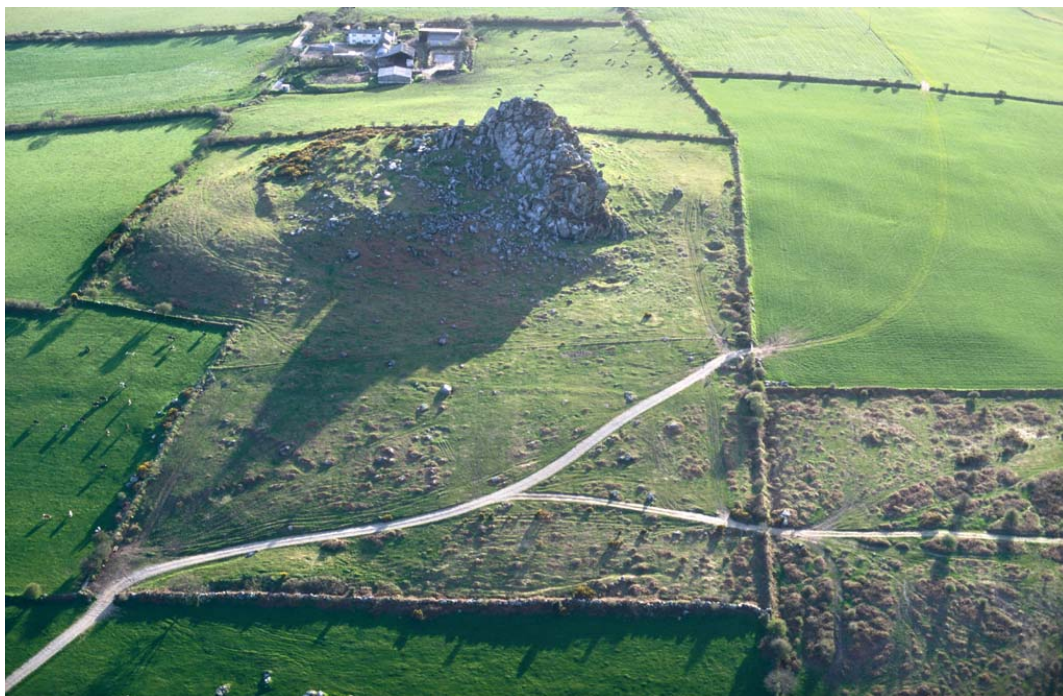
Aerial photograph of 2462. RCAHMW Crown Copyright © reference DI2006_1541.

A circular, earthwork defended enclosure occupying a gentle west-facing slope at c.75m above sea level. Immediately to the west the slope steepens into a scarp as it falls away by 40m to the valley floor of the Western Cleddau. The enclosure is divided in two by a fence, to the east of which is a field of improved pasture and to the west is scrubby deciduous woodland. The enclosure measures c.55m diameter internally. In the field to the east a curving bank rising 0.8m to 1m above the interior and 1m to 1.8m above the exterior, with traces of an external ditch, defines the site. There is an entrance on the north side. Within the woodland the rampart quickly fades and the western side of the enclosure is represented by the scarp slope. The bank in the field to the east is under scrub.

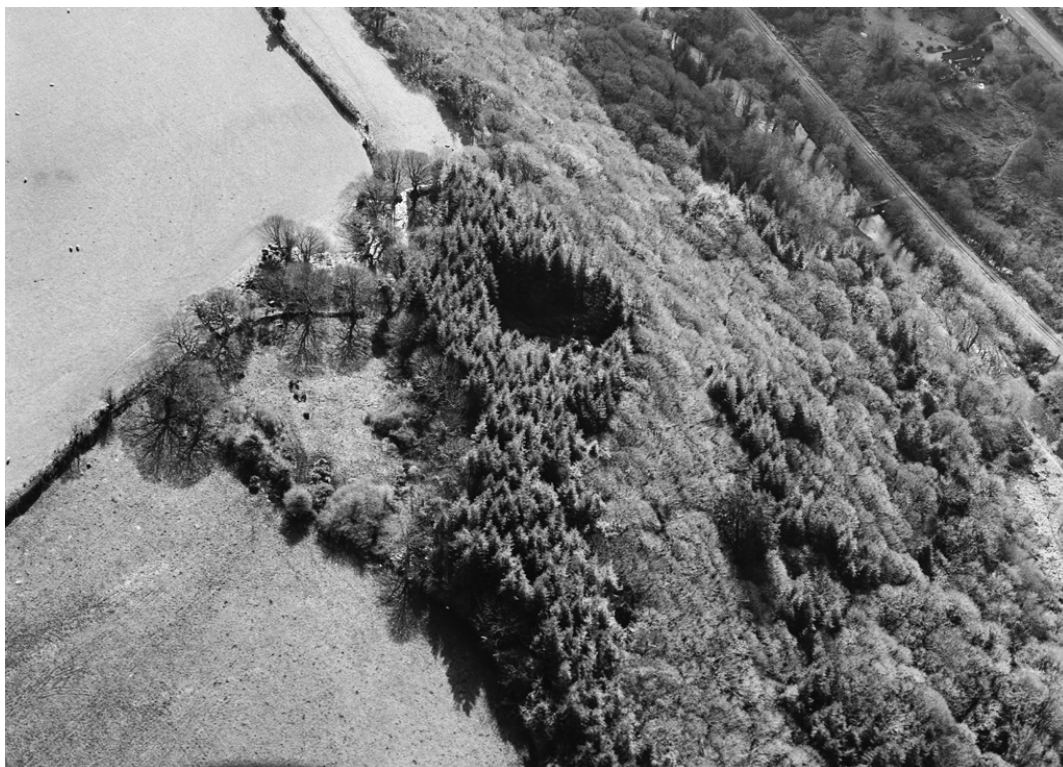
Aerial photograph of 2463. RCAHMW Crown Copyright © reference DI2006_1609.

Lying in a forestry plantation, Little Treffgarne Camp is a small, circular, earthwork defended enclosure occupying a gentle west-facing slope at 75m above sea level on the edge of a scarp slope that falls away to the valley floor of the Western Cleddau 40m below. The enclosure is about 25m diameter internally. The defences consist of a bank, 1m high above the interior and 1.3m above the external ditch, which is well-defined, on all sides except the west where they fade into the scarp slope. There is a simple entrance on the southeast side.

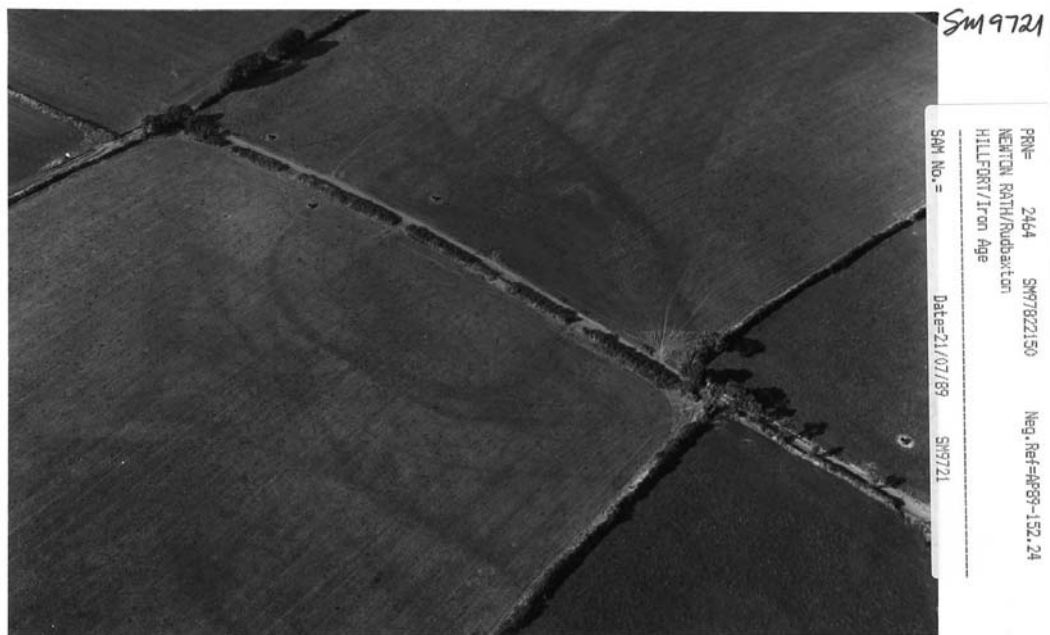
Aerial photograph of 2464. Cambria Archaeology reference AP89-152.24.

In 2006, the site was under improved pasture.

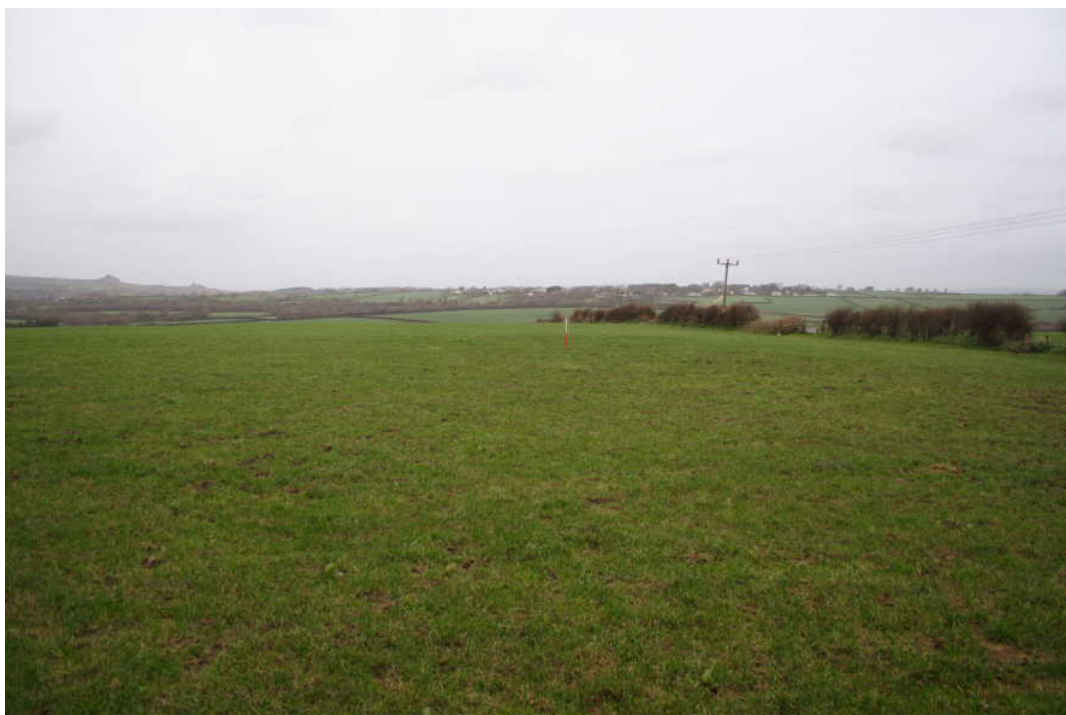
Ground photograph looking N over earthwork enclosure 2464.

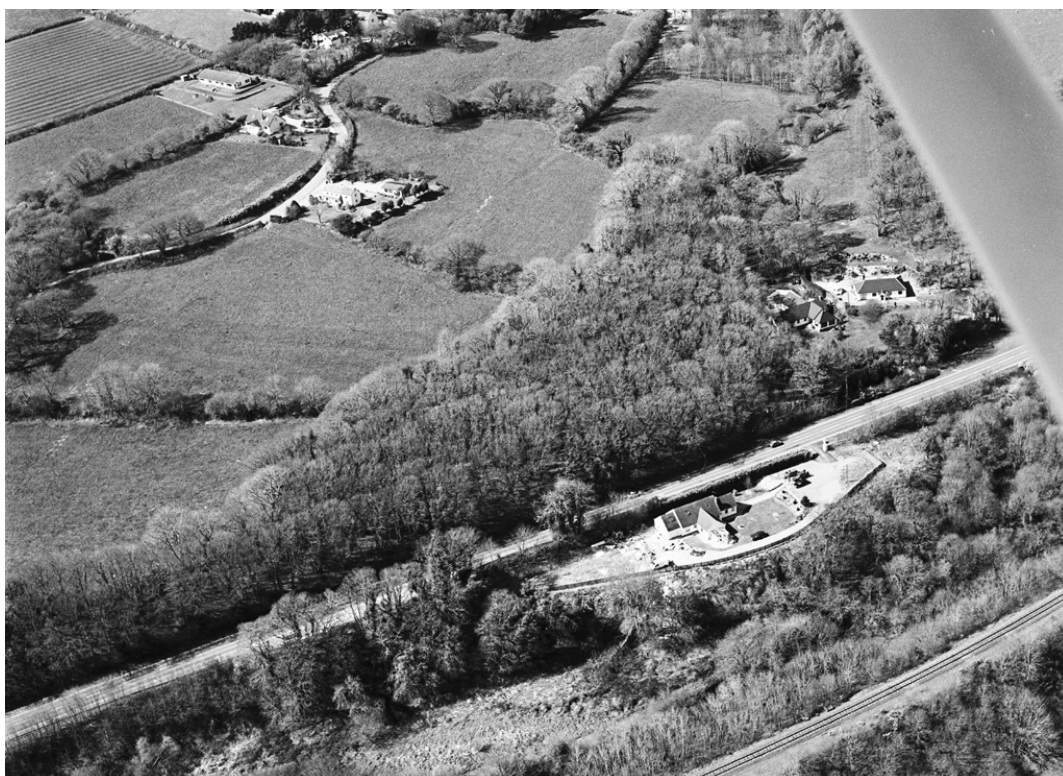
Aerial photograph of 2465. RCAHMW Crown Copyright © reference DI2006_1612.

Pant Lladron is a small, oval, earthwork defended enclosure lying on a terrace of fairly level ground at 35m above sea level at the foot of a steep east-facing valley side. The site lies in scrubby deciduous woodland. The enclosure measures c.40m N-S and 30m E-W internally. The defensive circuit is well preserved and comprises a bank rising c.1.2m above the interior and 2m above the 1.5m deep external ditch. There is a slight counterscarp to the ditch. There is a 3m wide entrance on the south side. The eastern side of the defensive circuit on the east side have been destroyed by a road.

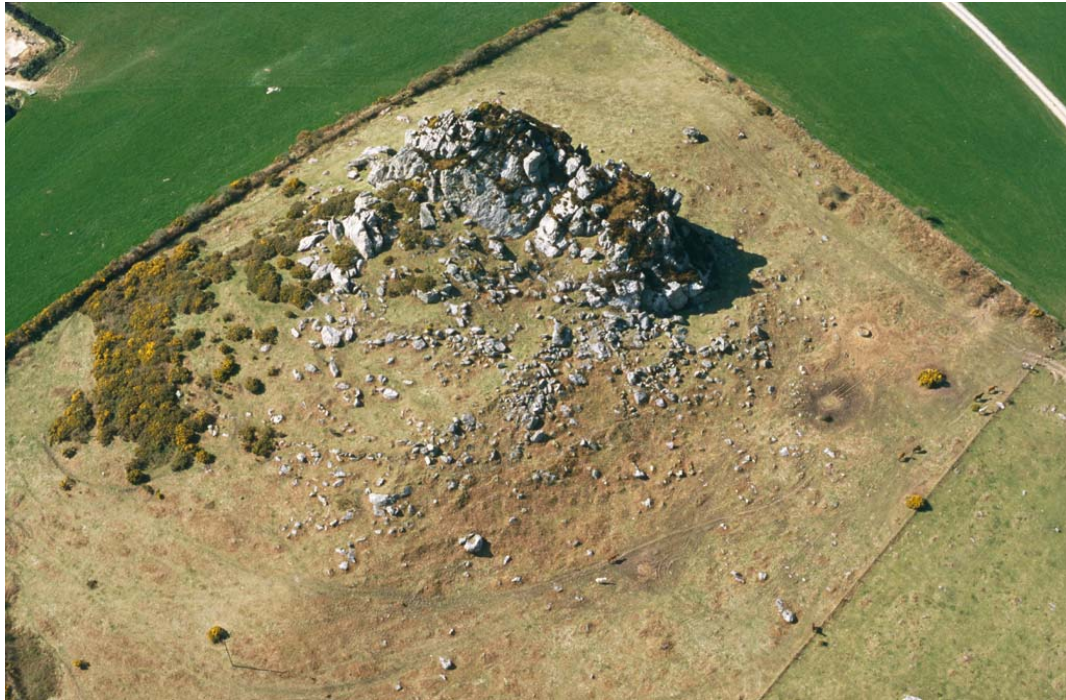
Aerial photograph of 2466. RCAHMW Crown Copyright © reference DI2006_1559.

The site is under rough pasture with gorse scrub.

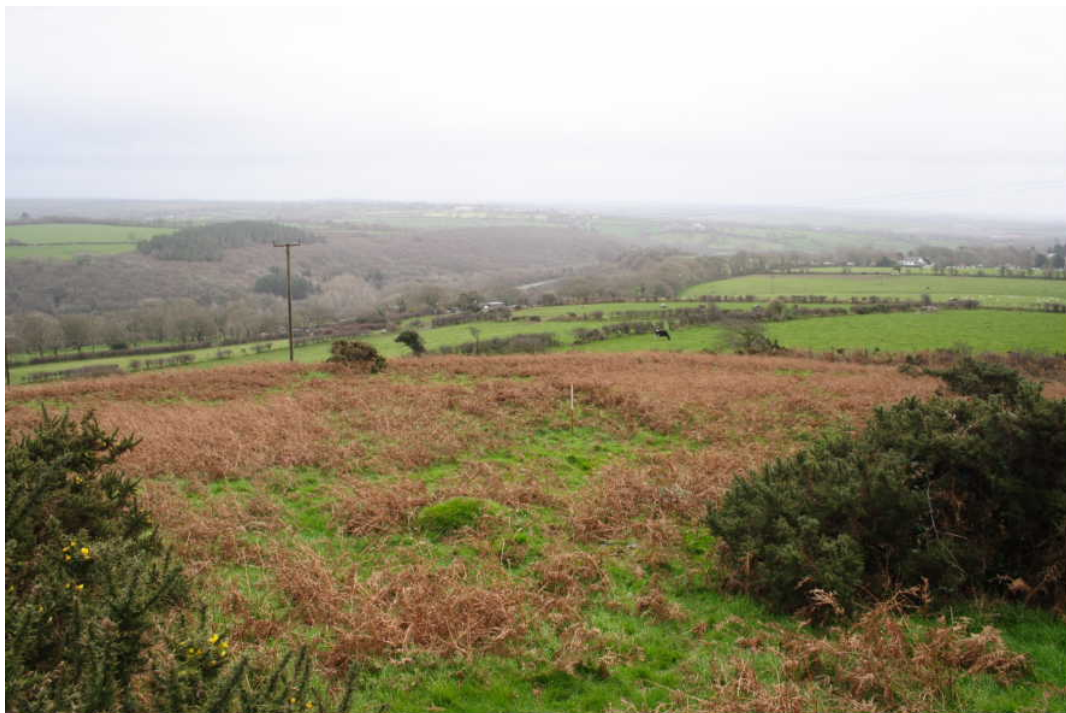
Ground photograph looking SW over interior of enclosure.
