A SURVEY OF DEFENDED ENCLOSURES IN PEMBROKESHIRE, 2006-07: GAZETTEER OF ORDNANCE SURVEY GRID SQUARE SM92

RHIF YR ADRODDIAD / REPORT NO. 2007/01
RHIF Y PROSIECT / PROJECT RECORD NO. 54269

SITE GAZETTEER OF 10KM GRID SQUARE SM92

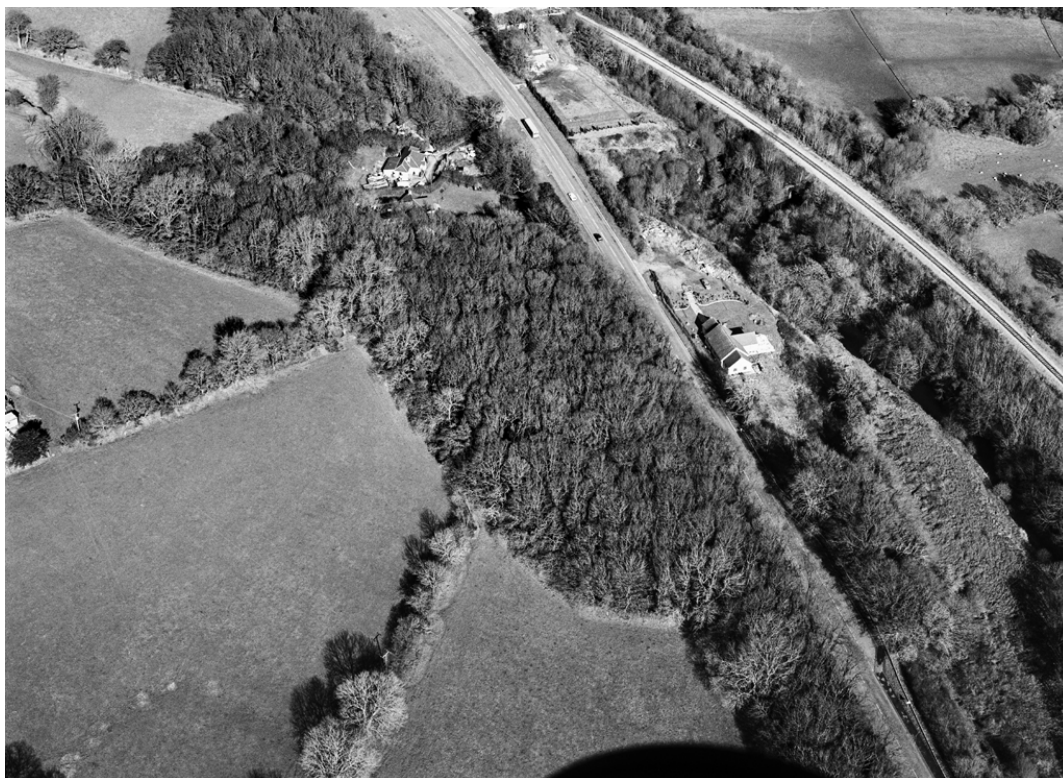
Aerial photograph of 2467. RCAHMW Crown Copyright © reference DI2006_1610.

This is a small, sub-circular, univallate, earthwork defended enclosure occupying a southwest-facing slope at 65m above sea level on the upper edge of a steep, west-facing valley side. The enclosure is c.40m diameter internally. The defences consist of an earth and stone bank which rises 1m above the interior and 1.3m-2m above the 0.3m deep external ditch. The ditch survives well on the east side, but has been infilled in the lawn area to Hazel Grove House on the east side. The northeast side of the enclosure has been mutilated and a septic tank inserted in the interior. There is no obvious entrance. Most of the enclosure lies in a deciduous wood, with the east side gardens.

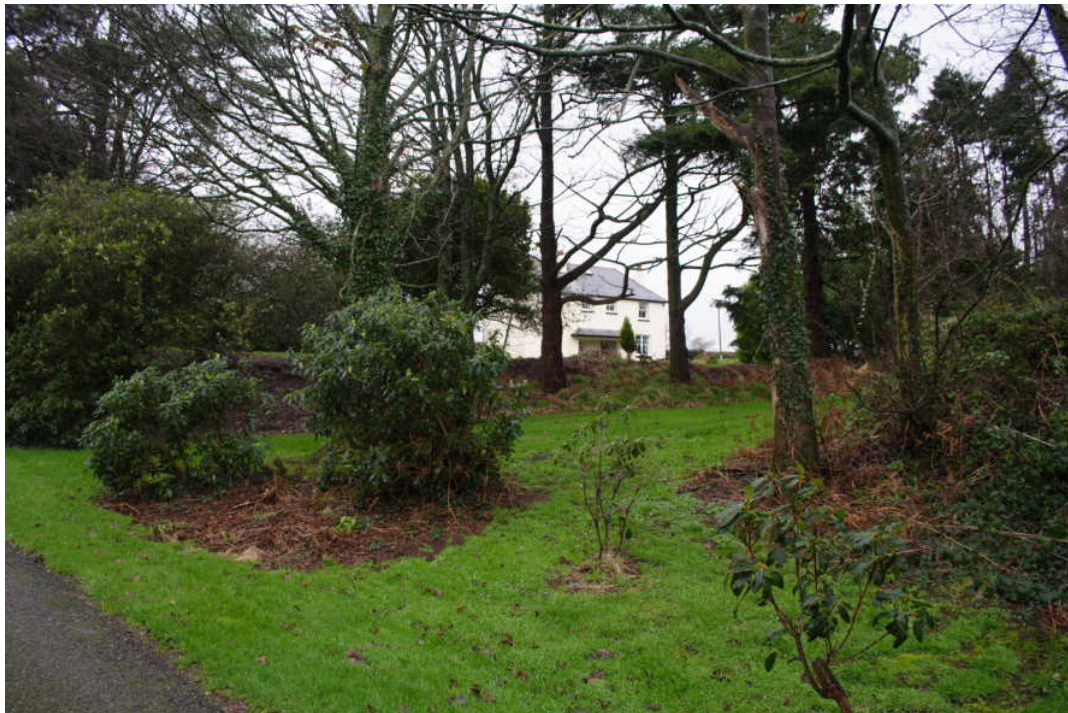
Ground photograph looking E over interior of enclosure 2471.

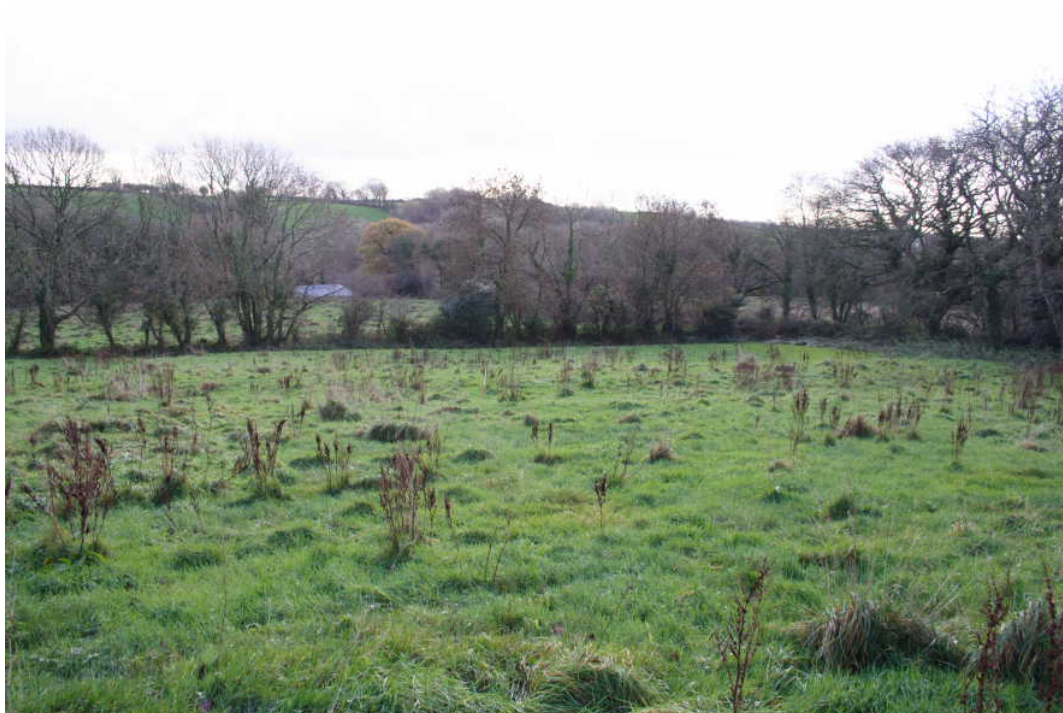
Ground photograph looking SE over earthwork enclosure 4584.

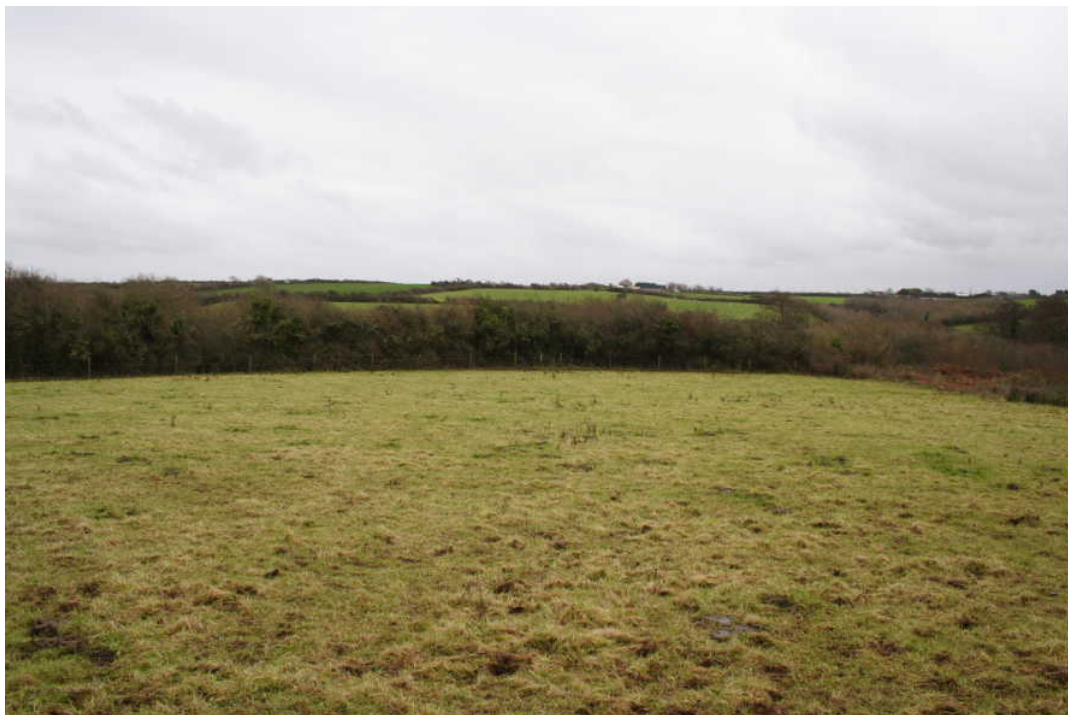
Ground photograph looking S over site of supposed cropmark enclosure 8392.

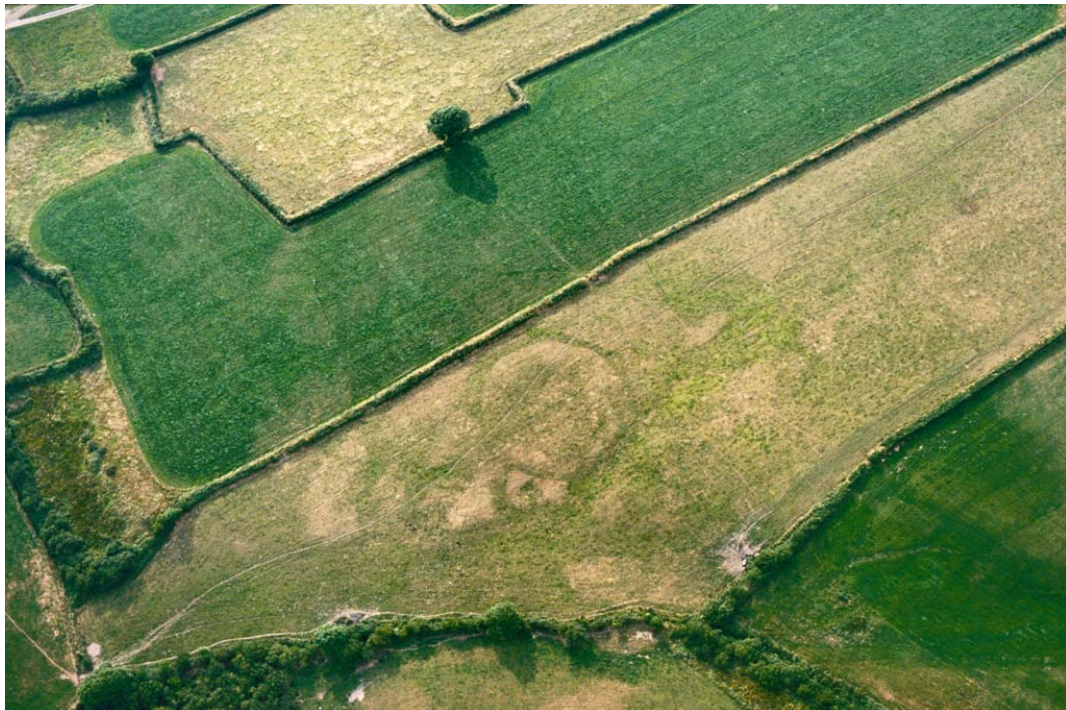
Aerial photograph of 14240. RCAHMW Crown Copyright © reference DI2006_1536.

On the ground the enclosure is represented by a circular hollow c.50m diameter and c.1m deep open on the downslope side at the location of the entrance. It seems that the enclosure was built across an existing hollow in the slope.

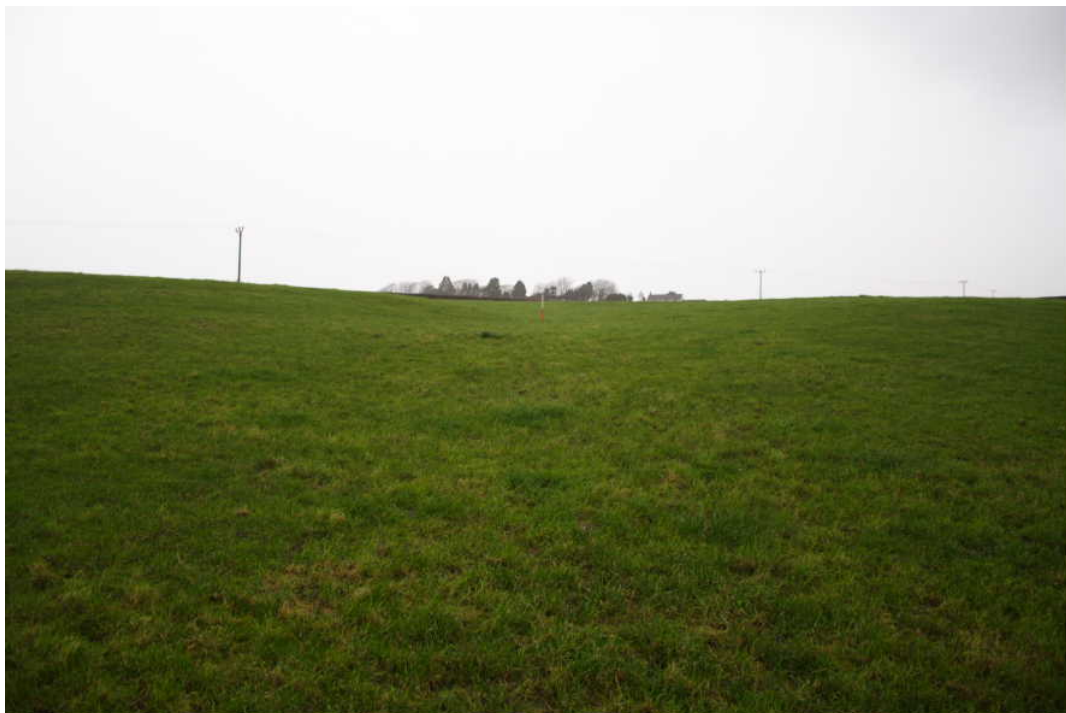
Ground photograph looking N into interior of enclosure 14240.

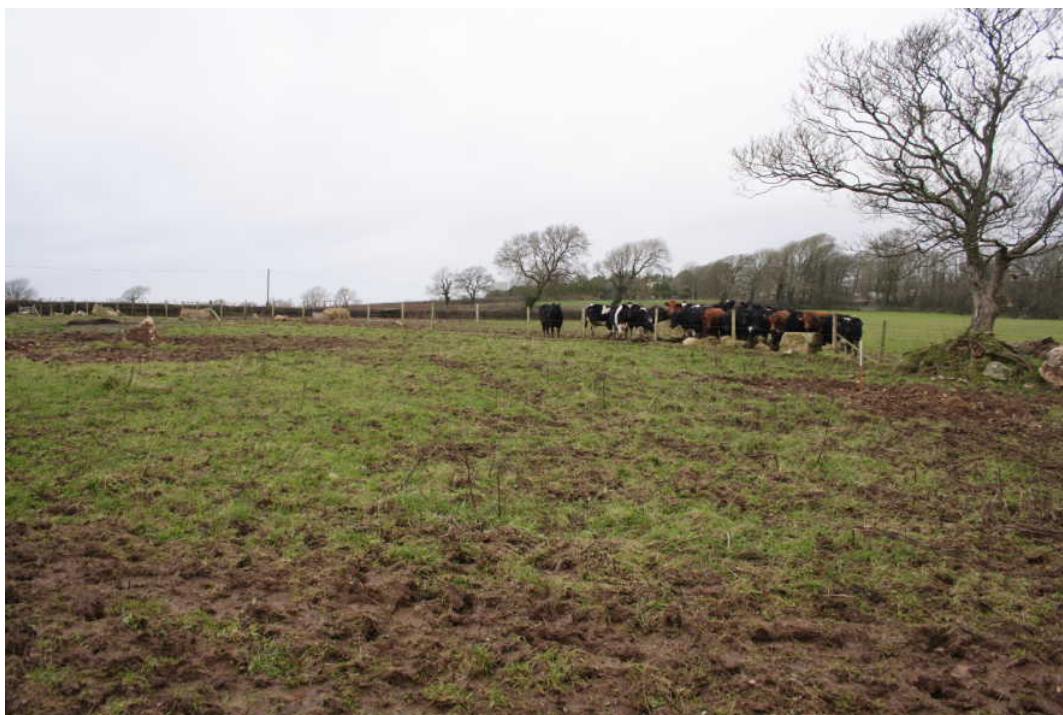
Ground photograph looking NW over site of former enclosure 14241.

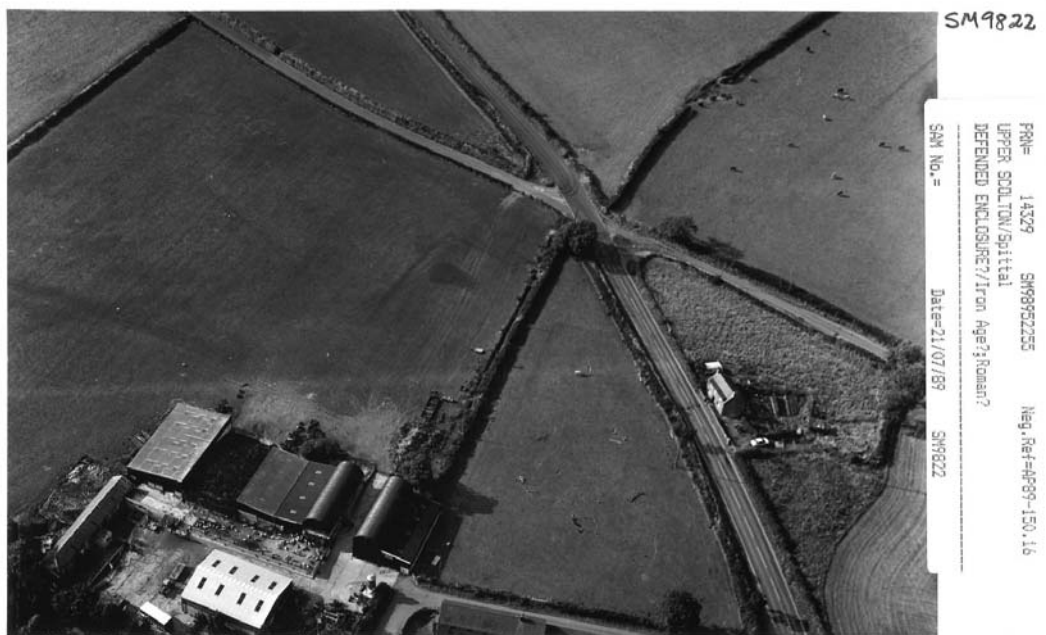
Aerial photograph of 14329. Cambria Archaeology reference AP89-150.16.

Aerial photographs taken in 1989 show crop-marked ditches of what may be two sides of a rectangular defended enclosure lying in improved pasture on level ground at 90m above sea level. The enclosure, if the ditches are projected, measures at least 45m N-S and 25m E-W. Within the centre of the enclosure is a large crop-mark splotch possibly of a large pit or a natural feature. There is no earthwork or other surface evidence of this site, which in 2006 was under improved pasture.

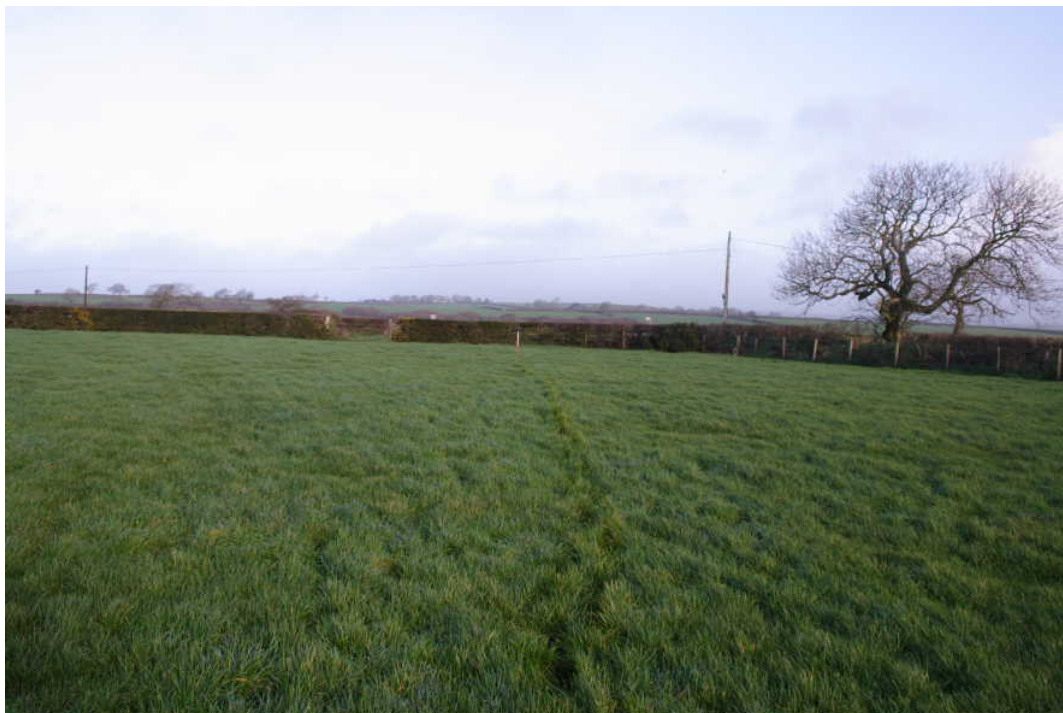
Ground photograph looking N over site of cropmark enclosure 14329.

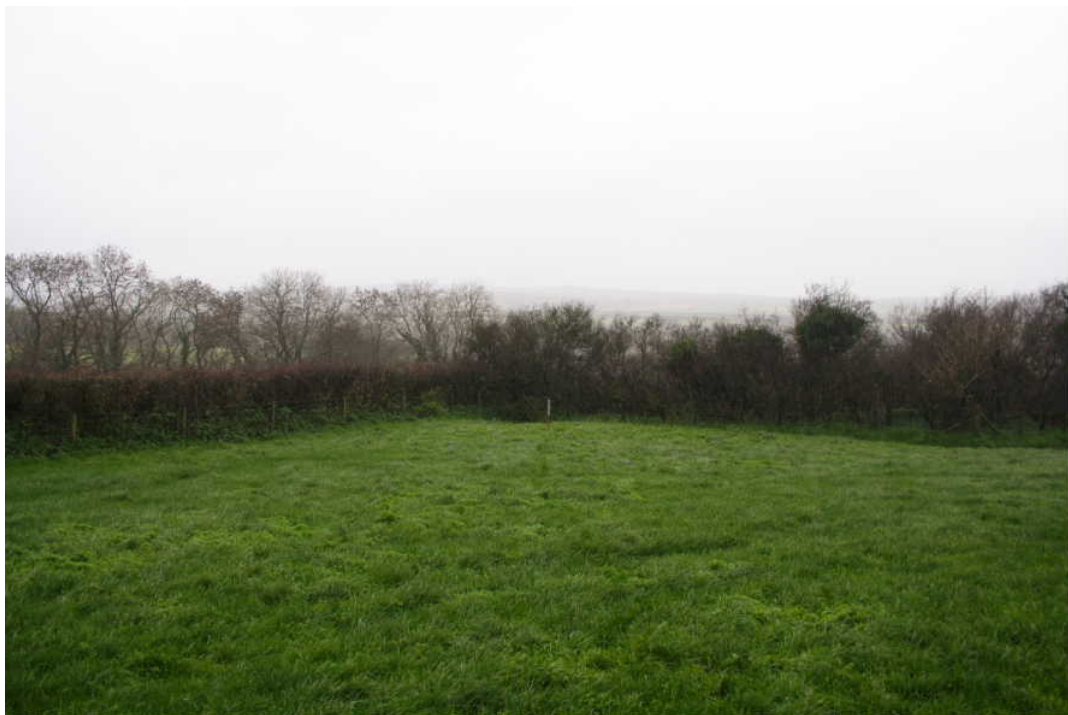
Ground photograph looking W over site of cropmark enclosure 35760.

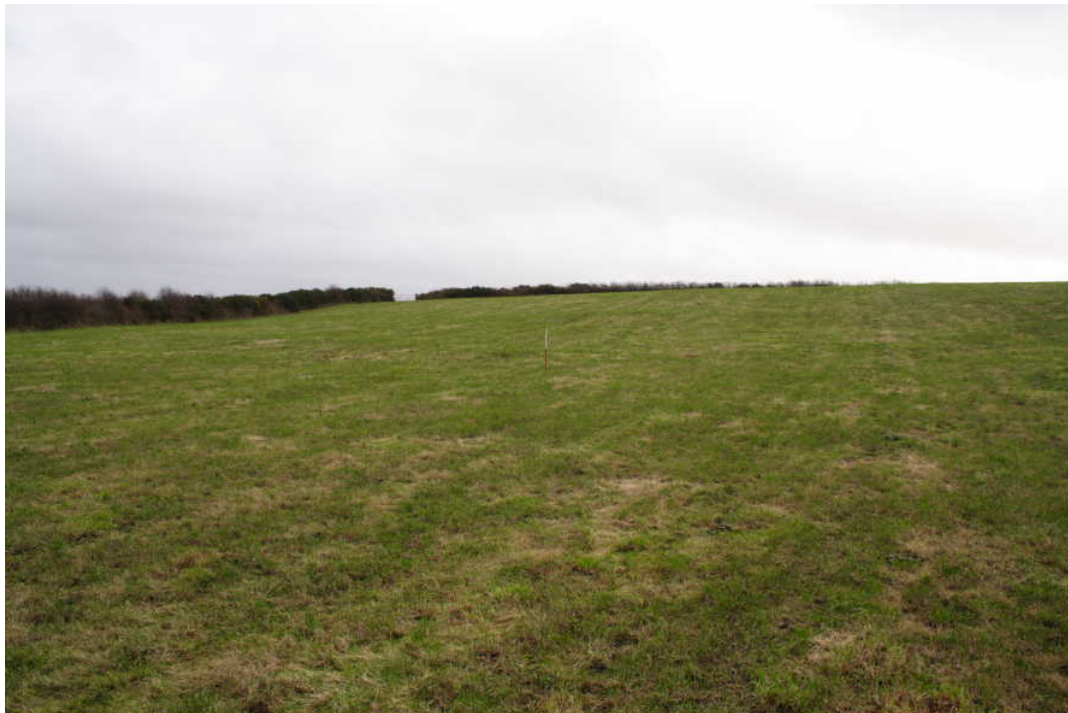
Ground photograph looking SE towards earthwork bank of 35778.
