TIR GOFAL MANAGEMENT PLAN: HERITAGE MANAGEMENT INFORMATION (HE2)

Prepared for:
Eforgrug

**Tir Gofal Reference No
W/13/6455**

**ACA Report No. 2008-02
Project Record No. 56728**

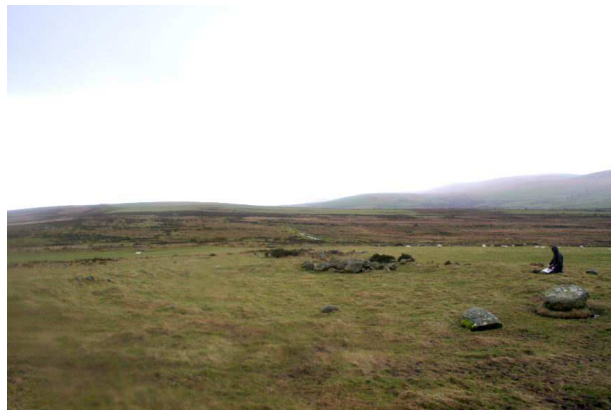
Name (& PRN)	Period/Site type	NGR	Status	SAM/listing	Management required
1	MYNYDD MELYN (1447)	Iron Age? enclosure	SN02473619	A	SAM PE360	Specific
The following description is taken from the most recent Cadw Field Monument Warden Visit dated 11 12 2007.						
The grass-covered bank is 0.75m high with a spread of 2m. Boulders show through the grassy bank. The entrance is on the east. The northern part of the interior gently slopes to the south, where it is more level. The feature is oval, measuring 16m (east to west) x 13m (north to south) internally. External measurement is 20m x 17m. The monument and its surrounding area are in a stable condition.

The enclosure from the west.

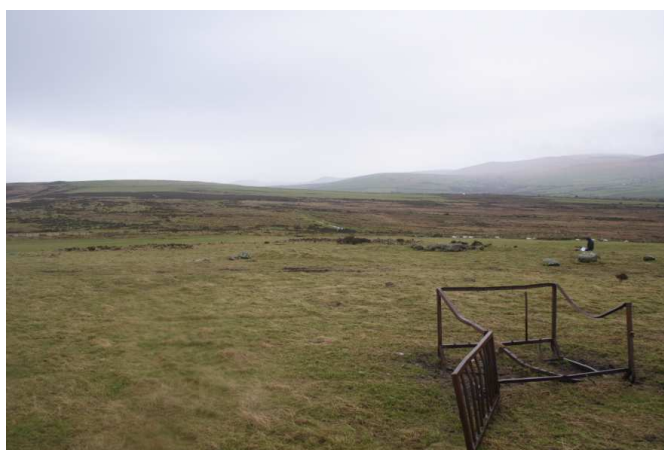
The Eforgrug section of the scheduled area has been extensively cleared of heather and improved, although an area of rough grassland (which has not been as improved as the remainder of the field) survives at the southern part of the section. The pasture has not been ploughed since the original clearance was undertaken.

In the south-west corner of this rough area, within the scheduled area is a large enclosure (PRN 1447). Further features of note include a large boulder to the west of the enclosure, an upright stone (standing stone?, natural feature? PRN 63854) and a circular hole with a diameter of 1m and 15cm deep and slightly banked around the edge. A short distance outside the western boundary of the scheduled area lies a recumbent boulder (stone PRN 63236).

The condition of ground cover within the area is good. Some old agricultural implements are dumped within the area and feeders have been placed there in the past yet there is little erosion present. Some wheel rutting has occurred in the past alongside the northern edge of the rough, unimproved area. This has grassed over. Sheep grazing predominates.

Inside the Scheduled Area facing southeast. Enclosure PRN1447 is visible in the middle ground.

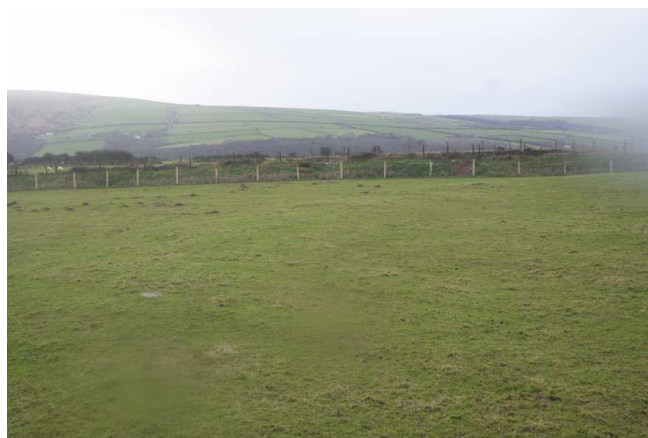
The earthworks comprise a spread earthwork bank, approximately 3m wide x 0.2m high internally x 0.4m externally with a vaguely discernible outer ditch, and no obvious entrance.

The area has been agriculturally improved in the past. A feeder is placed inside the enclosure currently although the ground cover is good with little erosion present (WWS February 2008).

Facing west across the enclosure interior.

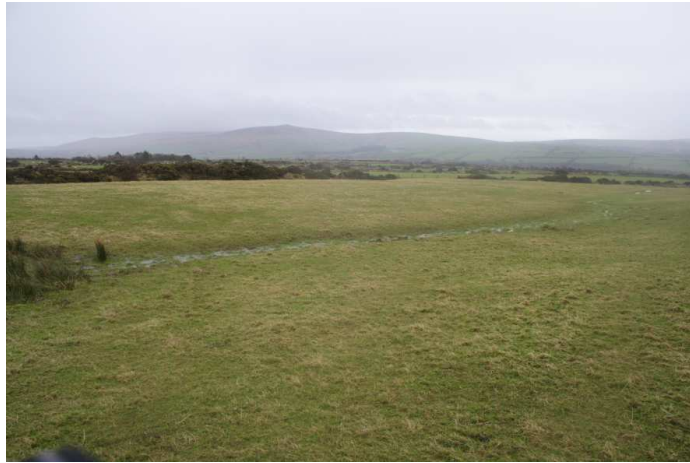
An oval enclosure noted through aerial survey by the RCAHMW. Earthwork banks surviving on the Meridian Airmaps (1955).

The enclosure is defined on its east and west sides by curving stream courses, whilst a thin curving ditch, approximately 1.0m wide by 0.3m high, completes the circuit to the south. There is no trace of a bank to accompany the ditch. A later linear hedge bank overlies the northern part of the enclosure. The enclosure is situated on a gentle slope, overlooking the Gwaun Valley, with rising ground to the north. It today lies within improved farmland (WWS February 2008).

Facing south-east across the enclosure.

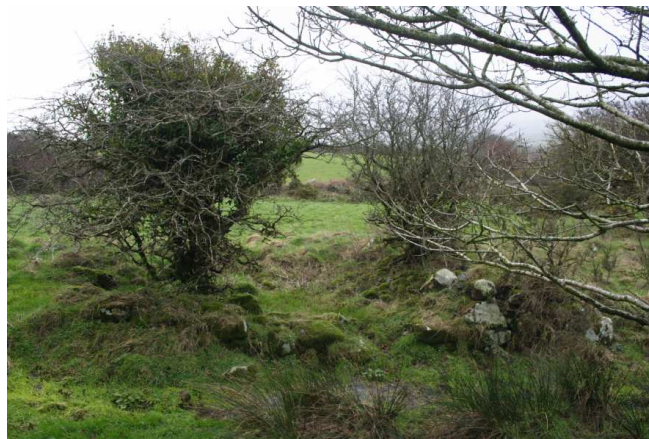
A cottage recorded on the tithe map (1844) and named on the Ordnance Survey (O.S.) 1st edition map (1889). Abandoned by the time of the O.S. 2nd edition (1907). The cottage is now evidenced by spread wall bases indicating a rectangular, three cell structure, approximately 19m N-S by 6m E-W. A stream passes close by to the front (west) of the cottage. Some mature trees have colonised the area. Relict enclosure banks lie to the north and east. Rough grassland predominates (WWS February 2008).

The cottage is now ruinous (view from west).

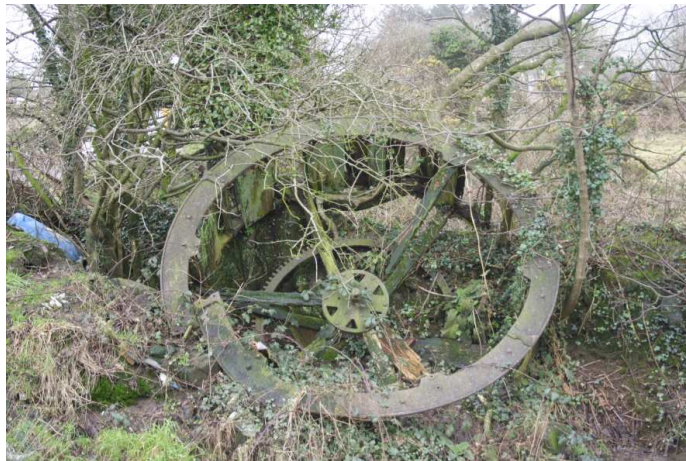
Tre-Dafydd-uchaf is recorded with a semi-formal layout on the Ordnance Survey 1st edition (1889) with buildings arranged loosely around a rectangular yard, and the house lying to the south. The complex has today been extensively modernised with new sheds now on the sites of many former traditional buildings, and a new house added to the east. The sole surviving traditional building is a long range behind the old farmhouse, comprising small late 18th/ 19th century cow sheds and early 20th century cow sheds. Of the water management features, little now remains, but the broken water wheel is still present in a corner of the farmyard where it has remained since being removed from the wheel pit (WWS February 2008).

The broken water wheel remains in a corner of the yard.

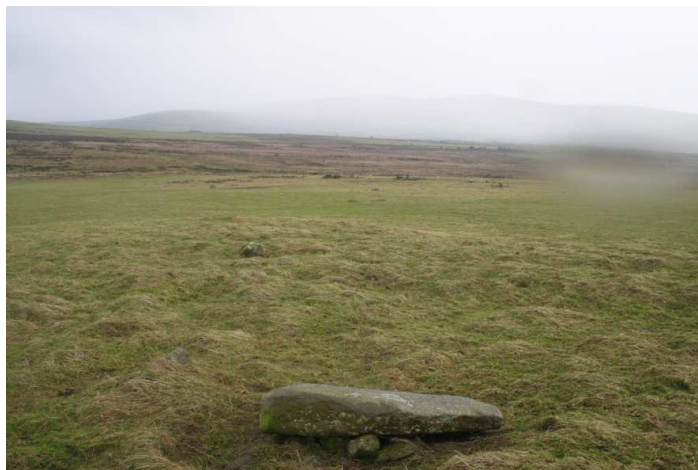
Site identified by the RCAHMW in 2004. Aerial Photographs show a monolith/boulder (recumbent?) at the centre of a patch of rough ground in an area of improved pasture.

The stone measures approximately 1.2m high by 1m long, tapering to the top (WWS February 2008).

The possible recumbent standing stone facing south-east. In the background is hut circle PRN 1447.

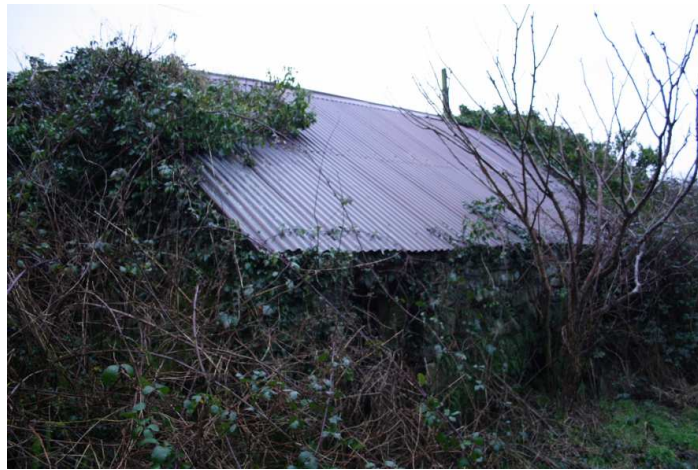
A redundant and now partly ruinous cottage site, lying besides a stream.

Recorded on the Ordnance Survey 1st edition map (1889) when it is shown comprising three units. The cottage part has since fallen into ruin, with only the lower wall bases now surviving. The southern end of the range remains intact and weather proof, although now altered with a narrow doorway in the left of the front wall and an inserted wide doorway in the centre suggesting an agricultural function. The cottage is situated along the edge of a pasture field and is now heavily overgrown with ivy and brambles now obscuring much of the structure (WWS February 2008).

The southern end of the range remains intact and weather proof.

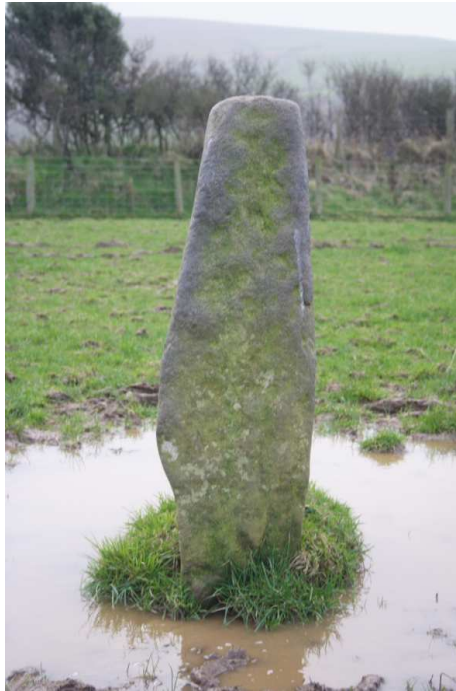
A "stone" recorded on the Ordnance Survey 1st edition map (1889) and apparent today as a slanting standing stone, approximately 1.4m high, by 1.0m long and 0.4m wide. The stone is aligned NNW x SSE and today lies within an improved pasture field. The origins of the stone are uncertain. Possible interpretations could include a prehistoric standing stone or a more recent cattle rubbing stone (WWS February 2008).

The standing stone, viewed from the north.

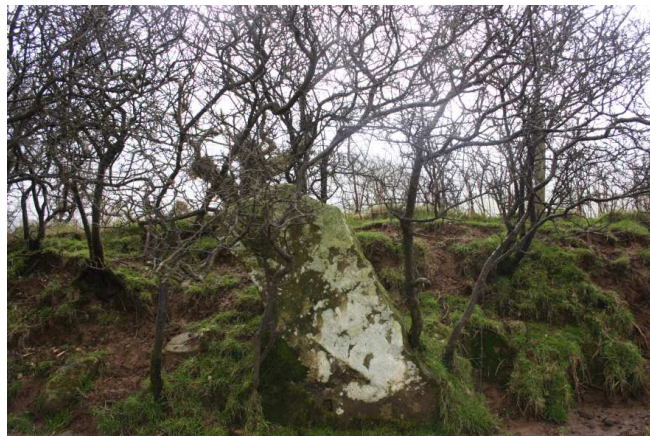
A possible prehistoric standing stone aligned with, and standing next to a stone faced hedge bank. The stone which stands approximately 1.8m high and 1.0m wide is aligned roughly east-west and appears to be well established in its location with good lichen cover. Overlooking the Gwaun Valley (WWS February 2008).

The possible prehistoric standing stone, aligned alongside a stone faced hedge bank.

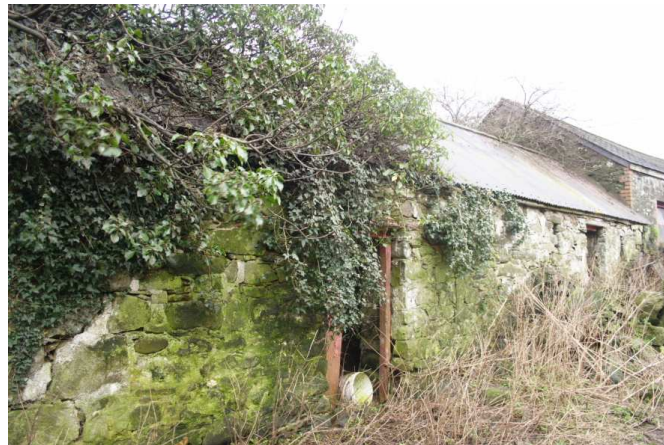
The old cow shed range at Tre-Dafydd-uchaf, facing north-west.

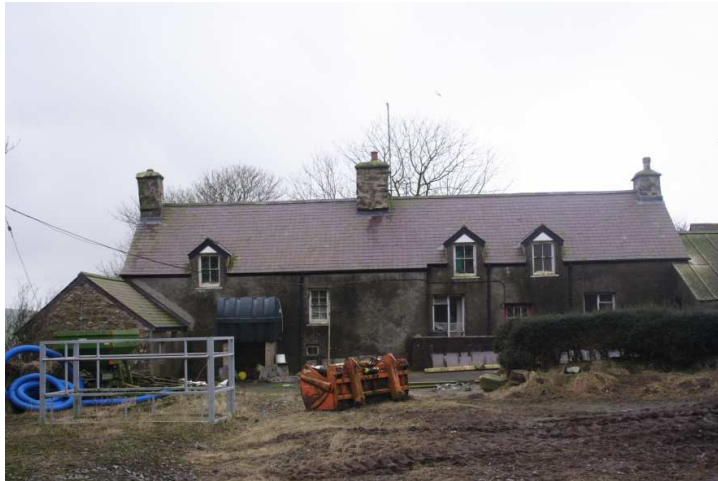
The old farmhouse, from the front (east).

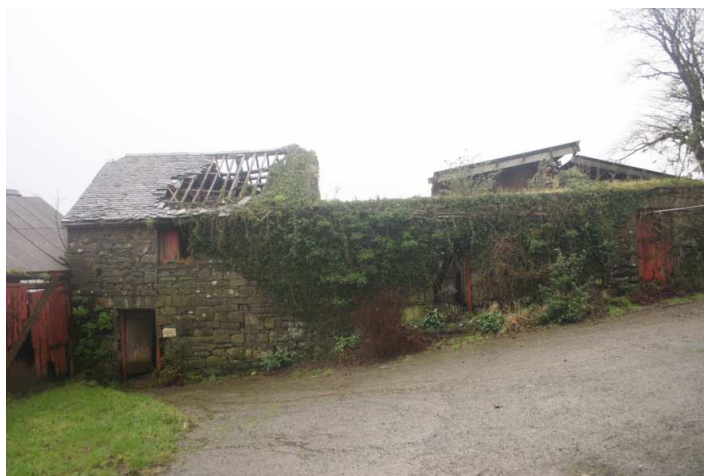
The buildings are of stone and slate roofed construction, grouted in part as was the tradition for the area. They include a long part ruinous ?threshing barn, cow house, stable and granary range to the southeast, a substantially remodelled ?cow house to the northeast and a small range of indistinct function which adjoins the farmhouse to the northwest. A long cart house range, entered from the east gable wall is situated away from the core some 10m to the northwest. Wood work throughout the farmstead retains a red estate paint signature.

The farmstead retains its historic layout with a number of earlier features surviving, however changing agricultural practices have seen a number of modifications including alterations to the original openings and remodelling of the interiors, whilst some of the traditional buildings are now falling into disrepair. A complex of modern agricultural buildings lies behind the historic core to the north-west (WWS February 2008).

?threshing barn, cow house, stable and granary range on the south-eastern side of the yard.

The roof of the ?threshing barn, cow house, stable and granary range is now in a poor condition over the stable and granary and absent from the rest of the range. A number of galvanised corrugated iron sheets are now loose or missing from the cart house.

Consider returning derelict and deteriorating buildings to a weatherproof condition. The long, part ruinous threshing barn, cow house, stable and granary range is a principal building within the group and now in a poor condition, whilst the corrugated tin roof of the cart house range to the rear is now in need of attention. These buildings should be the focus of repair. As a general rule remedial work should be guided by the need to ensure long-term survival, whilst maintaining the character of the building.

Repair broken down walls by re-building to their original height, consolidating areas of loose masonry and re-pointing where necessary.

- Replacing roof timbers: As a general rule, replacement features should be modelled on similar surviving examples. Where these do not exist the emphasis should be on matching details appropriate for the locality and buildings age. In this instance simple A-frame roof structures should be used where replacements are needed.
- Ideally the whole ?threshing barn, cow house, stable and granary range should be re-roofed with grouted slates, in the style that is appropriate to the locality, however it is recognised that this may be prohibitively expensive given the scale of works that are required. Galvanised corrugated iron is a cheap and durable alternative to traditional slate, and now a recognised historic material in its own right. Its use would be acceptable in this instance. Lost, damaged or loose corrugated iron sheets on the cart house should be replaced or secured where appropriate.

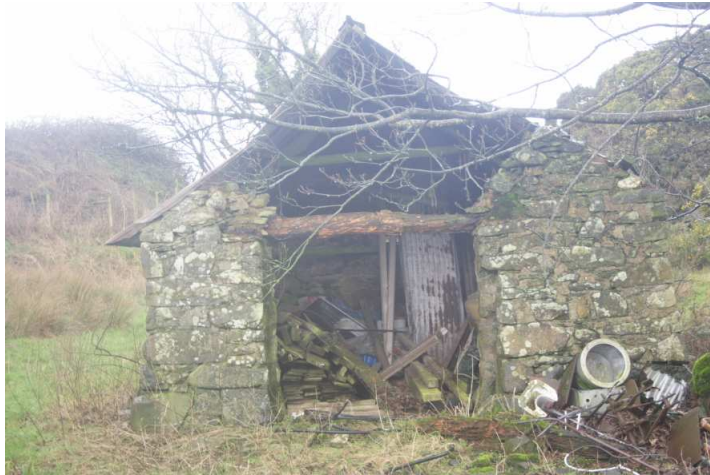
The cart house range, situated behind the main group of buildings.
