**TIR GOFAL MANAGEMENT PLAN:
HERITAGE MANAGEMENT INFORMATION
(Call Out)**

**Prepared for:
Pen-y-banc
Tir Gofal Reference No: W/12/6395**

Project Record Number: 56736

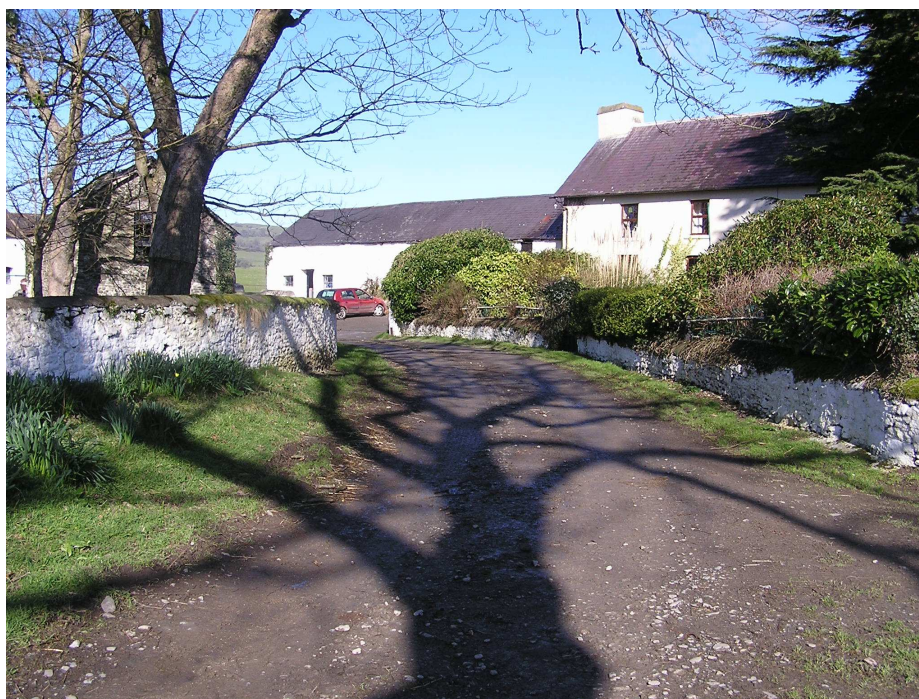
The entrance to Pen-y-banc farmstead.

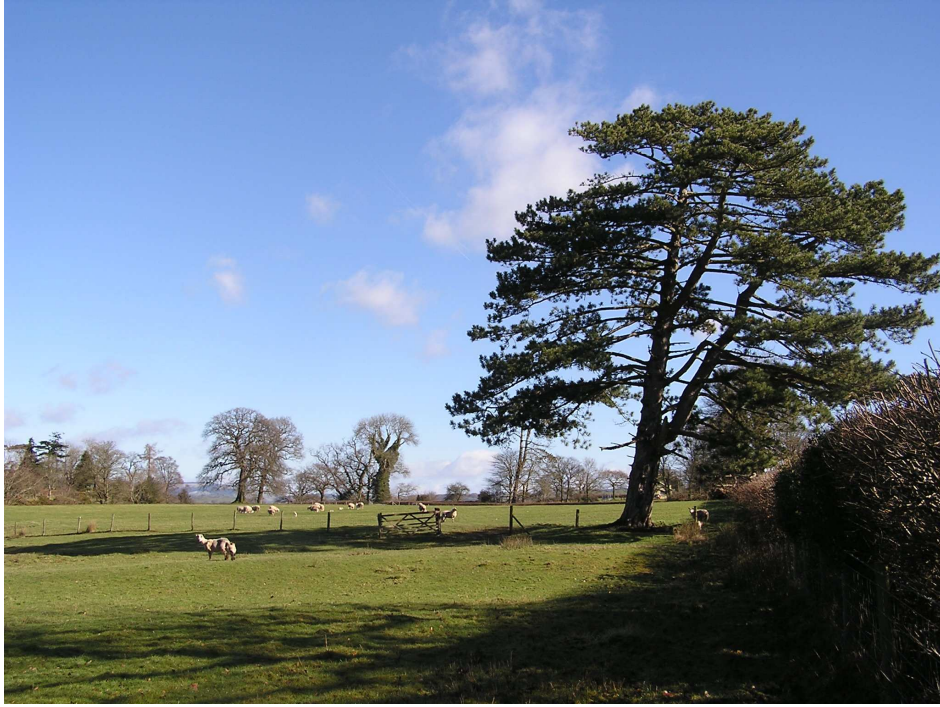
The area retains a parkland feel today with its open character largely intact and a few individual native and exotic parkland trees remaining. It is noticeable however that a number of trees have been lost, whilst others may be reaching the end of their natural lives.

Facing east across the parkland. A few of the original historic plantings remain.

1. Take care to maintain open vistas within the parkland. Do not plant new hedgerows along fence lines within the parkland.
2. Plant replacement parkland trees.
 - The 25 inch 1st edition Ordnance Survey map is most appropriate and accurate map to be used as the baseline for any future restoration of the parkland. Positions of parkland trees should follow as closely as possible the planting scheme represented on it (Ordnance Survey 1887).
 - Tree species should be based on the evidence of species represented in the parkland. No one species should dominate.
 - It may be possible to provide further advice on appropriate tree species following consultation with the Welsh Historic Gardens Trust or other parks and garden specialists at a later date.

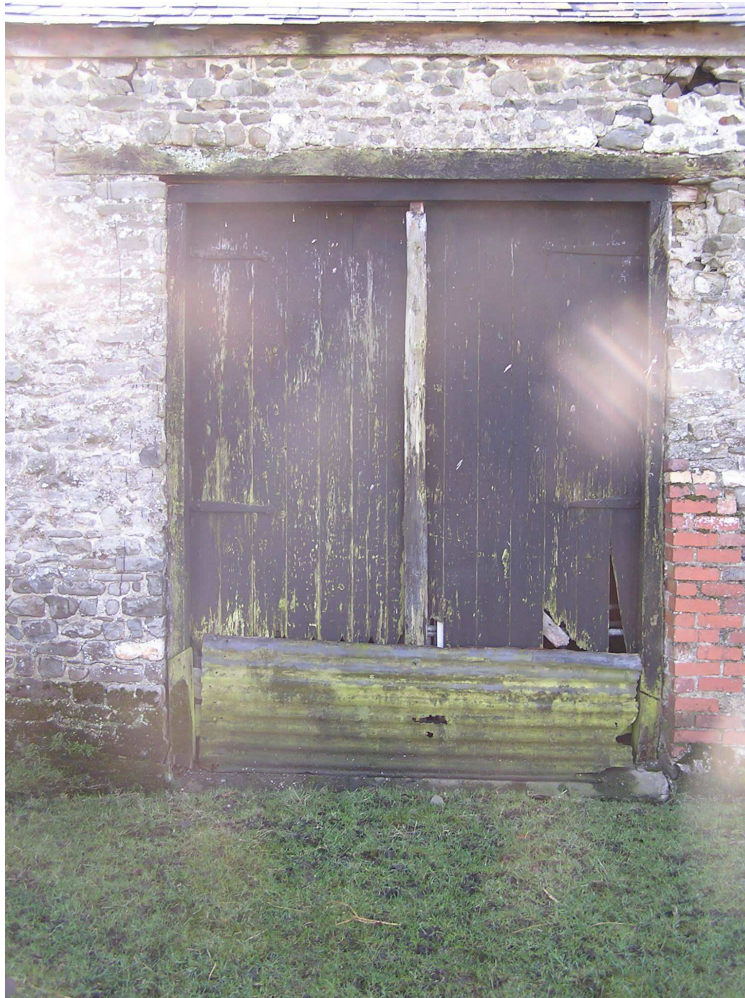
The barn doors are original but are in need of restoration. The doors should be repaired to the same format as the original design, or renewed if repair is not practically possible. They are equally sized plank construction with a removable centre post and wooden latches, painted black on the exterior.

The doors have been subjected to repairs in the past.

- If practically possible repairs should be carried out instead of wholesale replacement.
- When repair is not possible, replacement features must be modelled on the originals, using the same materials and methods of construction. Sawn plain pine planks of the same width should be used (preferably in a good quality pine such as Douglas Fir).
- Door furniture such as original hinges, latches etc. should also be re-used wherever possible and if not should be replaced on a like-for-like basis.
- Wherever possible historic finishes should be retained. Paying particular attention to any “estate colours” as appropriate. In this instance black paint is the appropriate finish.
