PEMBROKE CASTLE

ARCHAEOLOGICAL EVALUATION FOR THE NEW CAFÉ APRIL 2006

RHIF YR ADRODDIAD / REPORT NO. 2006/57
RHIF Y PROSIECT / PROJECT RECORD NO. 56795

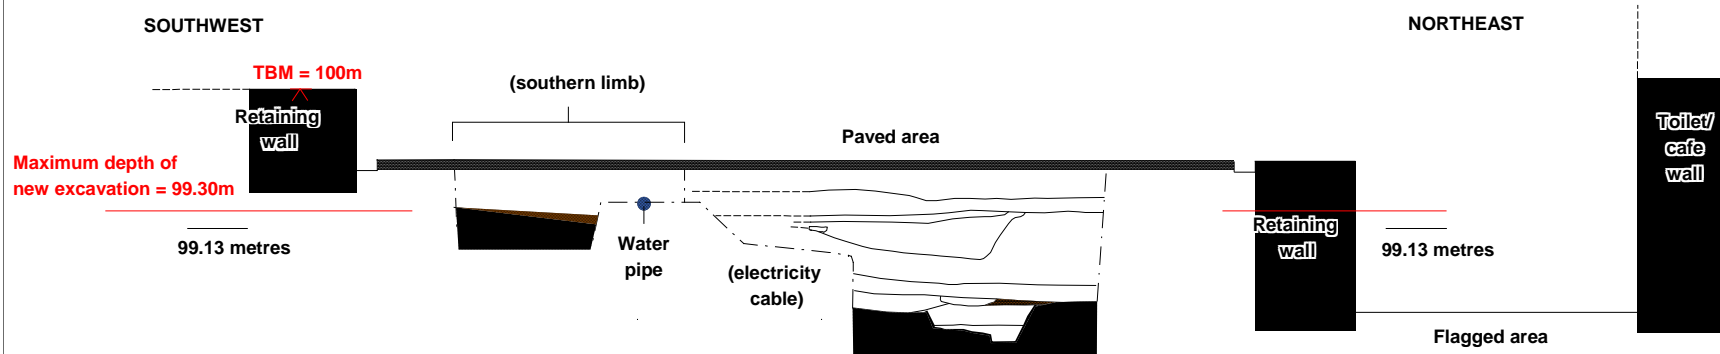
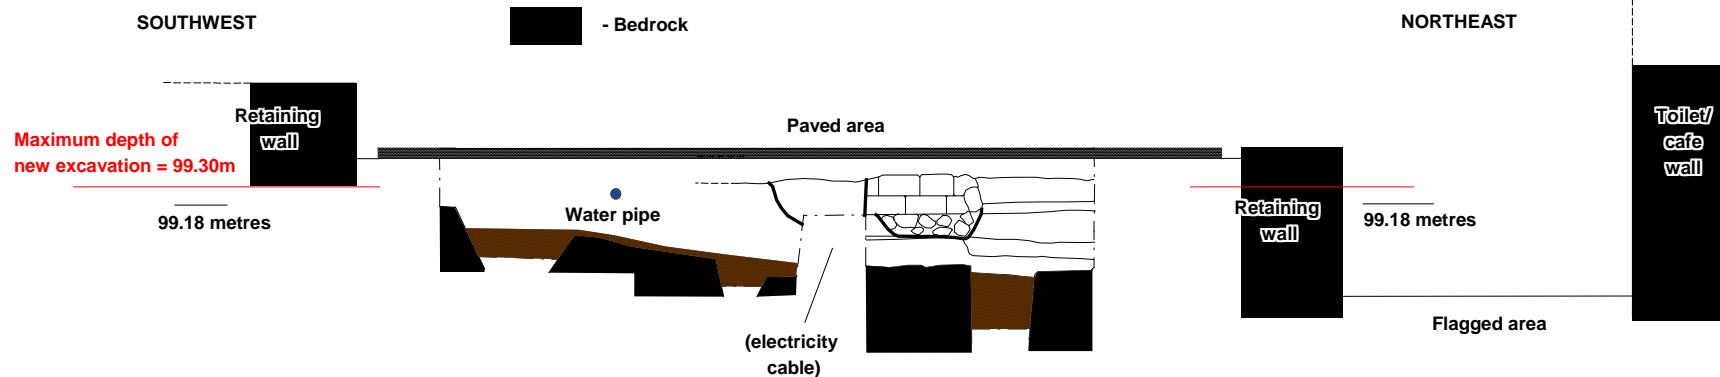
FIG. 3 - SECTIONS ACROSS SITE
(see Figs. 4 & 5 for context numbers)

TRENCH 1

TRENCH 2

It is recommended that the design of the new café takes into account the possibility that medieval building horizons may be present within the development area, along with a buried soil which overlies the bedrock. It is important that constructional levels do not intrude into this level. The proposed floor of the new café lies at the same as the flagged area in front of the existing café/toilet block. However, this lies at a lower level than the bedrock. It is recommended therefore that the proposed floor level is raised – Figs. 6 and 7 show the relative levels across the site (see also Fig. 3 for running sections across the site).

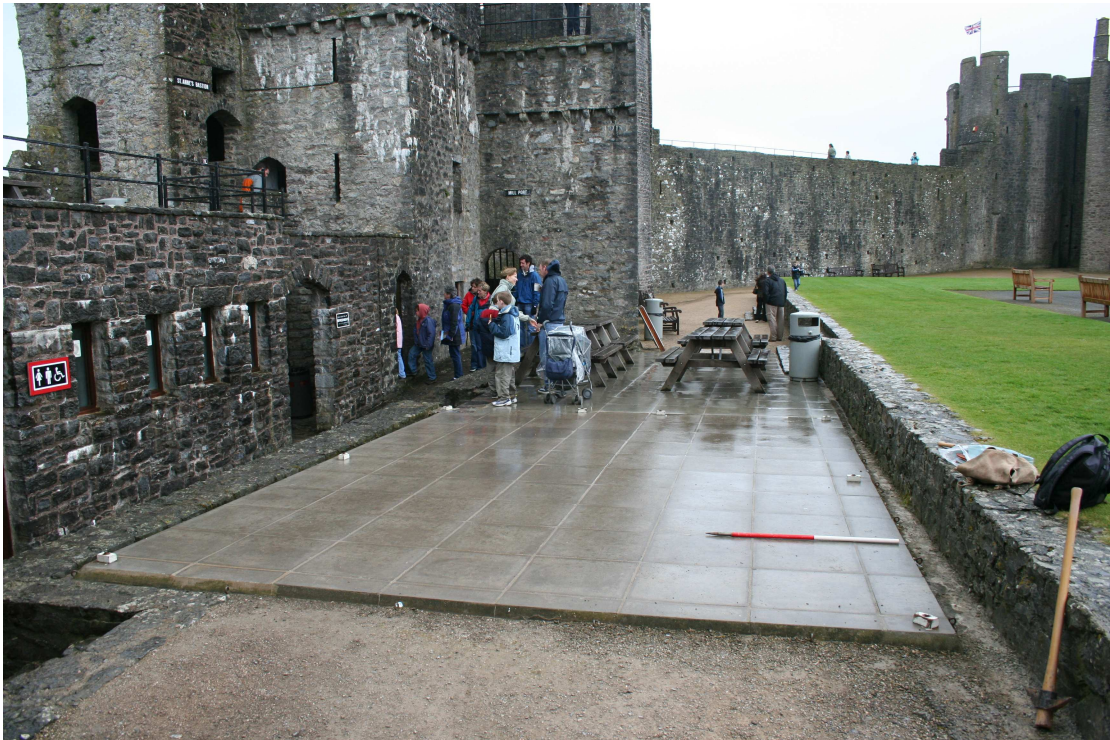
*Plate 1 – Site before excavation, looking southeast
(St Anne's Bastion and existing café/toilet block to left)*

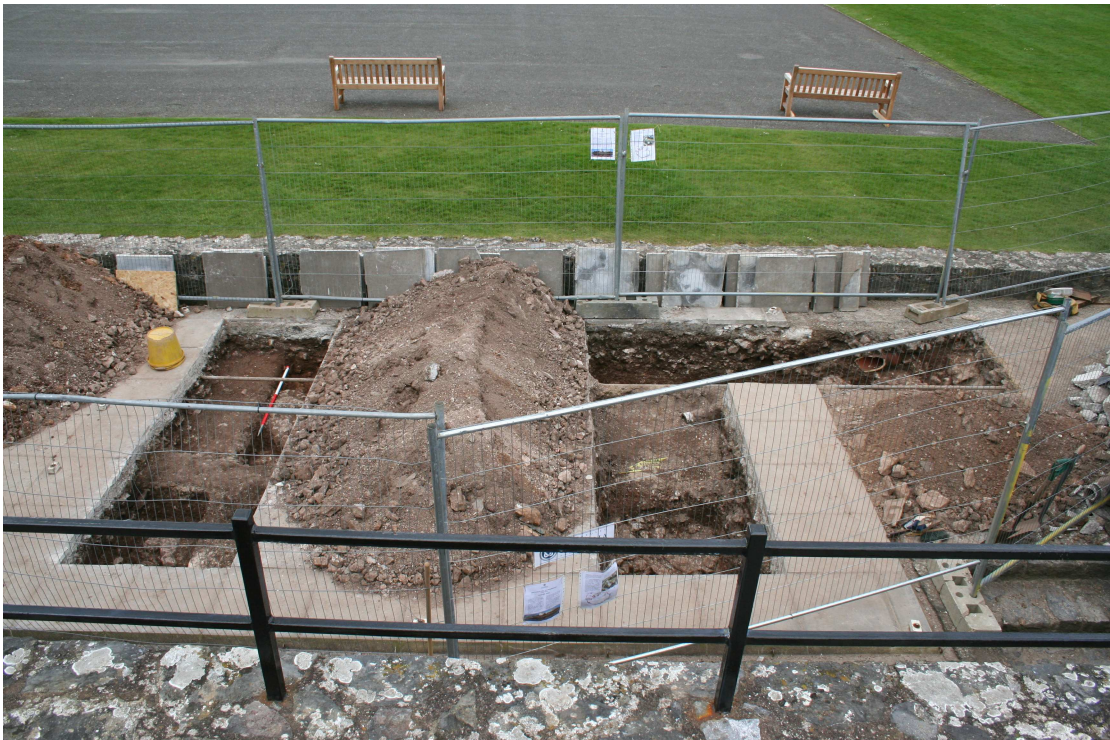
Plate 2 – Site during excavation, looking down from northeast

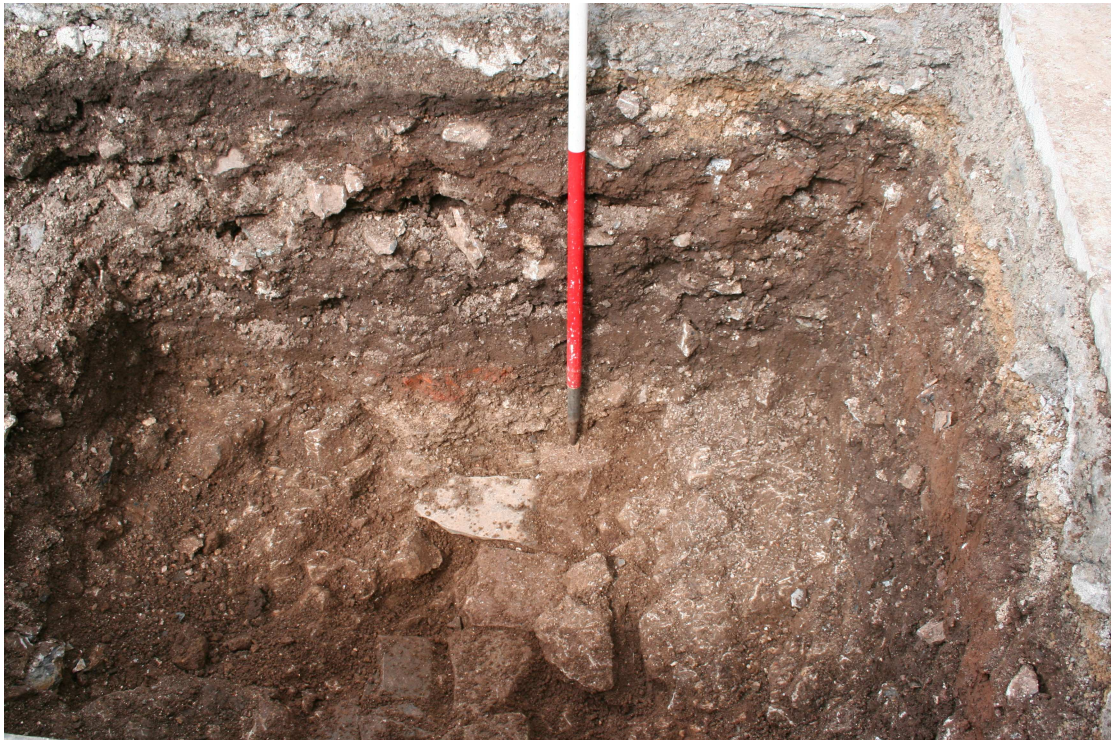
Plate 3 – Northeast end of T1 during excavation, from southeast, showing section and fill 009 of feature 010

However, deposits beneath 007 at the northeast end of the trench may be earlier, apparently filling a cut feature. This feature, 010, which measured 0.80 metres northwest-southeast and 0.50 metres southwest to northeast (but ran beneath the west edge of the trench), was cut through the limestone bedrock with an irregular stepped profile; it had a maximum depth of 0.25 metres. It had two discrete fills, the lower of which 009 was a 0.10 metre depth of light brown, sandy silt/clay with densely packed, irregular stones derived from the bedrock. This was overlain by a 0.15 metre thickness of buff-coloured mortar, 008, which was convincingly medieval in appearance and which contained sherds of medieval pottery (local wares), a number of iron nails with square shanks that also appeared to be medieval, and no recognizably later finds.

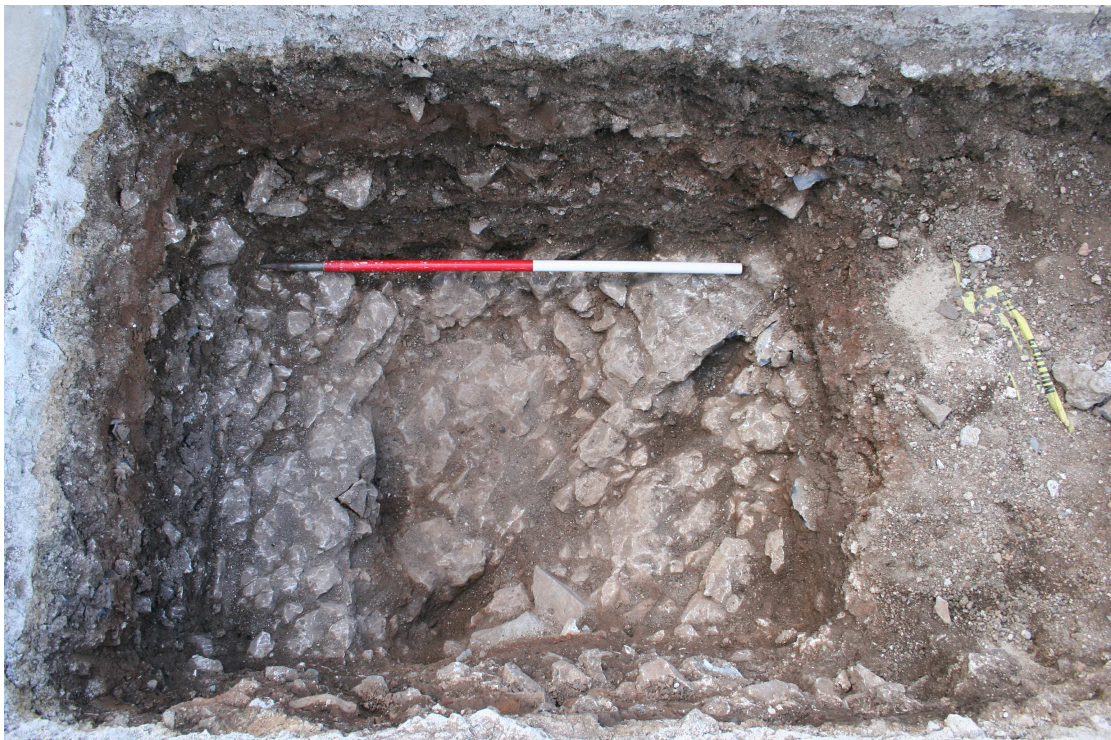
Plate 4 – Northeast end of T1 after excavation, from northwest, showing feature 010

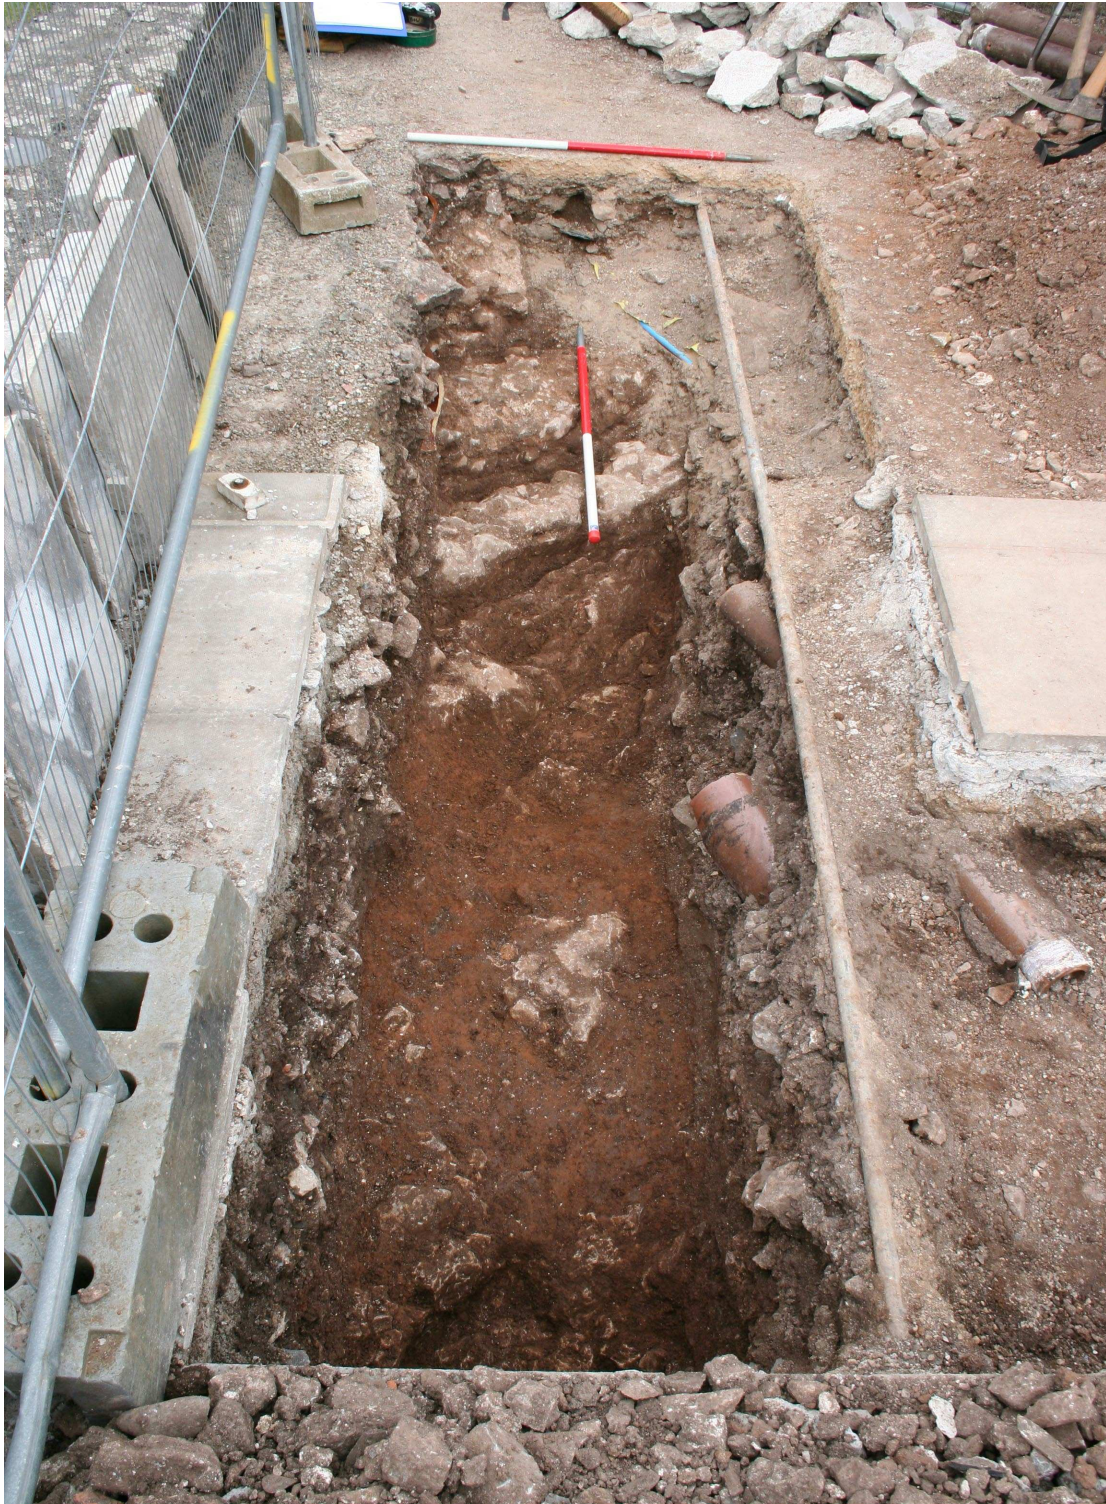
Plate 5 – Southern limb of T1 after excavation, from southeast, showing bedrock, with fissures, the natural soil and possible mortared walling in top left corner

At the other end of the trench, in the southern limb, bedrock occurred at the much shallower depth of 0.56 metres. However, through most of the central part of this limb it lay beneath a red-brown, stiff clay loam, which was entirely sterile. This clay loam also occupied the fissures in the bedrock and apparently represents a natural soil horizon. Similar soils have been observed over the limestone bedrock at the nearby Carew Castle (Richard Ramsey, Cambria

The bedrock protruded through the natural soil at the northwest end of this southern limb. Patches of mortar adhering to the bedrock suggest that it may have been used as a constructional horizon. A boss of stone in the southwest corner of this limb, at the higher level of 0.26 metres from the surface, does in fact appear to be mortared masonry rather than mortar on bedrock. However, its form and character could not be determined; neither could any interpretations be made on the nature of the possible constructional horizon.

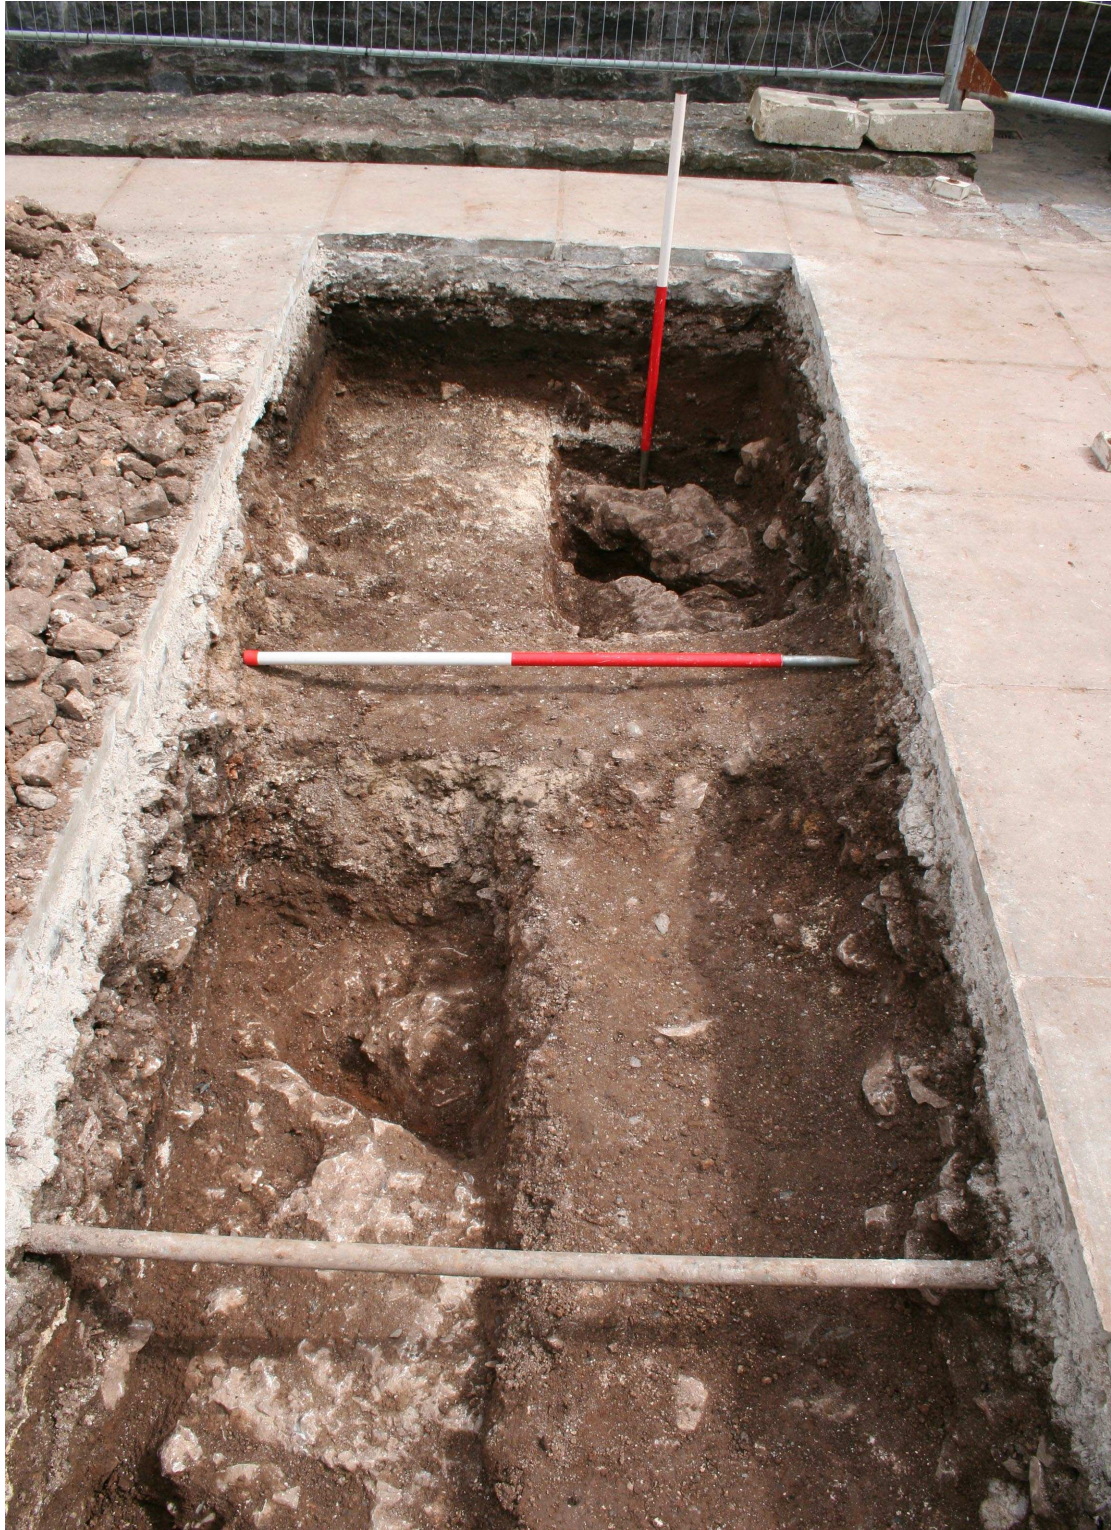
*Plate 6 – T2 after excavation, from southwest,
showing part-excavated sections (with mortar 017)
and fully excavated sections with fissured bedrock and natural soil*

Beneath 016 was a creamy-white, very clean deposit of mortar 017. It averaged 0.10 metres in thickness, though thicker to the north where it appeared to occupy a slight cut, and was at first regarded as possibly representing a medieval destruction or construction horizon, but it overlay a layer, 018, that comprised reddish-brown friable silty clay and containing mortar, slate and fragments of 19th-20th century brick, much like 007 in T1 – which may be the same layer. The same sequence was seen in the southwestern half of the trench.

Layer 018 directly overlay the same natural soil that was encountered in T1. As in T1, the soils was patchy, the underlying being exposed in a number of locations, and deeply fissured as in T1. The bedrock lay 0.60 metres beneath the paving slabs at the northeast end of the trench but rose to a depth of 0.43 metres at the southwest end. Patches of mortar were seen to adhere to the bedrock where the soil was absent at the northeast end, as in T1, and were similarly amorphous but interpreted as possibly representing a medieval building horizon.

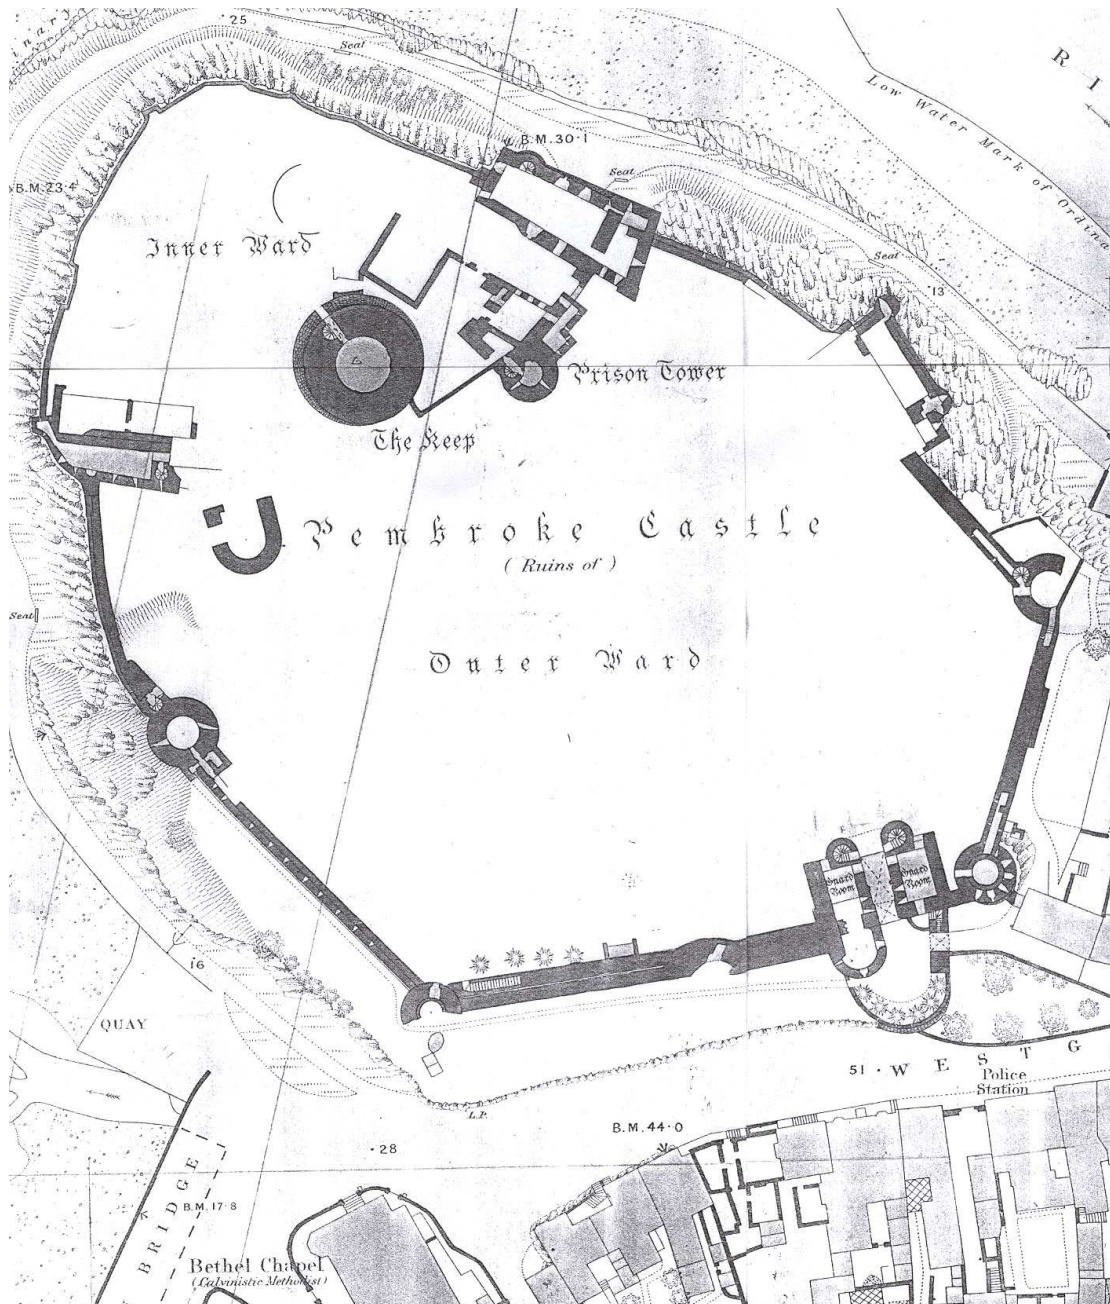
APPENDIX 5

Detail from Ordnance Survey 1:500, First Edition,
Pembrokeshire Sheet XL 9.8, 1861

In plan, the bastion in its present form reflects medieval arrangements and is shown in its unrestored form on the Ordnance Survey First Edition map of 1861 (Appendix 5). This map also shows the stump of a wall running parallel with the outer wall of the bastion but 8 metres to the southwest, as if to define a rectangular area within the bastion. Prints and photographs taken prior to restoration, provide some further detail (Appendix 1 – 3, 7 & 8). The arrangements shown appear to be reflected in the present structure, but much of the inner faces of the turrets, the parapets, and the small rectangular open 'turret' that now forms the northwest corner of the bastion (see Fig. 2), are missing. However, it is clear that the present corbel tables follow an earlier pattern (cf. Appendix 2 and 3). What is also clear is that it was always a substantial structure. Taken overall, the structural evidence suggests a date early in the 14th century, possibly under Aymer de Valence (1307-1324); succeeding Lords of Pembroke were largely absentee.
