ST SADWRN'S
CHURCH, LLANSADWRN,
CARMARTHENSHIRE: BUILDING
RECORDING AND
ARCHAEOLOGICAL WATCHING
BRIEF 2005-06

RHIF YR ADRODDIAD / REPORT NO. 2006/128
RHIF Y PROSIECT / PROJECT RECORD NO. 56796

ST SADWRN'S CHURCH, LLANSADWRN, CARMARTHENSHIRE: BUILDING RECORDING AND ARCHAEOLOGICAL WATCHING BRIEF 2005-06

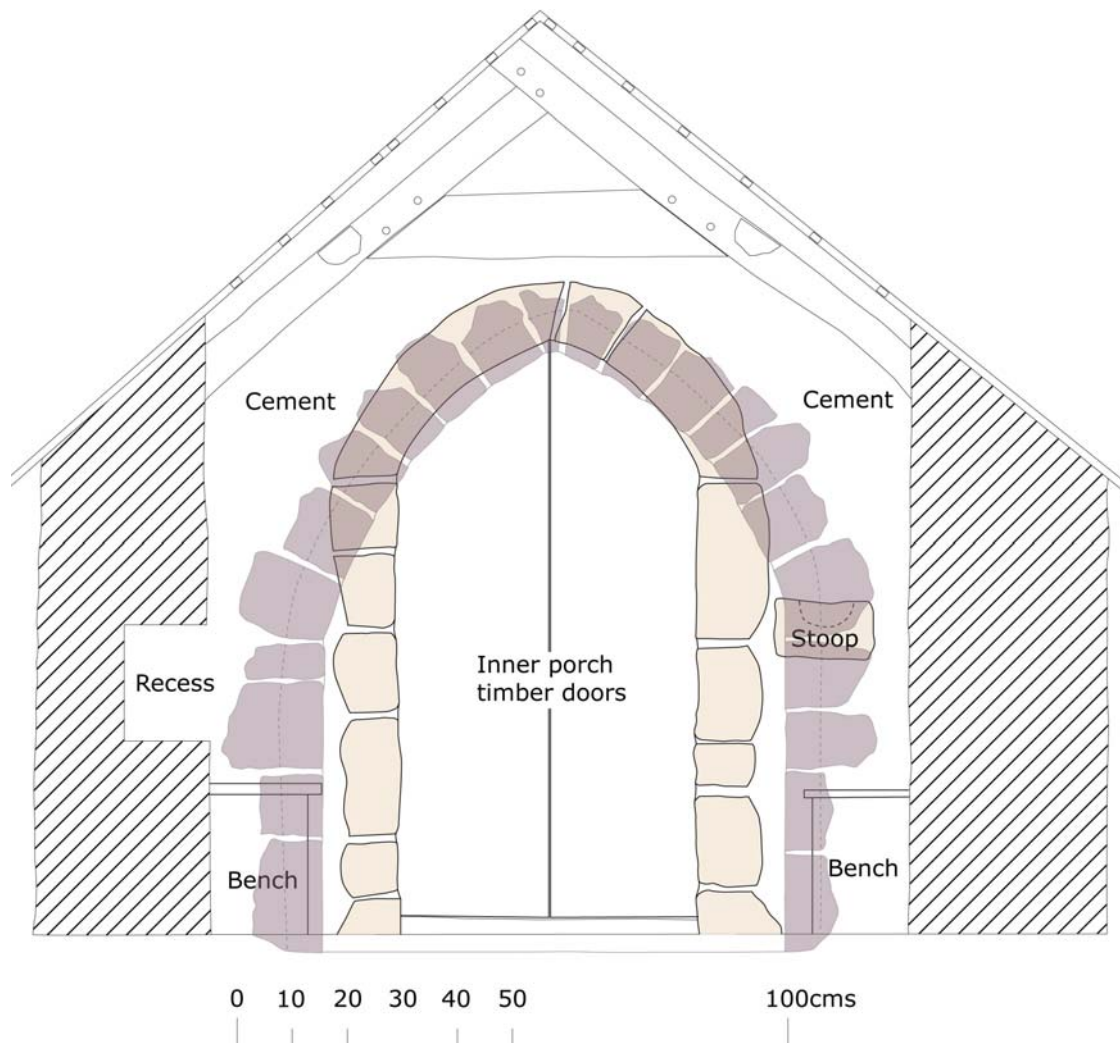
Figure 3. South elevation of porch - inner (buff) and outer (purple) doors shown.

The south porch probably dates to c.1400. The door into the church has a segmental arch of dressed stone (Fig. 3, Photo. 5). The arch into the porch from the outside is also a simple arch. The porch contains a masonry benching, a plain square aumbry in the west wall and stoup to the east of the door.

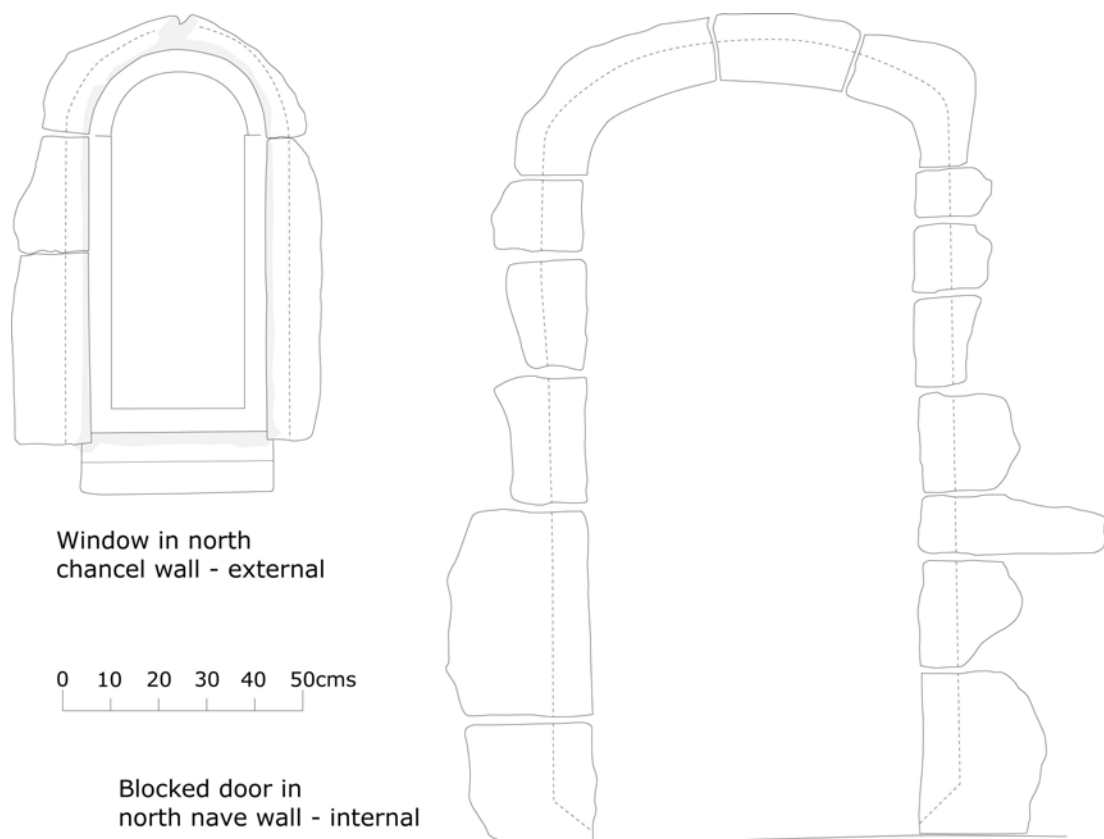
Fig. 6. Window and door in north wall of church.

A blocked door with a four-centred arch in the north wall of the east end of the nave originally led into the north transept (Figs. 2 and 6). The external face of wall has been rebuilt at an unknown date. Immediately to the east of this is a mid 19th century 3-light window which cuts through an earlier, blocked window.

A moulded Bath Stone chancel arch built in 1883-4, probably replacing an earlier arch, separates the chancel from the nave. A blocked, flat-headed door and a simple, small round-headed window (Fig. 6) are located in the north chancel wall. The door may have led into a north chapel/transept. There is no trace of the blocked door in the external elevation, as the wall here has been re-skinned, but off-set foundations are visible, as well as a butt joint low down in the wall between the chancel and nave. This joint may be an indication that the nave and chancel are of different phases, it may be the resulting scar left when the north transept was removed, or it could be both.

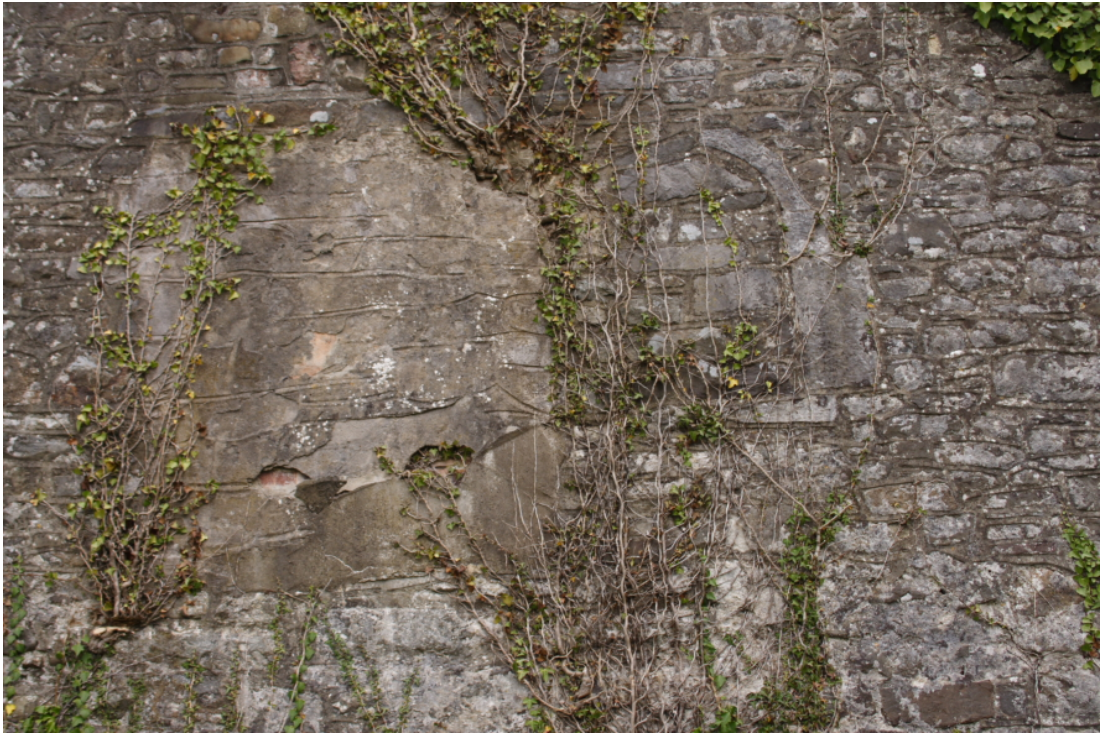
Photograph 3. Old windows in the west wall prior to restoration.

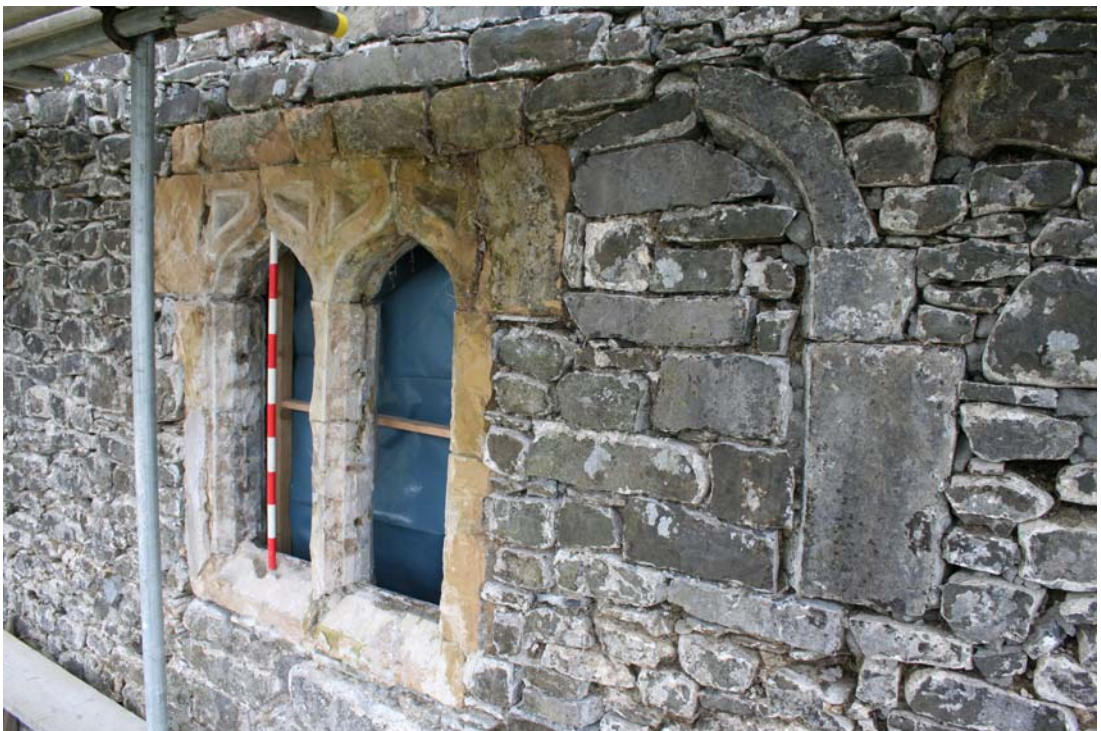
Photograph 4. Old windows in west wall during restoration.

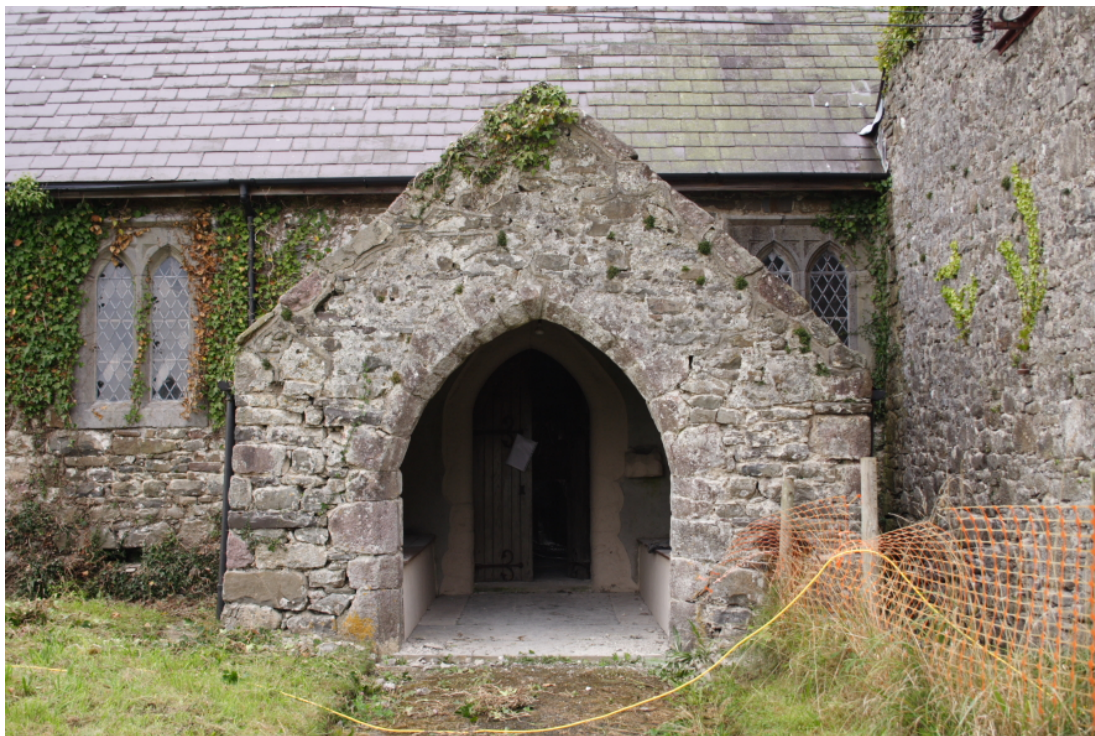
Photograph 5. The south porch.

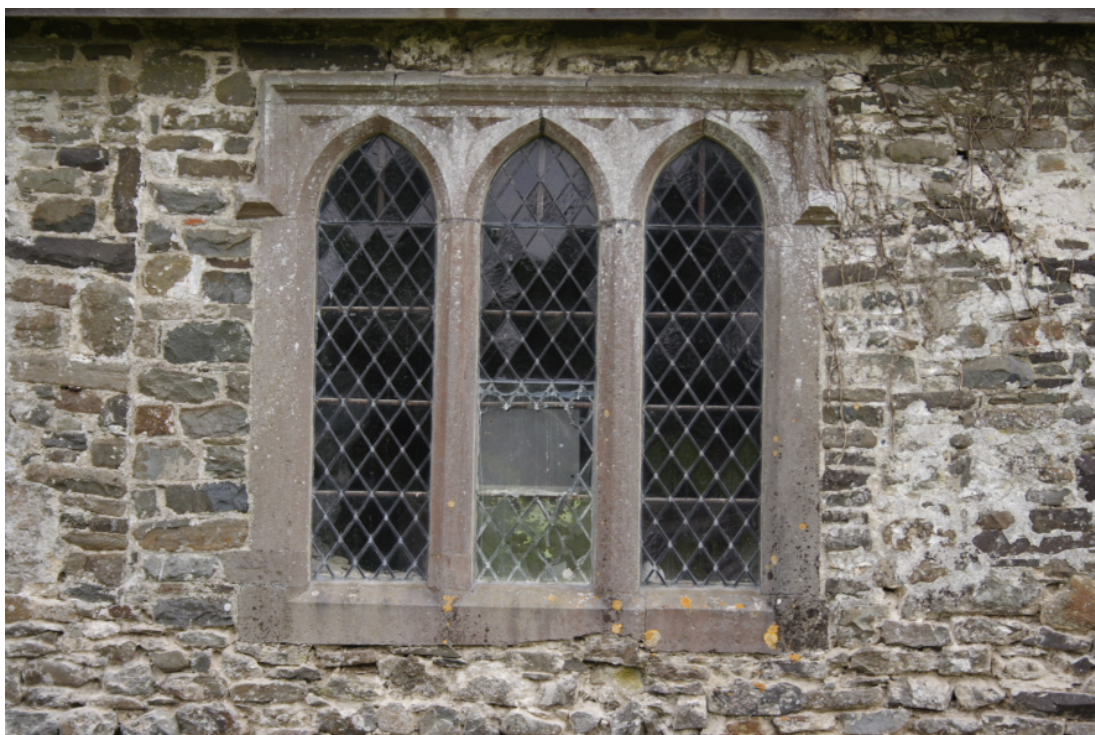
Photograph 6. Early 19th century window in north wall of church.

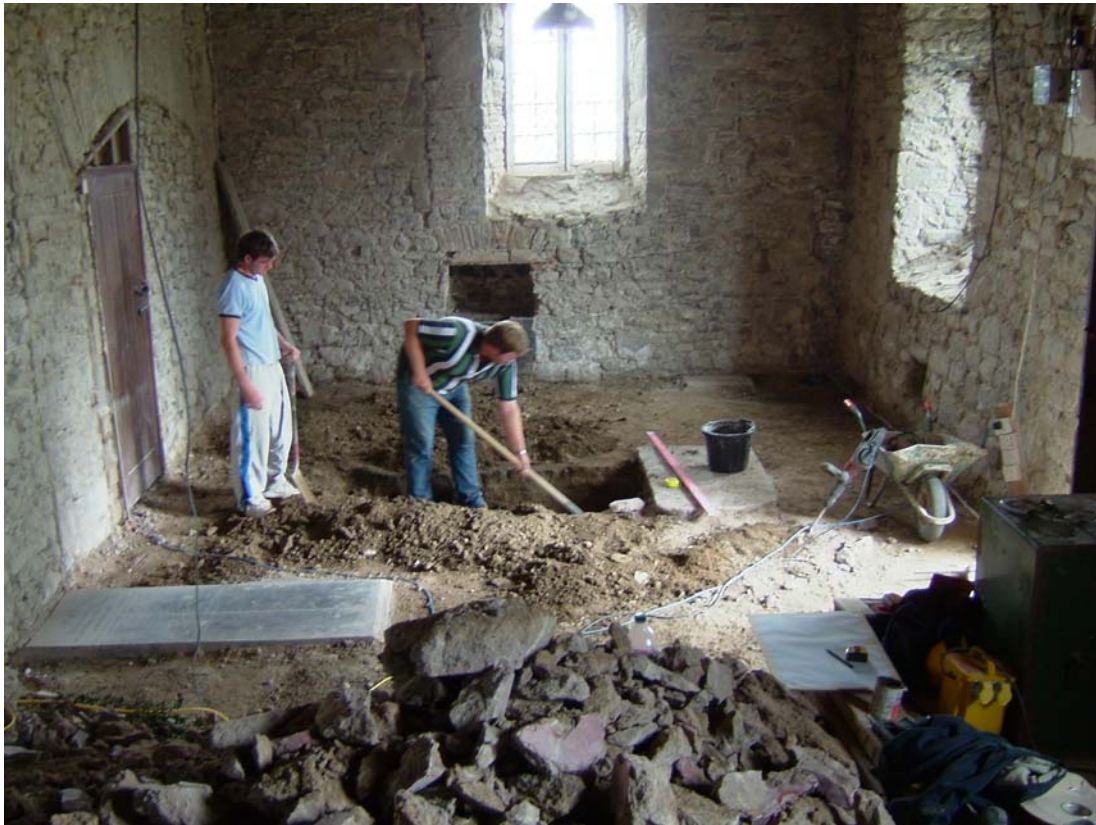
Photograph 7. Excavating the floor of the south chapel.

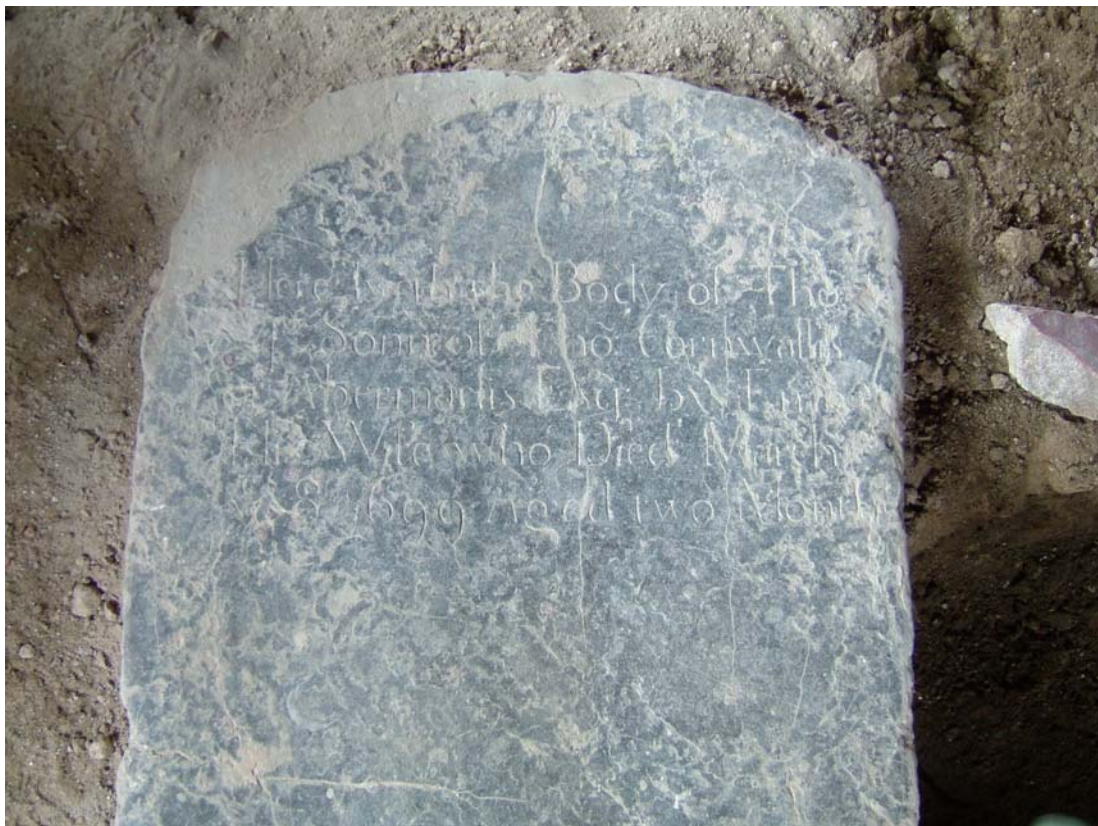
Two grave slabs (and part of a third slab) had been incorporated into the concrete floor - they were not *in situ*. One commemorated David Thomas of Troedyrhiw, who died in 1853, and his wife Margaret, who died in 1866. The other (Photo. 8) was inscribed: Here lyth the Body of Thomas Son of Tho Cornwallis of Abermarlis Esq. by E.... his Wife who died March 8 1699 Aged two months. Ludlow (1998, 4) notes that the chapel is known as the 'Abermarlais Chapel' after its patrons and possible founders.

Photograph 8. Memorial stone of Thomas Cornwallis from the south chapel.

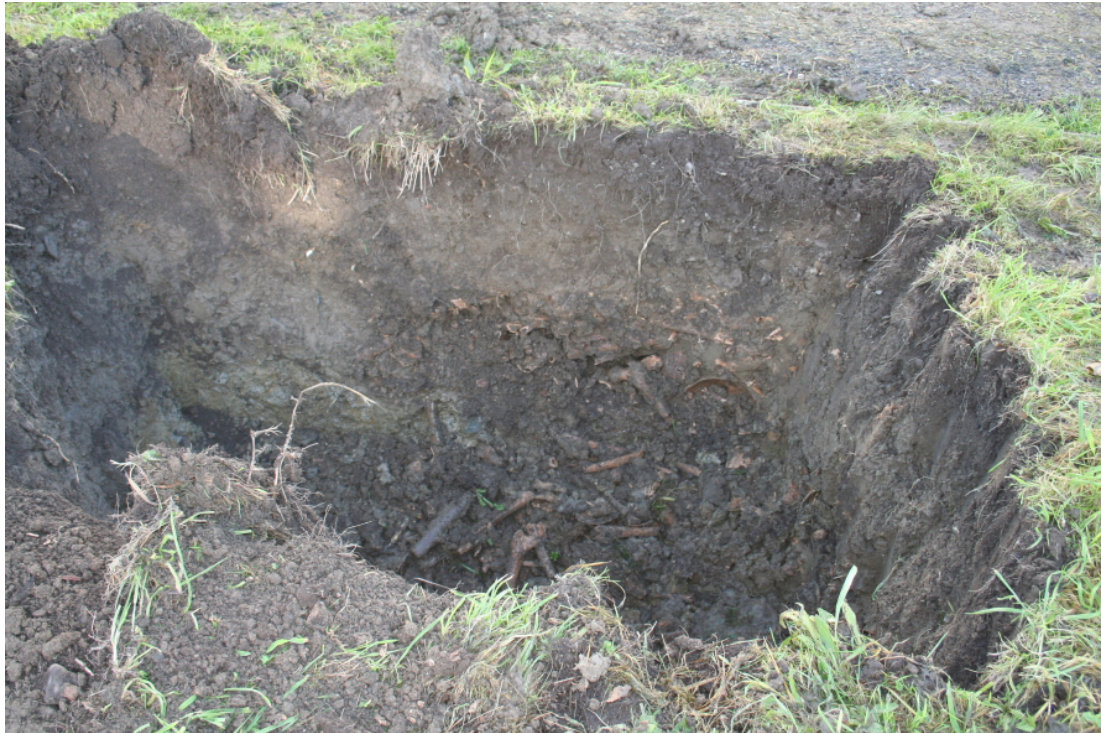
Photograph 9. Bones in pit cut through by the soak-away pit.

A second shallow pit was dug a few meters to the west to re-bury the bones in. No further human bone or grave cuts were observed within this second cut.

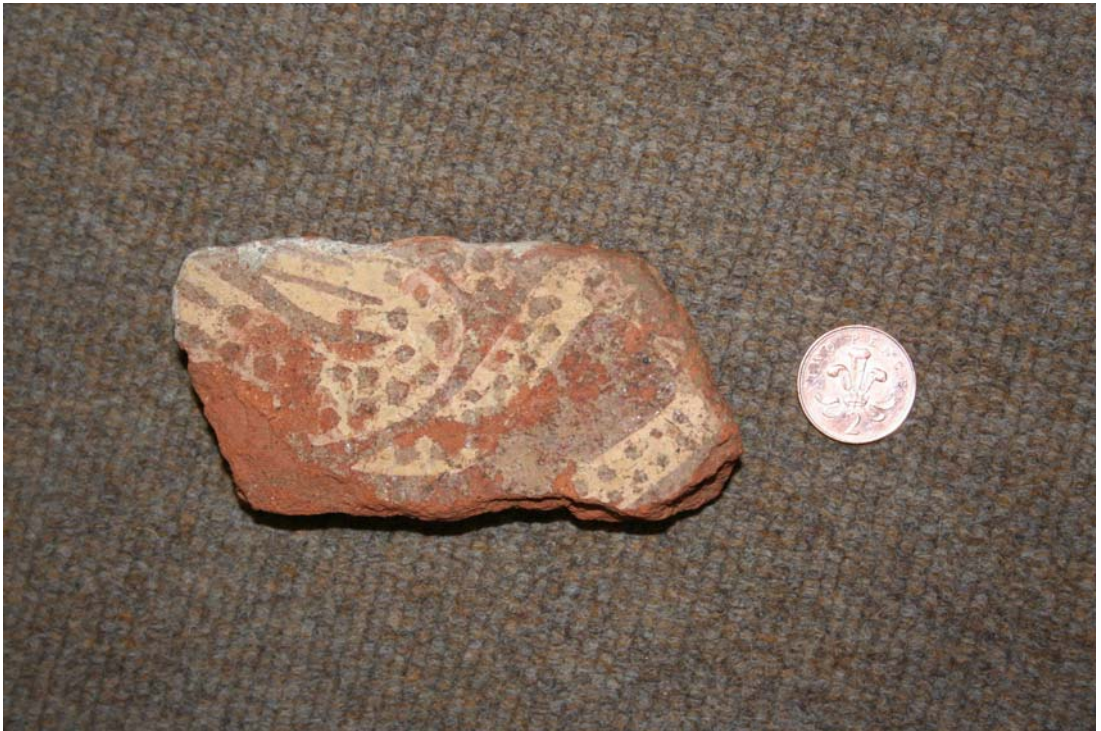
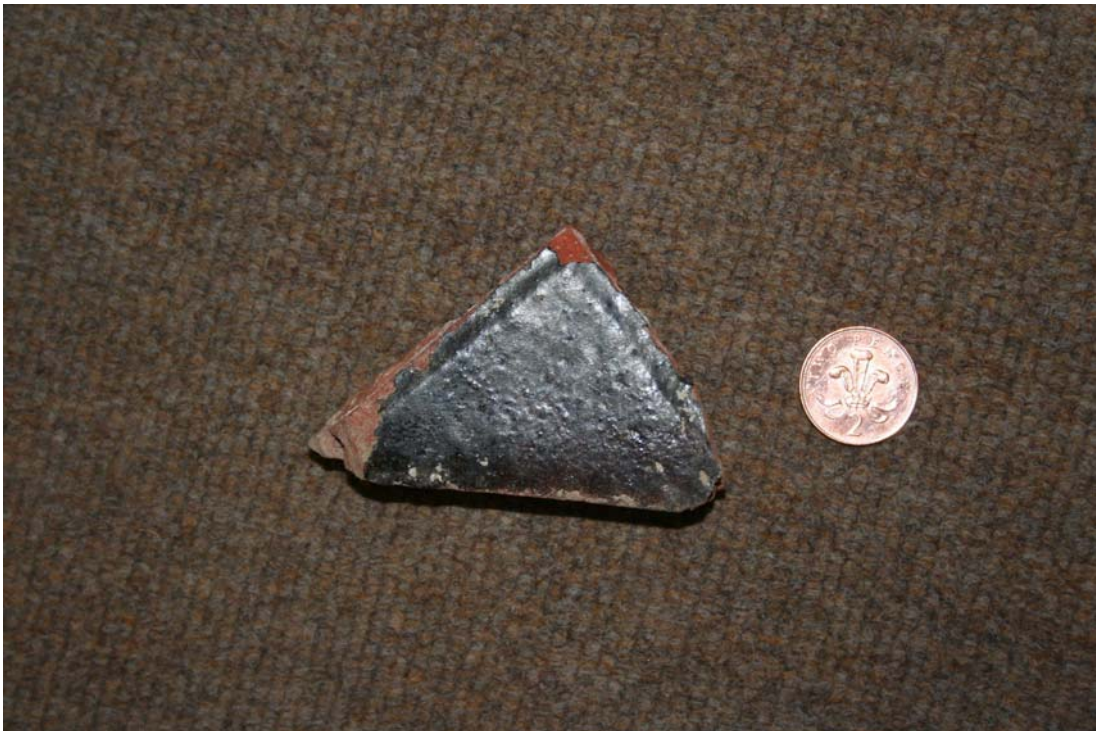
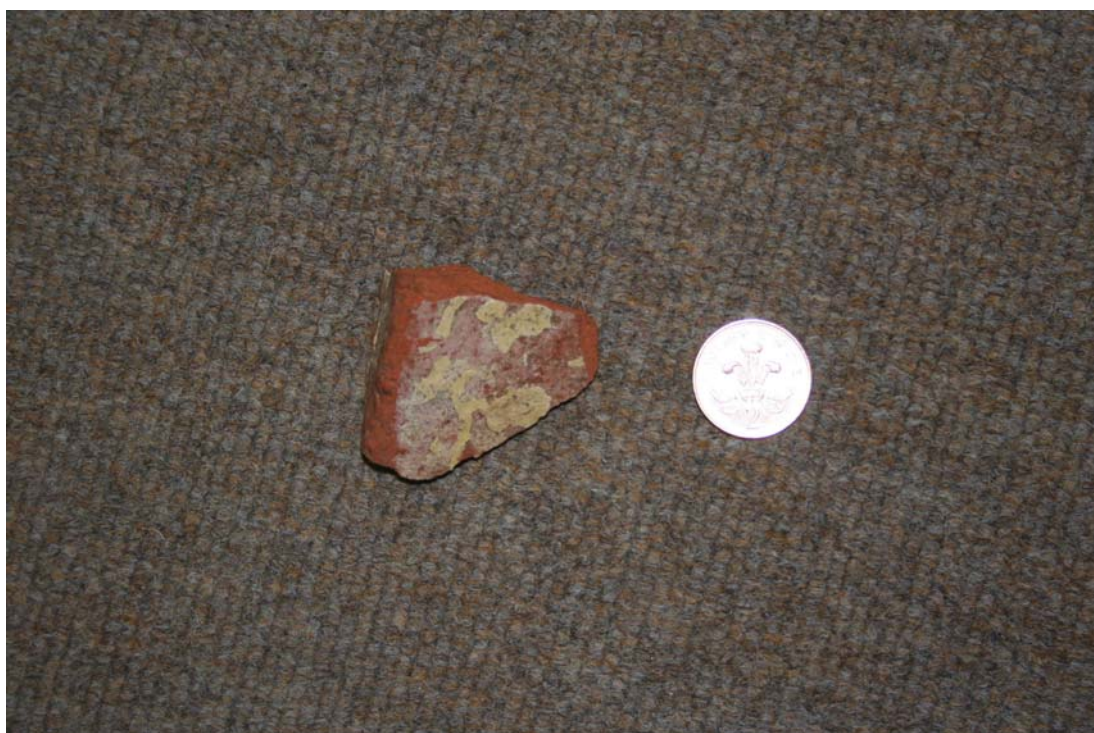
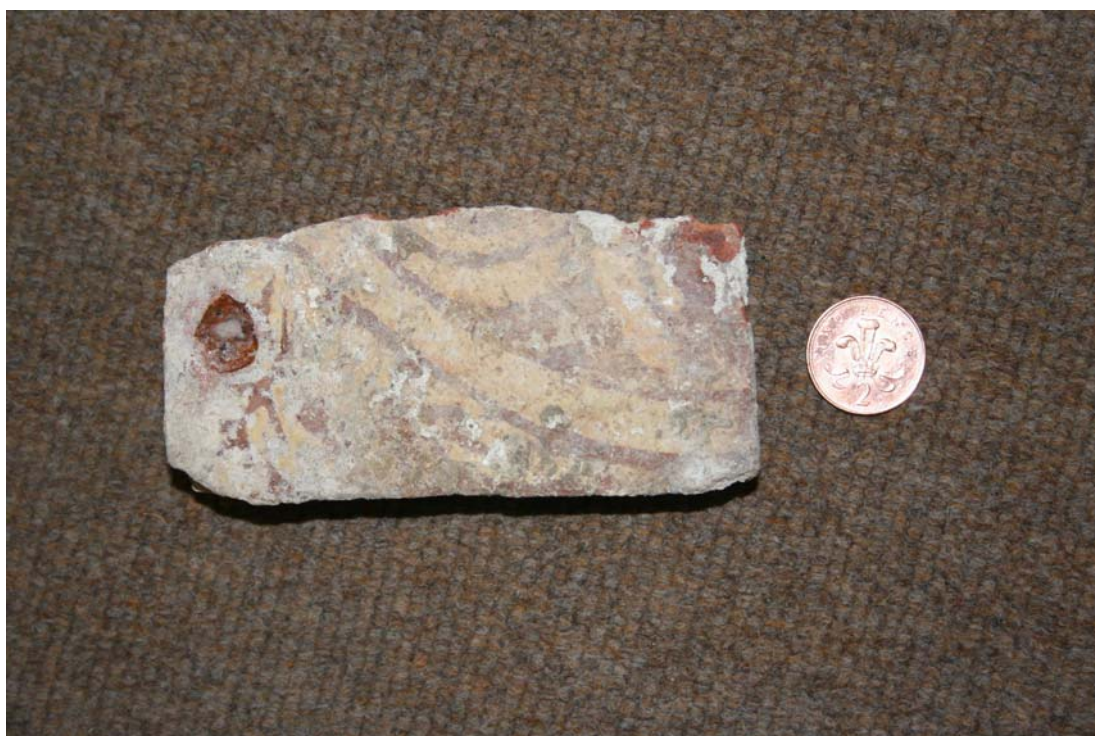
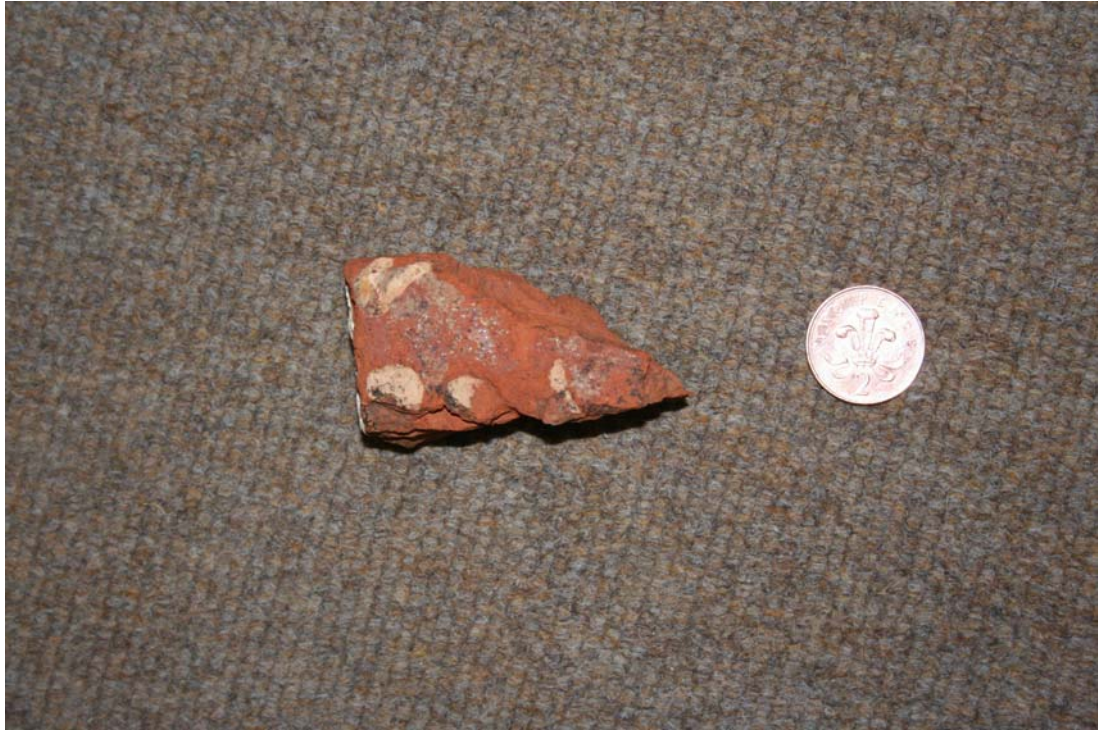
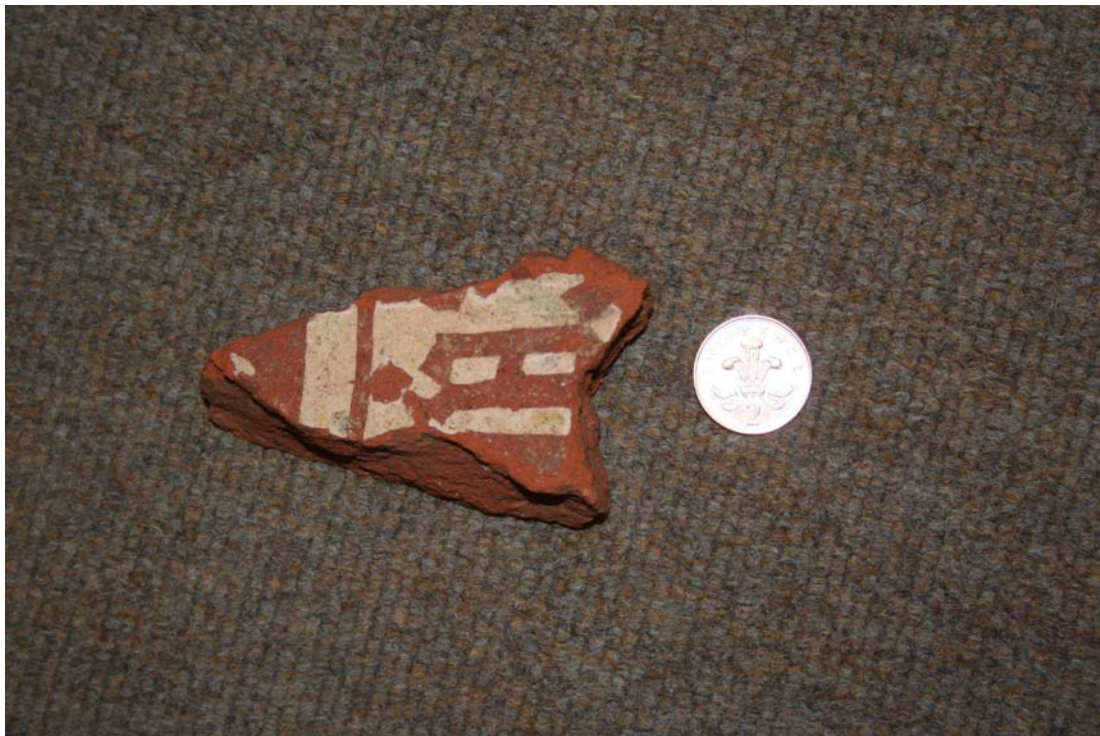
A quantity of non articulated human bone was found in the soil (this was reburied in the churchyard), as well as several pieces of medieval floor tile (Photos. 10-15), several fragments of roofing slate, a sherd of late 19th century transfer-ware pottery and some miscellaneous pieces of iron. The floor tile demonstrates that the church probably had a surprisingly high quality floor at one time. This was perhaps not in the medieval period, as there is the possibility that the tile was recovered from a higher status ecclesiastical establishment, such as Talley Abbey, at the dissolution in the 1530s and reused in St Sadwrn's. The roofing slate is

The only artefacts were found in the soil make up in the south chapel. Finds such as late 19th century pottery and miscellaneous ironwork probably of a similar date have been disposed of. Several fragments of micaceous stone roof tile were found, one complete example of which has been retained in the archive. Eight pieces of medieval floor tile were also found. These have been retained in the archive. Photographs (Photos. 10-15) are provided of the best examples.

Photographs 10 - 15. Medieval floor tile from sub-floor of South Chapel.
