CARMARTHEN FOOTBALL CLUB NEW STAND AND FLOODLIGHTS 2004-5 PHASE TWO STAND EXTENSIONS 2006

ARCHAEOLOGICAL WATCHING BRIEF

Prepared by Cambria Archaeology
For Carmarthen Town Football Club

RHIF YR ADRODDIAD / REPORT NO. 2006/115
RHIF Y PROSIECT / PROJECT RECORD NO. 51298 and 57056

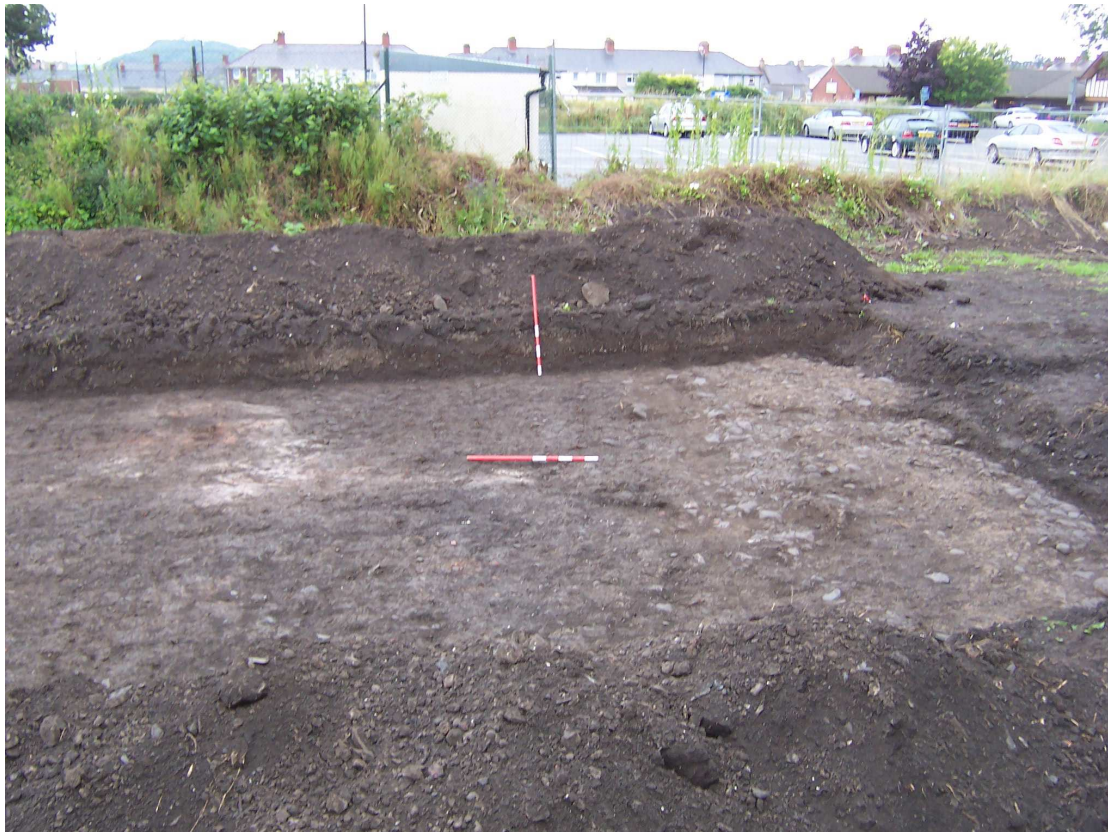
Photo. 1. Roman road (105) far right, heat affected area to left. View NW. Scales 1m

The most obvious feature encountered was part of a Roman road (105), although only the southern half of this road was within the stripped area. This road is almost certainly part of that which is known to bisect the football pitch. The lowest visible layer (109) of this road appeared to be an earlier road surface. This layer consisted of orange sandy clay with about 80% smallish flat rounded cobbles and rounded angular pebbles; there was also an area with tiles, which could be a variation in construction or a repair. Along the edge of this layer (109), there was a line of stones, possibly the remains of a kerb. Above the metalling (109) there was a thin layer (108, not indicated on plan), possibly buried soil or mud deposited on the road before re-covering. Over this there was a layer (107) of dull orange compact sandy clay with 20% rounded and flat stones; this was probably a sub-strata or make up for the road surface above. The road surface (106) was made from a few large flat stones along with other large flat rounded cobble interspersed with sub-circular pebbles. Above this (106), at the northwest corner of the trench, there was a linear patch of material (123), similar to the make-up (107) below the road surface, possibly a repair or remaining re-surfacing of the road. Much of the upper road material appeared to have been eroded or disturbed, probably by later cultivation.

South of the postholes (113 and 115) and west of the daub patches (117 and 118) there was a large patch of very light brown clay (119 and 120), part of which was very heat affected, possibly the remains of an oven or kiln.

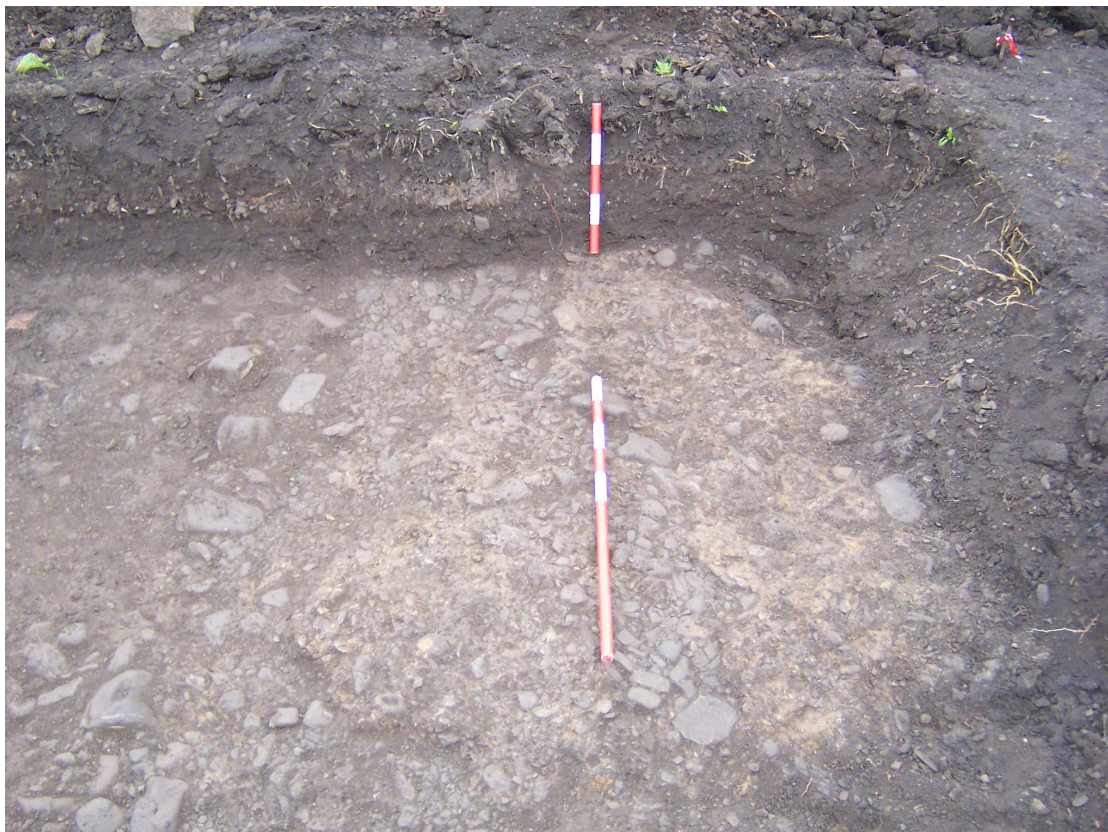
Photo. 2: Detail of Roman road (105) surface. View NW. Scales 0.5m and 1m

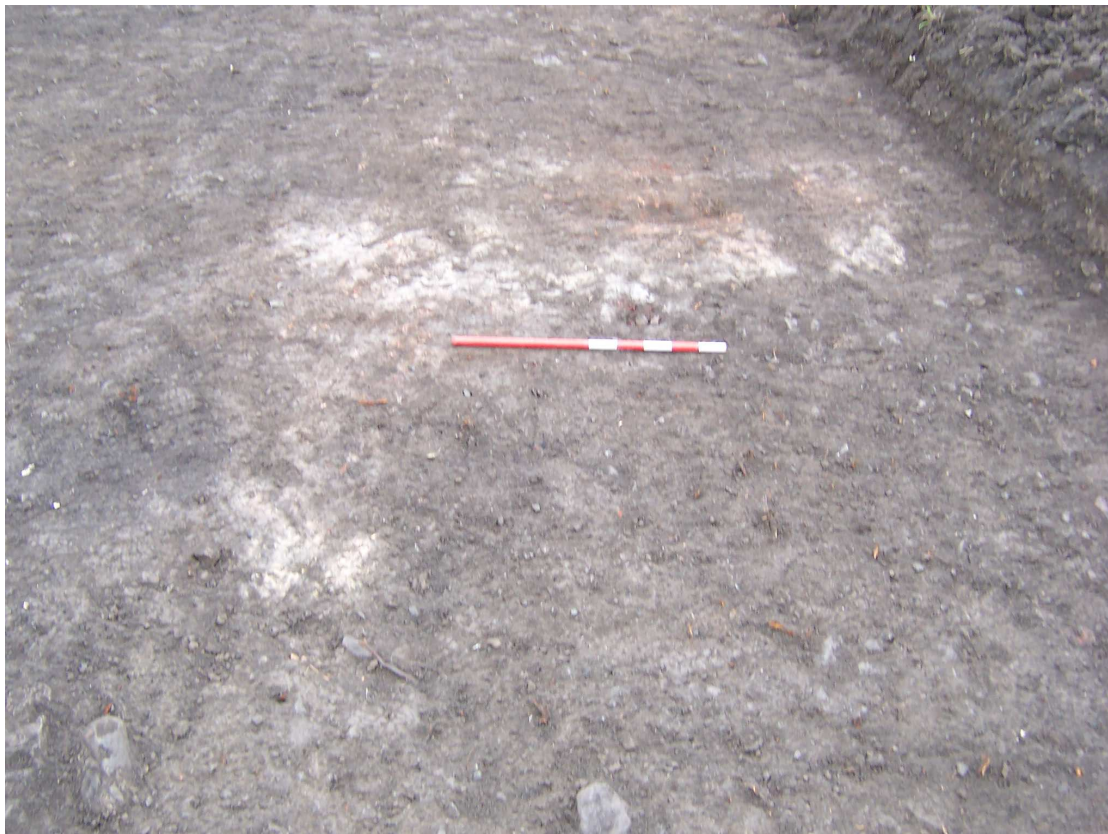
Photo. 3: Detail of heat affected clay (120). View SW. Scale 1m

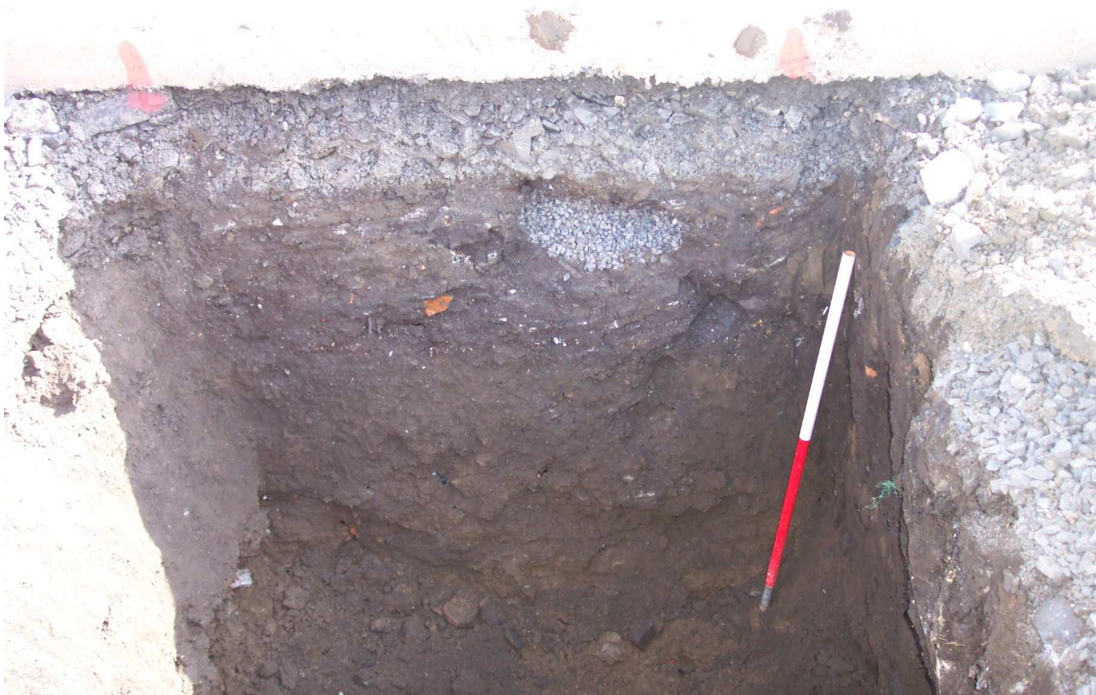
Roman deposits were reached at a depth of c.1.25m. This area appears to have been built up in the past, as modern plastic, glass and ceramics were encountered down to the top of the Roman layer. The Roman deposit was a brown loose silty clay loam containing charcoal flecks, brick and tile fragments and mortar. A Roman brick was recovered from this deposit.

Photo. 4: WFLB1 showing the modern overburden overlying the Roman deposit, visible as the lighter brown material at the base of the pit. View E. Scale 1m

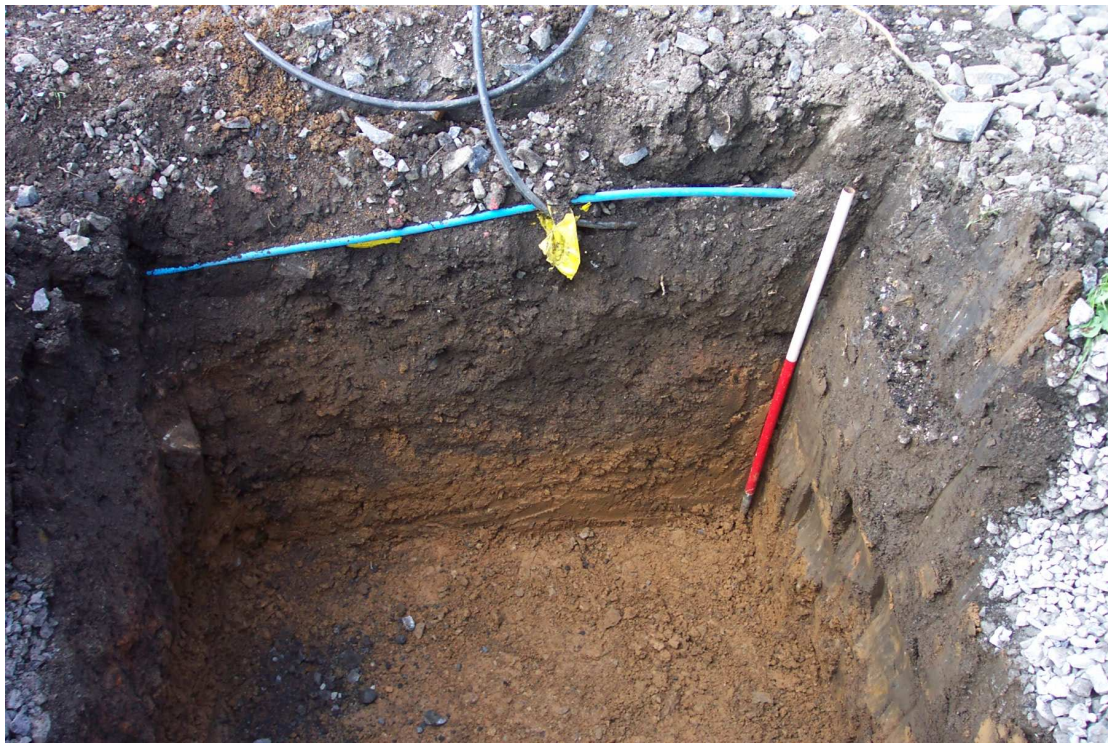
The top of the Roman deposits were encountered at a depth of 0.45m. The deposit, 58cm thick was a light brown silty clay loam containing pottery sherds, small fragments of brick and tile, charcoal flecks, mortar and a large amount of burnt clay particularly towards the bottom of the layer. A shallow pit filled with charcoal flecks, angular stones, small fragments of brick or tile and mortar was cut into the top of the Roman deposit. It is not clear if the pit was dug in the late Roman period, or sometime later, although a Roman date is likely.

Photo. 5: WFLB2. Roman deposits starting below dark grey layer and modern disturbance. View W. Scale 1m

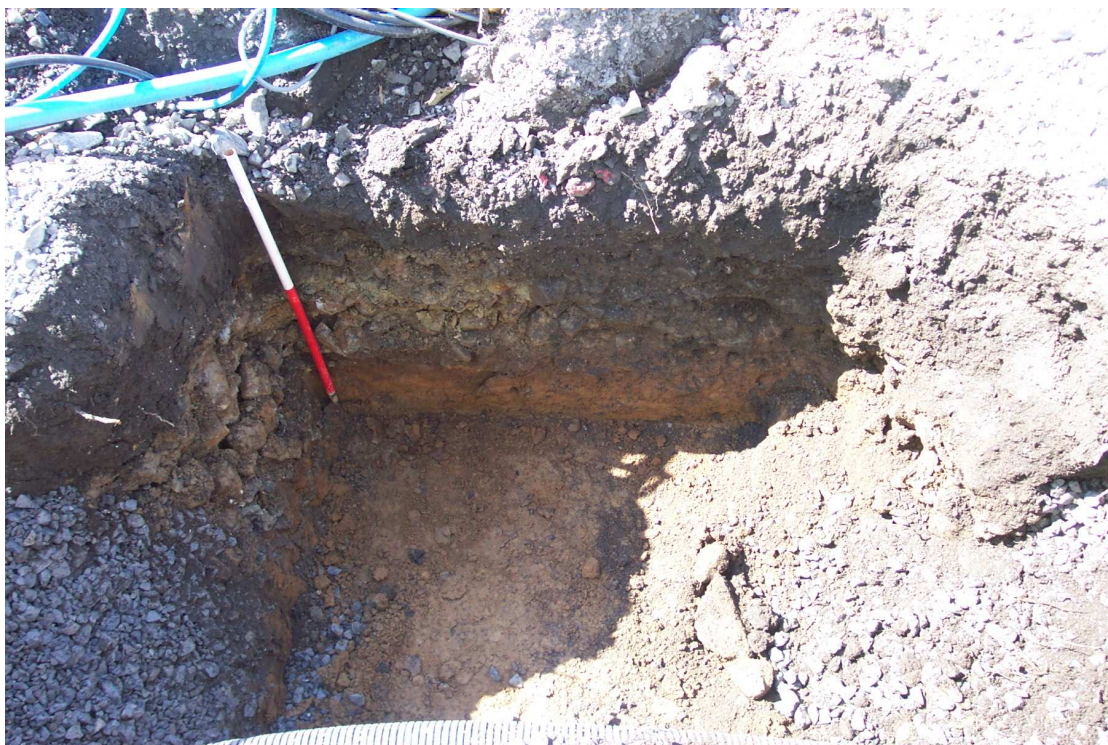
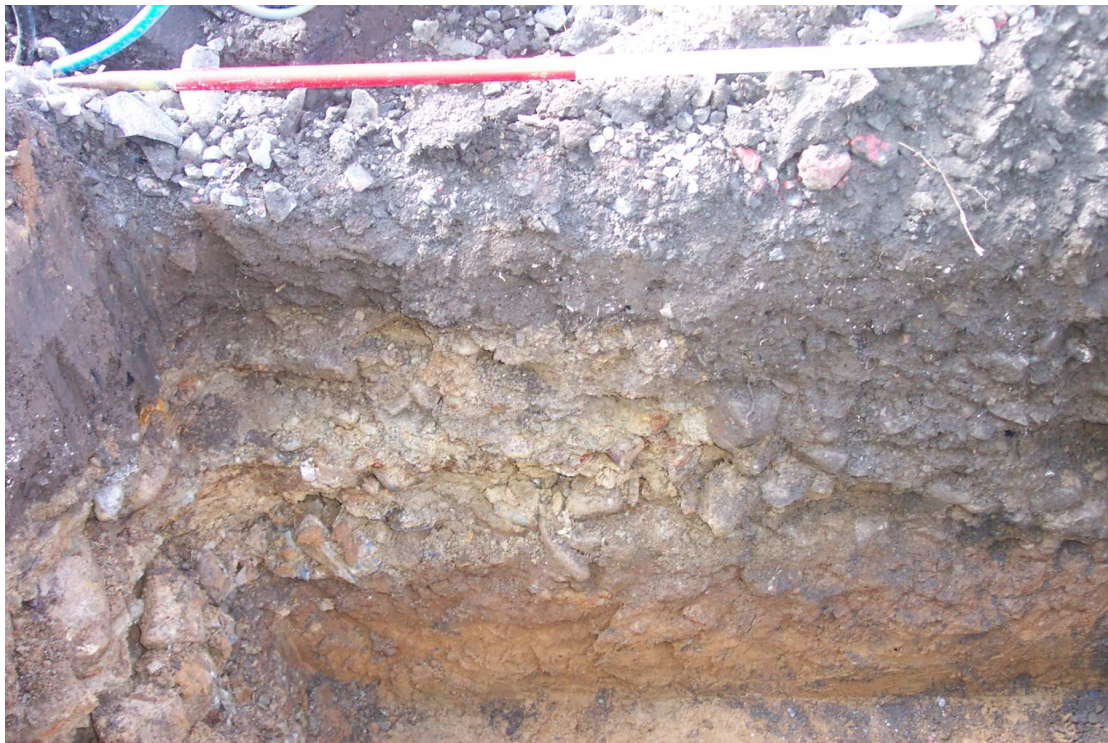
The top of a Roman road was found 0.6m below the surface, with a gravel surface above large stone foundation extending up to 0.48m deep. This road is almost certainly part of the same road that bisects the football field and was also identified in the northern extent of the new stands area. Below the road foundation there was a layer, 0.1m thick of stiff brown clay with charcoal flecks, possibly a working surface or original ground surface prior to construction of the road. Below this charcoal flecked layer there was a natural subsoil, c. 1.18 below the ground surface.

Photo. 6: WFLB3. Roman road, light covered deposit behind scale. View W. Scale 1m

Photo. 7: WFLB3. Detail of Roman road in section. View W. Scale 1m

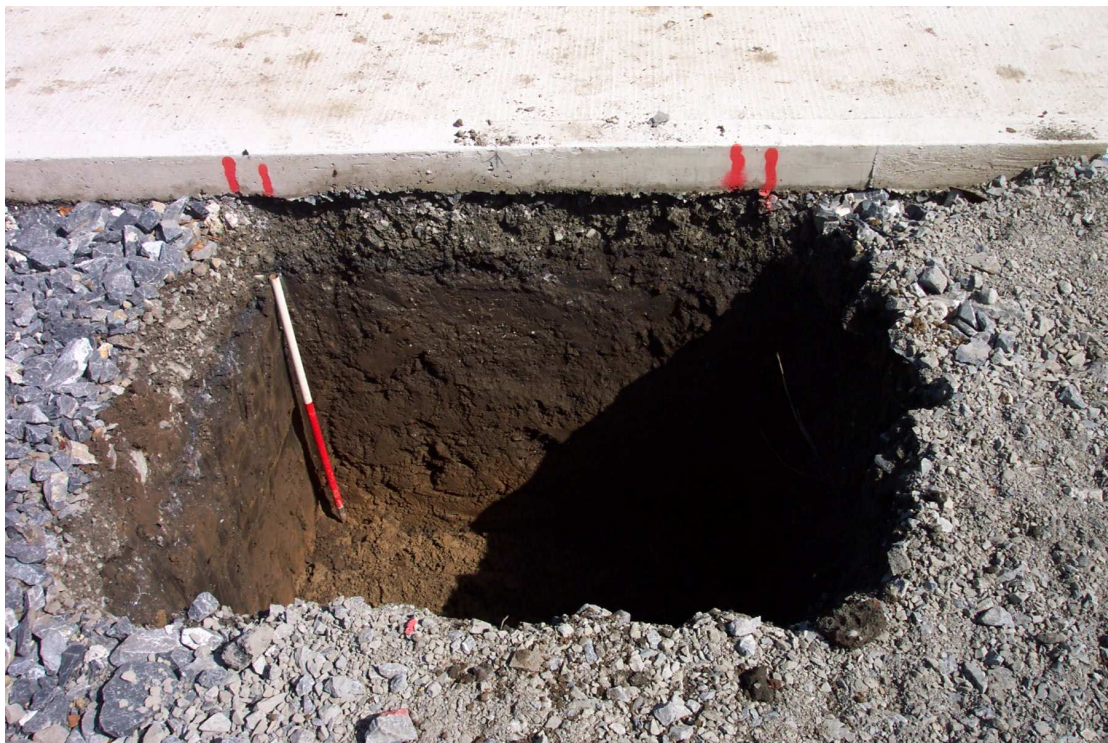
Possible Roman deposits were found 0.5m below the ground surface. This deposit or deposits were nearly 0.5m deep and overlay the natural subsoil.

Photo. 8: WFLB4. View E. Scale 1m

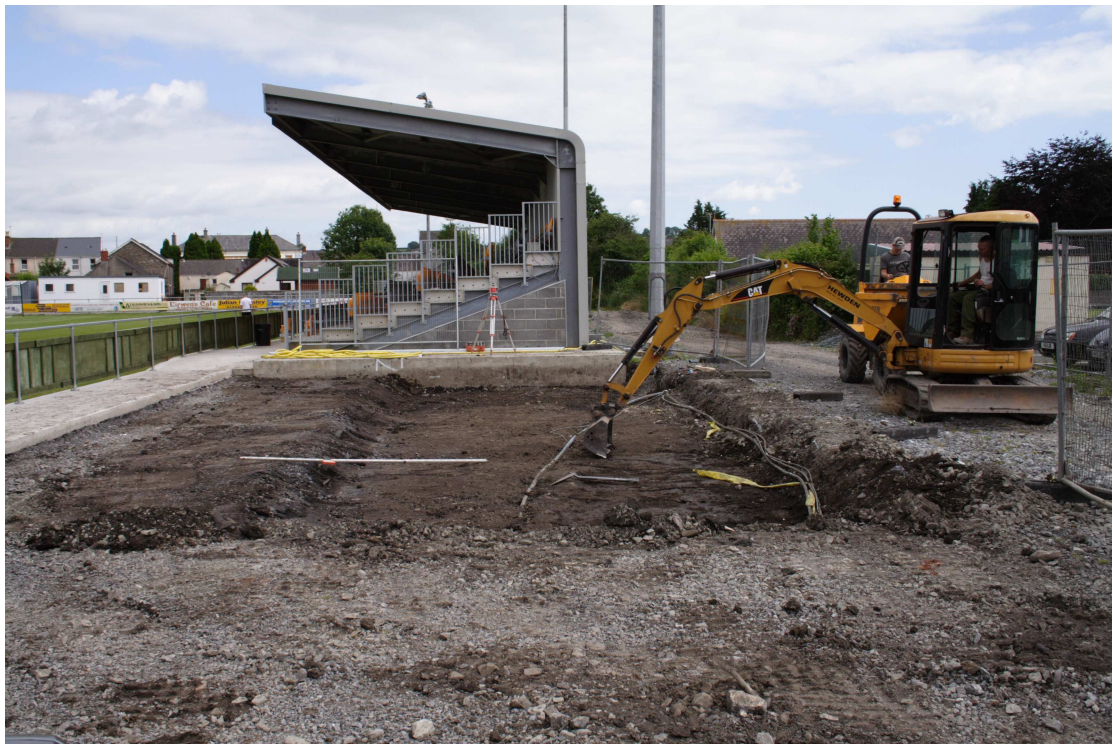
Nothing of archaeological interest was seen in the northern extension area (Photo. 9). Crossing most of the rear (west) of the area there was a service trench, approximately 0.5m into the area. This trench contained three cables, of which at least one was for electricity. The bottom of the trench was approximately level with the finished excavation depth. There was a modern gravel filled trench extending from the southwest corner, which had been dug below the finished excavation depth. This gravel filled trench was joined by a plastic water pipe with a cable immediately below (possibly telephone, as no warning tape), about 4m north of the new stand's concrete raft. At the western edge the water pipe and cable trench was above depth excavated but extended below this depth from where it encountered the line of the gravel filled trench, but probably no more than 100mm or so below the finished depth.

Photo. 9: North extension area as excavated. View SSW

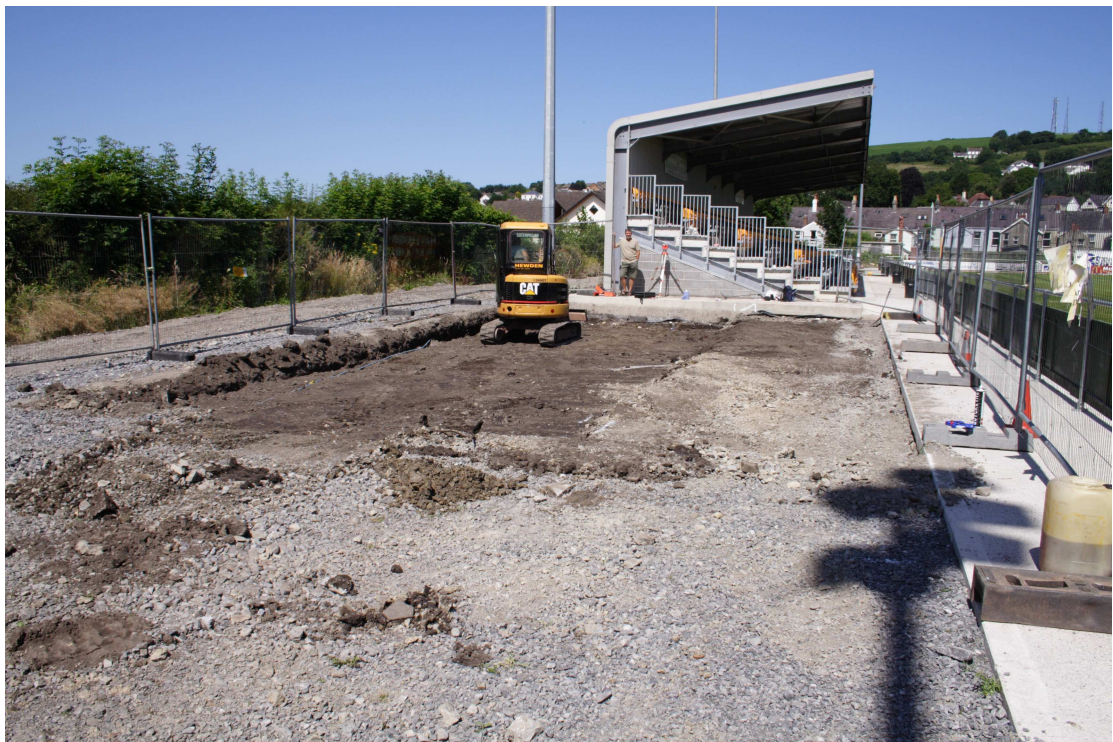
In the south stand area (Photo. 10) part of a possible Roman period deposit was just uncovered, but not damaged, where the machine went a little too deep

Photo. 10: South extension area as excavated. View N

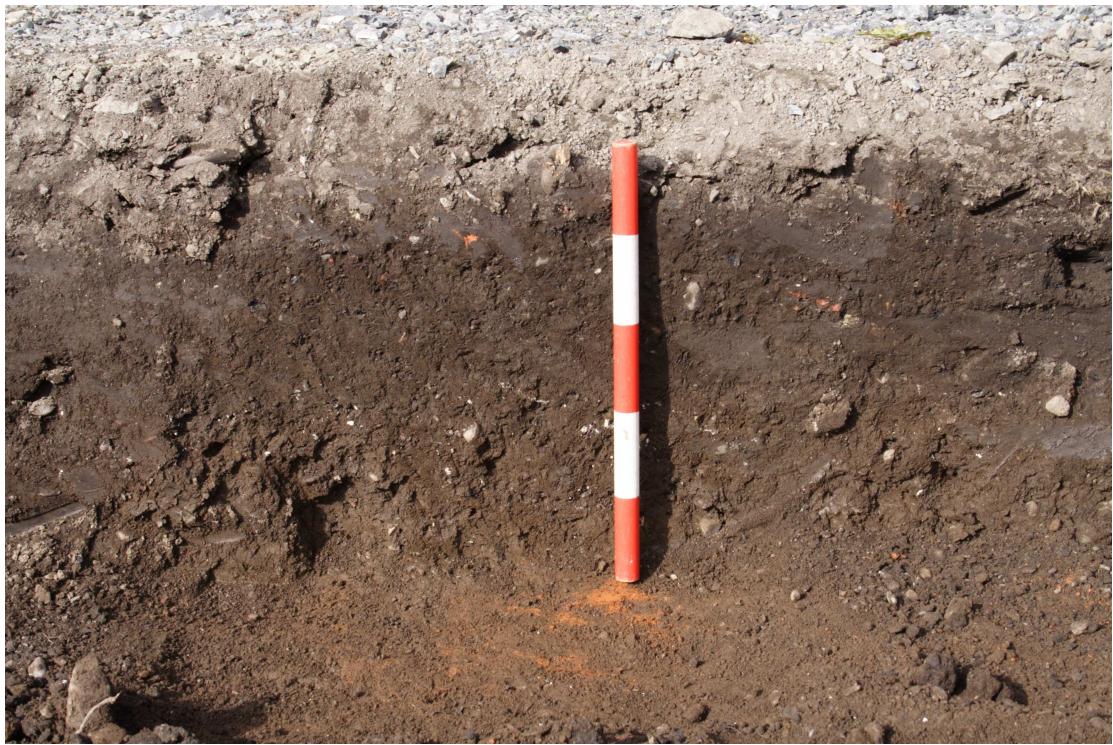
(22.46m OD) against the west section (Photo. 11). The deposit contained a large amount of fire-reddened material but no coal flecks, unlike the layer of lower topsoil or plough soil above which contained significant coal flecks. There was a line of modern postholes, running parallel to the football field that may have been for a fence, possibly of the same period as the old stand. There was again a very recent water pipe trench with an electric cable below just in the rear of the machined area. In the higher area, to the east, there was a stone chipping filled trench, 0.5 to 1m west of the pavement alongside the football field. The depth or purpose of this trench was not ascertained but was presumably contemporary with the new stand.

Photo. 11: South extension area, detail of west section, with possible Roman deposit just showing at the base of 0.5m scale. View W

The excavation for the stand extensions did not disturb archaeological features but it was evident from an accidental shallow machine scoop in the south area that they are likely to exist just below the depth excavated.
